# Inspector General

United States  
Department of Defense

## Ballistic Testing for Interceptor Body Armor Inserts Needs Improvement

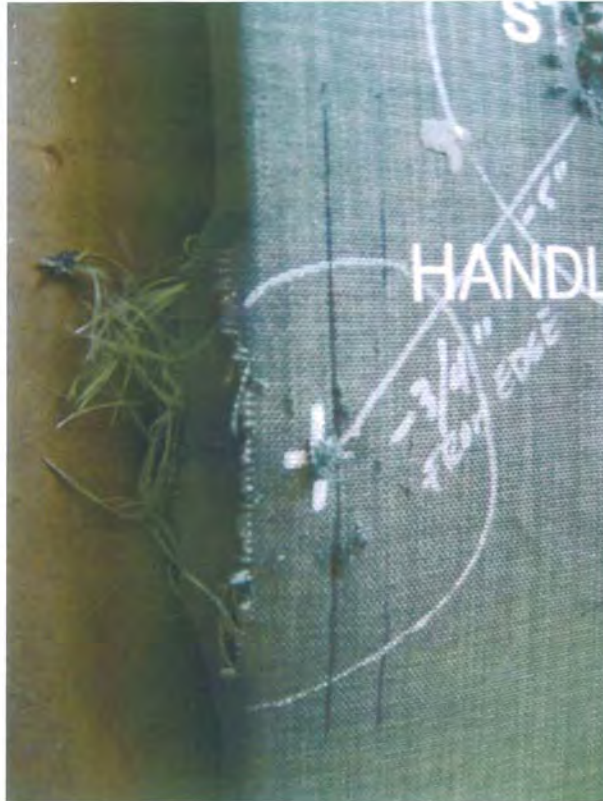
**Figure 2. Photograph of the Contested Ballistic Insert**

PM SEQ did not properly document and support its decision to overturn a potential catastrophic failure as defined by the COPD. PM SEQ accepted ballistic inserts on contract W91CRB-04-D-0040 although a LAT had a BFD of 48 mm. PM SEQ officials did not adequately document their decision to accept the lot even though the COPD considers a BFD of 48 mm to be a catastrophic failure. The chief scientist claimed that the lot did not fail because the shot was too close to the edge. The COPD requires that the first shot be between .75 and 1.25 inches from an edge. PM SEQ did not document the incident.

On March 29, 2007, an additional ballistic insert was tested and achieved a passing score. Based on this test, PM SEQ accepted and distributed the lot. Figure 2 contains a photograph of the ballistic insert, taken by the contractor and provided to us by PM SEQ. However, there were no identifiable serial numbers or tile numbers to indicate that the ballistic insert in question was the same as the one in the photograph. We asked to see the ballistic insert, but PM SEQ staff could not locate it.

In instances that involve a disputed test, PM SEQ should maintain adequate documentation in the event that future questions are raised. Documentation should include photographs, x-rays, serial numbers, or the actual item, as appropriate.

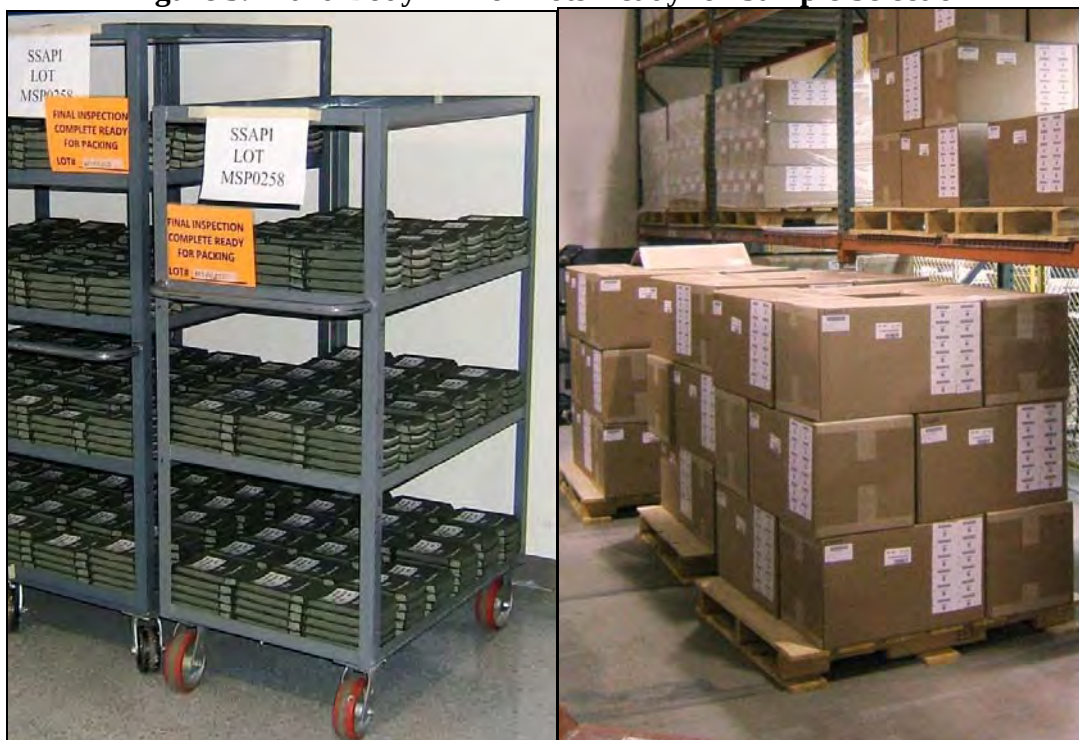
**Figure 3. Hard Body Armor Lots Ready for Sample Selection**

The QAR selects the samples and observes as a contractor employee verifies that weight and dimensions comply with contract requirements. The contractor employee records the serial numbers on the DD 1222, "Request for and Result of Tests," and the QAR signs it. The QAR then sends the samples and the DD 1222 to the applicable test lab for LATs.
