Thule Air Base Airfield White Painting and Permafrost Investigation

Phases I–IV

June 2013

Final report

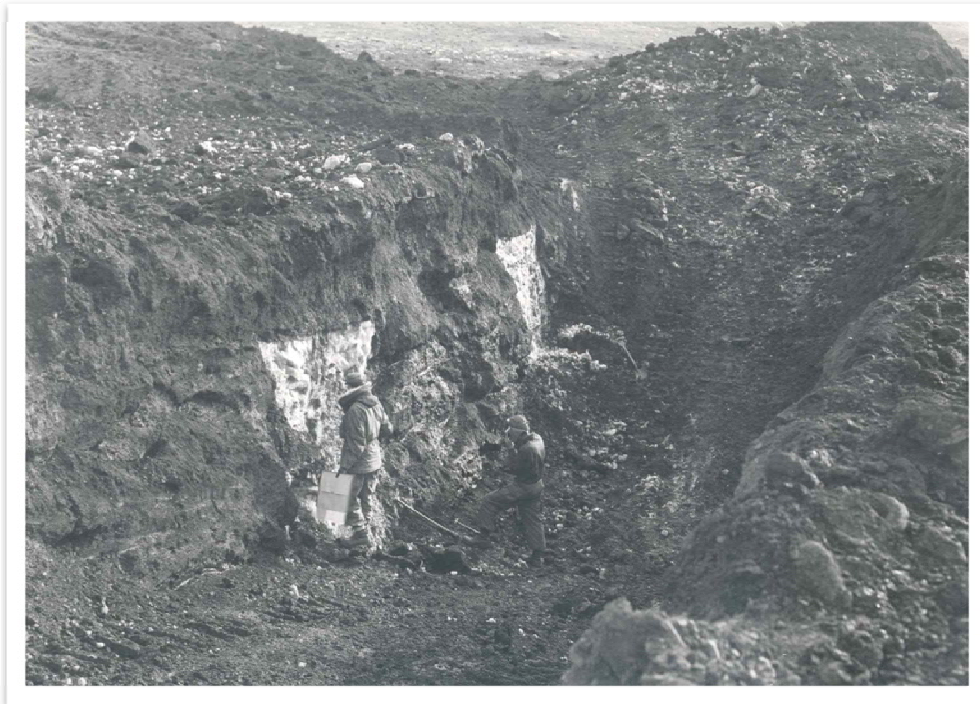
Figure 5. Ice wedges excavated at Thule in the 1960s (CRREL photo). Ice wedges such as these, located under the runway, are the cause of many previous localized depressions on the runway. Depressions that currently exist at 62+00 and 70+00 were drilled in 2009 and wedge ice was found at the 6 ft depth.

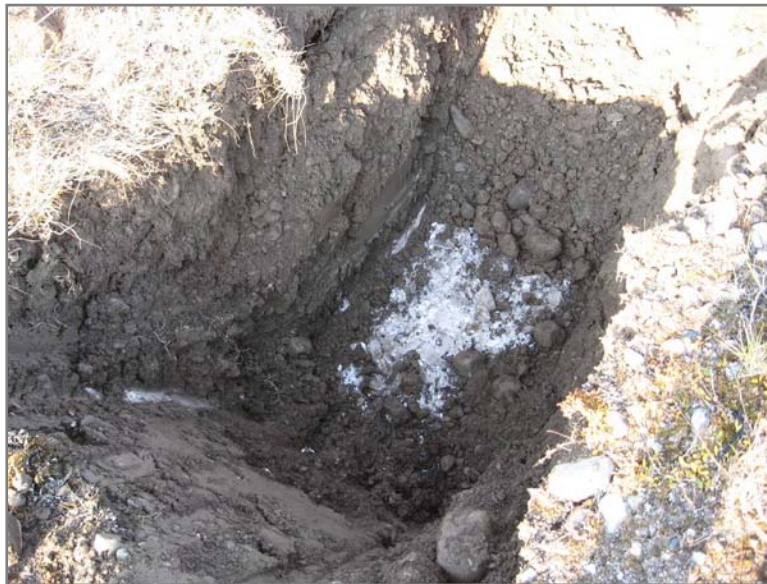
Figure 11. Test pit near Taxiway Bravo Extension. Wedge ice is seen at 5.5 ft depth.

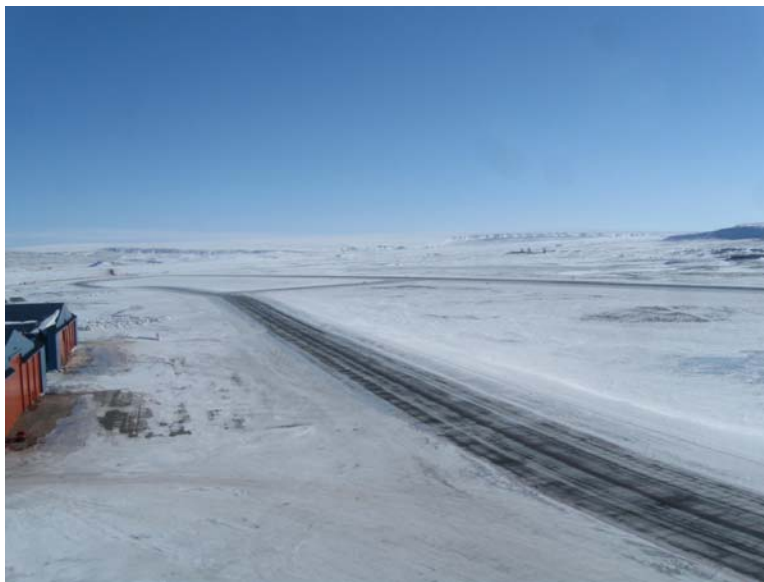
Figure 15. View from the tower April 2011, looking east to the 26 end of the runway. The faded and dark nature of the paint is very evident against the backdrop of white snow.

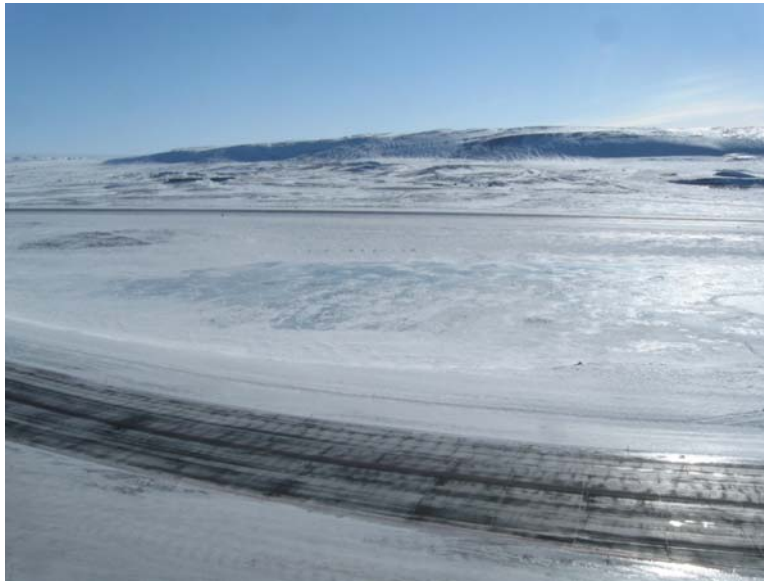
Figure 16. View from the tower in April 2011, looking directly south over Lake Eddy. The dark colored runway and taxiway are visible.

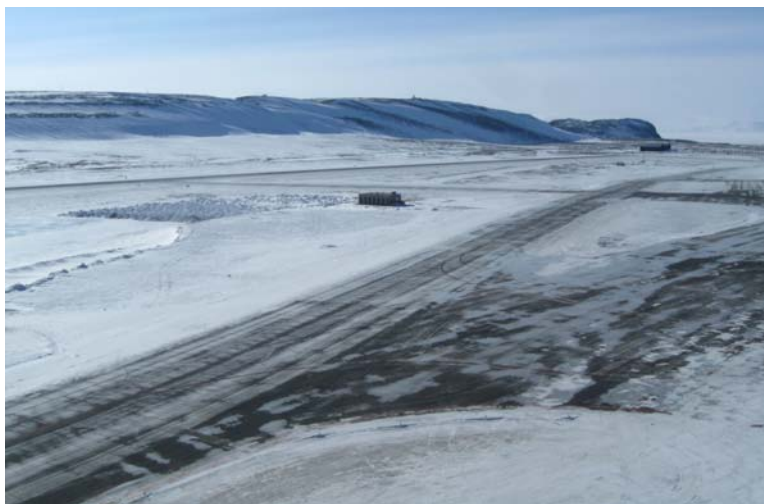
Figure 17. View from the Tower in April 2011, looking southwest to the 08 end of the runway. The dark colored runway and taxiways is visible.

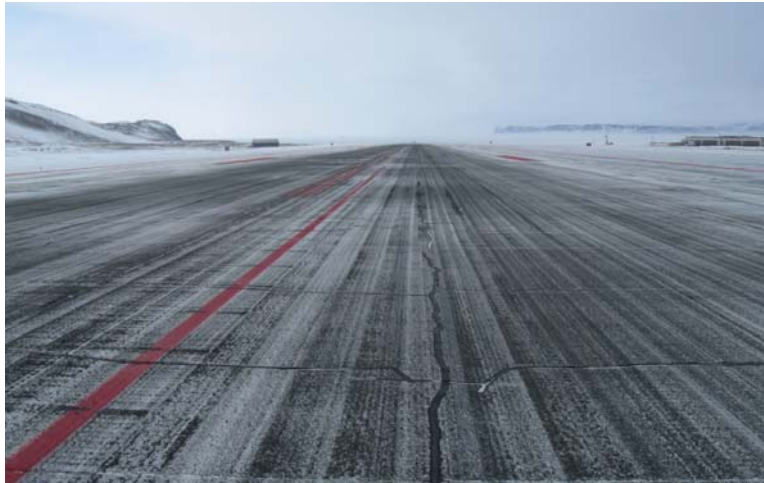
wash is reapplied (Fig. 18). Therefore, since summer 2009, the runway has had virtually no white paint along this 100-ft-wide keel during the crucial solar heating months of June, July, and early August. No thaw depressions have been created during this time, and the existing thaw depressions (namely at 62+00) have not increased in size or depth. This is especially enlightening because the summers of 2008, 2009, and 2011 were the fifth, third, and fourth warmest summers, respectively, on record since 1951 (Table 1).

Figure 18. View of the 26 end of the runway April 2011. The winter maintenance has removed the white wash coating applied the previous summer. This state persists through the warm period of June, July and early August before repainting.

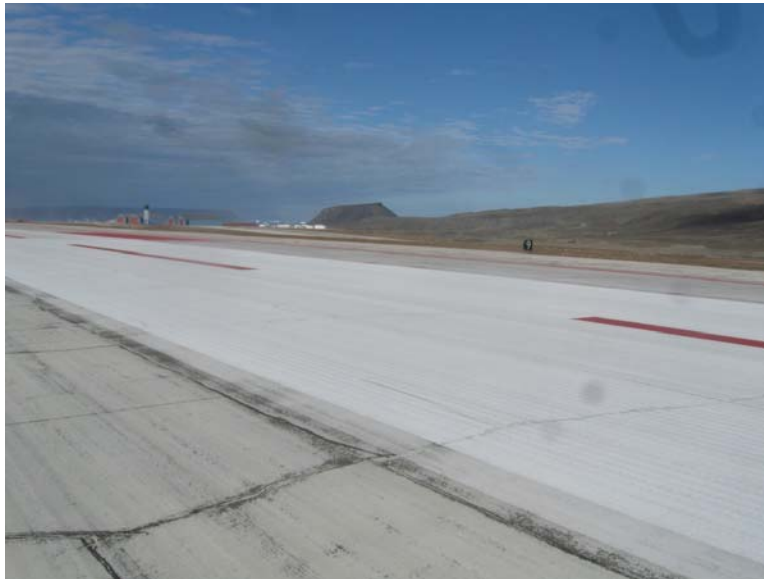
Figure 20. Bright white runway at 91+00. Albedo measured at 0.58 and the thaw depth measured at 3.9 ft.

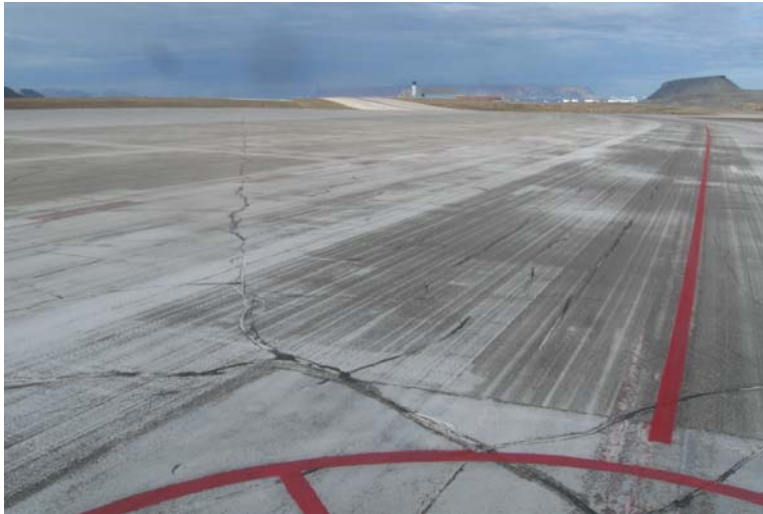
Figure 21. Brushed and faded milled surface on Txwy A at Vortac Calibration. Albedo measured at 0.26 and thaw depth measured at 5.3 ft.

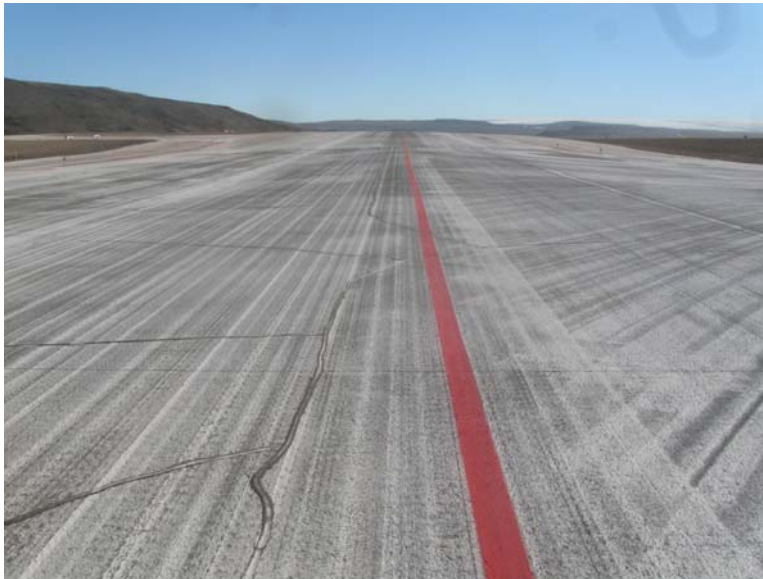
Figure 22. View east along Txwy A at Txwy Charlie. Albedo measured at 0.32. The measured thaw depth is 5.3 ft.

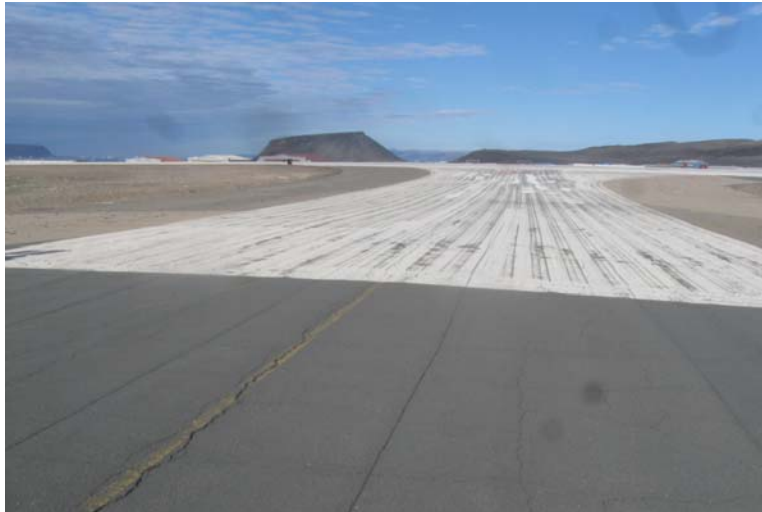
Figure 23. Old white paint transitioning to never painted surface at Txyw Bravo Extension. The white albedo measured 0.44 and the thaw depth measured 5.1 ft, while the black surface measured 0.15 and the thaw depth measured 6.5 ft.

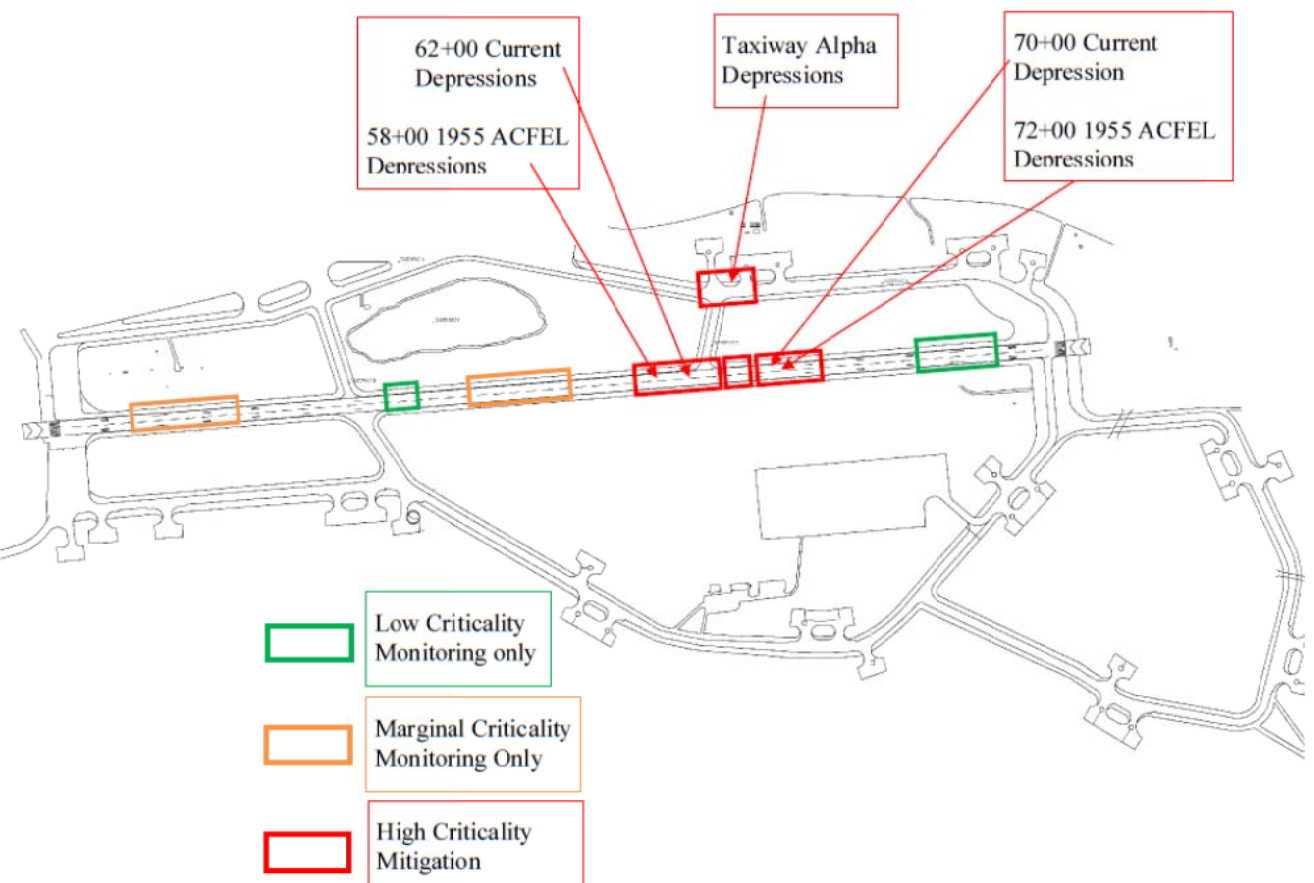
Figure 37. Plan view of the areas absolutely requiring and possibly requiring thaw mitigation.

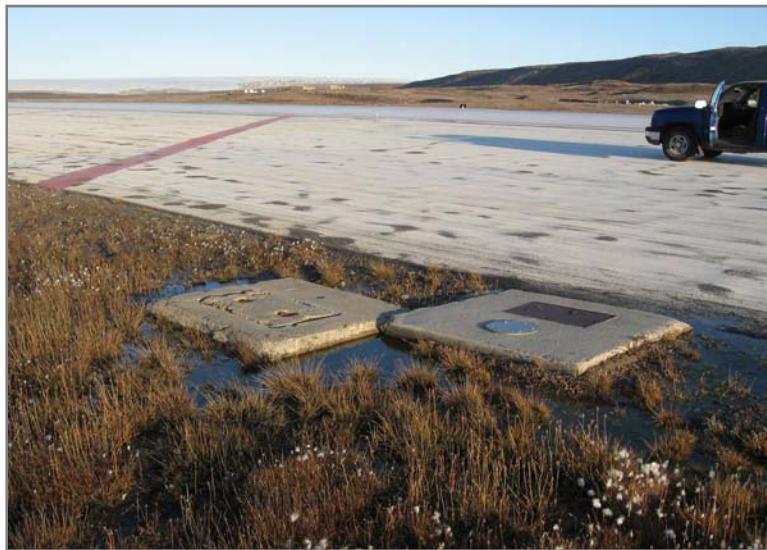
Figure 41. North shoulder of runway at 38+00. Seepage water is flowing from the electric vaults, and the visible splotchy asphalt of the shoulder is coincident with this area suggesting fatigue due to weakening of the base course or freeze–thaw problems. Water flows from the locations of the runway lighting early in the thawing season, slowly diminishing over the summer.
