## **Investigation of the Corrosion Mechanism and Determination of the EMS Estimated Service Life at Site 81**

February 2013

Final report

Prepared for U.S. Army Corps of Engineers  
Europe District  
CMR 410, Box 1, APO, AE 09049

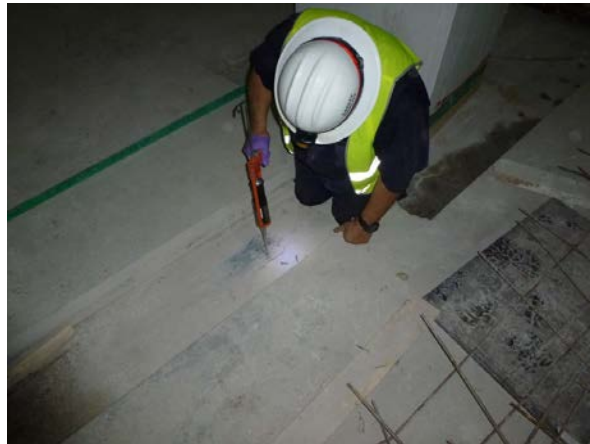
Figure 8. Existing trough in concrete liner over EMS steel plate.

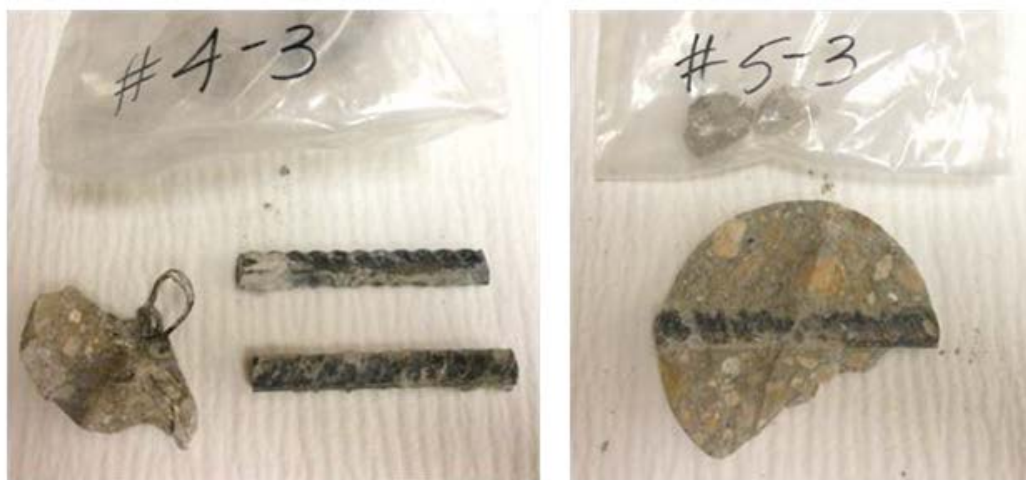
Results from acid-soluble chloride analysis are presented in Table 1 and Table 2 for each of the sixteen concrete cores at 0–1 in., 1–2 in., and 2–3 in. depths from the surface. Chloride content ranges from 0.097–2.068 lb/yd<sup>3</sup>. However, all but the topmost layer in sample #1 were below the threshold limit of 1 to 2 lbs/yd<sup>3</sup> of concrete necessary to initiate corrosion. 11 of the 16 cores tested had no definable increase in chloride ion concentration from the 3 in. level up through the 2 in. level to the 1 in. depth. Because the GSL team had no knowledge of the configuration and location of concrete cores taken at Site 81, conclusions related to potential exposure conditions and chloride ingress trends could not be made. Reinforcing bars extracted from cores showed signs of minor corrosion (Figure 15); however, this condition most likely was due to atmospheric corrosion prior to or during original installation of the rebar. Corrosion of the reinforcing steel's exposed surface at the exterior of concrete cores was also noted; however, such corrosion likely occurred following the coring process when the steel was exposed to neutral pH water and oxygen.

Figure 15. Segments of reinforcing steel extracted at 2-3 in. depth from core sample #4 (left) and core sample #5 (right) with both showing minor surface corrosion.

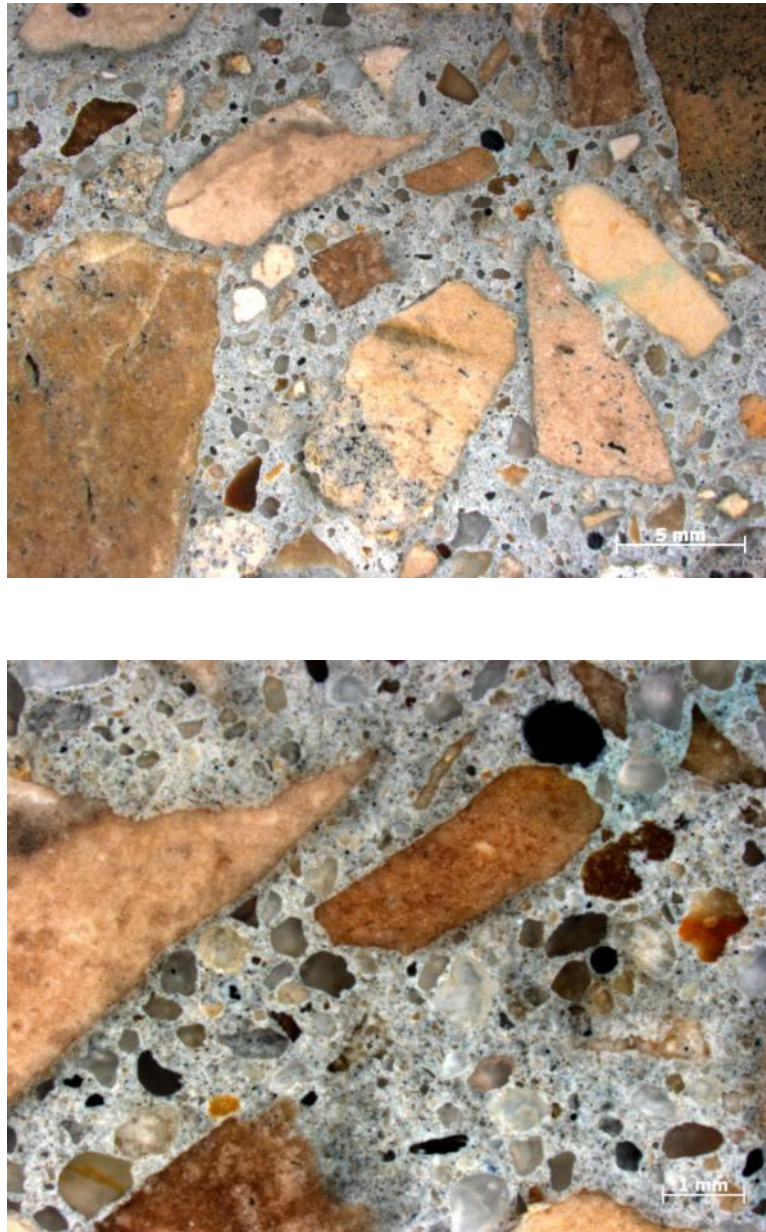
Figure 16. Photomicrographs of core sample #1 (5x above; 15x below).

Images of concrete from core sample #1 are shown in Figure 16. The concrete appears to be composed of an angular coarse and subangular-shaped fine aggregate of unknown composition. There appears to be very little air in the concrete. The concrete appears quite competent, with no visible cracks or signs of chemical reactions.

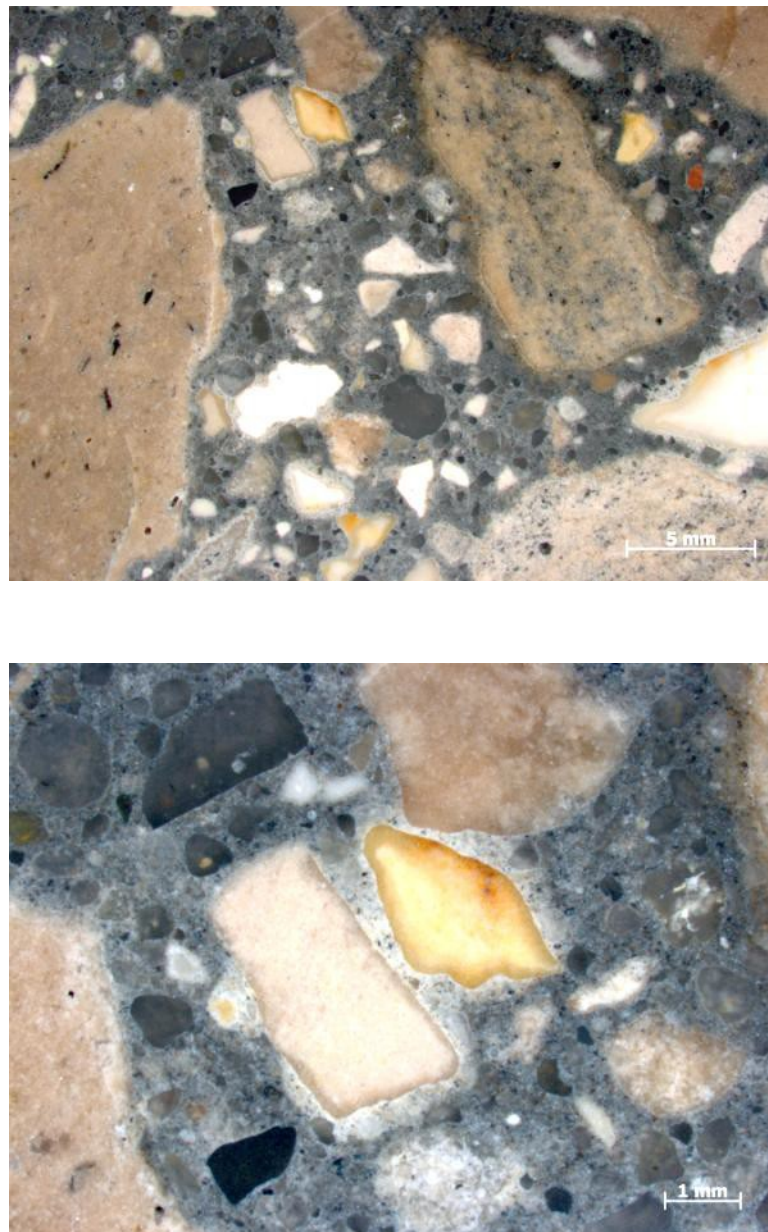
Figure 17. Photomicrographs of core sample #3 (5x above; 15x below).

Images of concrete from core sample #3 are shown in Figure 17. The concrete appears to be composed of an angular coarse and subangular-shaped fine aggregate of unknown composition. There appears to be very little air in the concrete. Although the concrete appears competent with no visible cracks, there are areas in the cement paste around selected aggregate particles that are lighter in color than the surrounding paste.

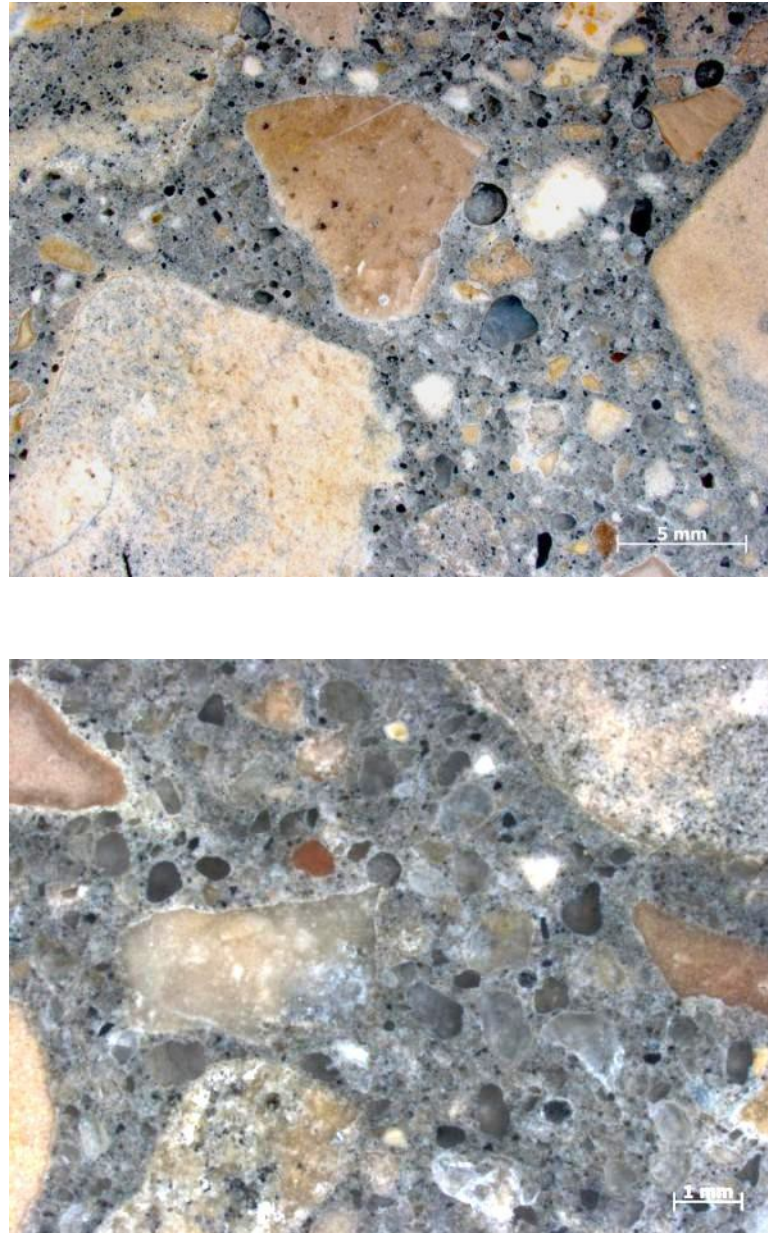
Figure 18. Photomicrographs of core sample #4 (5x above, 15x below).

Images of concrete from core sample #4 are shown in Figure 18. The concrete appears to be composed of an angular coarse and subangular-shaped fine aggregate of unknown composition. Some entrapped air is visible in the concrete. The concrete appears quite competent, with no visible cracks or signs of chemical reactions.

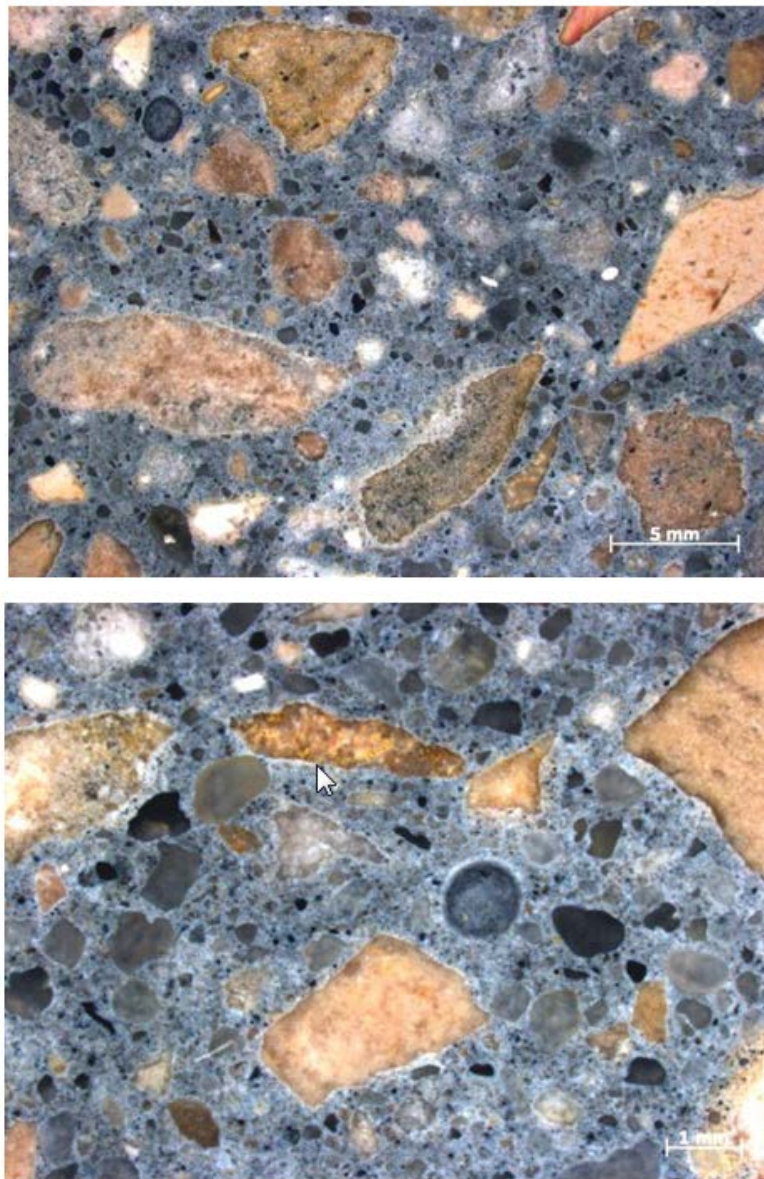
Figure 19. Photomicrographs of core sample #5 (5x above, 15x below).

Images of concrete from core sample #5 are shown in Figure 19. The concrete appears to be composed of an angular coarse and subangular-shaped fine aggregate of unknown composition. There appears to be very little air in the concrete. Although the concrete appears competent with no visible cracks, there are areas in the cement paste around selected aggregate particles that are lighter in color than the surrounding paste.

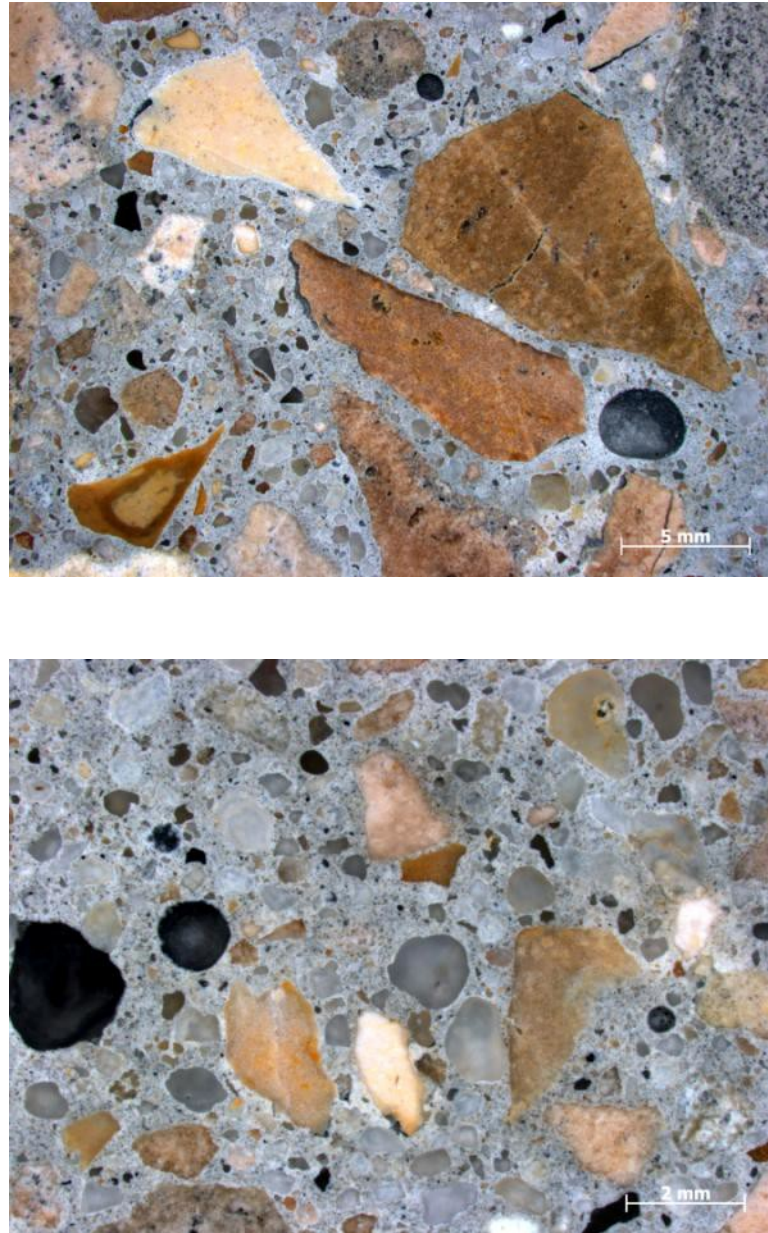
Figure 20. Photomicrographs of core sample #6 (5x above, 15x below).

Images of concrete from core sample #6 are shown in Figure 20. The concrete appears to be composed of an angular coarse and subangular-shaped fine aggregate of unknown composition. There appears to be very little air in the concrete. The concrete appears quite competent, with no visible cracks or signs of chemical reactions.

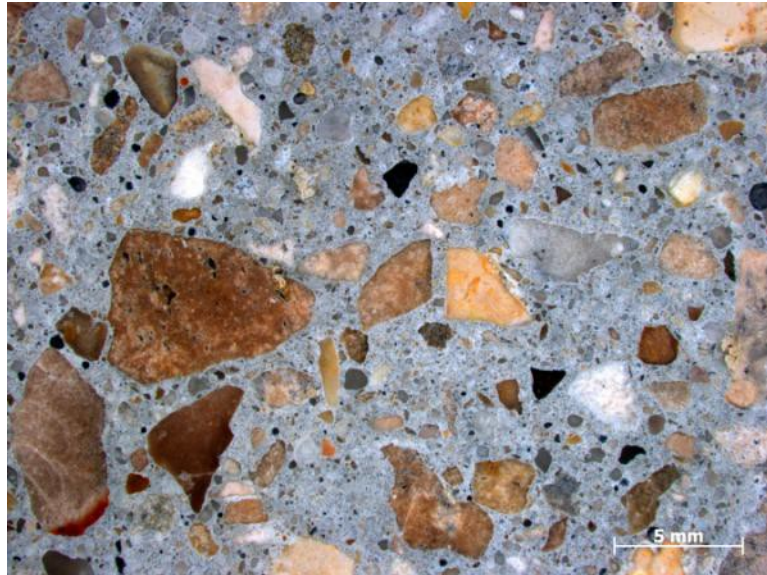
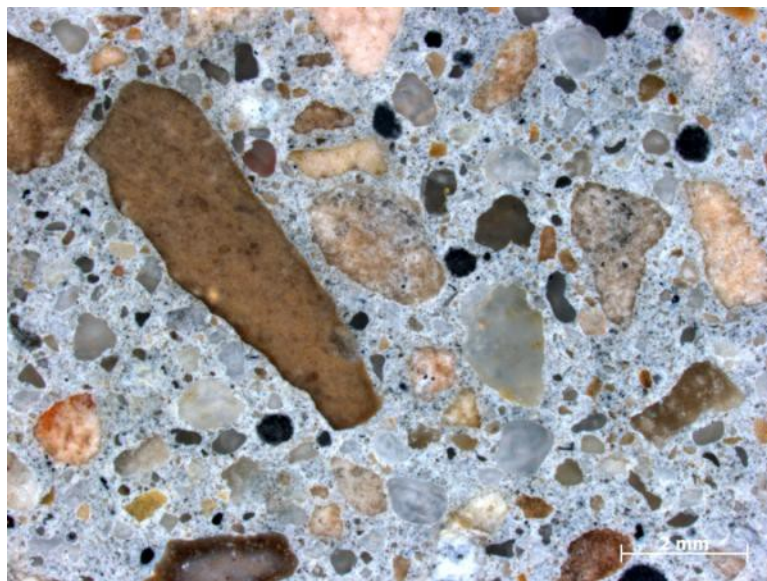
Figure 21. Photomicrographs of core sample #7 (5x above, 15x below).

Images of concrete from core sample #7 are shown in Figure 21. The concrete appears to be composed of an angular coarse and subangular-shaped fine aggregate of unknown composition. There appears to be very little air in the concrete. The concrete appears quite competent, with no visible cracks or signs of chemical reactions.

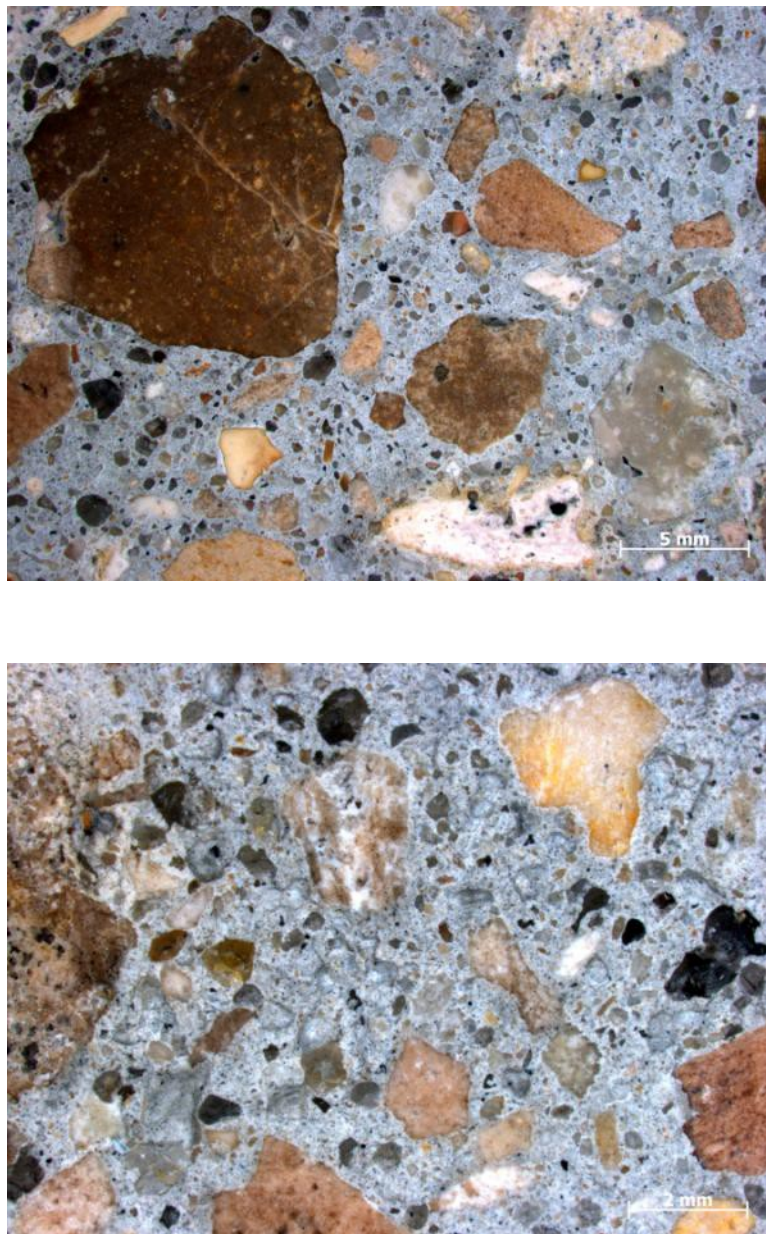
Figure 22. Photomicrographs of core sample #8 (5x above, 15x below).

Images of concrete from core sample #8 are shown in Figure 22. The concrete appears to be composed of an angular coarse and subangular-shaped fine aggregate of unknown composition. There appears to be very little air in the concrete. The concrete appears quite competent, with no visible cracks or signs of chemical reactions.

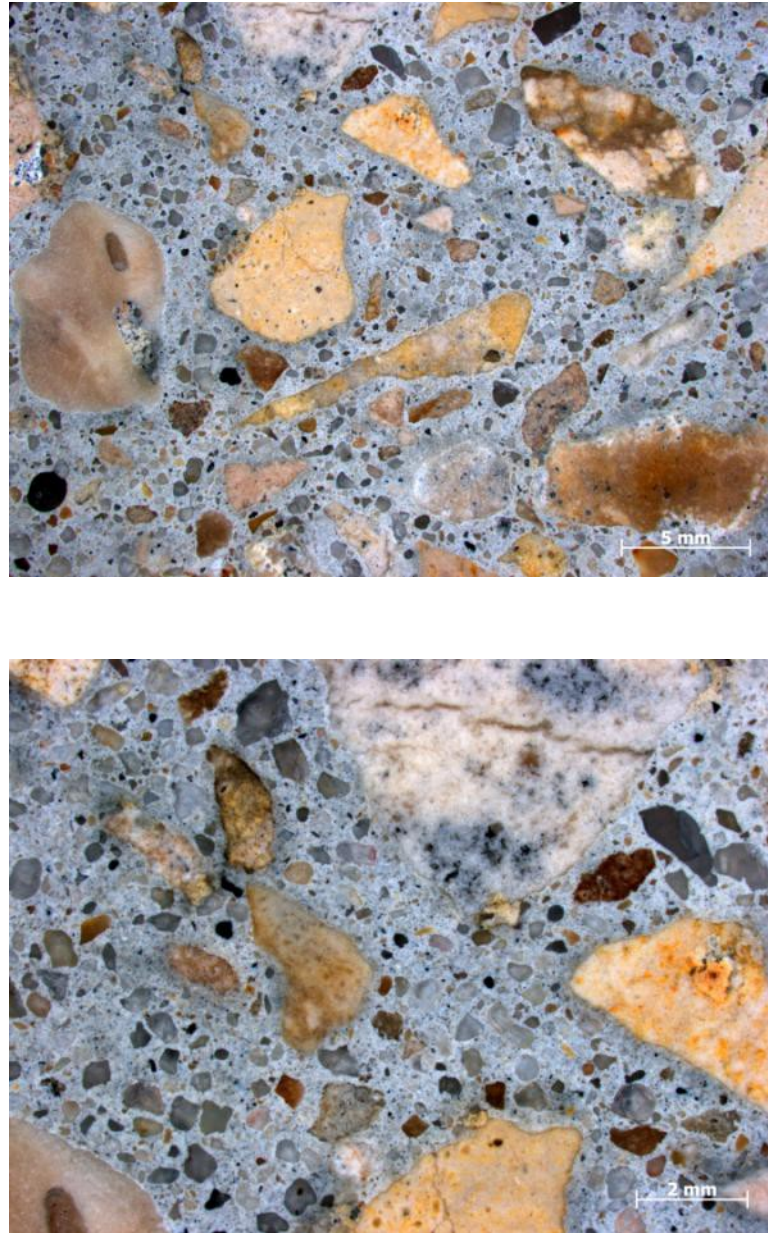
Figure 23. Photomicrographs of core sample #9 (5x above, 15x below).

Images of concrete from core sample #9 are shown in Figure 23. The concrete appears to be composed of an angular coarse and subangular-shaped fine aggregate of unknown composition. There appears to be very little air in the concrete. The concrete appears quite competent, with no visible cracks or signs of chemical reactions.

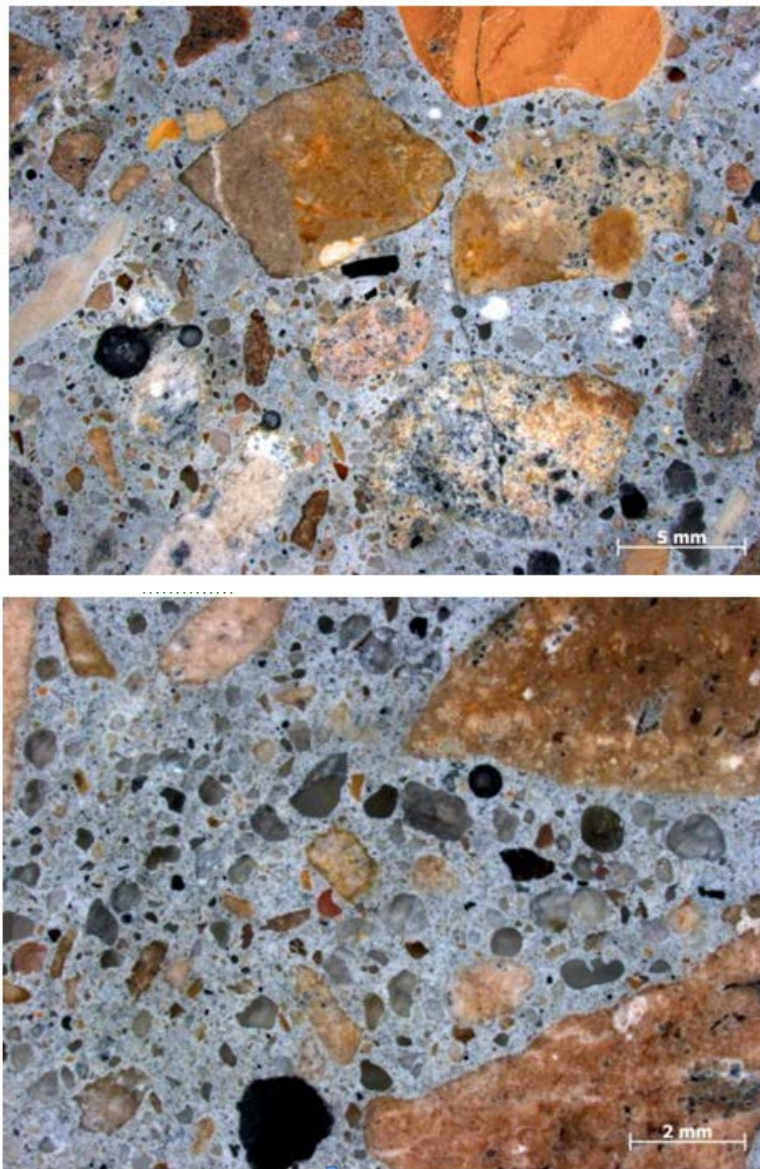
Figure 24. Photomicrographs of core sample #10 (5x above, 15x below).

Images from core sample #10 are shown in Figure 24. The concrete appears to be composed of an angular coarse and subangular-shaped fine aggregate of unknown composition. There appears to be very little air in the concrete. A large crack in the concrete starts at the upper right center and proceeds through an orange-colored aggregate that extends into the cement paste. There are no indications of any chemical reactions, which may indicate the damage is due to application of some structural load.

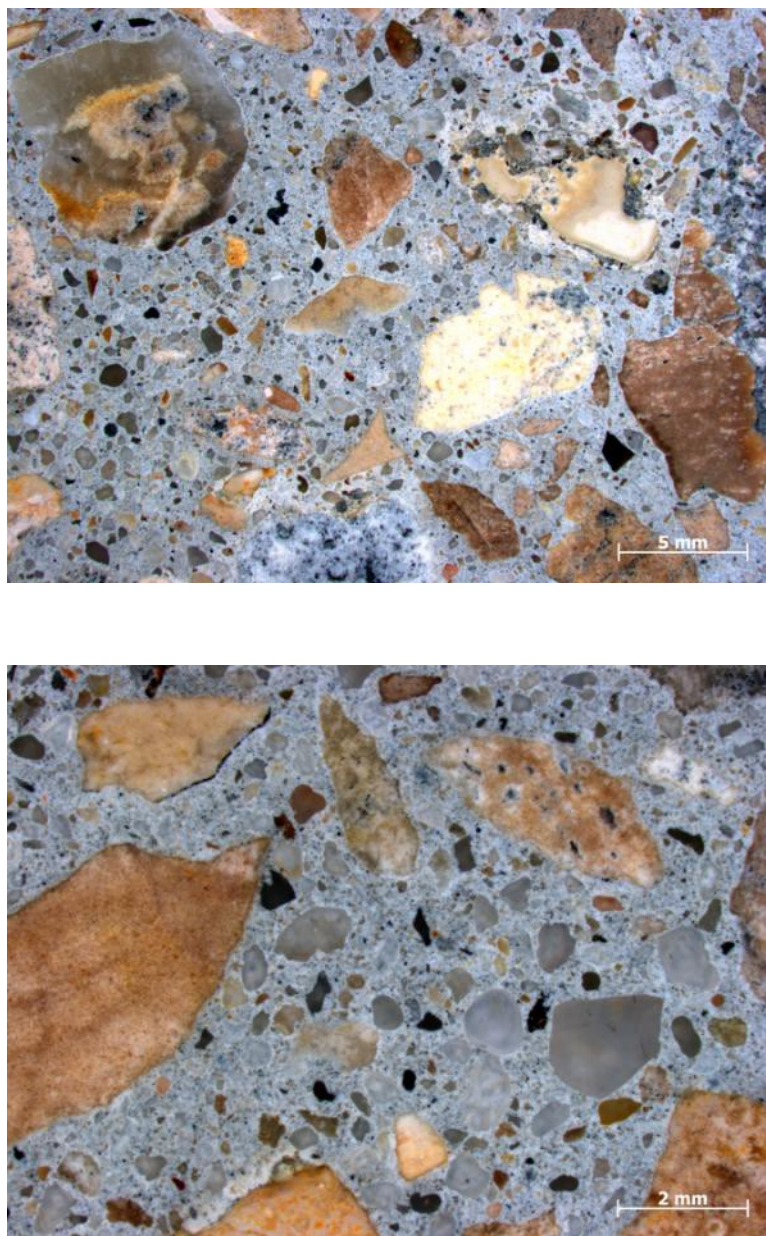
Figure 25. Photomicrographs of core sample #11 (5x above, 15x below).

Images of concrete from core sample #11 are shown in Figure 25. The concrete appears to be composed of an angular coarse and subangular-shaped fine aggregate of unknown composition. There appears to be very little air in the concrete. The concrete appears quite competent, with no visible cracks or signs of chemical reactions.

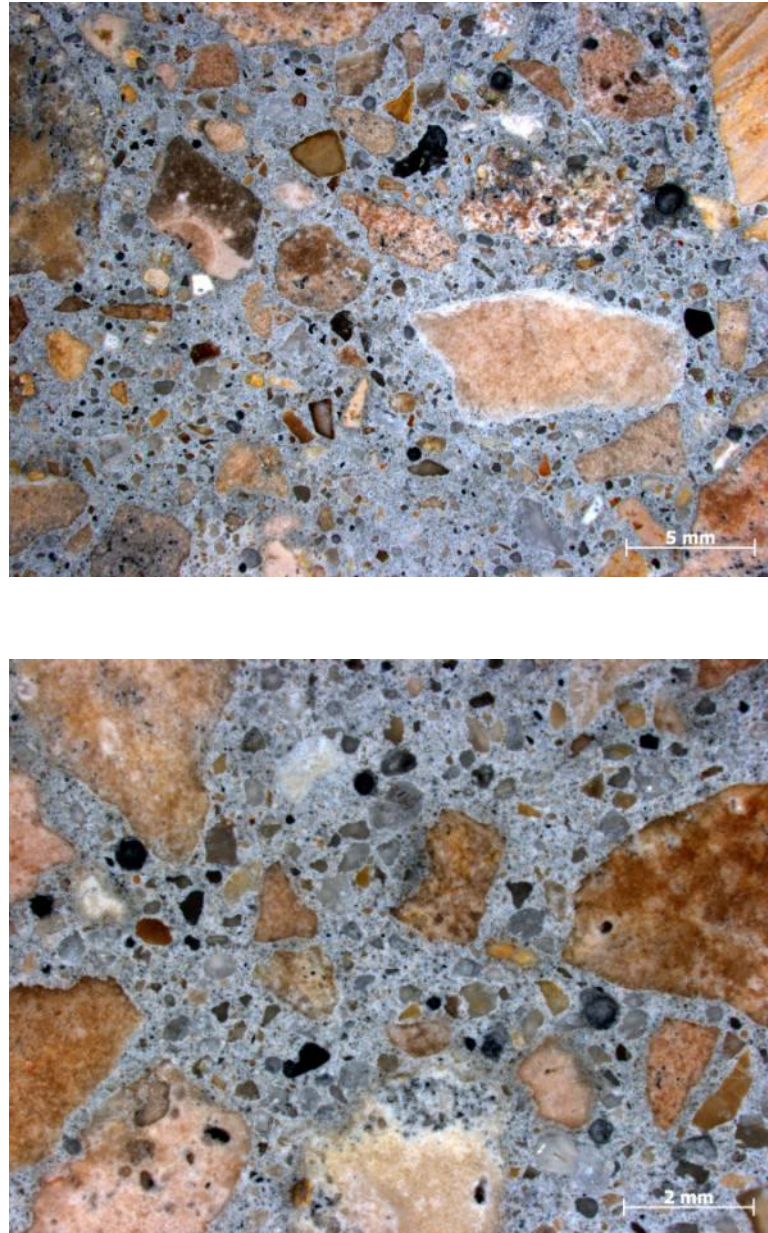
Figure 26. Photomicrographs of core sample #12 (5x above, 15x below).

Images of concrete from core sample #12 are shown in Figure 26. The concrete appears to be composed of an angular coarse and subangular-shaped fine aggregate of unknown composition. There appears to be very little air in the concrete. The concrete appears quite competent, with no visible cracks or signs of chemical reactions.

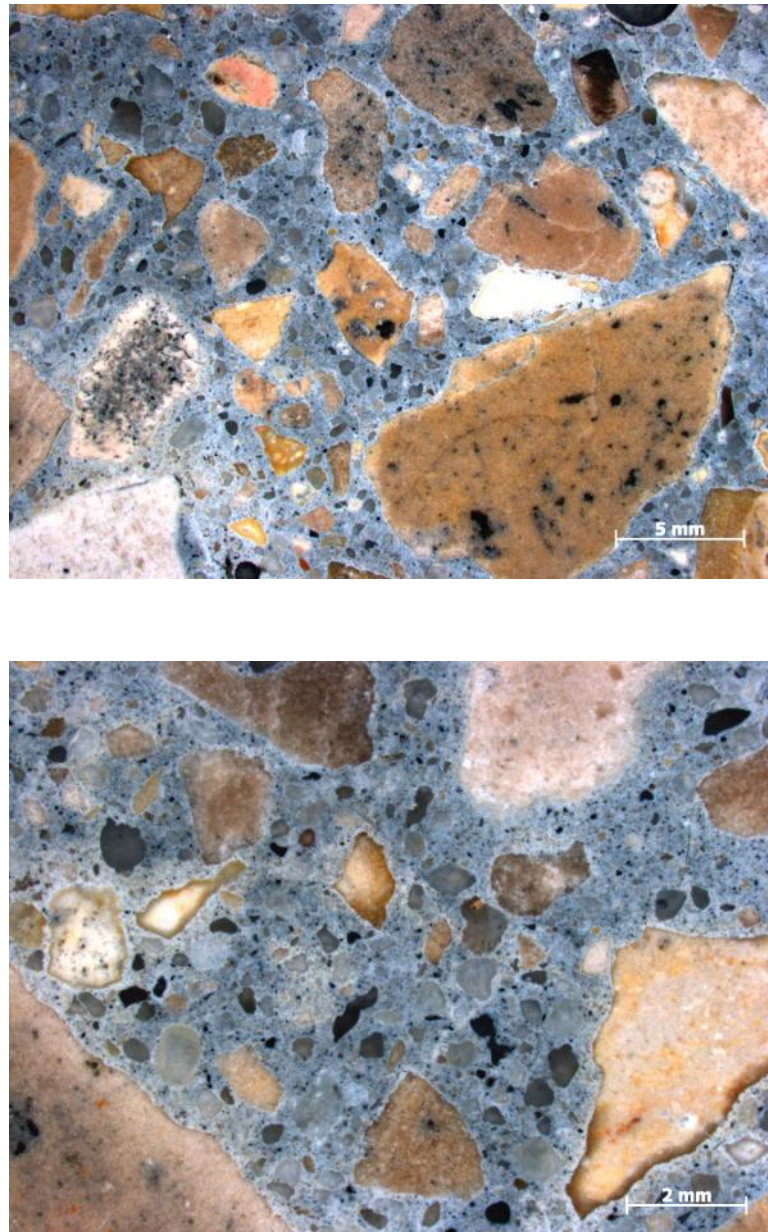
Figure 27. Photomicrographs of core sample #13 (5x above, 15x below).

Images of concrete from core sample #13 are shown in Figure 27. The concrete appears to be composed of an angular coarse and subangular-shaped fine aggregate of unknown composition. There appears to be very little air in the concrete. The concrete appears quite competent, with no visible cracks or signs of chemical reactions.

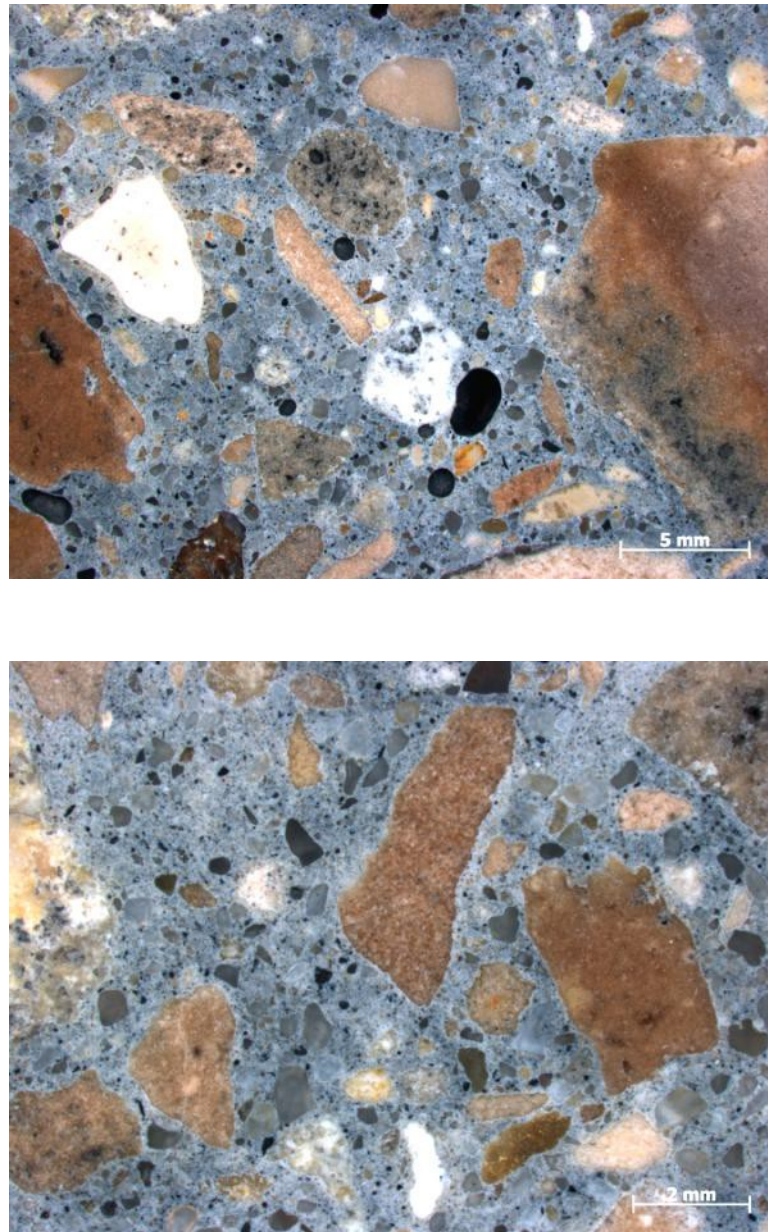
Figure 28. Photomicrographs of core sample #14 (5x above, 15x below).

Images of concrete from core sample #14 are shown in Figure 28. The concrete appears to be composed of an angular coarse and subangular-shaped fine aggregate of unknown composition. There appears to be very little air in the concrete. The concrete appears quite competent, with no visible cracks or signs of chemical reactions.

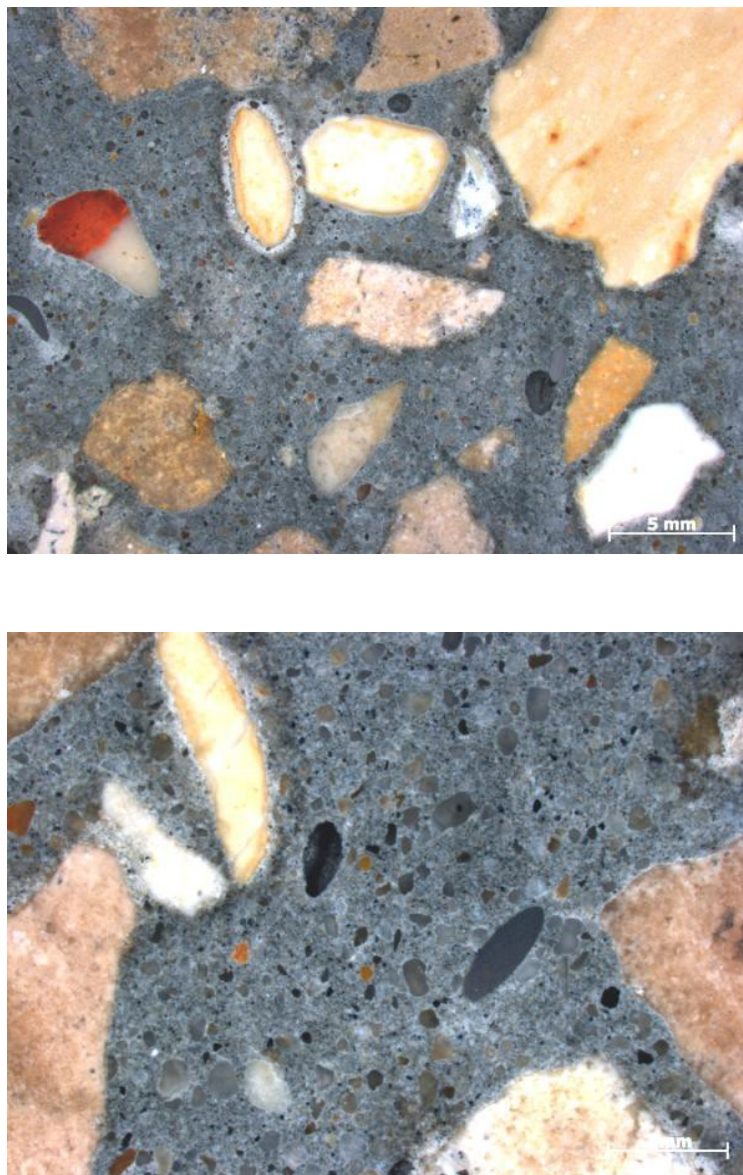
Figure 29. Photomicrographs of core sample #15 (5x above, 15x below).

Images of concrete from core sample #15 are shown in Figure 29. The concrete appears to be composed of an angular-to-rounded coarse and subangular-to-rounded shaped fine aggregate of unknown composition. Steel fibers are present in the concrete. There appears to be very little air in the concrete. Although the concrete appears competent with no visible cracks, there are areas in the cement paste around selected aggregate particles that are lighter in color than the surrounding paste.

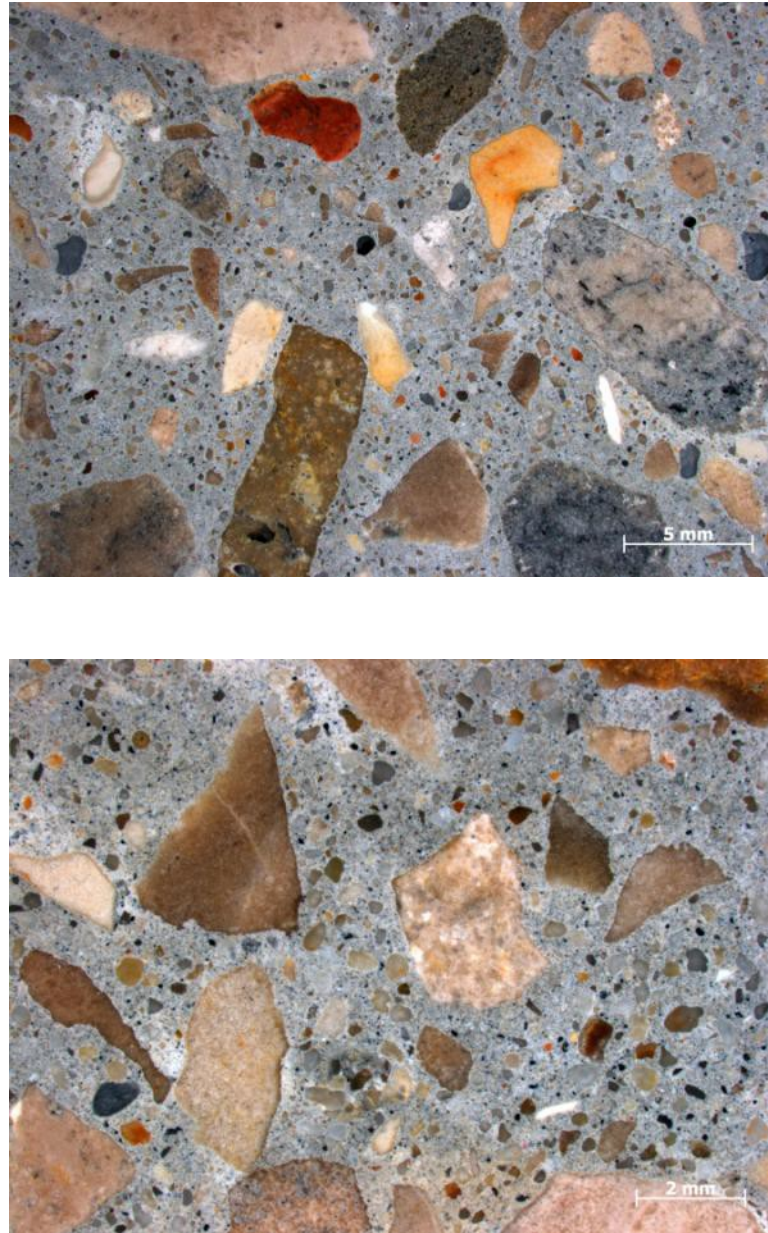
Figure 30. Photomicrographs of core sample #16 (5x above, 15x below).

Images of concrete from core sample #16 are shown in Figure 30. The concrete appears to be composed of an angular coarse and subangular-shaped fine aggregate of unknown composition. There appears to be very little air in the concrete. The concrete appears quite competent, with no visible cracks or signs of chemical reactions.

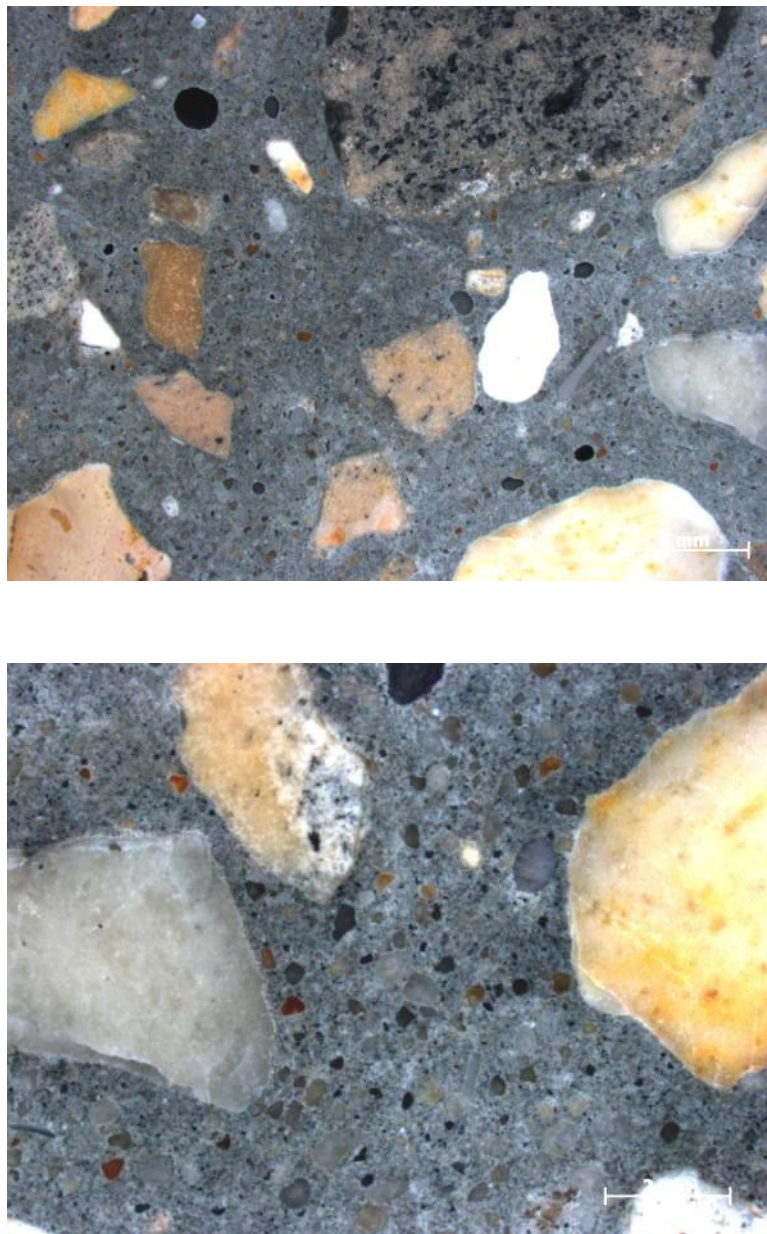
Figure 31. Photomicrographs of core sample #17 (5x above, 15x below).

Images of concrete from core sample #17 are shown in Figure 31. The concrete appears to be composed of an angular-to-subangular coarse and subangular-to-rounded shaped fine aggregate of unknown composition. Steel fibers are present in the concrete. There appears to be very little air in the concrete. The concrete appears quite competent, with no visible cracks or signs of chemical reactions.
