**TECHNICAL REPORT**  
**TR-NAVFAC-EXWC-PW-1303**  
**SEPTEMBER 2013**

**BUILDING INTEGRATED PHOTOVOLTAIC (PV)  
ROOFS FOR SUSTAINABILITY AND ENERGY  
EFFICIENCY**

**ESTCP Number: EW-200813**

**September 2013**

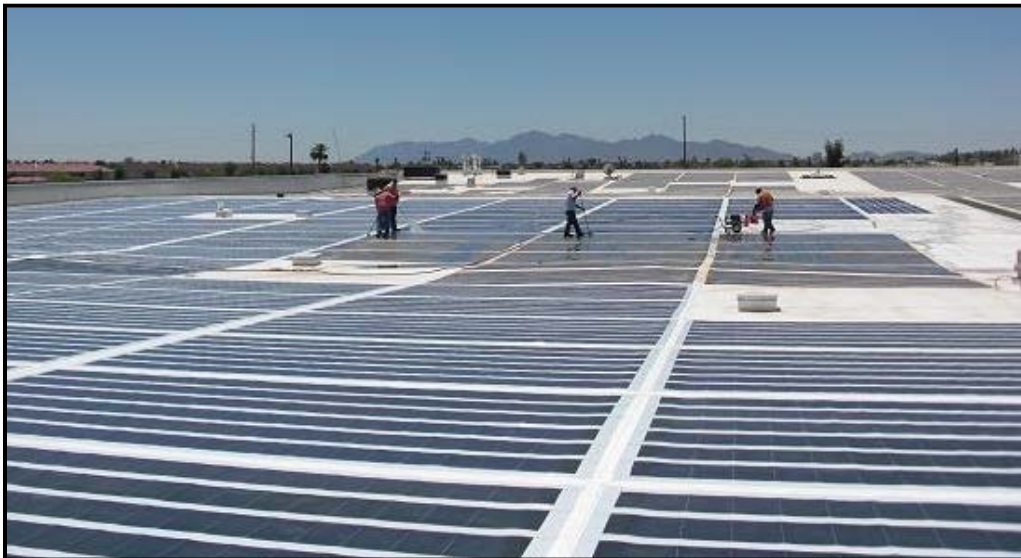
Figure-8: Luke AFB BIPV roof being cleaned during adhesive-failure fix.

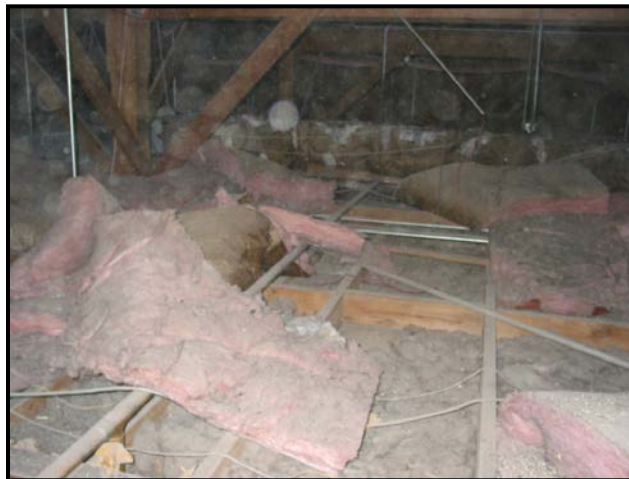
**Figure-12: Attic space of Building 228 at Site III (MCAS Yuma) showing poor insulation.**

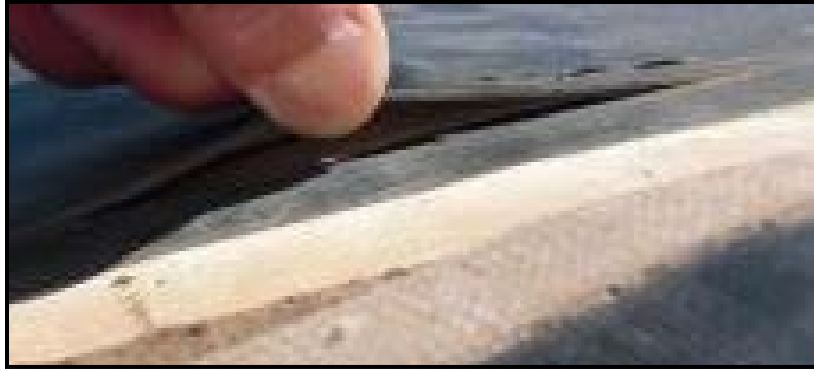
For example, Figure-20 shows the bond failure between the PV and PVC carrier sheet. Since the carrier sheet may still provide for a water tight roof assembly, problems experienced by the PV modules may not impact ROOFER scoring. However, the indices still provide an indication of how well the PVC portion of the roof is enduring over time.

**Figure-20: Bonding failure between PVL and PVC at Site I (Luke AFB).**

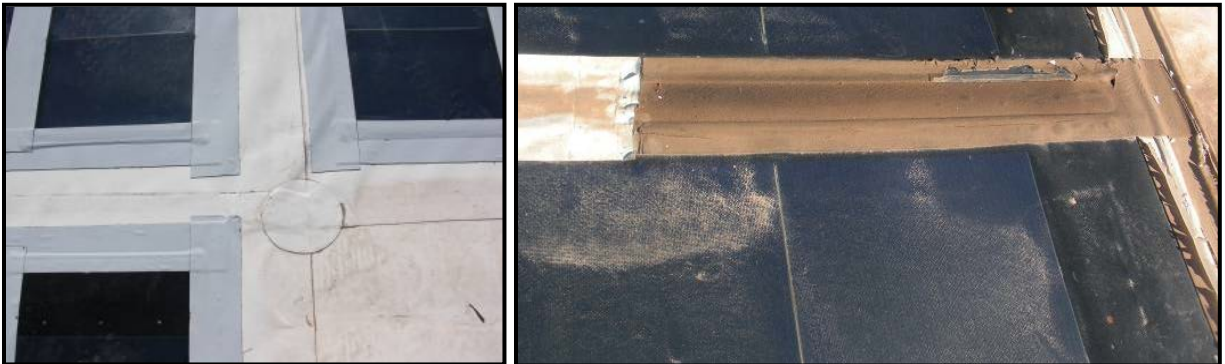
In response to the bond failure, the PV manufacturer taped the frame around the PV laminate to the adjacent PVC membrane in an attempt to repair the problem in May 2010 (Figure-21, left). Unfortunately, some of the tape deteriorated less than six months after the tape was applied. The photo on the right in Figure-21 was taken about one year after the tape solution was applied and shows the significant difference between the surviving tape and the deteriorated tape. The white portion of the area between the two PV laminates indicates where the tape survived and the brown portion indicates where the top layer of the tape deteriorated and collected dirt. In addition to impacting the roof integrity, the deteriorated tape reduces the overall roof reflectivity which can increase the facility's cooling load.

**Figure-21: Tape solution soon after it was applied (left) and deterioration later that year (right) Site I (Luke AFB).**

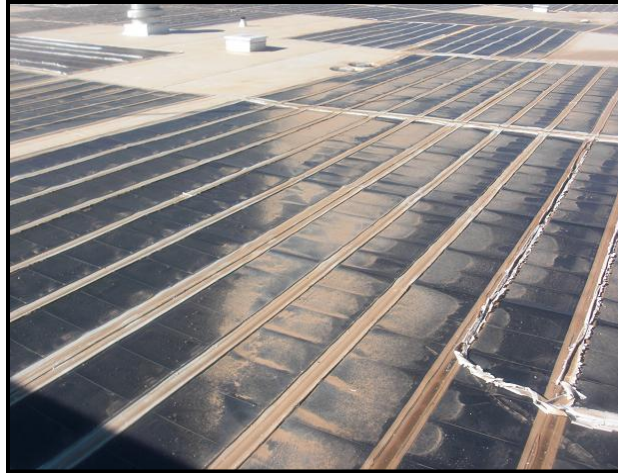
Figure-22 shows some of the tape deterioration along with soiling of the PV modules. The significant soiling is expected to be a result of the low-slope BIPV roof surface, which does not allow for all the water to completely leave the surface and causes any dirt trapped by the water to settle on the BIPV roof after the water dries. The soiling on the PV modules will reduce the overall roof reflectivity and the energy output of the PV system.

**Figure-22: Tape deterioration and soiling of the PV system at Site I (Luke AFB).**

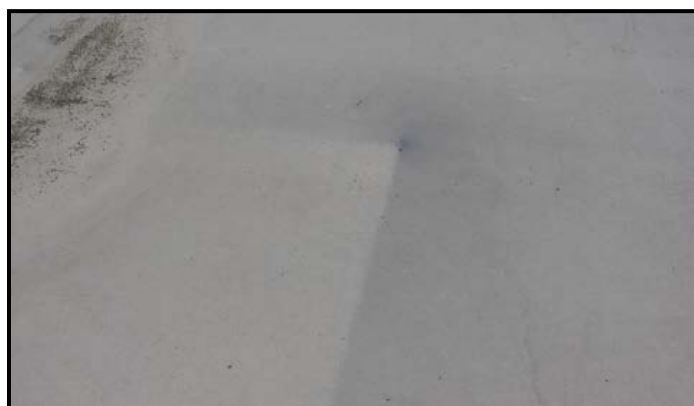
**Figure-28: Mold growth (upper left corner) and warping dens-deck (center) at Site II (NAS Patuxent River).**

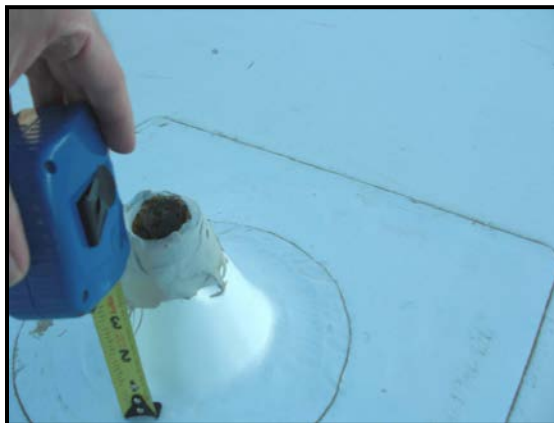
**Figure-44: Photo of Site III (MCAS Yuma) air vent with insufficient flashing height.**

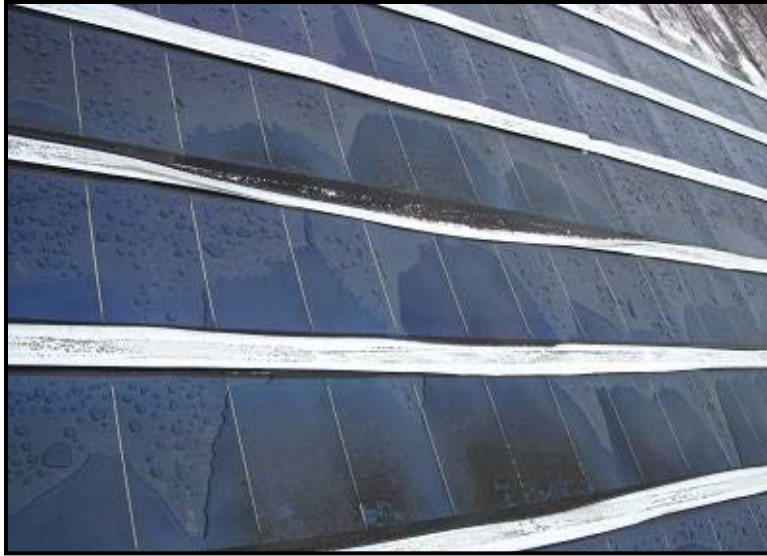
**Figure-45: Water ponding due to the failing tape and PV module orientation. Mold growth in the upper right corner.**

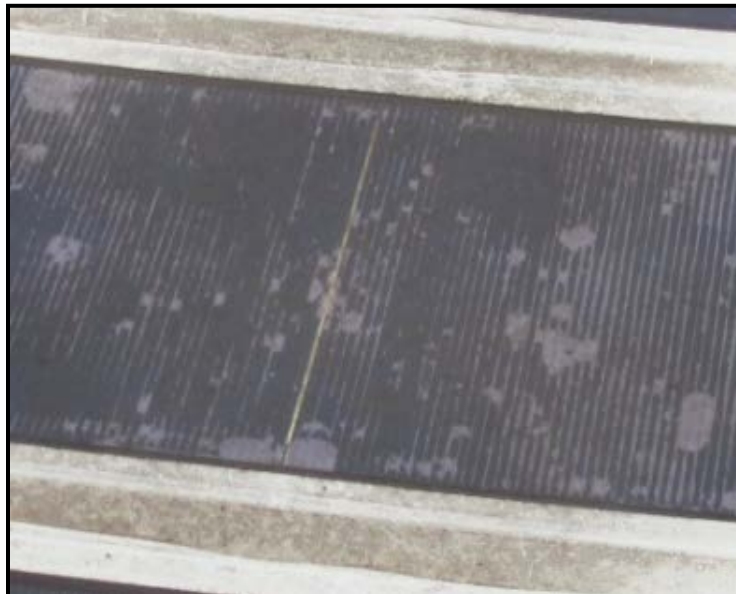
**Figure-46: Evidence of PV delamination.**

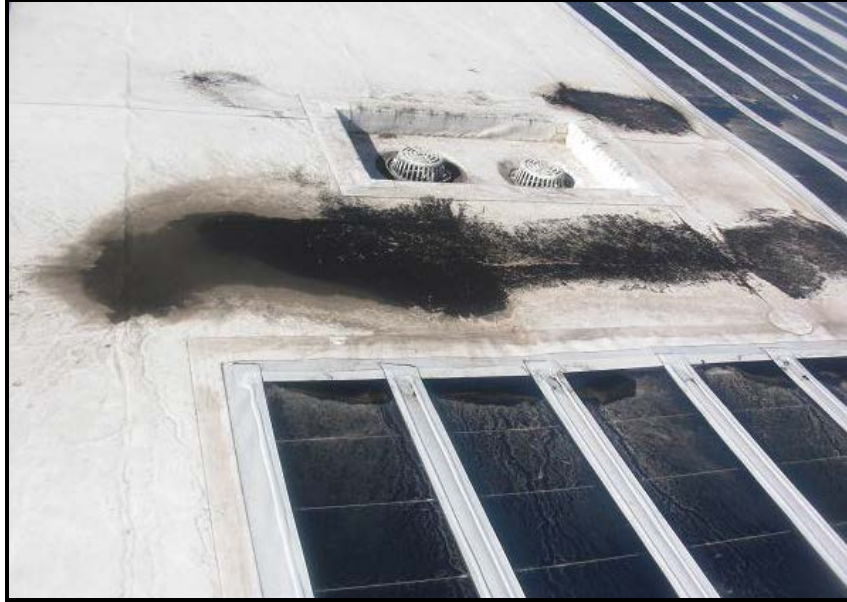
**Figure-47: Severe, localized mold growth due to water ponding before it reaches the drains.**

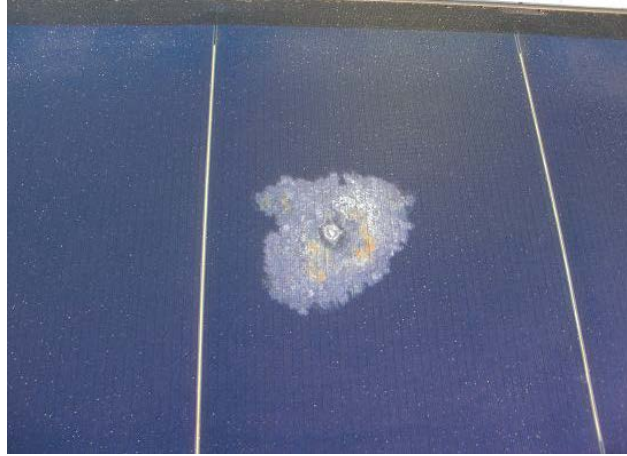
**Figure-50: Corrosion of PV material due to a pin-size hole at Site II (NAS Patuxent River).**
