**U.S. ARMY CERL LIBRARY  
REPAIR, EVALUATION, MAINTENANCE, AND  
REHABILITATION RESEARCH PROGRAM**

TECHNICAL REPORT REMR-CS-16

# **REPAIR OF DAM INTAKE STRUCTURES AND CONDUITS. CASE HISTORIES**

**January 1988**

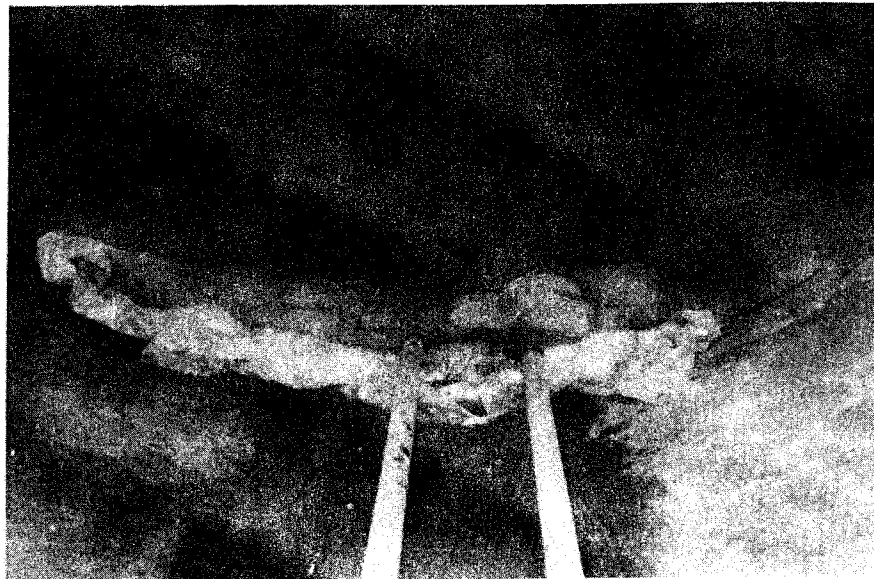
Figure 3. Sandbag dike and drain pipes, Arkabutla Dam, 1977

18. 1977. Remedial grouting (USAED, Vicksburg 1979) was performed by the Vicksburg District personnel in June 1977 at joints and cracks of monoliths 1 through 9. After closure of the control structures gates, drilling and grouting equipment were placed in the conduit. A 2-ft-high sandbag dike was constructed across the transition section (Figure 3) and two 3-in.-diameter drain pipes extended from there to near the end of the conduit to pass water leaking from around the gates through the repair area.

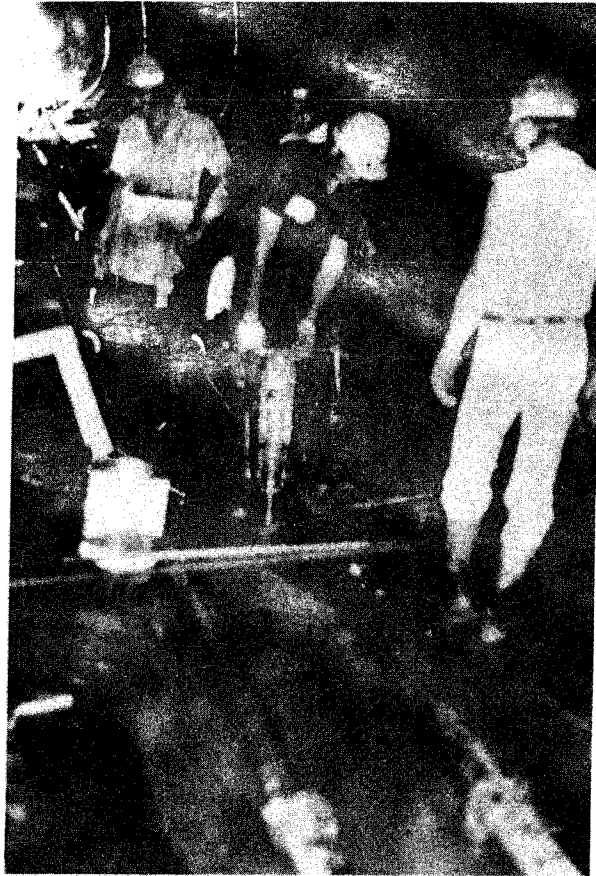
Figure 4. Drilling of grout hole in conduit invert, Arkabutla Dam, 1977

19. Ports from previous grouting operations were utilized whenever possible. New 2-1/2-in.-diameter grout holes were percussion (jackhammer) drilled

in the invert to a depth of 22 in. (Figure 4). A 1-1/2-in. inside diameter pipe coupling with nipple (flared at the bottom) was grouted in each hole. After the grout had set, a 1-3/8-in.-diameter hole was drilled to refusal (steel rebar) or through the conduit concrete to foundation sand and a 1-in. inside diameter cutoff valve installed.

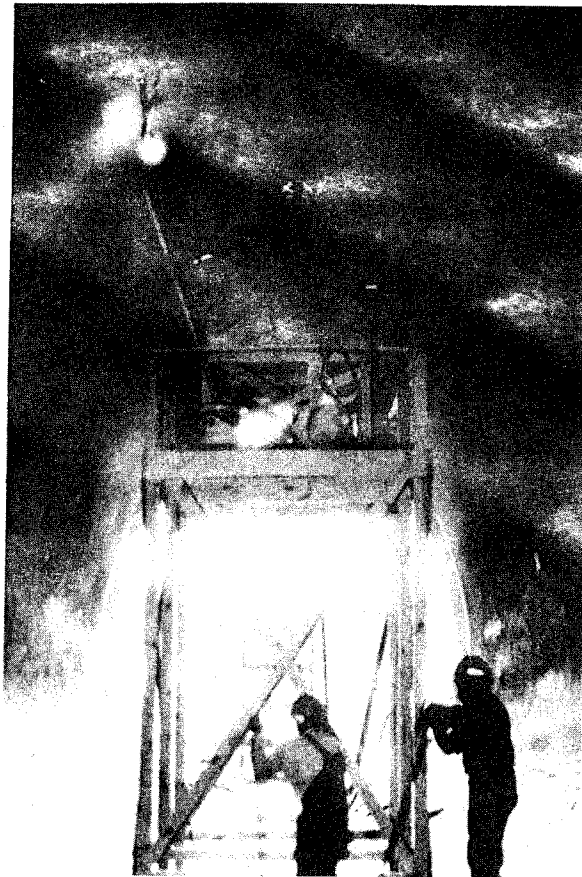
Figure 5. Drilling exploratory hole in conduit crown, Arkabutla Dam, 1977

20. An exploratory hole was drilled in the crown at monolith joint 12/13 mainly to check the area near the bottom of the sinkhole that developed in the embankment close to the downstream end of the conduit in 1974. An air-powered rotary drill equipped with a 2-1/2-in.-diameter, thin-wall diamond bit was used to drill 2 ft into the joint. The drill was mounted and braced between the top of a wooden scaffold and the top of the conduit (Figure 5). When the waterstop was penetrated, no water was encountered. A 2-in. inside diameter, 20-in.-long, pipe coupling and nipple with a flared end were grouted in place.

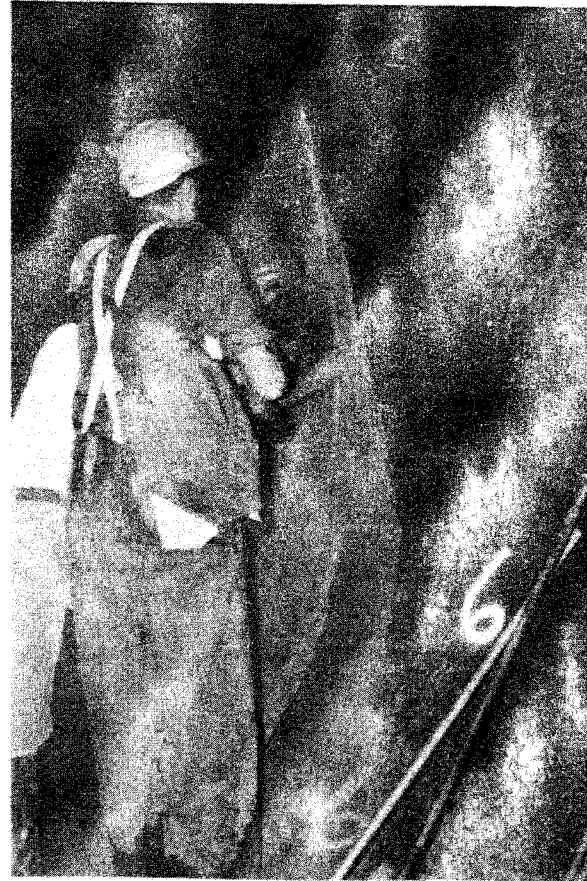
Figure 8. Chinking joint with lead wool, Arkabutla Dam, 1977

22. A hydraulically operated dual mixing bin grout machine with a 20-cu-ft sump tank capacity was located on the embankment surface about 20 ft from the right stilling basin wall. Approximately 300 ft of 1-1/2-in. inside diameter hose extended from the grout machine to a set of control valves (Figure 6). An additional 300 ft of the hose was used to complete the loop back to the machine for recirculation of the grout during periods when the grouting operation had to be interrupted. At the control valves, a 50-ft-long, 1-1/2-in. inside diameter line was used to connect to injection ports. Grout pressure was indicated by a gauge at the set of control valves (Figure 6) and a second gauge at the injection port (Figure 7). Lead wool was used to chink grout leaks in the conduit (Figure 8).

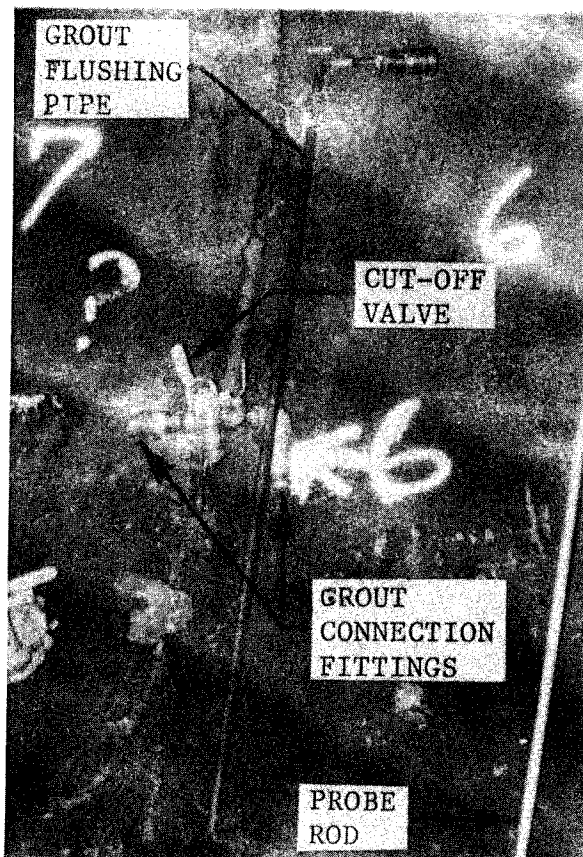
Figure 9. Grout hole with cutoff valve, Arkabutla Dam, 1977

23. Immediately prior to grouting any port having back pressure, the cut-off valve was opened and a 1/2-in. inside diameter, 6-ft-long, flushing pipe inserted (Figure 9). Grout was jetted through the pipe into the hole to

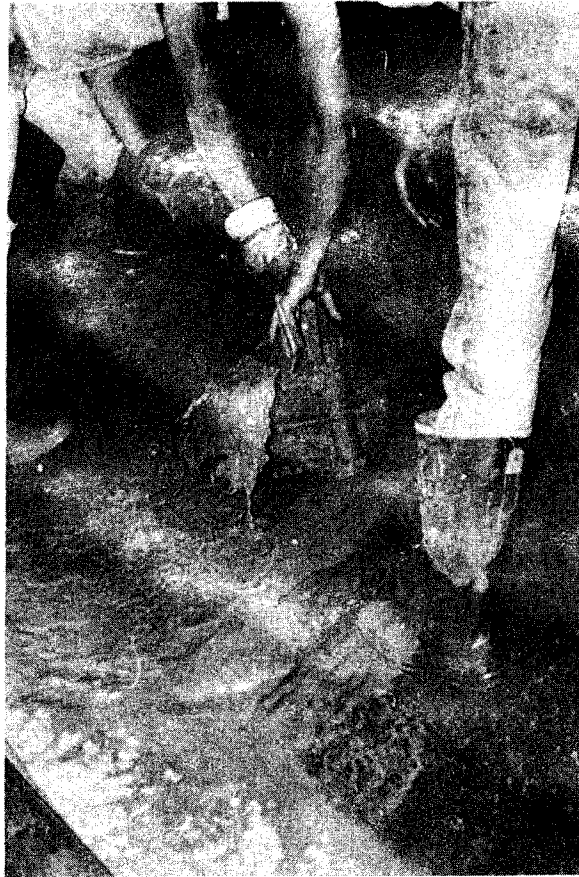
Figure 10. Flushing of grout hole, Arkabutla Dam, 1977

remove foundation sands that had filled the port (Figure 10). After the port was cleared, the pipe was quickly removed and the valve closed. When the regular grout connection was made, the hole was unobstructed and could freely pass grout to adjacent voids.

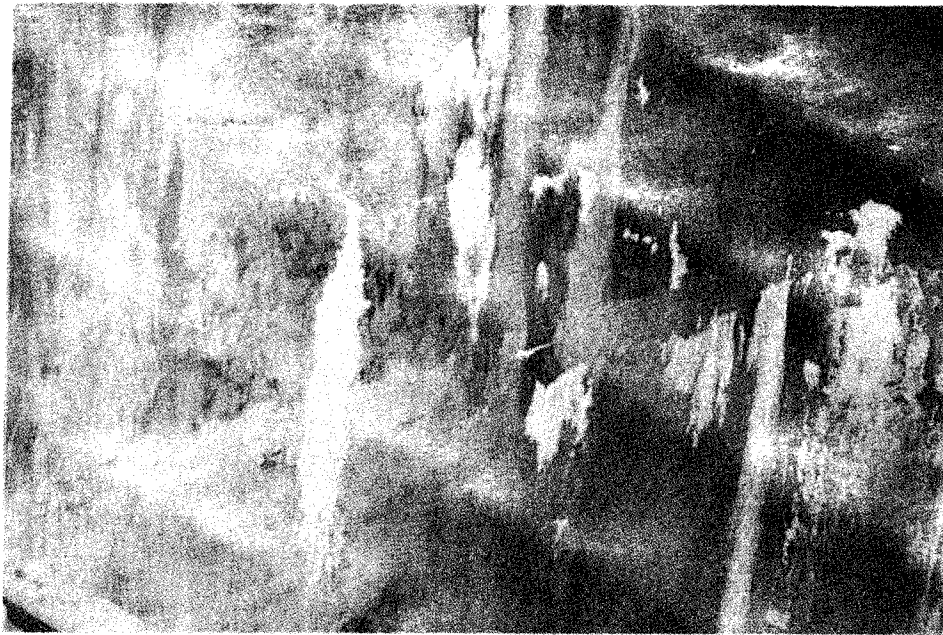
Figure 12. Area of interior wall treated with Vandex, Beltzville Dam, June 1983

Adhesive Engineering Co. of San Carlos, California. After surfaces bordering the joints and cracks were cleaned and sealed, injection ports were drilled and packers installed. The joints and cracks were then injected using 100-psi pressure. As with the repair with the Vandex treatment, the performance of the Concretive 1380 repair was not considered effective enough in stopping the intake tower leakage and deterring the formation of calcite to warrant further use.

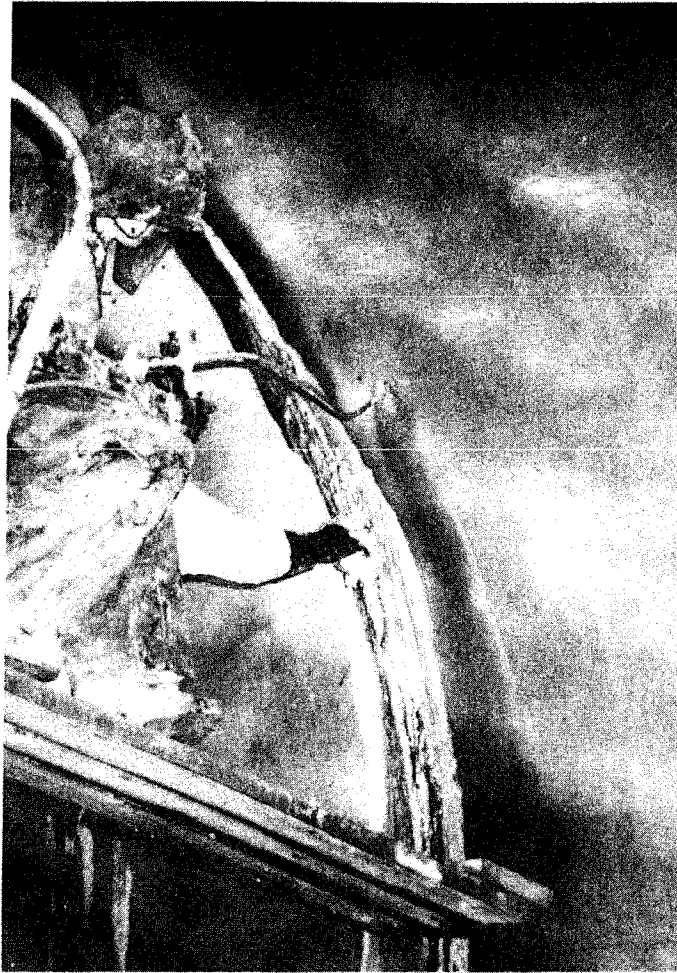
Figure 18. Injection of monolith joint 4/5 with chemical grout leaking out of joint, Blakely Mountain Dam, 1986

86. A switch was made to TACSS 020 NF to obtain a more rapid gel time with the maximum dosage of 10 percent accelerator. Injection of grout was moved to 8 ft left where 8.0 gal of grout were injected with 2.0 gal coming through joint (Figure 18). The left side of the tunnel started to seal and the injection of grout was moved to 5 ft left where 2.0 gal of grout were

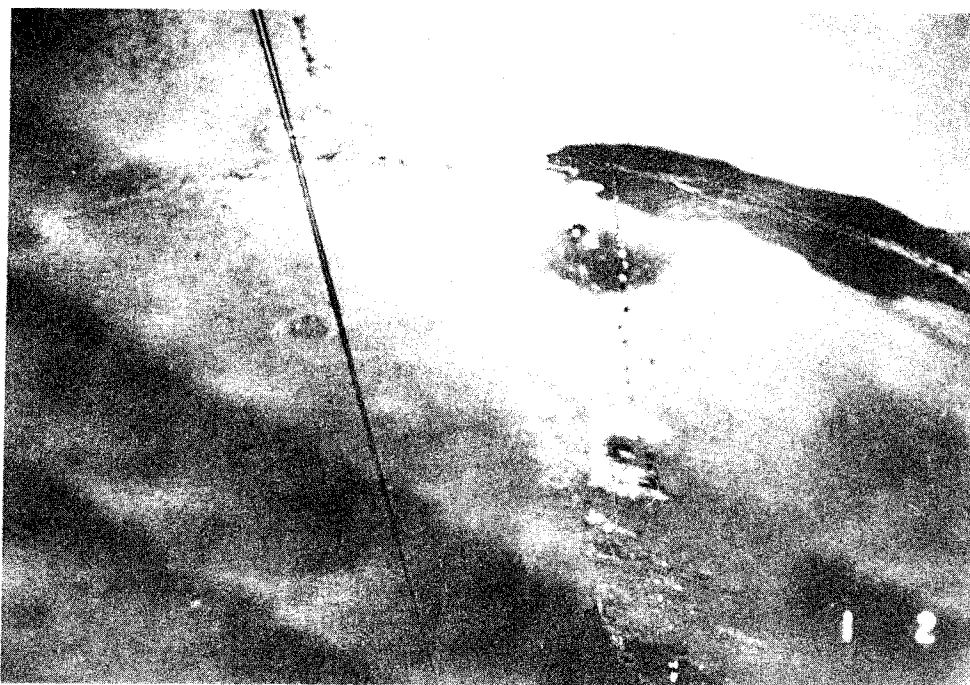
92. The flow from joint 4/5 had been nearly stopped on 6 February 1986. However, this joint was leaking again at 3 ft right of crown centerline. Also additional weeping was observed from cracks in the crown of both monoliths 4 and 5 (Figures 19 and 20). The seepage at joint 3/4 had increased some from 6 February 1986 with the seepage occurring at 3 to 5-ft right of the crown

Figure 19. Monolith joint 4/5 before grouting, Blakely Mountain Dam, 1986

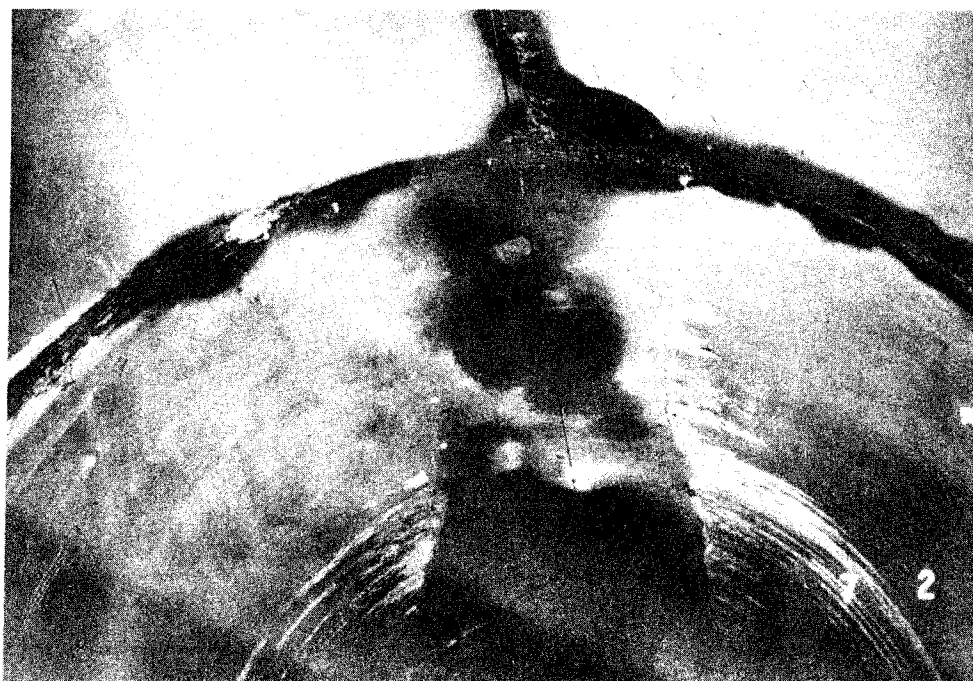
Figure 20. Monolith joint 4/5 after grouting, Blakely Mountain Dam, 1986

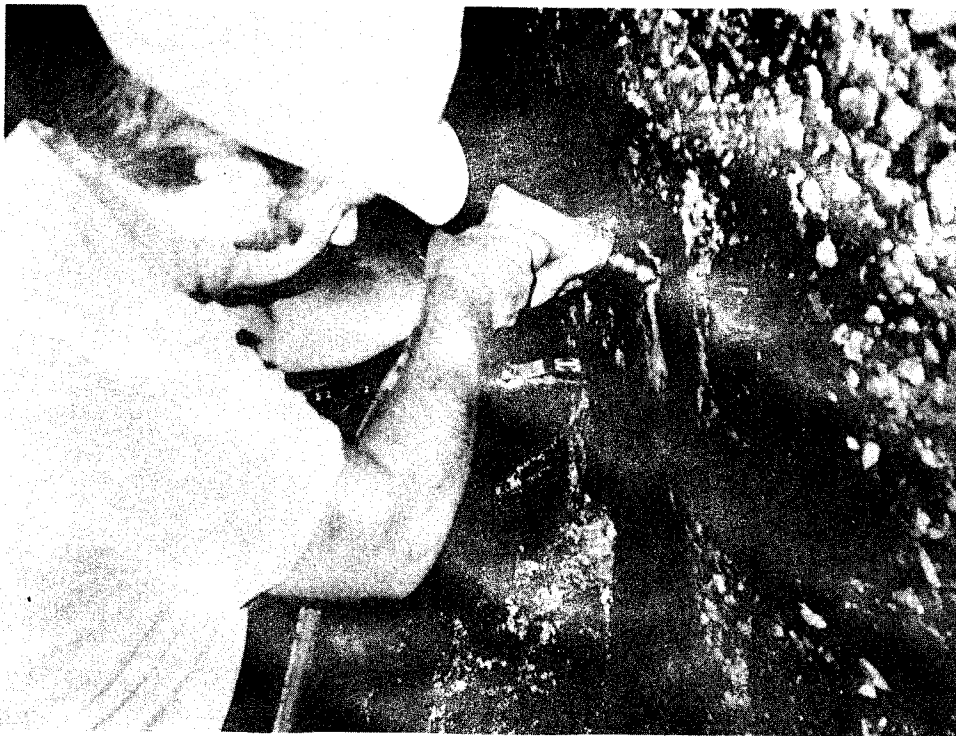
Figure 21. Drilling of injection port using pneumatic drill, Buckhorn Lake Dam, August 1986

98. Three, 3/4-in.-diameter holes were drilled to reduce or relieve water pressures during the sealing of injection ports. These holes (Figure 21) were drilled to the depth of the waterstop (approximately 6 in.), but not penetrating it. Port tubings were inserted near full depth of each of the five holes to provide a longer flow path, thereby, increasing the time in which the grout had to set before exiting the concrete. Oakum was packed into cracks and holes around ports until the majority of leakage was flowing through ports (Figure 22). This process had to be done in a persistent manner, since pressure increased as each small quantity of flow was shut off by the packing of the oakum. At times one closure would cause a previously sealed area to seep again. After the packing of the oakum was completed, valves were closed to check effectiveness of packing (Figure 23). Preco Plug

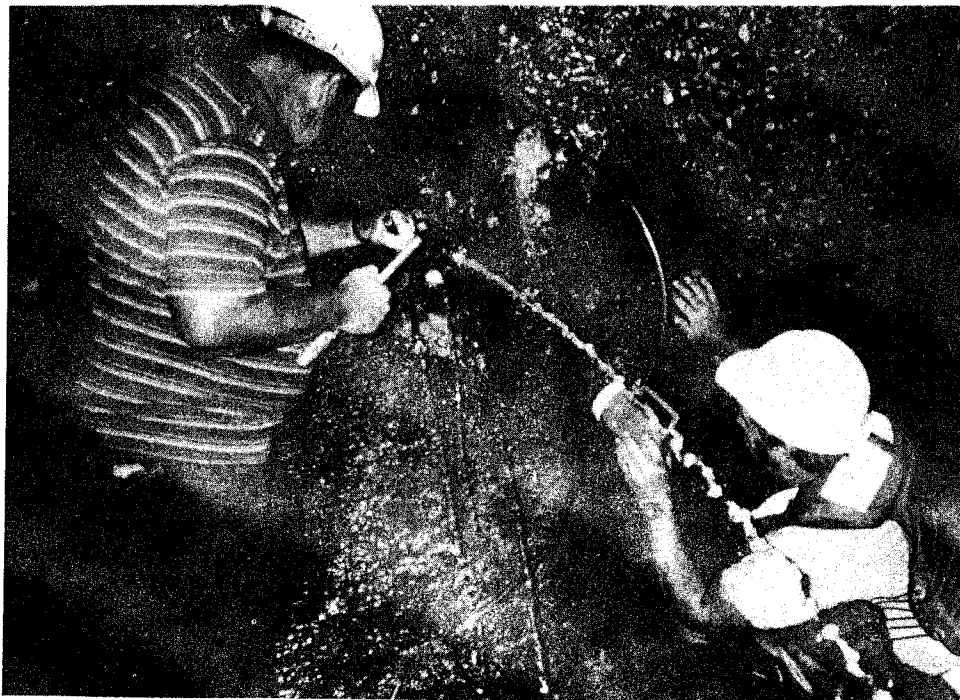
Figure 22. Packing oakum around injection ports, Buckhorn Lake Dam, August 1986

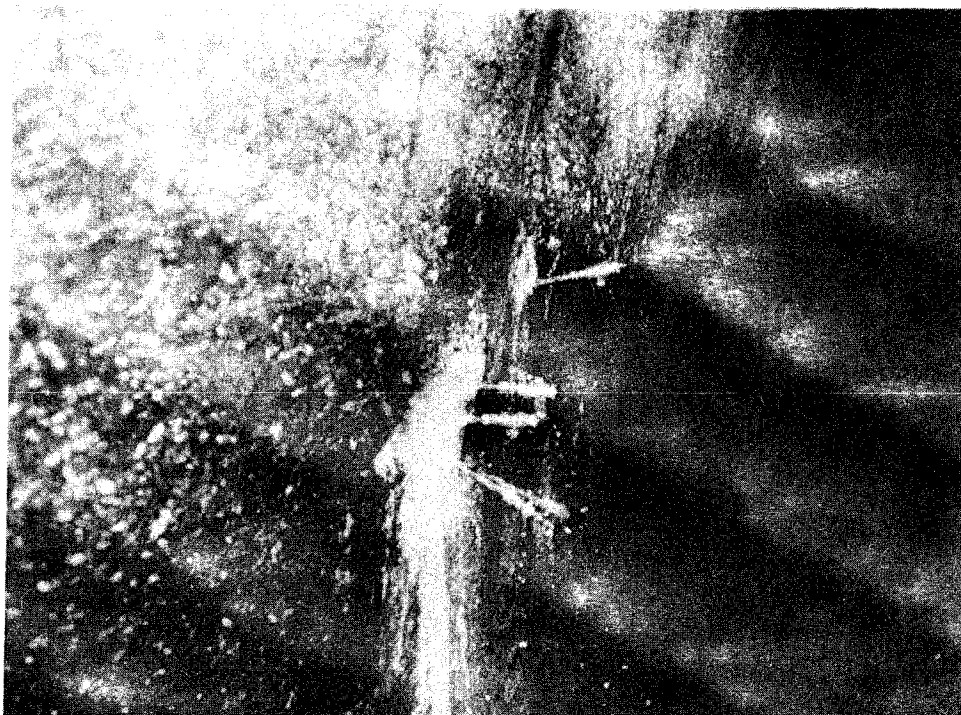
Figure 23. Valves closed to check the effectiveness of packing, Buckhorn Lake Dam, August 1986

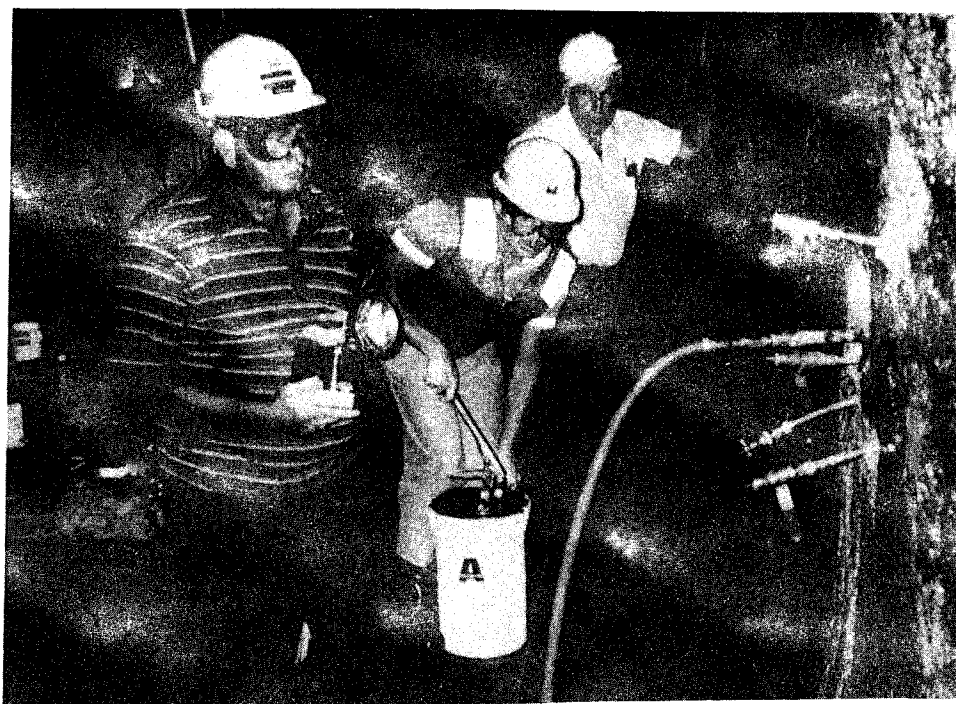
Figure 24. Injection of TACSS-020 NF mix into port occupying nondrilled hole, Buckhorn Lake Dam, August 1986

99. After the Preco Plug had set for about 20 min, 2-1/2 gal of TACSS-020 NF was mixed with 5 percent of C-852 accelerator. With the other four valves closed, grout was pumped through the open valve of the port occupying the nondrilled hole (Figure 24). There were a number of small seeps that existed prior to the start of the grouting operation. After 2 to 3 min of pumping these seeps stopped with grout solidifying on the interior wall at some of the seep locations. After all of the approximately 2-1/2 gal of grout had been pumped, the port valve was closed to allow time for grout to react and solidify. Another 2-1/2 gal of grout was prepared and the pump connected to the single port downstream of the joint. The pumping of grout into the port was initiated, but no grout was taken. With valves closed and hose removed, the previously injected grout was allowed to gel for an additional 30 min. Ports were then cut off slightly below the wall surface and projecting oakum removed. Preco Plug was mixed and spread over the work area to form a protective seal (Figure 25).

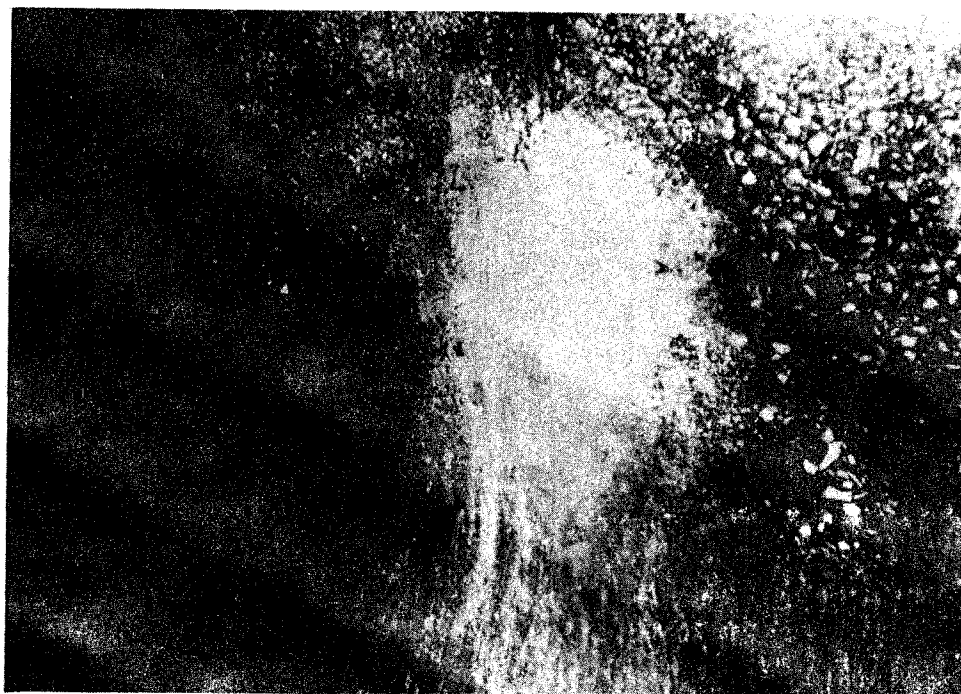
Figure 25. Surface after repair, Buckhorn Lake Dam, August 1986

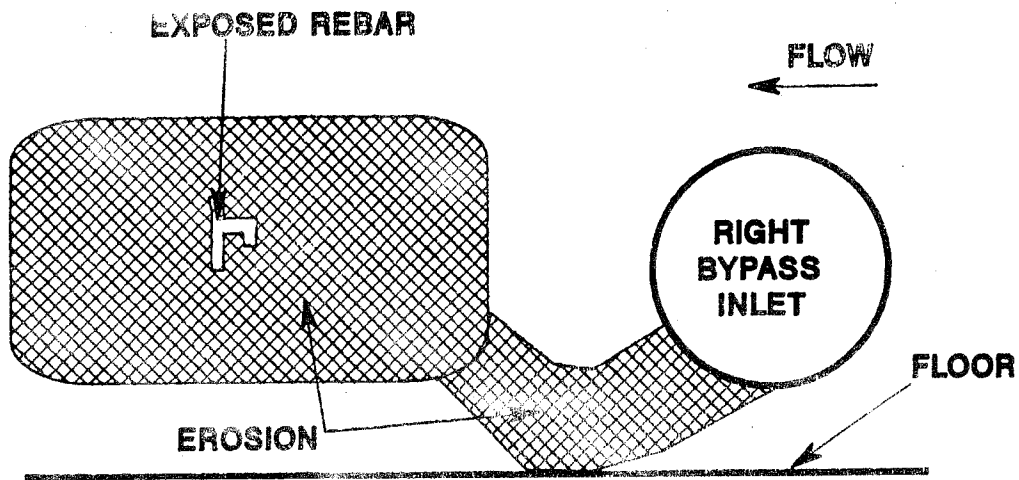
103. During a 1980 inspection, erosion damage was observed in the surface of the concrete in the two gate passages and transition of the outlet works. In the right passage, cavitation damage had occurred immediately downstream of the bypass outlet (Figure 26). The eroded area was approximately 6 ft long, 3 ft wide, and 8 in. deep at the deepest point with exposed reinforcing bars. In the left passage, cavitation damage (Figure 27) had also occurred immediately downstream of the bypass outlet and was approximately 4 ft long and 2 ft wide with a maximum depth of about 4 in. Abrasion damage had occurred in the transition between end of the passages and the beginning of the conduit. The damage consisted of two eroded areas downstream of the

Figure 26. Sketch of cavitation damage in wall of right passage, Cave Run Dam, 1982

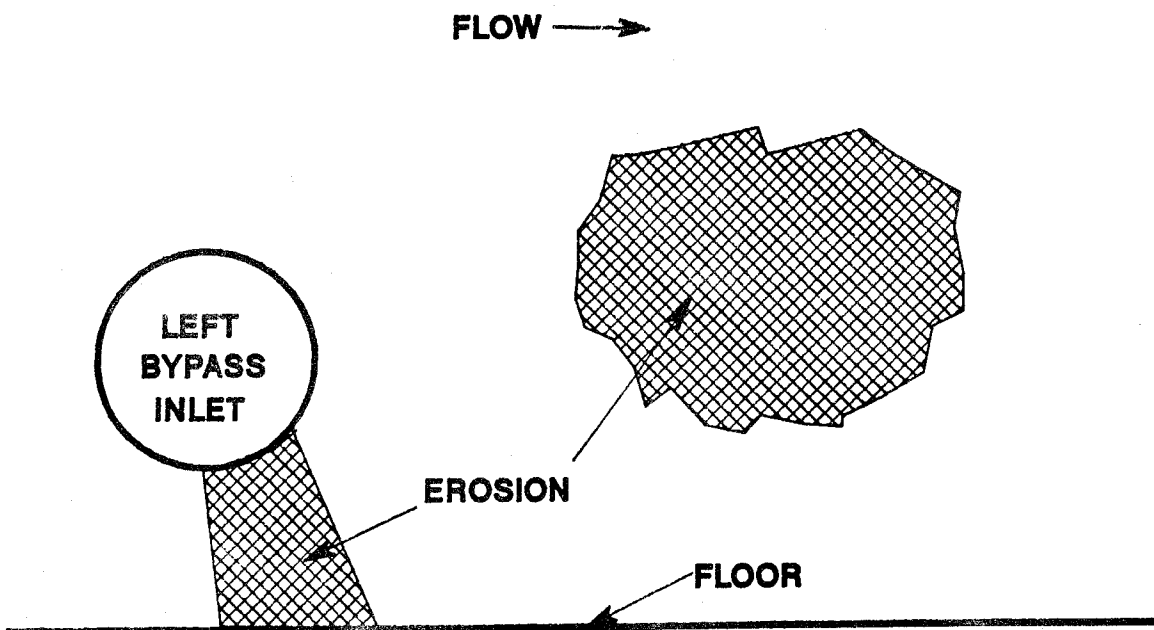
Figure 27. Sketch of cavitation damage in wall of left gate passage, Cave Run Dam, 1982

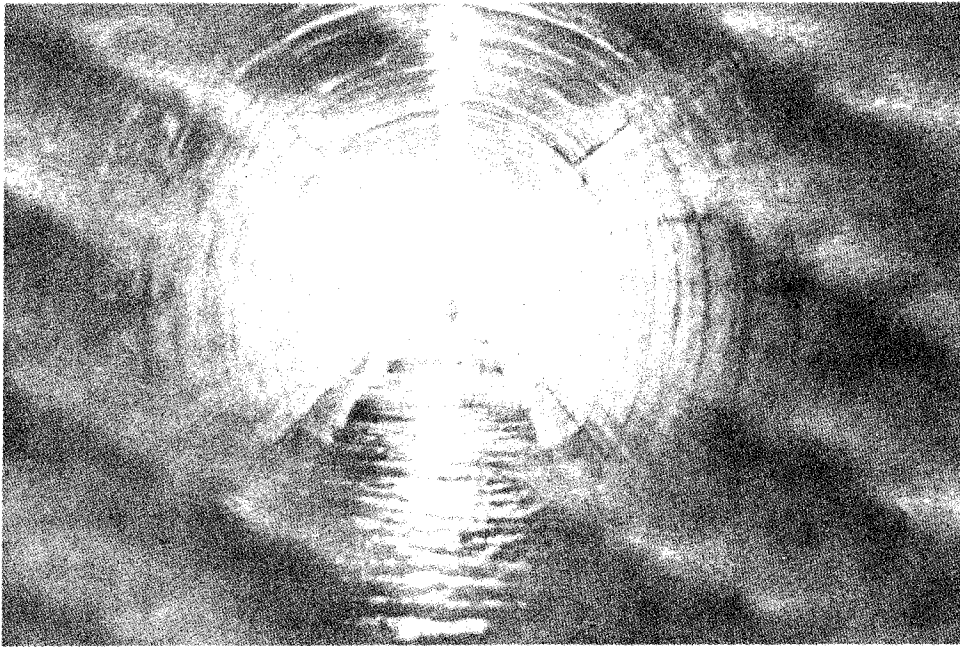
a. Longitudinal crack in crown

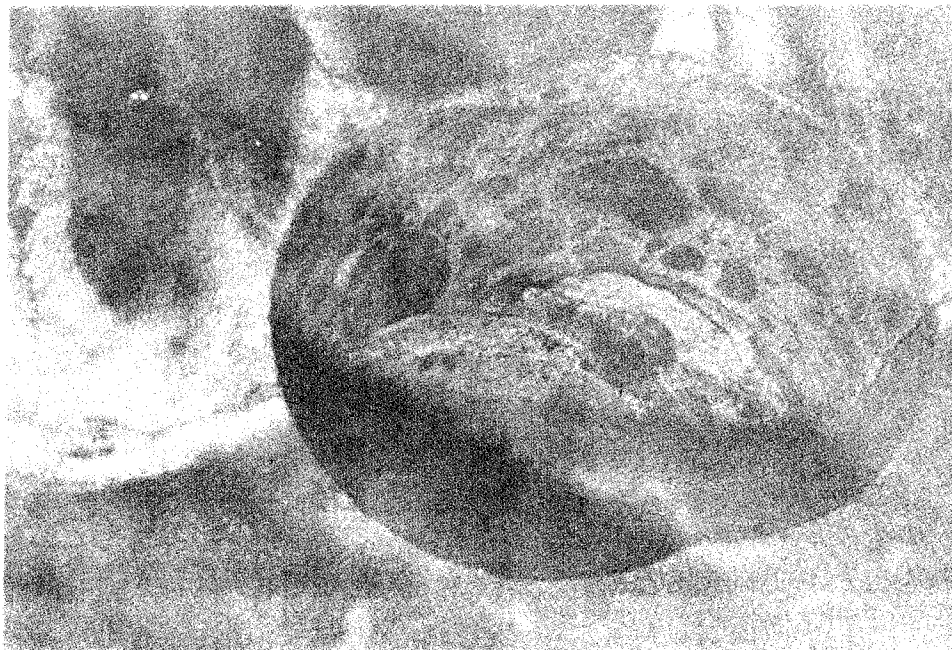
b. Delamination at reinforcement

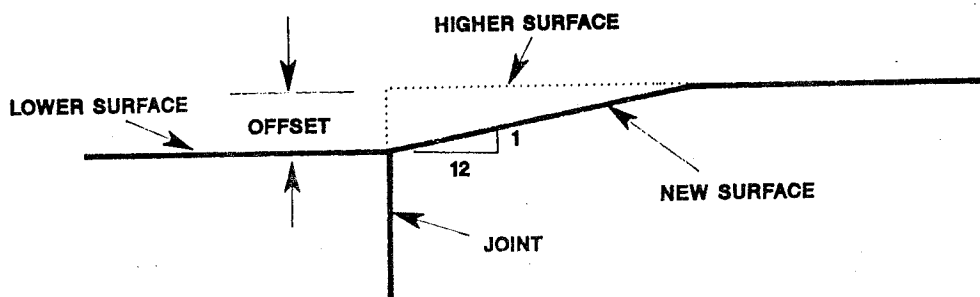
Figure 35. Sketch of repair of offset, Hidden Lake Dam

127. In 1984, district personnel rented a high-speed, car buffer type grinder with a diamond stone. The higher surface at each of the two joints was ground to the level of the lower surface at the joint and cut back on a 1 to 12 slope away from the joint (Figure 35). This produced a smooth surface transition across the joints, thereby, reducing the possibility of cavitation damage occurring during high-flow releases.

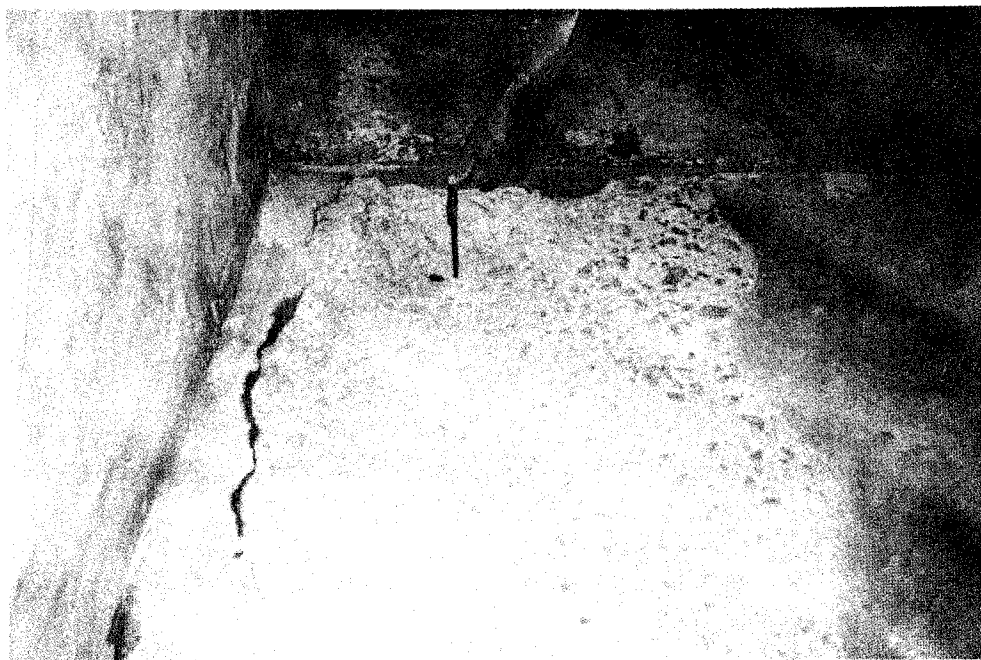
157. A delaminated section of the invert repair was pried loose and examined. The Quartz was firmly attached to the concrete indicating the bond was good and that the concrete beneath the bond had failed. It was speculated that seepage at the joint during the repair had reduced the bond causing the Magma Quartz at the joint to spall, thereby, setting up an abrupt surface irregularity for cavitation to occur. Water then progressively undermined the Magma

Figure 40. Erosion damage, Isabella Dam, December 1983

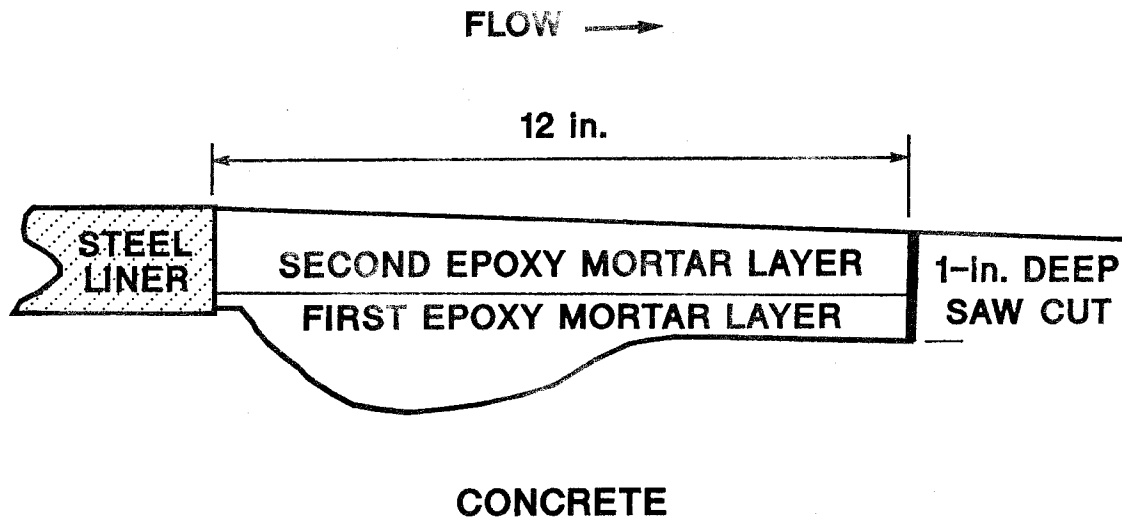
196. In May 1985, 21 months later, the patch was inspected. The epoxy mortar surface had settled or flowed, before hardening, to about 1/4 to 3/8 in. below the level of the steel. It appeared that the bond was still intact and that the mortar surface had little sign of wear.

Figure 45. Repair immediately downstream of steel liner, Milford Dam

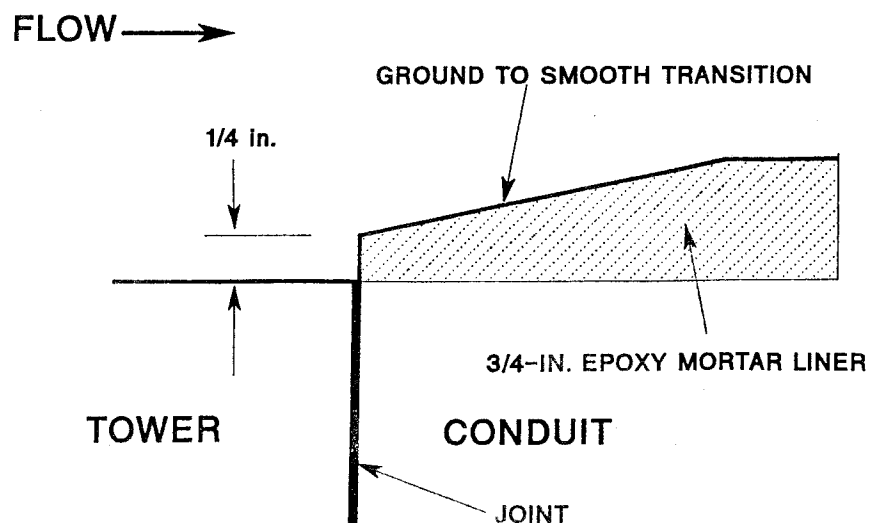
Figure 46. Edge ground to provide smooth transition at monolith joint, Milford Dam

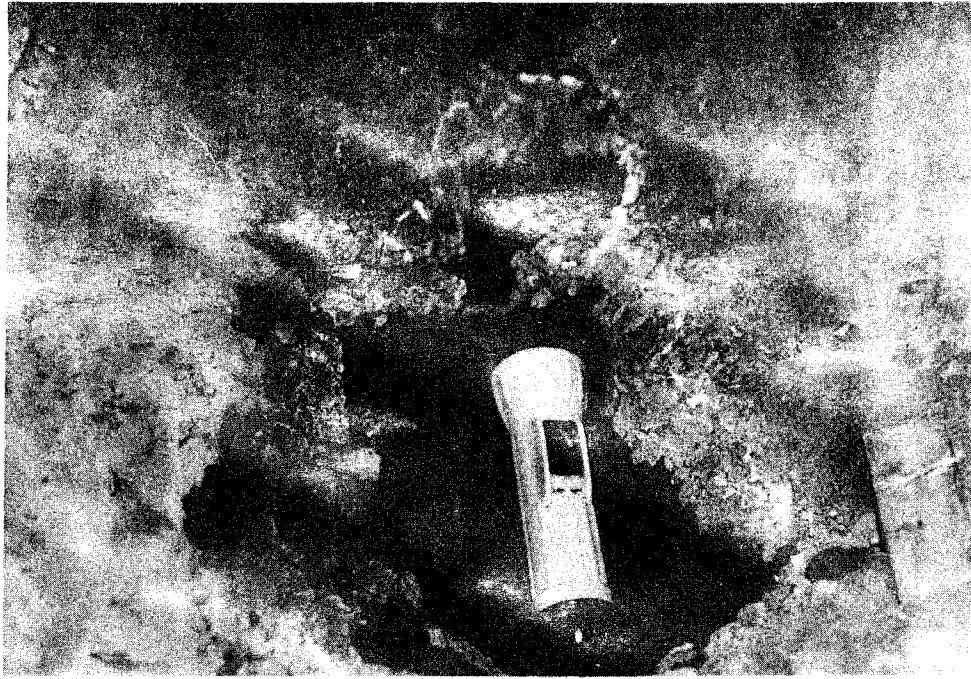
199. The metal forms that were used during placement were removed from the interior of the conduit for the first time in 1984. About two-thirds of the way up the conduit there was a 60 to 80-ft reach of honeycomb areas and cavities along the invert. In one spot there was a triangular shaped cavity partly covered with a piece of metal plate. The cavity extended through the full depth of the slab and appeared to be wider at the bottom. At another monolith upstream, there were two cavities that penetrated the full depth of slab. One cavity in the middle of the monolith (Figure 47) was about 6 ft long with a varying width of about 10 in. at the maximum. The second cavity located at the upstream end of this monolith was about 12 in. wide by 18 in. long. At the joint, the water stop was firmly embedded into the adjacent monolith, but fully exposed on the side of the cavity. There were two or three other V shaped cavities 5 to 7 ft long and varying in depth from about 1-1/2 to 8 in. About two-fifths of the way up the conduit, the end of a 3- by 3-in. piece of wood was embedded about 8 in. left of invert. Except for an area of scattered pits (approximately 1-1/2 in. in diameter by 1/2 in. deep)

Figure 47. Hole through conduit at invert, Mulberry Dam
