US Army Corps  
of Engineers

# REPAIR, EVALUATION, MAINTENANCE, AND REHABILITATION RESEARCH PROGRAM

TECHNICAL REPORT REMR-CS-4

## REPAIR OF WATERSTOP FAILURES: CASE HISTORIES

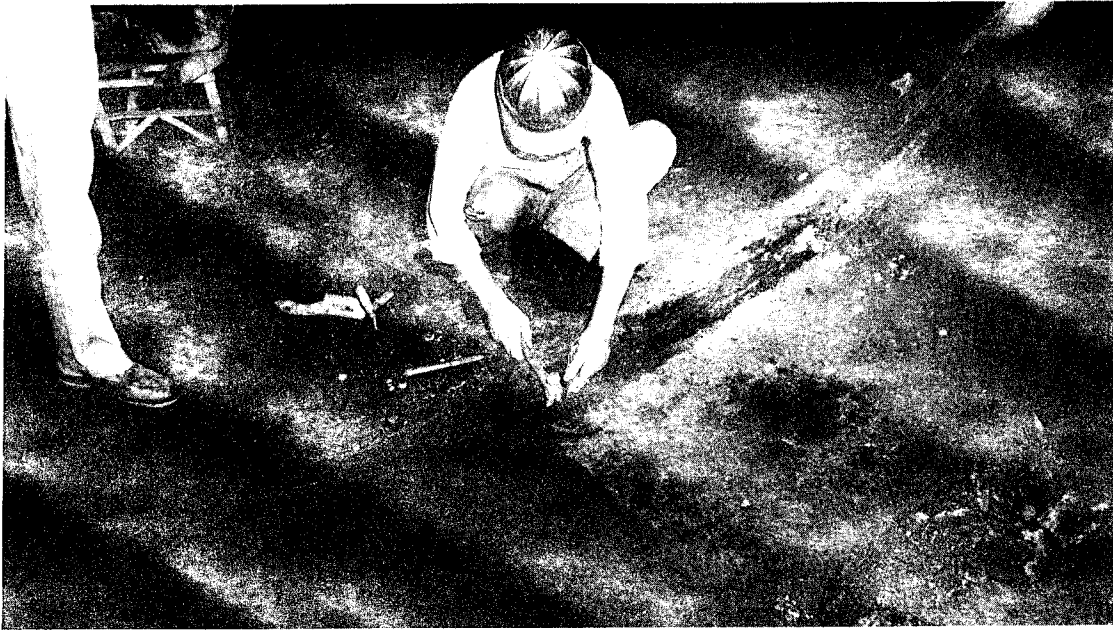
Figure 17. Removal of a portion of the remaining concrete key in preparation for repair, Sardis Dam

- a. Joints 2/3, 4/5, and 5/6 were repaired at leaking areas by removing the remaining concrete key, packing the joint below the keyway with oakum, sealing the oakum with lead wool, and replacing the key with Skinkote, which is described by the manufacturer, Hallemite Co., Cleveland, Ohio, as a "thin-ply concrete" that will adhere to set surfaces.

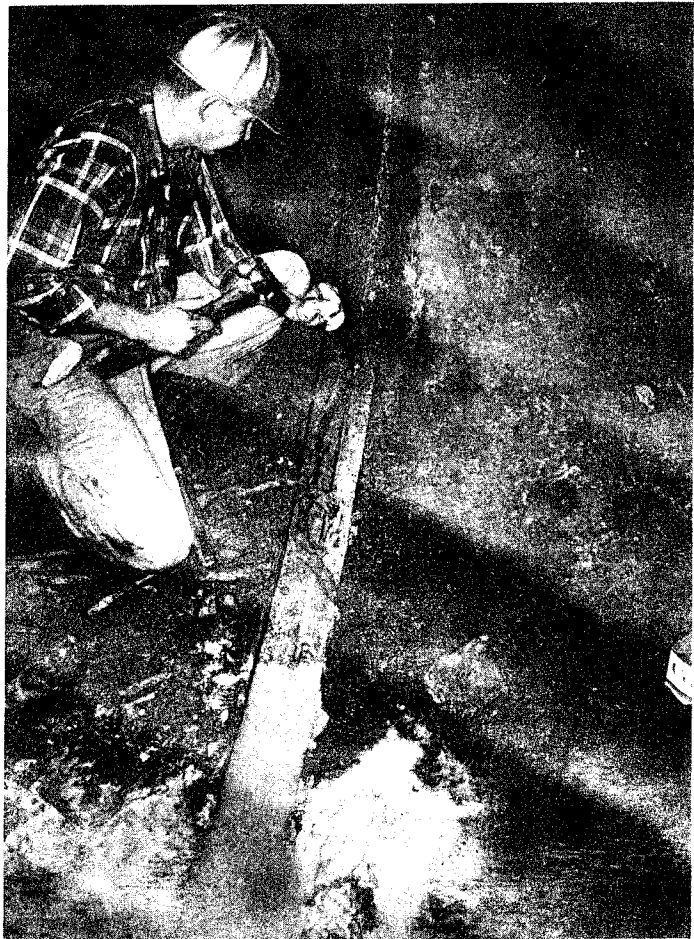
Figure 18. Packing a conduit joint, Sardis Dam

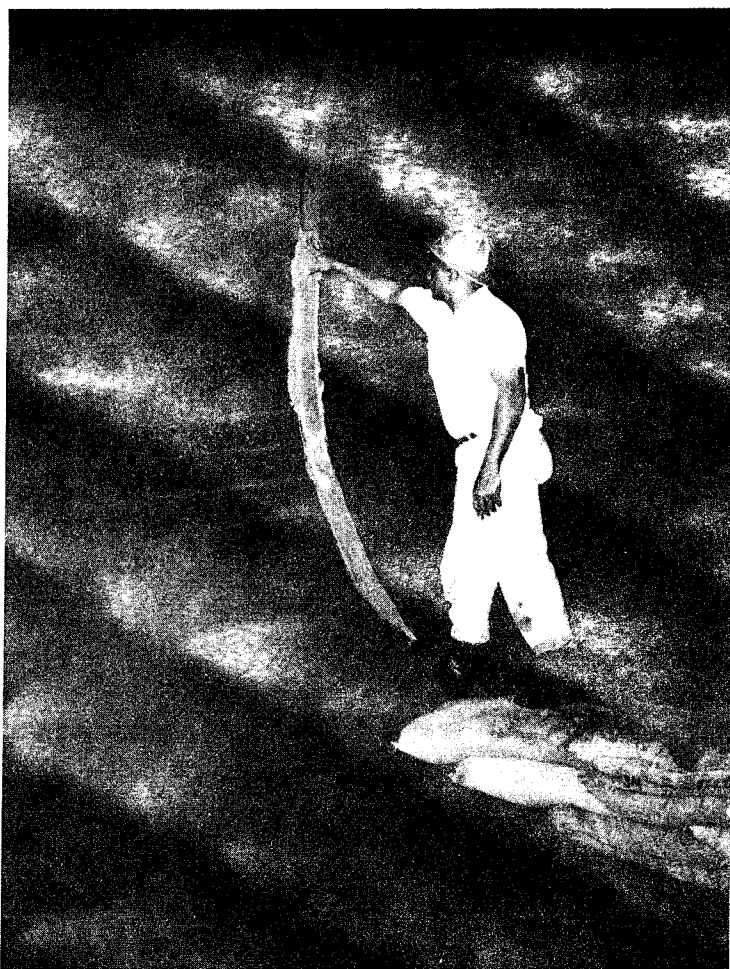
Figure 19. Partially replaced joint keyway,  
Sardis Dam

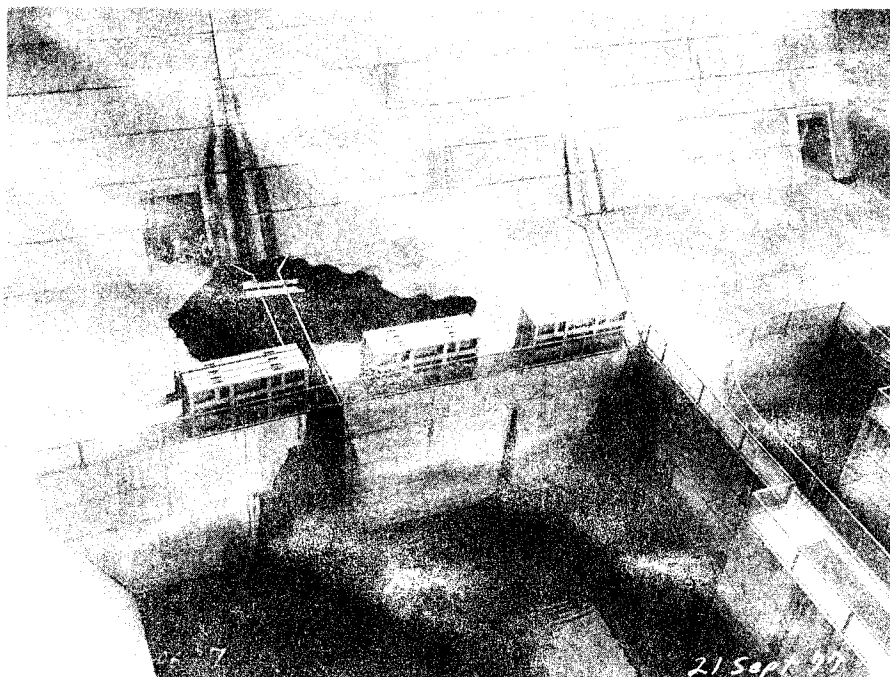
Figure 46. Leakage through north nonoverflow monolith joints, Ice Harbor Dam

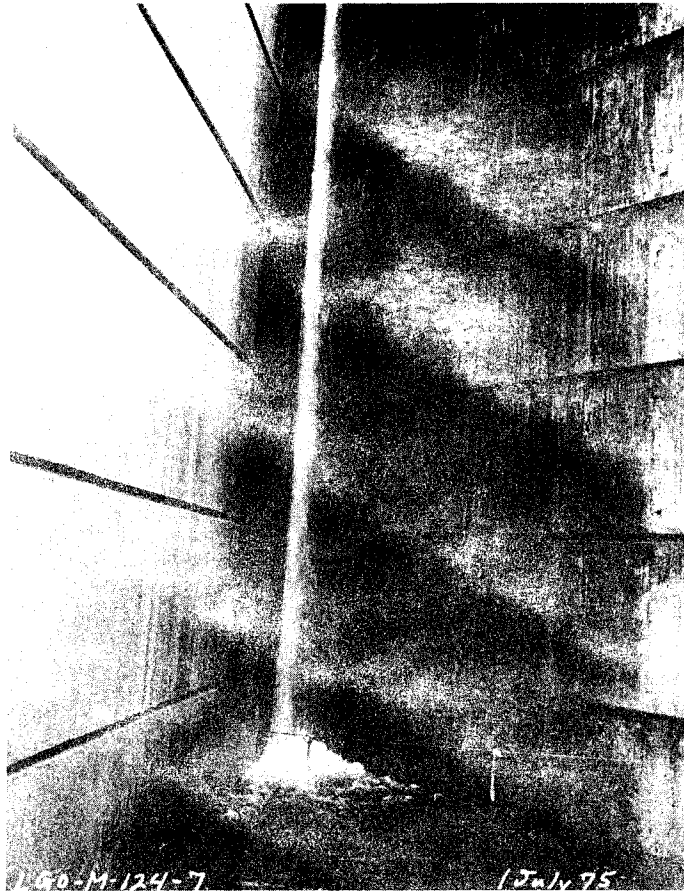
Figure 63. Monolith joint 4/6 leakage,  
July 1975, Little Goose Lock

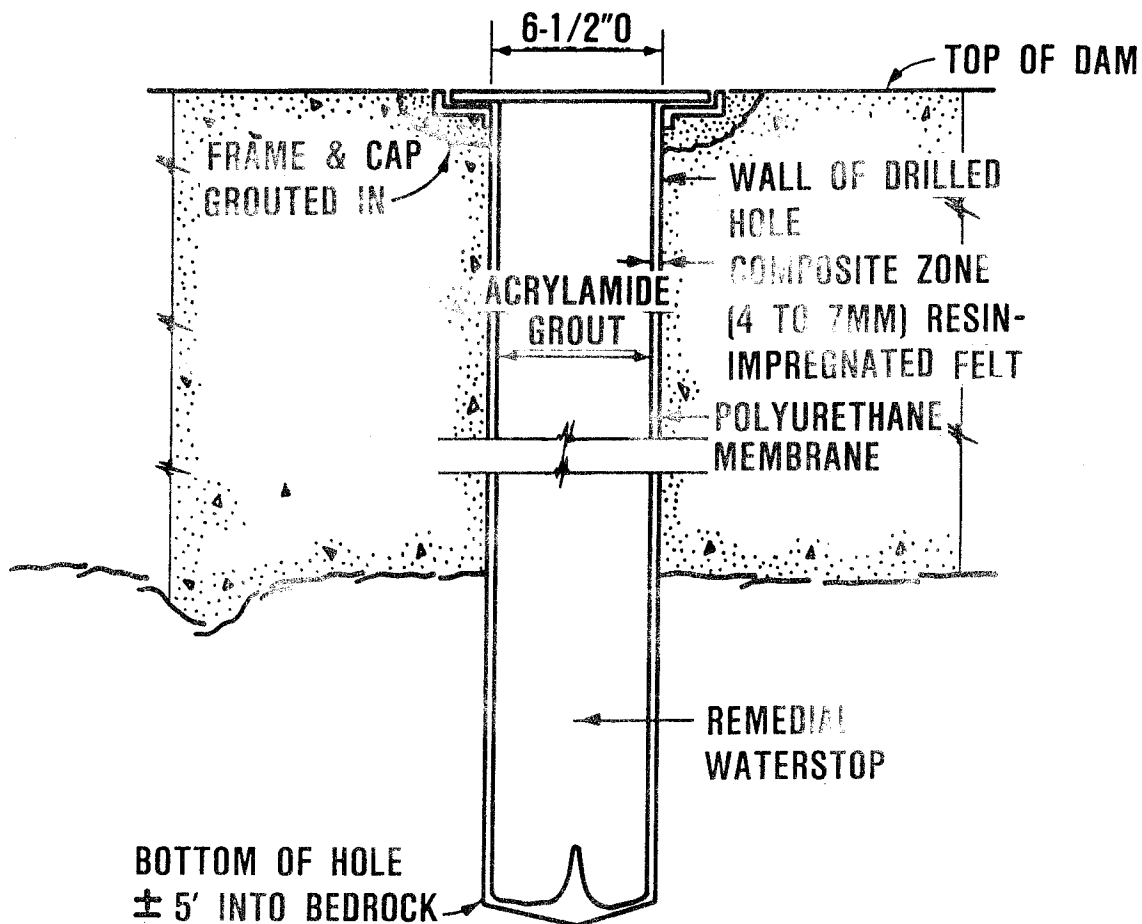
Figure 105. Completed remedial waterstop, Pine Flat Dam

196. A remedial waterstop was installed in hole 30/31 (191 ft deep) on 7 March 1985. As the end of the liner tube approached the bottom of the drill hole, resistance to further progress was encountered. This was mistakenly interpreted to indicate that the bottom had been reached and the control cable was tied off. Later television inspection showed that the tube was within approximately 10 ft of the bottom of the hole. Apparently, the joint near the bottom of the drill hole is relatively tight. Since water within the drill
