ARMORED VEHICLE COMPONENTS

Metallurgical Examination of
Armored Vehicle Components (Armor Attachment Bolts
and Welded Armor Sections) from a German PZKW III Tank.

Report No. 710/472
Watertown Arsenal
Problem B-26

January 2, 1943

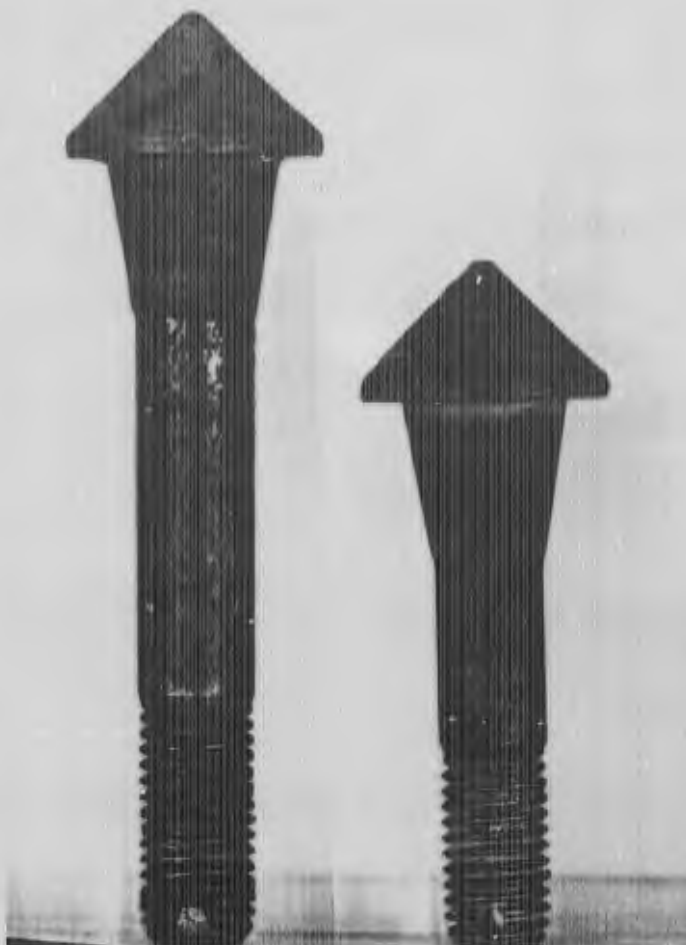
FIGURE 1

The bolts were painted completely with a dull black paint, and no visible markings were observed. The sizes of the bolts were 4"x.625"D and 2-3/4"x.546"D for the large and small bolt respectively, see Figure 1.

ARMOR ATTACHMENT BOLTS FROM A GERMAN PzKw III TANK
NOVEMBER 5, 1942 WTN. 710-1951

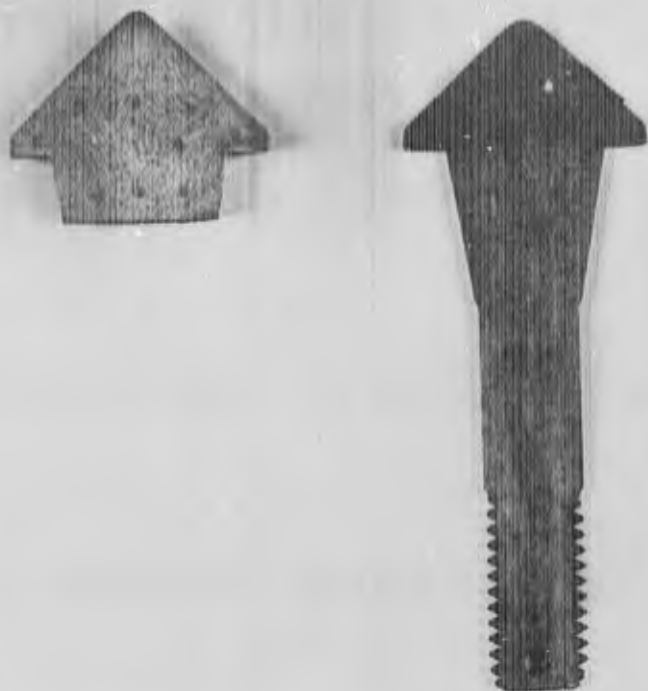
FIGURE 2

In Figure 2 is shown the macroetched longitudinal sections of the bolts on which the hardness impressions are still visible. The bolts were both forged (as observed from the grainflow) from relatively poor quality bar stock. They were then machined and the threads formed by rolling (indicated by the deformation adjacent to the threads) prior to heat treatment.

MACROETCHED LONGITUDINAL SECTIONS OF ARMOR
ATTACHMENT BOLTS FROM A GERMAN PZ KW III
TANK. NOVEMBER 18 1942 WTN.710-1958

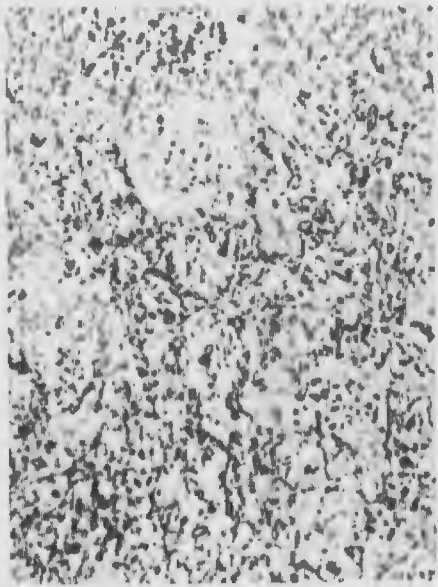
Both bolts are made from steel having a large amount of nonmetallic stringers, Figure 3A. The microstructure consists of tempered martensite, Figures 3B and C, with excess undissolved carbides which were especially prominent in the smaller bolt.

X1000 C Picral-nital
Small bolt: Tempered martensitic structure and undissolved carbides

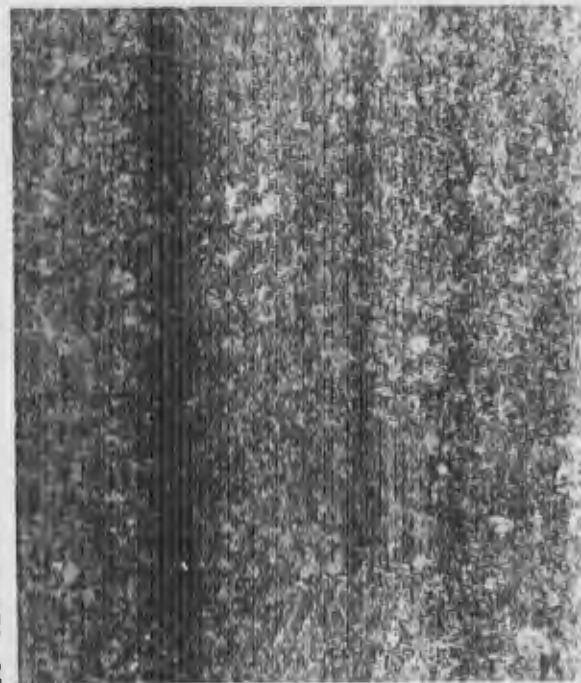
X100 -D- Picral Nital
Large Bolt: Banding in longitudinal direction.

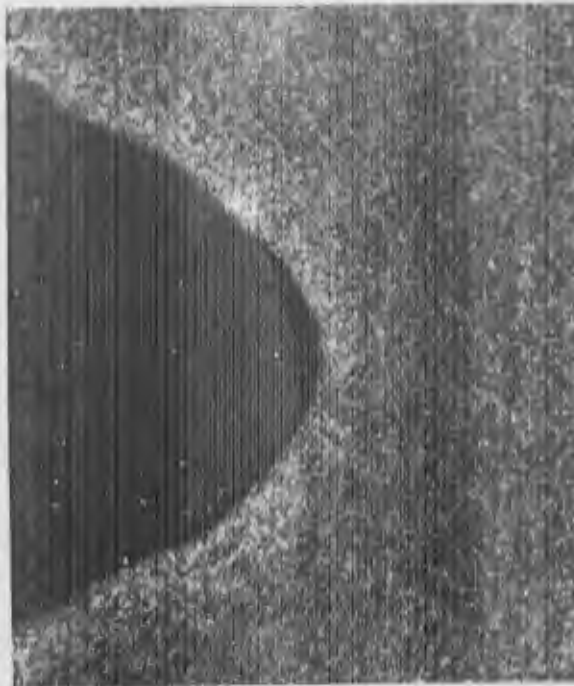
In Figure 3E is shown the cross section of a thread revealing the slight decarburization and the local deformation of the metallic and nonmetallic segregations resulting from the thread "rolling" operation. This offers further evidence that the bolts were forged, machined, threaded, and heat treated in that order.

X100 -E- Picral Nital
Small Bolt: Decarburization and cold work at root of rolled threads

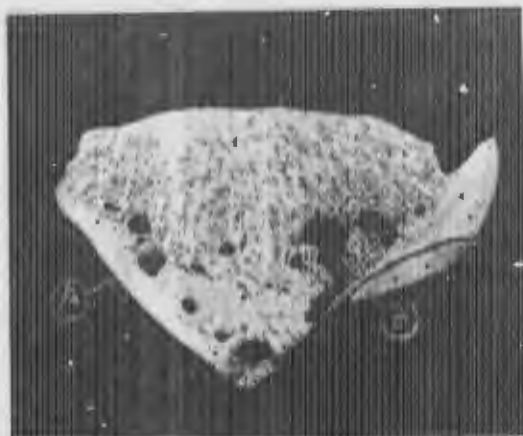
The analyses of the weld and the base metal at (B) in Figure 5A are as follows:

d. The structure of the weld metal specimen is shown in Figure 5. The excessive amount of porosity present was most prominent at the fusion line and between the two weld layers, see Figure 5A. The welding procedure employed is rather difficult to determine although it is believed that there were two single-pass layers. A lack of fusion was especially noticeable between the base metal (B) and the first pass.

X3 -A- Picral-Nital
Cross Section of Weld

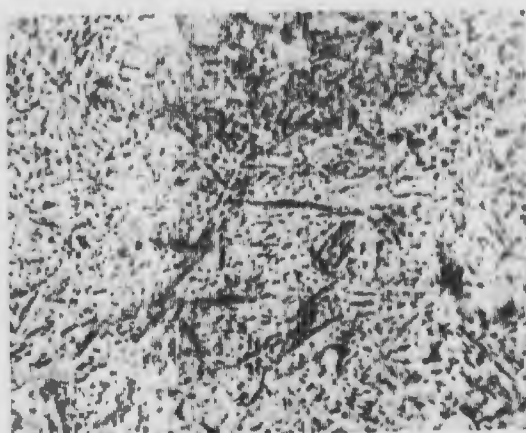
The weld metal is composed of a low carbon martensite of fairly high hardness. The base metal fragments attached are also martensitic but of a much higher hardness. Heat affected zone B (Figure 5D) which was analyzed, contains undissolved carbides in martensite. The other heat affected zone (Figure 5C) consists of an acicular martensite having very little undissolved carbide present.

X1000 -C- Picral-Nital
Heat affected zone A: Martensite

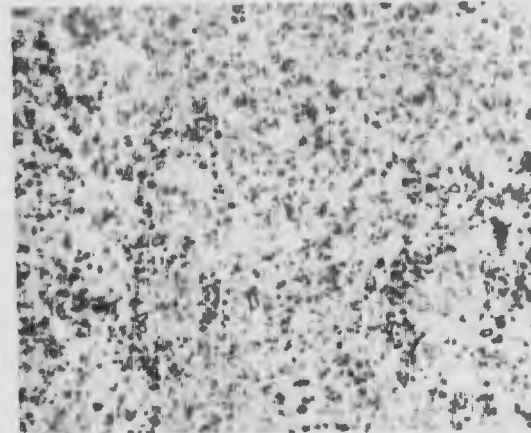
X1000 -D- Picral-nital
Heat affected zone B: Martensite
and undissolved carbides

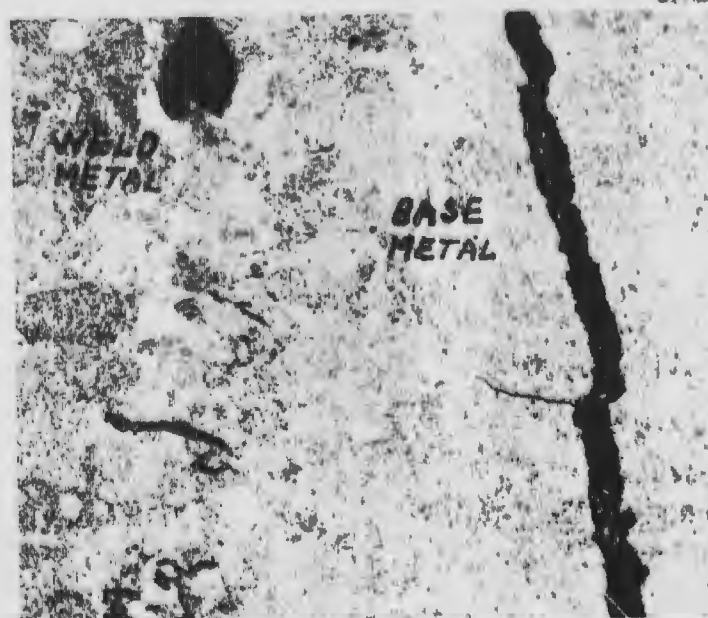
The weldment, which was probably a hurried field repair job, was very unsatisfactory. Weld metal was porous and did not adhere well to the base metal. The extreme hardness in the heat affected zones indicated that no attempt was made to either preheat or postheat the weld and thereby reduce its susceptibility toward cracking.

X100 -E- Picral-Nital
Fusion zone B: Porosity in weld and crack
in heat affected zone

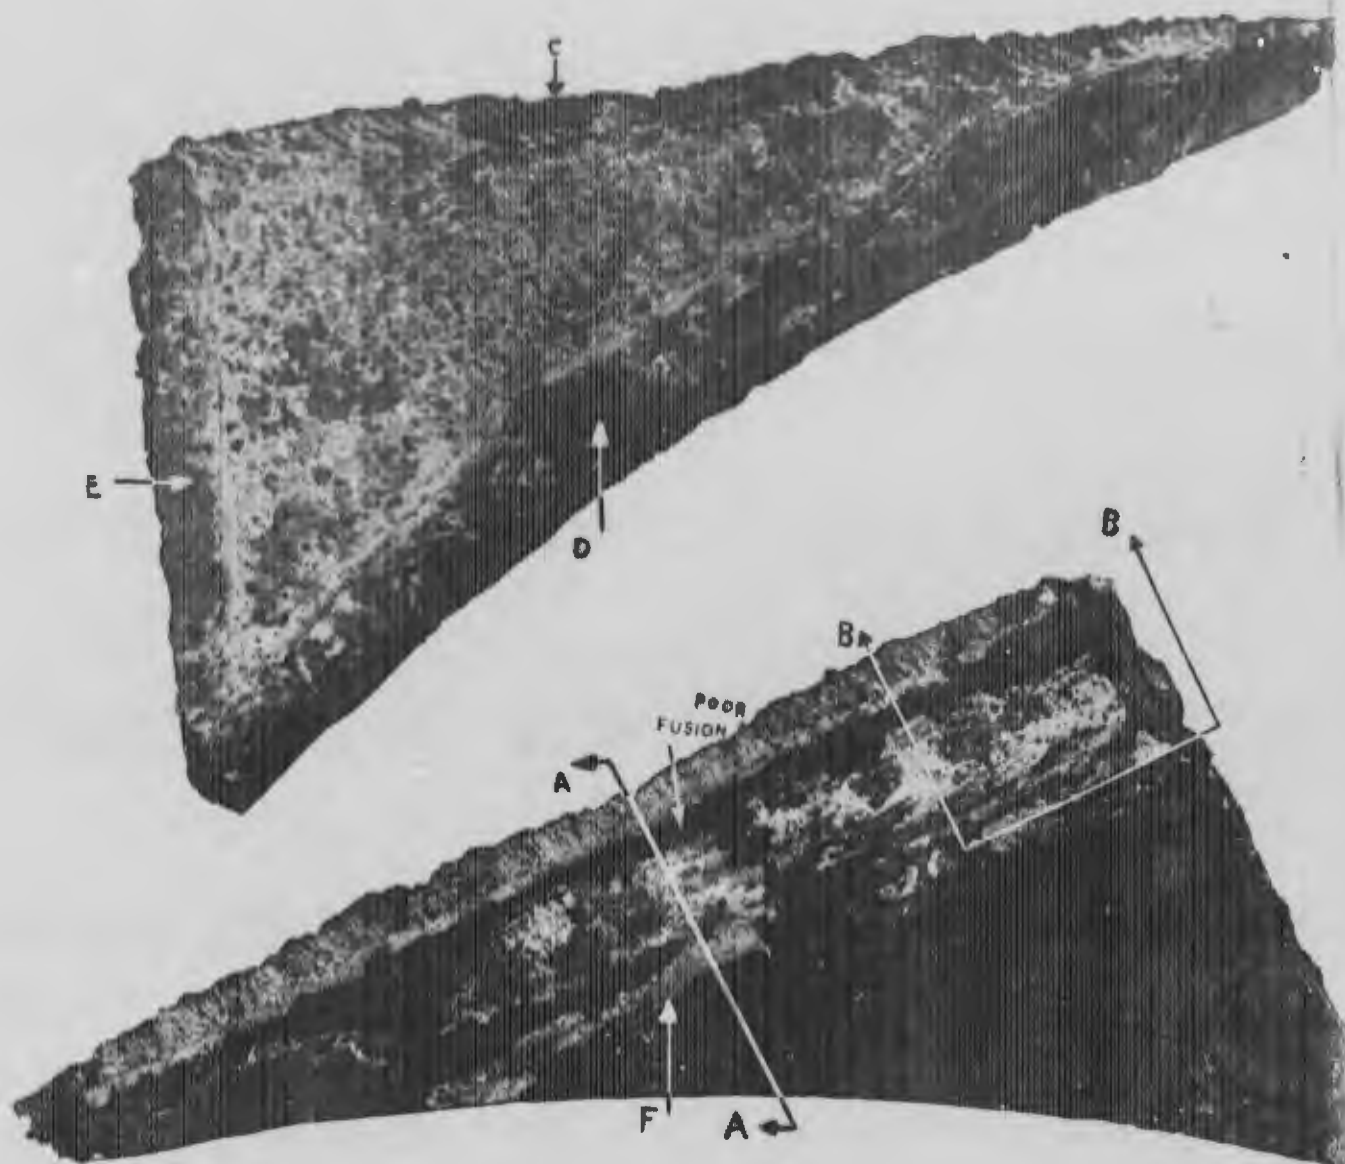
FIGURE 6

The triangularly shaped section shown in Figure 6 was broken from the carrier of the roof of the tank. It consisted of an 11 mm (.426" actual) armor section with weld deposits on the three edges as well as one across the back of the plate. The armor was painted on the back with a dull black paint which was flecked with rust. On the face this paint was covered with a thick iron oxide type paint. Stamped on both the face and back of the plate was the following:

The failure of the weldments generally occurred through the weld metal, although some lack of fusion was apparent in the fracture at one edge, see Figure 6.

WELDED ARMOR SECTION FROM THE CARRIER OF THE ROOF OF A GERMAN PzKw III TANK
NOVEMBER 6 1942 WTN.710-1952

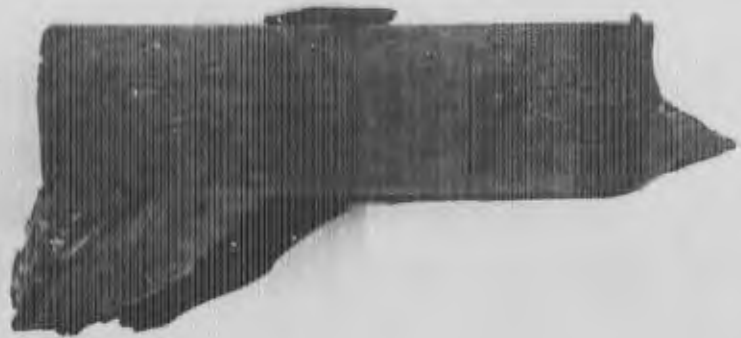
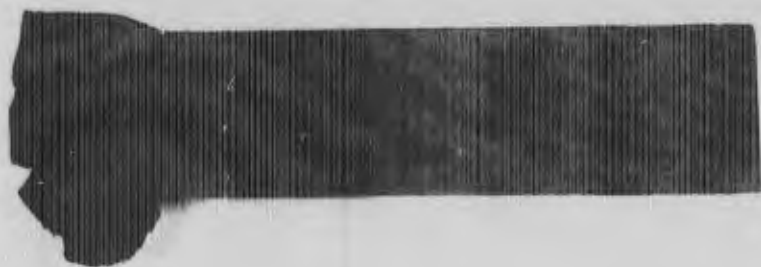
FIGURE 7

The macroetched sections in both the longitudinal and transverse directions is shown in Figure 7. The etching characteristics were similar in both directions indicating that the steel was cross-rolled. The armor was made from good quality steel as indicated by the freedom from nonmetallic segregations in the two sections examined.

MACROETCHED SECTIONS OF A WELDED ARMOR SECTION FROM THE
CARRIER OF THE ROOF OF A GERMAN PZKW III TANK. MAG. X2
TOP: LONGITUDINAL SECTION - BOTTOM: TRANSVERSE SECTION
DECEMBER 15 1942 WTN.710-1981

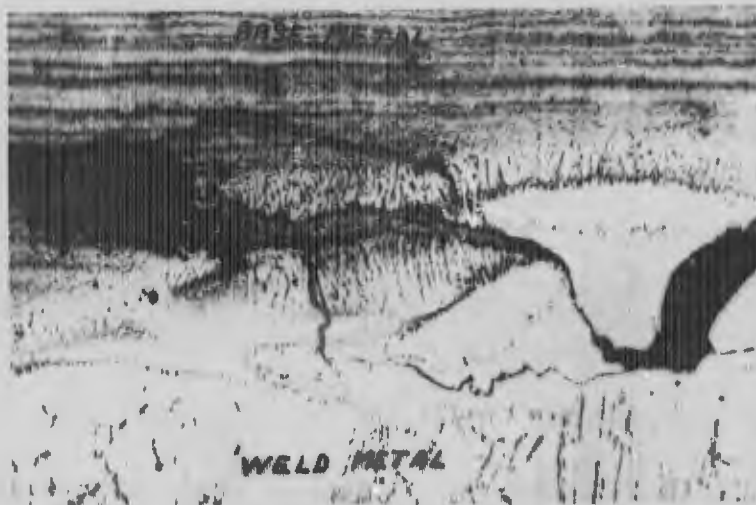
Several cracks were observed in the heat affected zones of the base metal in an area adjacent to the high alloy weld metal. See Figures 8A and B. The extension of one or two of these cracks was associated with the line of fusion of the high alloy weld metal. The low alloy weld metal, on the other hand, formed a very good bond with the base metal and it was difficult to distinguish the line of fusion between the two. There was also a satisfactory bond between the two types of weld metal although, in one case, a crack formed in the first pass of the low alloy weld metal. See Figure 8C. Another defect observed was the lack of fusion at the toe of welds and the general poor quality of the welding technique as a probable result of welding under field conditions.

X100 -B- Picral Etch
Fusion Zone at 2. High alloy weld bead.
Cracking in Heat affected zone.

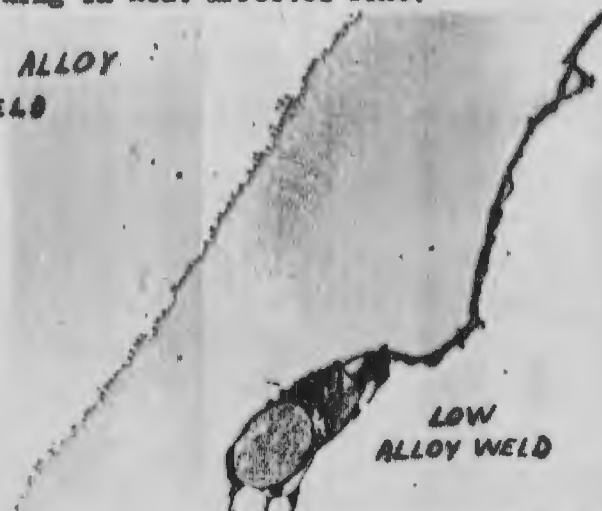
X100 -C- Picral Etch
Fusion zone at 3 between low and high alloy
weld metal. Note cracking in low alloy
weld zone.

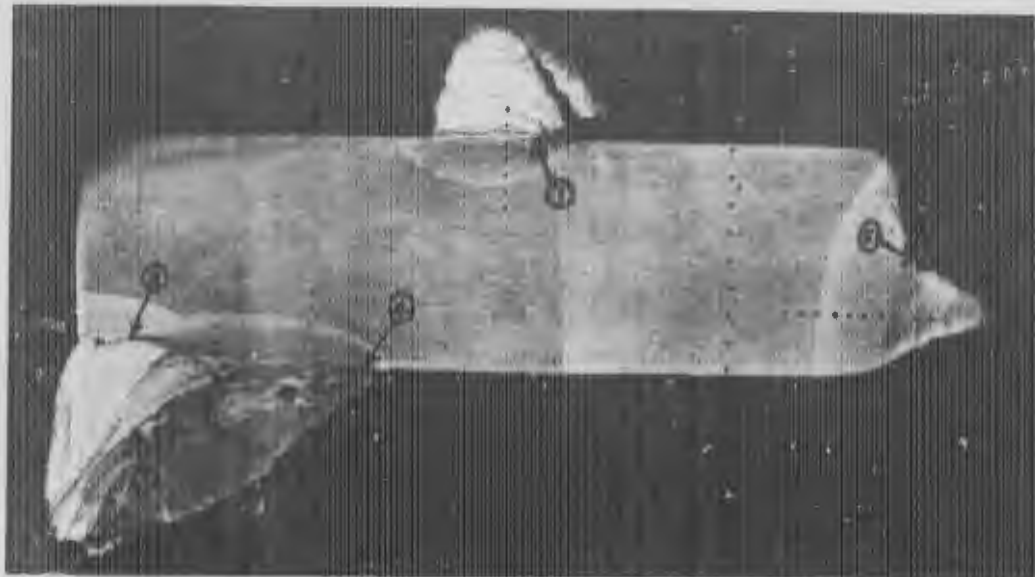
Hardness surveys were obtained every .03" across the heat affected zones as shown in Figure 8D and 9A. Subsequent readings were taken on other specimens to verify the original surveys.

Section A-A in Figure 6: Position of the vickers surveys and photomicrographs

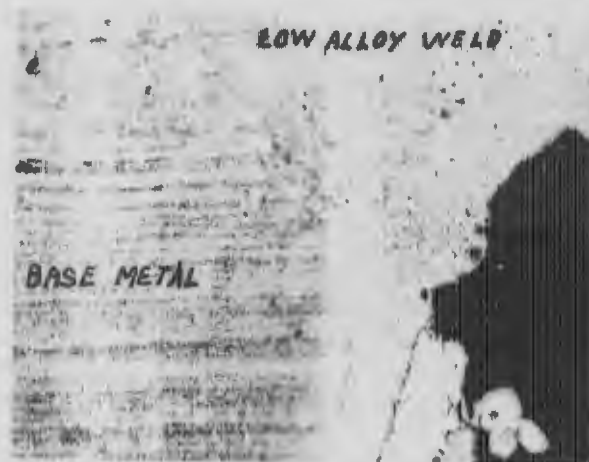
Fusion zone at 5. Note fracture in the high alloy weld bead

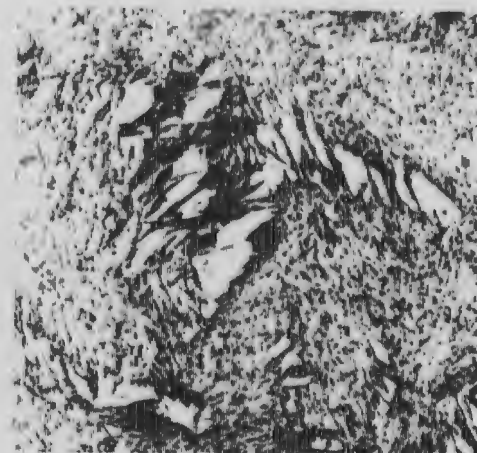
The low alloy weld metal was almost completely martensite with small amounts of retained austenite. See Figure 8F and H. The high alloy Cr-Mn weld metal was almost entirely austenite with bands of an acicular transformation product, probably bainite. See Figure 9C and E. The presence of austenite was substantiated by x-ray diffraction.

Martensite and austenite in low alloy weld at 5.

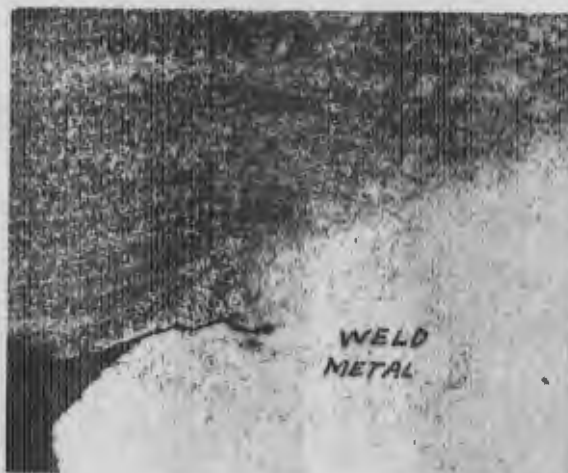
Fusion zone at 4. Low alloy weld bead showing very good fusion except at the toe.

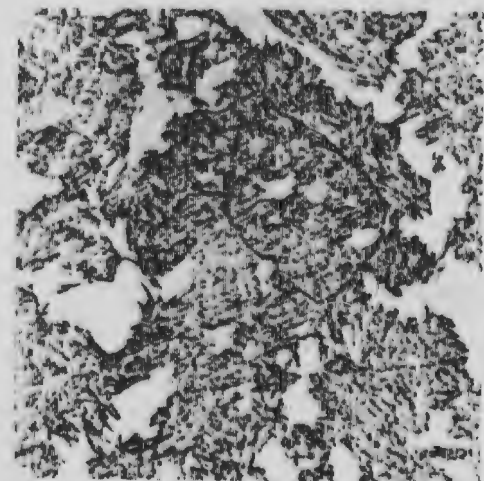
Martensite and austenite in low alloy weld at 4.

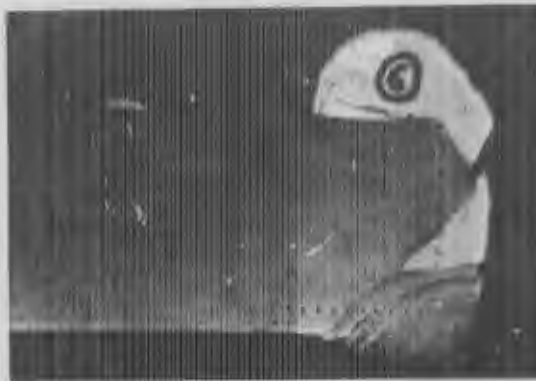
X3 A Nital Etch
Section B-B in Figure 6: Position
of Vickers surveys & photographs

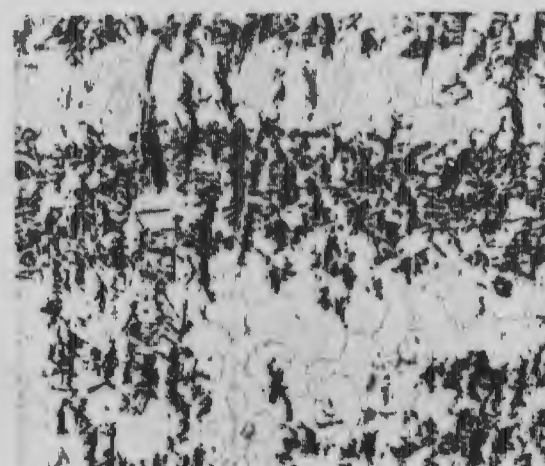
X100 C Chromic acid Etch
Weld metal at 6: Bainite in high
alloy weld

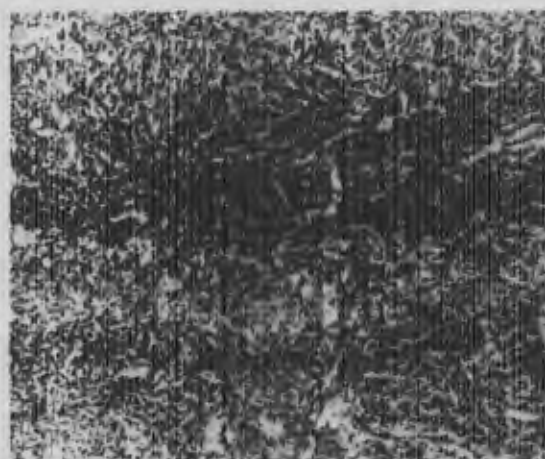
The structure of the base metal is a typical tempered martensite, Figure 9D, containing some undissolved carbides and indicating incomplete heat treating. At low magnification banding or alloy segregation is observed. The similarity of the etching characteristics in both the longitudinal and transverse directions indicates that the steel was cross-rolled. The distribution of nonmetallics in the longitudinal direction is shown in Figure 9B. The general freedom from nonmetallic segregations observed here is typical of German armor which has been previously studied at this Arsenal*.

X1000 D Picral Etch
Base metal: Martensite and undissolved
carbides
