**AIR FORCE FLIGHT  
EVALUATION (SYSTEMS)  
OF THE  
A-10A PROTOTYPE AIRCRAFT**

**TECHNICAL REPORT No. 73-3**

**MARCH 1973**

**AIR FORCE FLIGHT TEST CENTER  
EDWARDS AIR FORCE BASE, CALIFORNIA  
AIR FORCE SYSTEMS COMMAND  
UNITED STATES AIR FORCE**

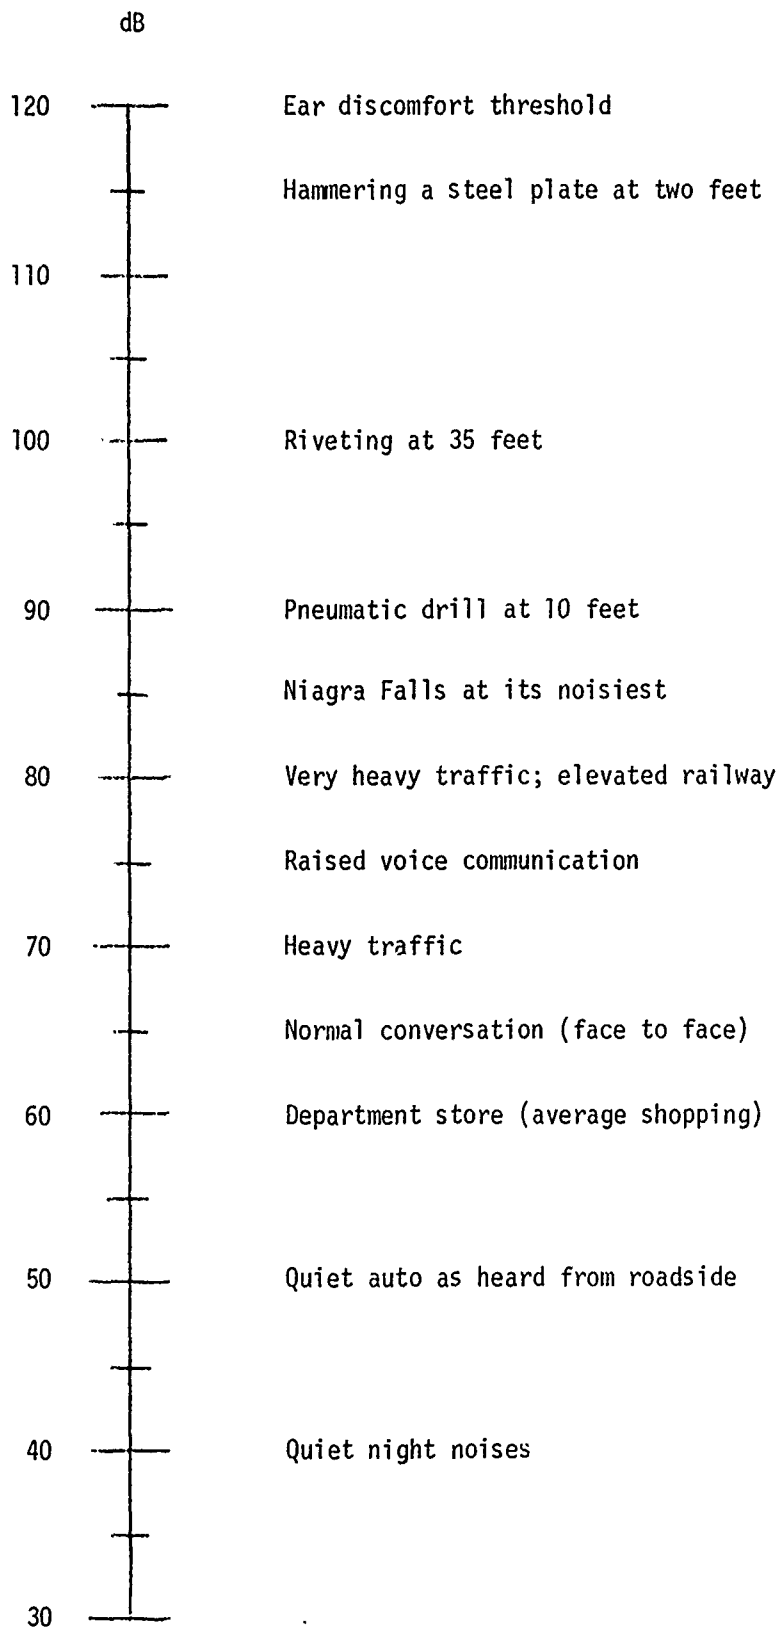
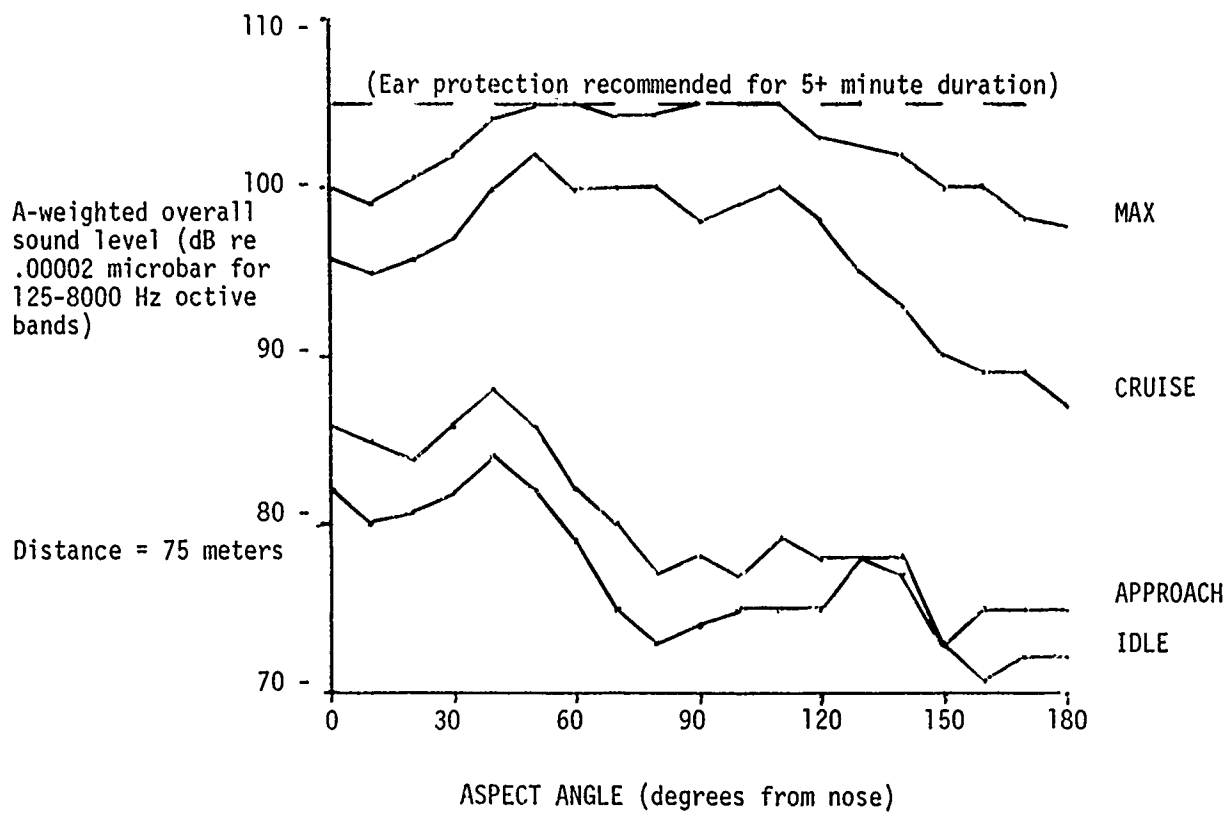
Figure 1. Graph of A-10A sound levels at various power settings by aspect angle.

As shown by the graph in Figure 1, relative sound levels around the A-10A at high power settings follow a different pattern than at lower power settings. Although no levels were found to present an accoustical noise hazard to airfield operations, at higher power settings (CRUISE, MAX) noise was most intense in the beam quadrant; at lower settings the front quadrant was most affected. At 75 meters, ear protection was advisable for beam exposure to MAX power noise for durations exceeding five minutes. (The specified time limit for sustained MAX power is five minutes.) Maximum exposure times are summarized in Table I.

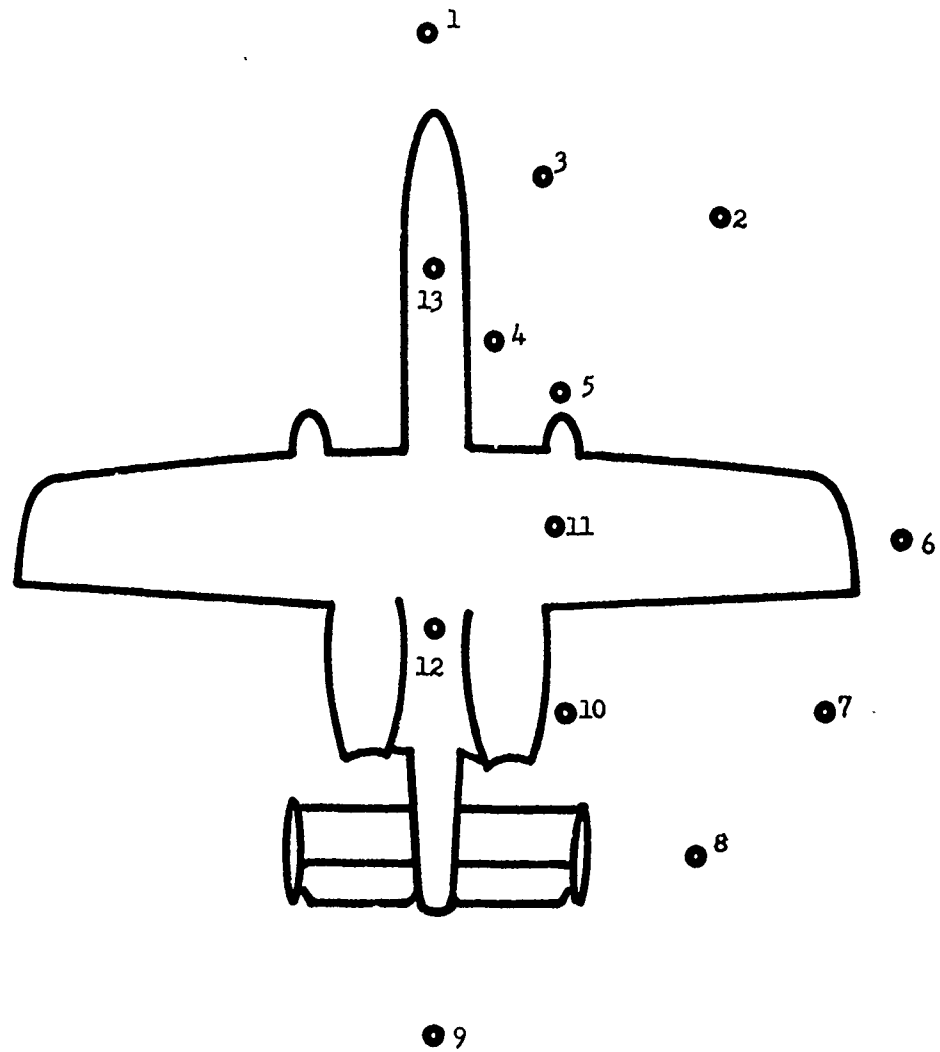
Figure 2 Nearfield Microphone Locations for A 10 Aircraft

Near-field maintenance positions at which sound levels were sampled are shown in Figure 2. Sound levels at all of these locations with engines at IDLE were well within acceptable limits as shown in Table II. Maintenance personnel with ear protection could spend an entire eight-hour day in these positions without incurring ear damage. APU operation did not contribute significantly to the overall sound level.

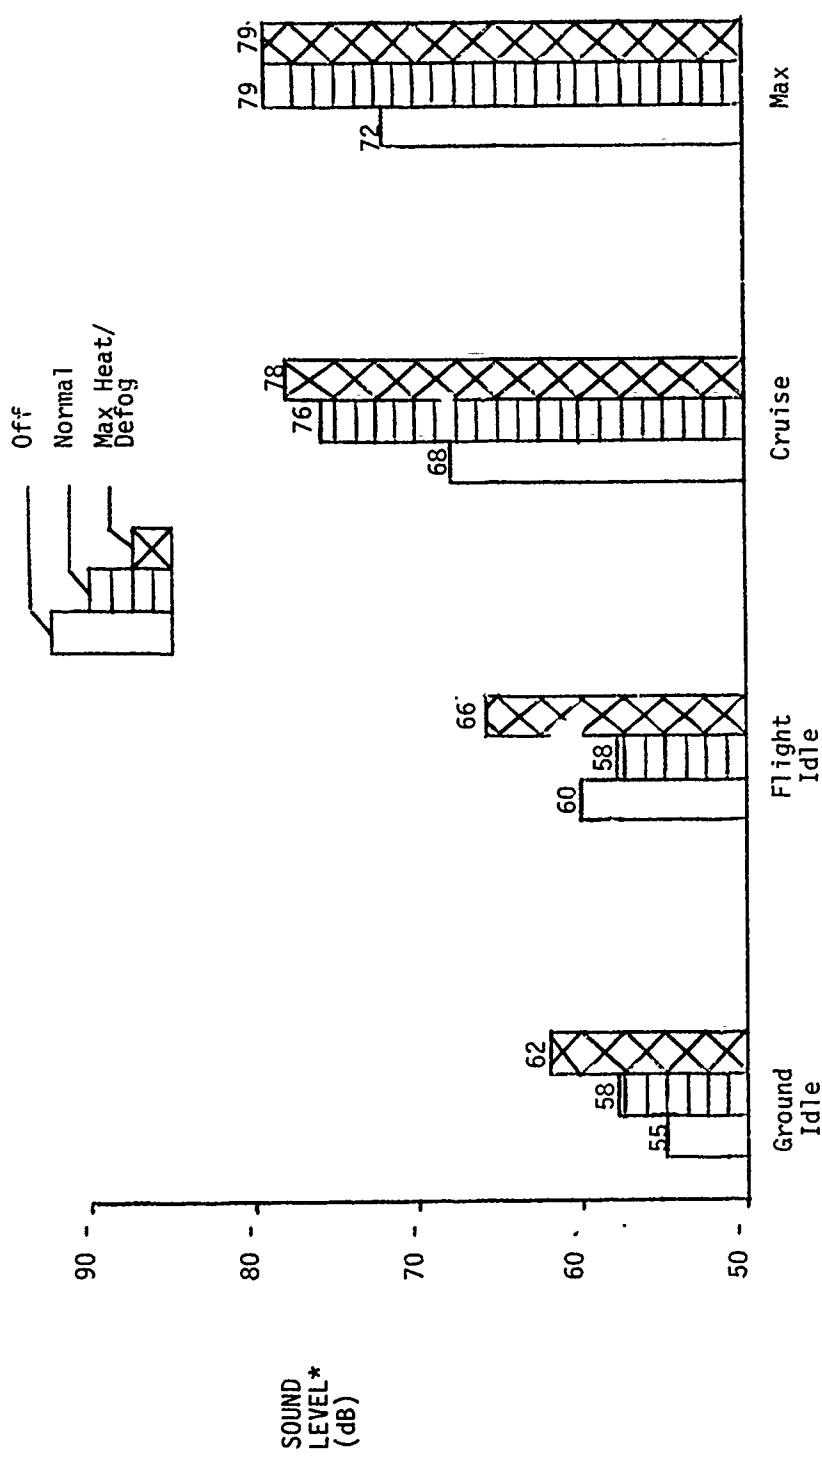
Figure 3. Graph of A-10A cockpit sound levels by power setting and ECS condition.

well within tolerable limits as attenuated by helmet/communications unit, and were considered not to be a performance degrading factor. ECS operation contributed to the overall noise level as expected, but not to an unreasonable extent.
