Report No. 131500-603  
14 January 1977

INTERIM TEST REPORT  
ON THE SHOCK-DROP TEST  
OF THE  
AN/TRN-41 TACAN NAVIGATIONAL SET

Prepared by:  
✓ E-Systems, Inc., Montek Division  
2268 South 3270 West  
Salt Lake City, Utah 84119

This test report is an interim report describing the failure and the proposed corrective action resulting from the Shock-Drop test on the AN/TRN-41 TACAN Navigational Set. After the corrective action has been taken, these tests will be repeated.

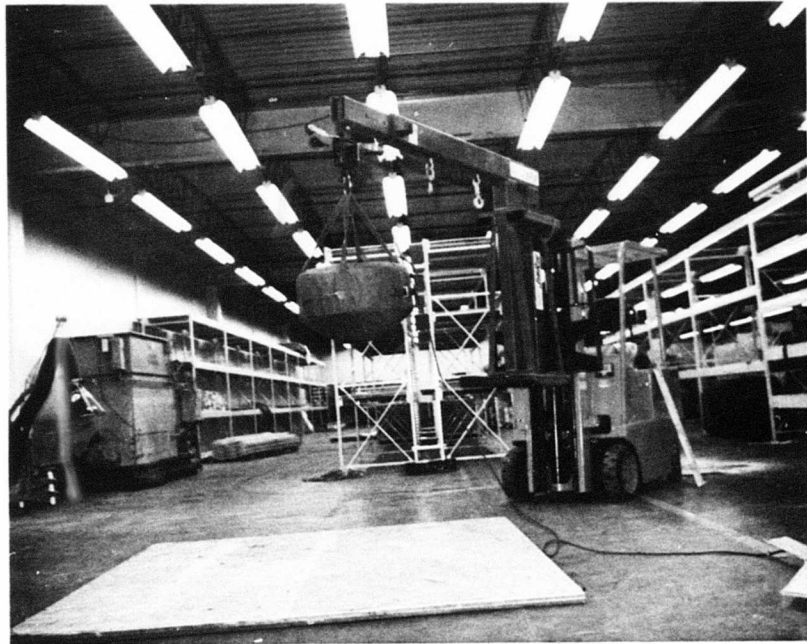
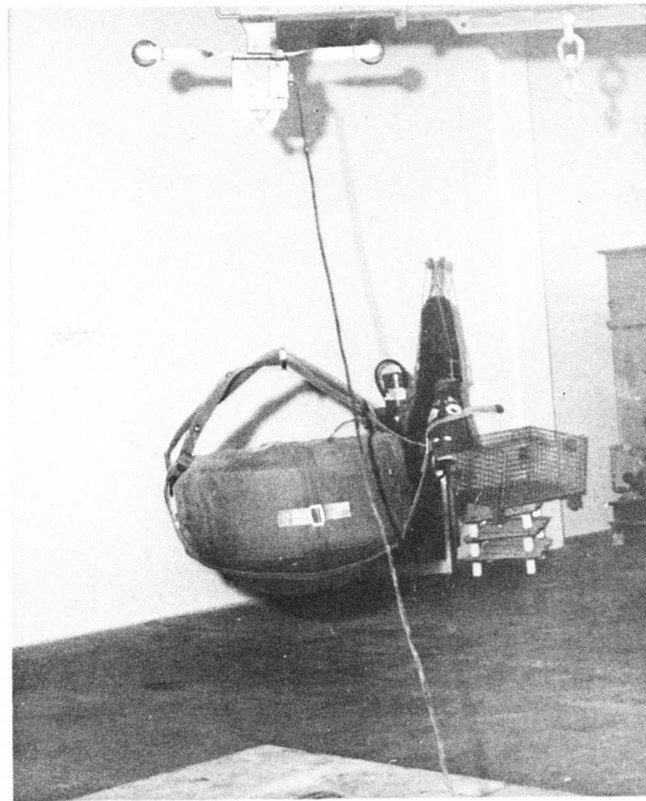
b. Antenna Unit. The antenna unit incurred damage with two types of drops. First, an angular drop on the upper radome such that the radome was deformed, damaging the 15 Hz and 135 Hz rotating drums. Second, the angular drop on the lower portion cracked the pedestal and lower radome.

ANTENNA 48" DROP TEST

The antenna pedestal was redesigned by removing the compass and reducing its height. A nylon ring was added to the top of the radome to mount the compass during alignment. At all other times, the compass will be with the ancillary equipment. The design of the compass will change from the north seeking type to a 360° type - it will be the same compass that is used in the AN/TRN-26 system. The reduction in height of the pedestal allows the packing to be arranged so that the center of gravity is closer to the man's back.

The upper radome was strengthened by adding two plies of fiberglass across the sides and top of the radome. This strengthening now prevents the radome from touching the 15 Hz and 135 Hz rotating drums.

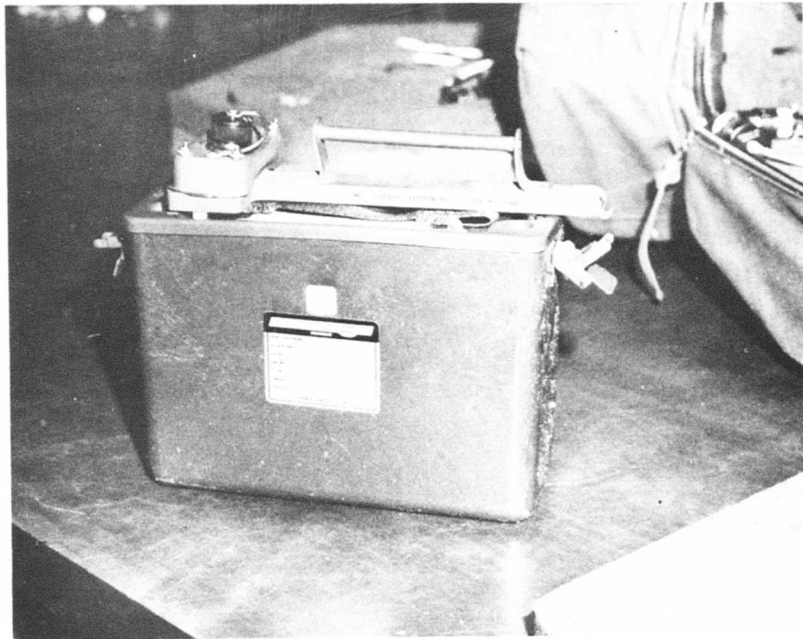
(2) The battery adapter handle was bent; however, it was still functional.

BATTERY AND ADAPTER AFTER 48" DROP TEST

The density of the packing surrounding the battery and battery adapter will be increased. In addition, the battery adapter will nest in the packing.

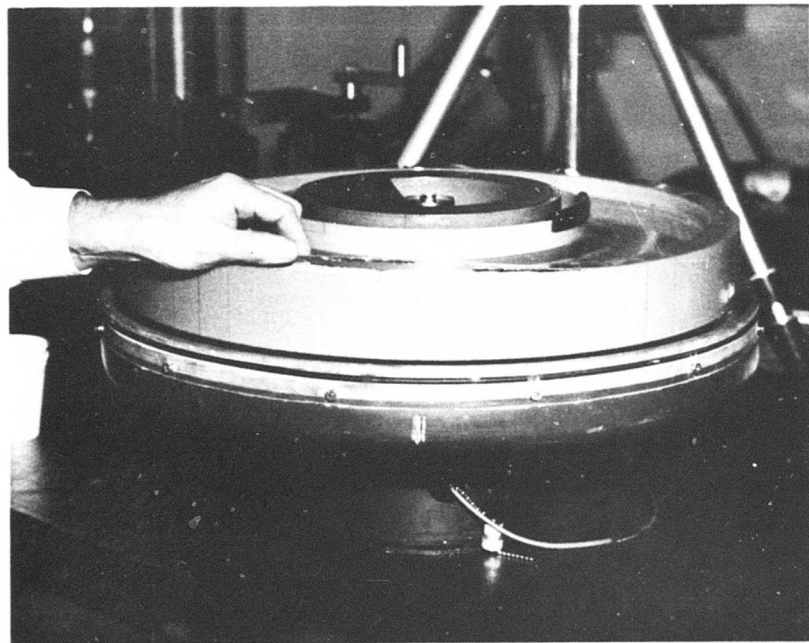
(3) Damage was done to the 15 Hz and 135 Hz rotating drums, caused from making contact with the radome.

INSIDE ANTENNA AFTER 48" DROP TEST

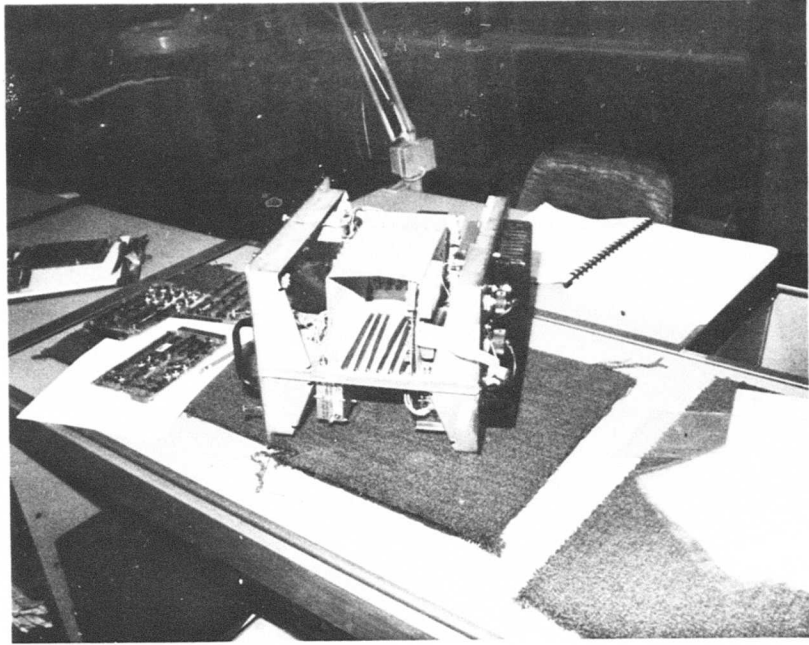
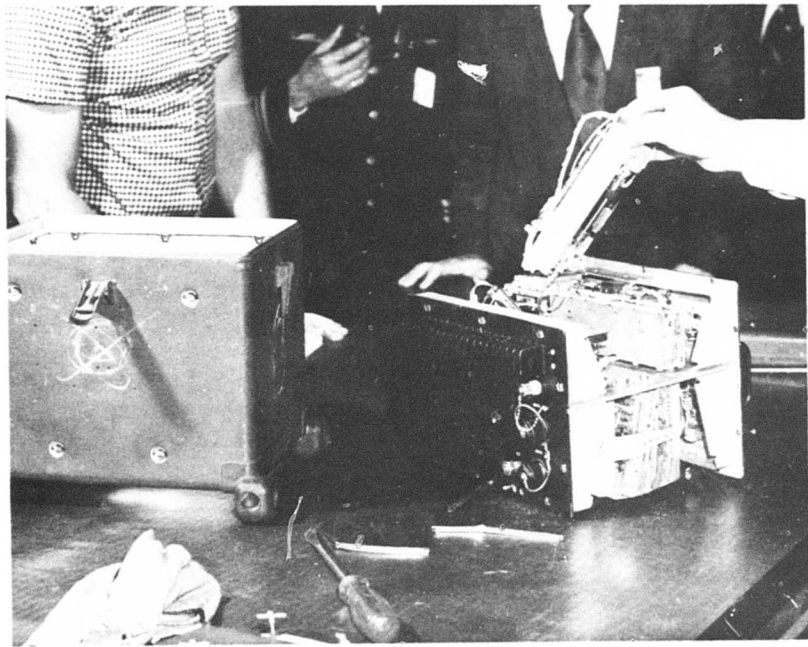
(2) Card Rack. The card rack securing the seven circuit card assemblies deformed badly. All of the connectors used in securing the circuit cards broke; the card guides became twisted and deformed, and all circuit cards became loose.

(3) Synthesizer Chassis. The mounting flanges on this assembly broke off; therefore, this assembly became loose and caused major secondary damage.

a. Receiver-Transmitter (RT) Unit. The RT unit incurred major damage when it was dropped on the rear surface that mounts the heat exchanger. The rubber bumpers permitted the heat exchanger to strike the plywood floor with enough force to have an imprint of the exchanger on the floor. This severe shock deformed the rear of the case, broke the mounting of the synthesizer allowing it to float in the unit, and deformed the card cage so that the printed circuit cards became loose.

RT AFTER 48" DROP TEST

The rubber bumper blocks originally provided 1/8 inch clearance to the heat exchanger. This clearance has been increased by 1/2 inch and the area of these bumpers increased from 3.5 square inches to 9.0 square inches. The increase in depth and surface areas will prevent the heat sink from bottoming during drops.

The card rack has been redesigned to provide more rigidity so that the rack does not spring out of shape, allowing the cards to become loose and breaking the connectors. To increase the rigidity of the case, the aluminum composition and temper were changed, the rear connector plate was redesigned to one piece fastened to the side and top of the case, and the new front cover adds rigidity to the case by fastening to the sides at four places, in addition to supporting the printed circuit cards.

The synthesizer casting was redesigned to provide more rigidity and support at the top of the unit. The thickness of the mounting flange was increased to 1/16 inch and two bosses were added at the top of the casting to fasten to the braces. Braces were installed at the top of the unit from the front to the rear to provide support for the synthesizer and receiver.

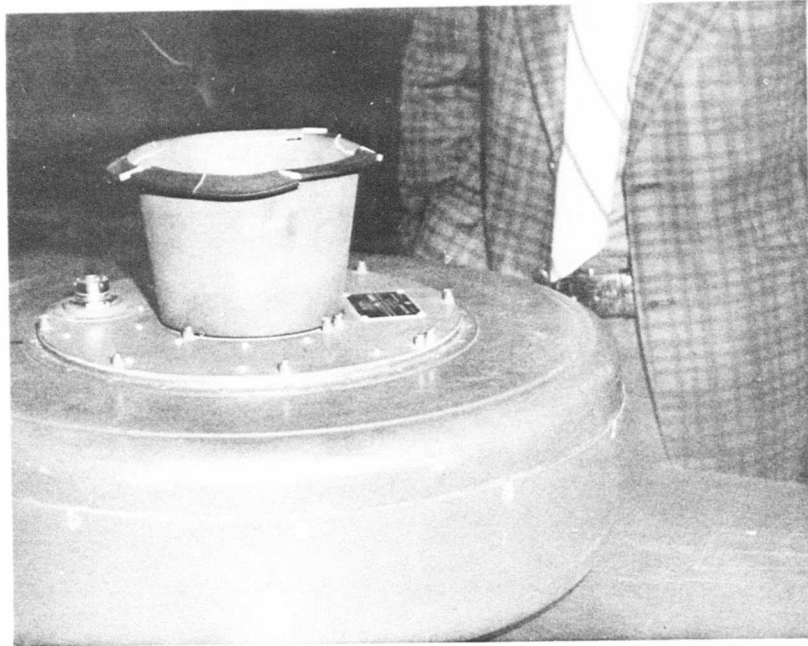
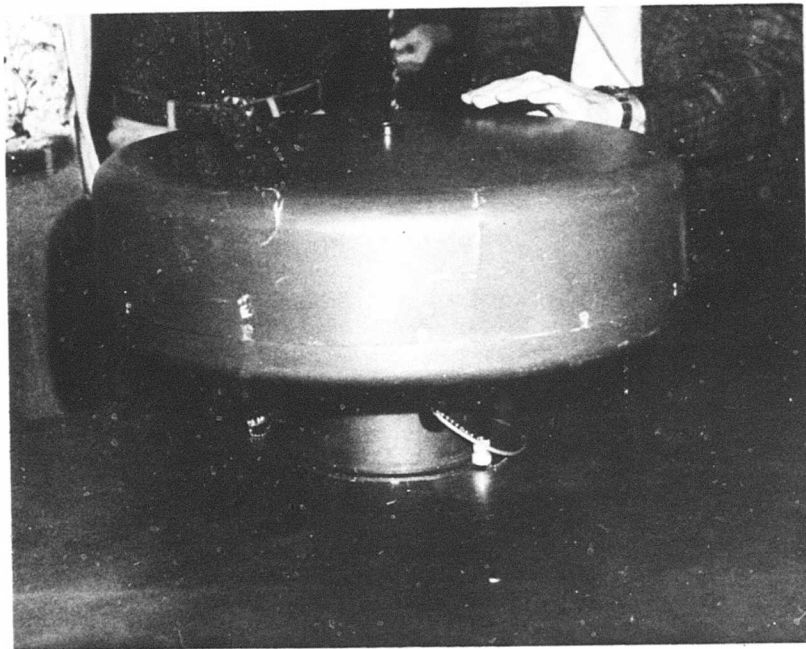
(1) The upper radome cracked.

(2) The lower radome cracked.

(4) Pedestal base broke.

ANTENNA - AFTER 48" DROP TEST

The smaller pedestal is packed so that the drop shock is not concentrated on the flange of the pedestal, but distributed over the lower section of the antenna.

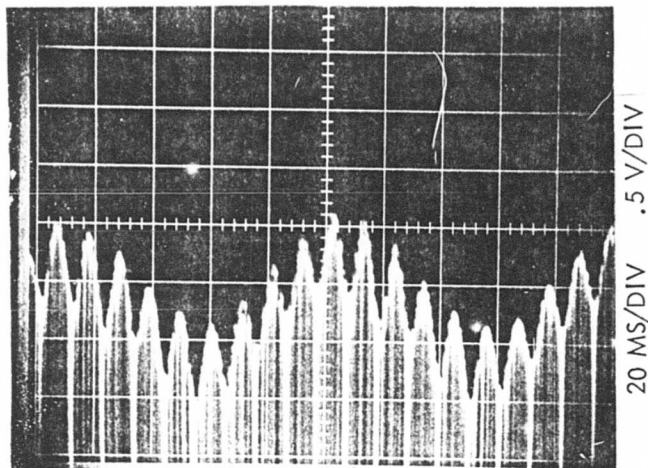
ANT S/N 001 WITH RT S/N 002

PRE SHOCK TEST - RADIATED DET SIGNAL 12/15/76

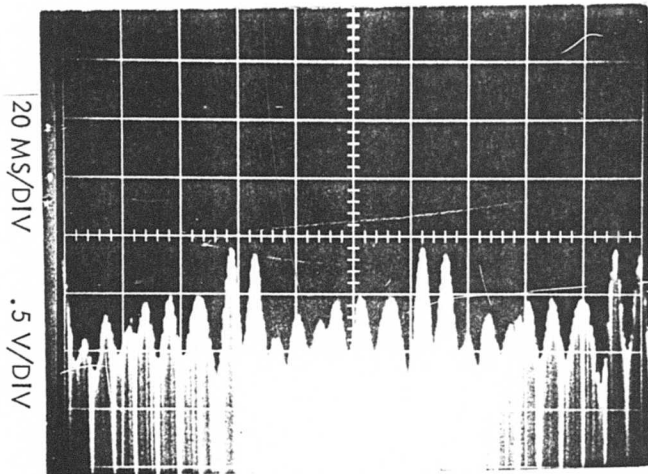
ANT S/N 001

POST SHOCK TEST - RADIATED DET SIGNAL 12/16/76
