MTMC REPORT OA 81-4a-27

# ANALYSIS OF MTMC PARTICIPATION IN THE REFORGER 81 EXERCISE

MAY 1982

**MILITARY TRAFFIC MANAGEMENT COMMAND**  
**TRANSPORTATION ENGINEERING AGENCY**  
NEWPORT NEWS, VIRGINIA 23606

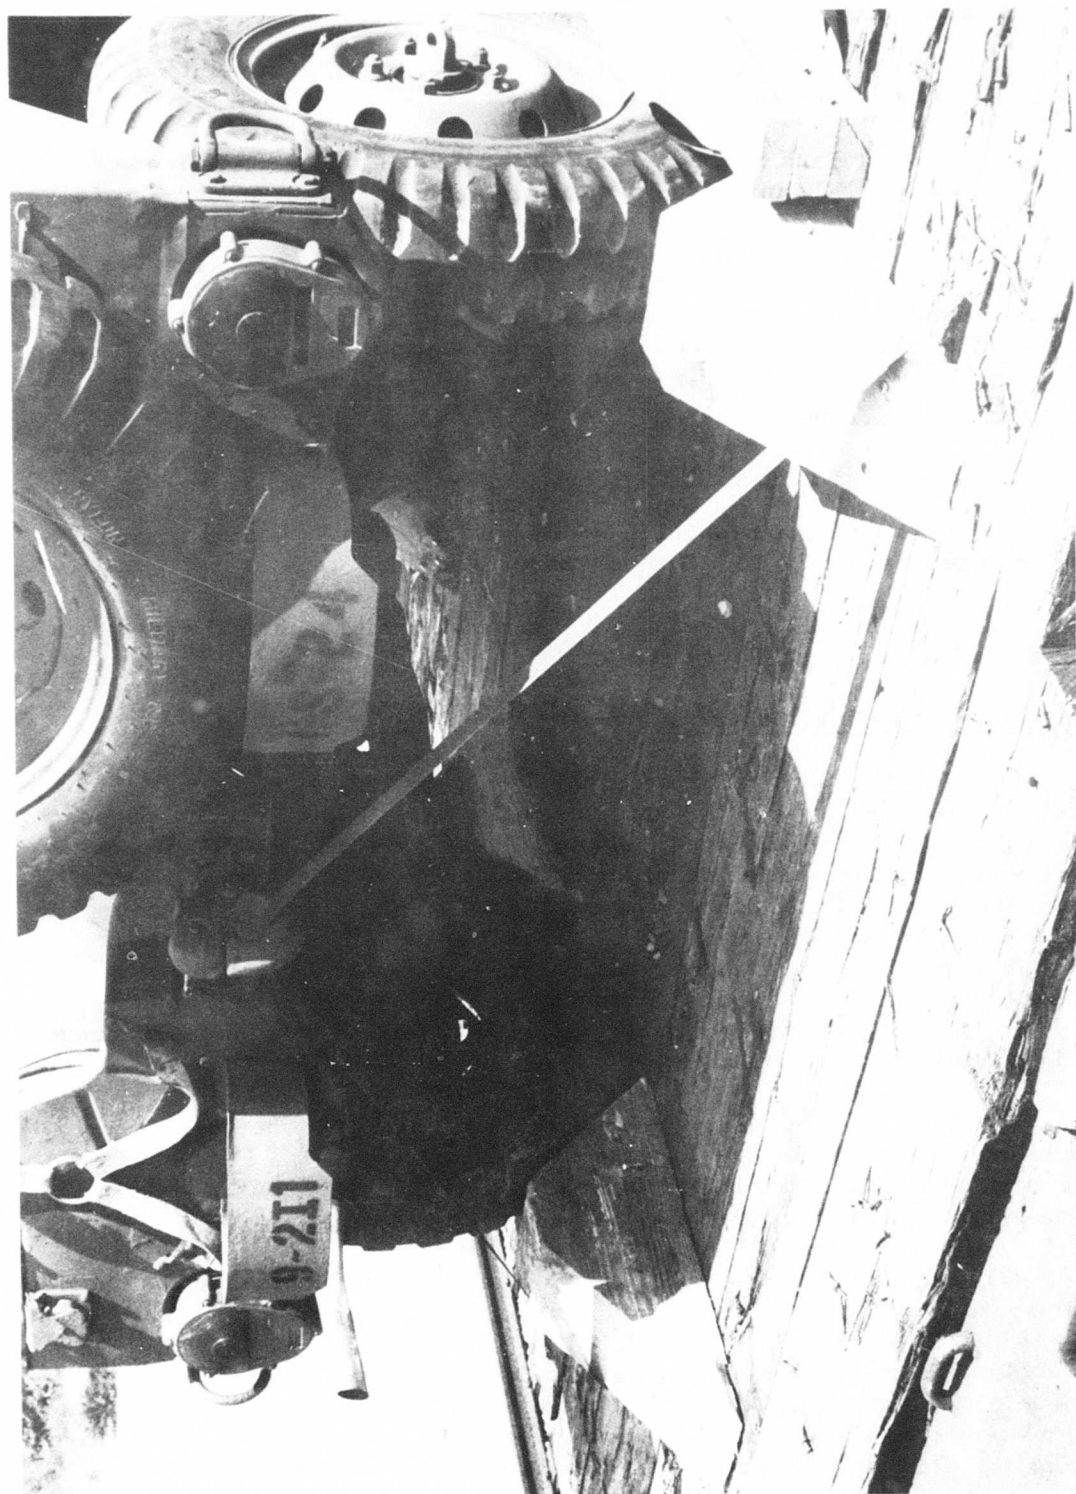
(2) Jeeps loaded on standard flatcars were secured with 1-inch banding (fig 4-2), in accordance with TM 55-2200-001-12, section 6, figure 49, item E; however, the banding was found to be broken upon arrival at the SPOE.

Figure 4-2. Jeep secured with 1-inch banding.

(3) Standard blocking and bracing methods using wire rope, instead of banding, be used to secure vehicles onto standard flatcars, and that TM 55-2200-001-12 be changed to reflect this recommendation.

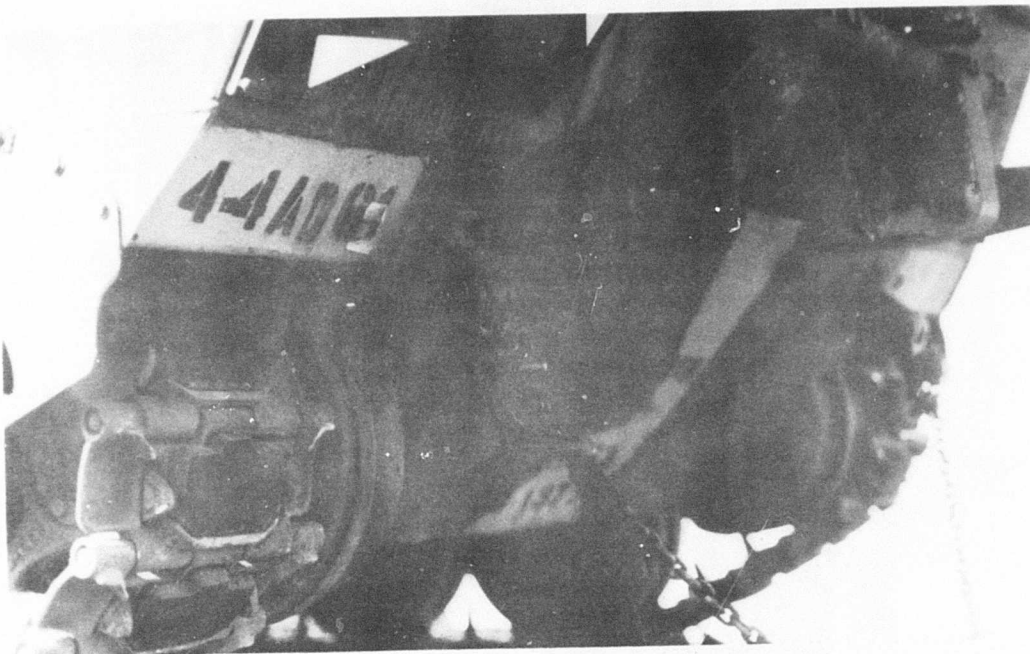
Figure 4-6. Vehicle fitted with "T" shackle instead of "U" shackle.

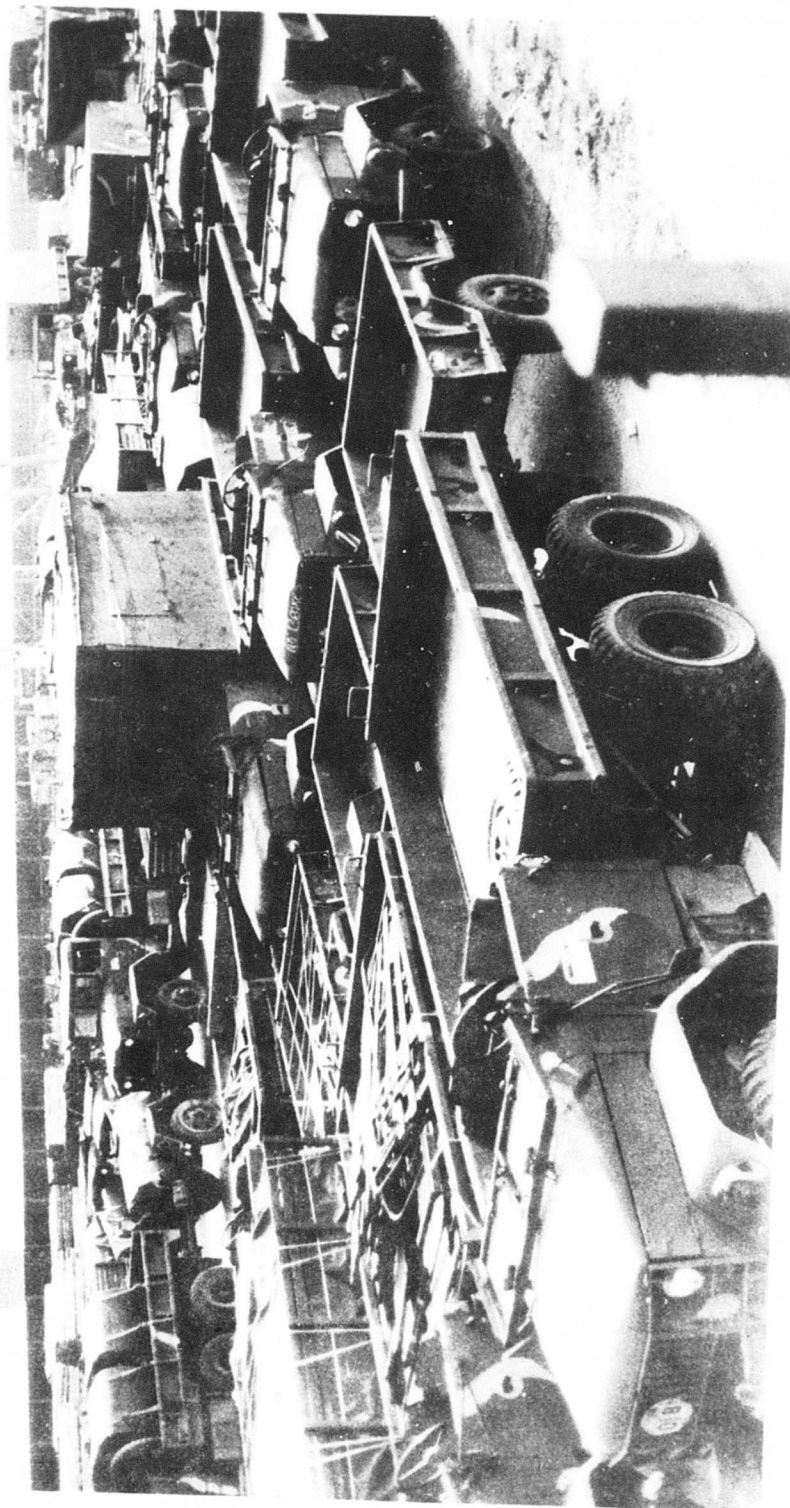
Figure 4-7. Vehicles with unused cargo space.

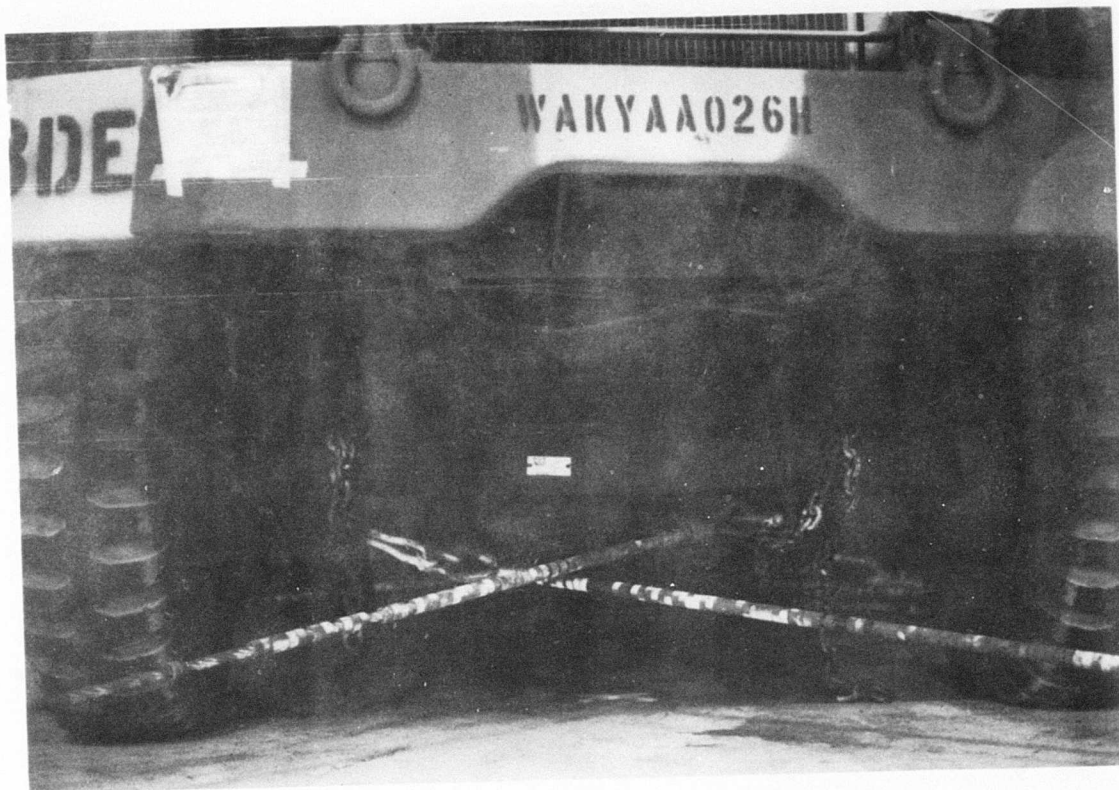
Figure 5-4. Lashings applied over axles on USNS Meteor.

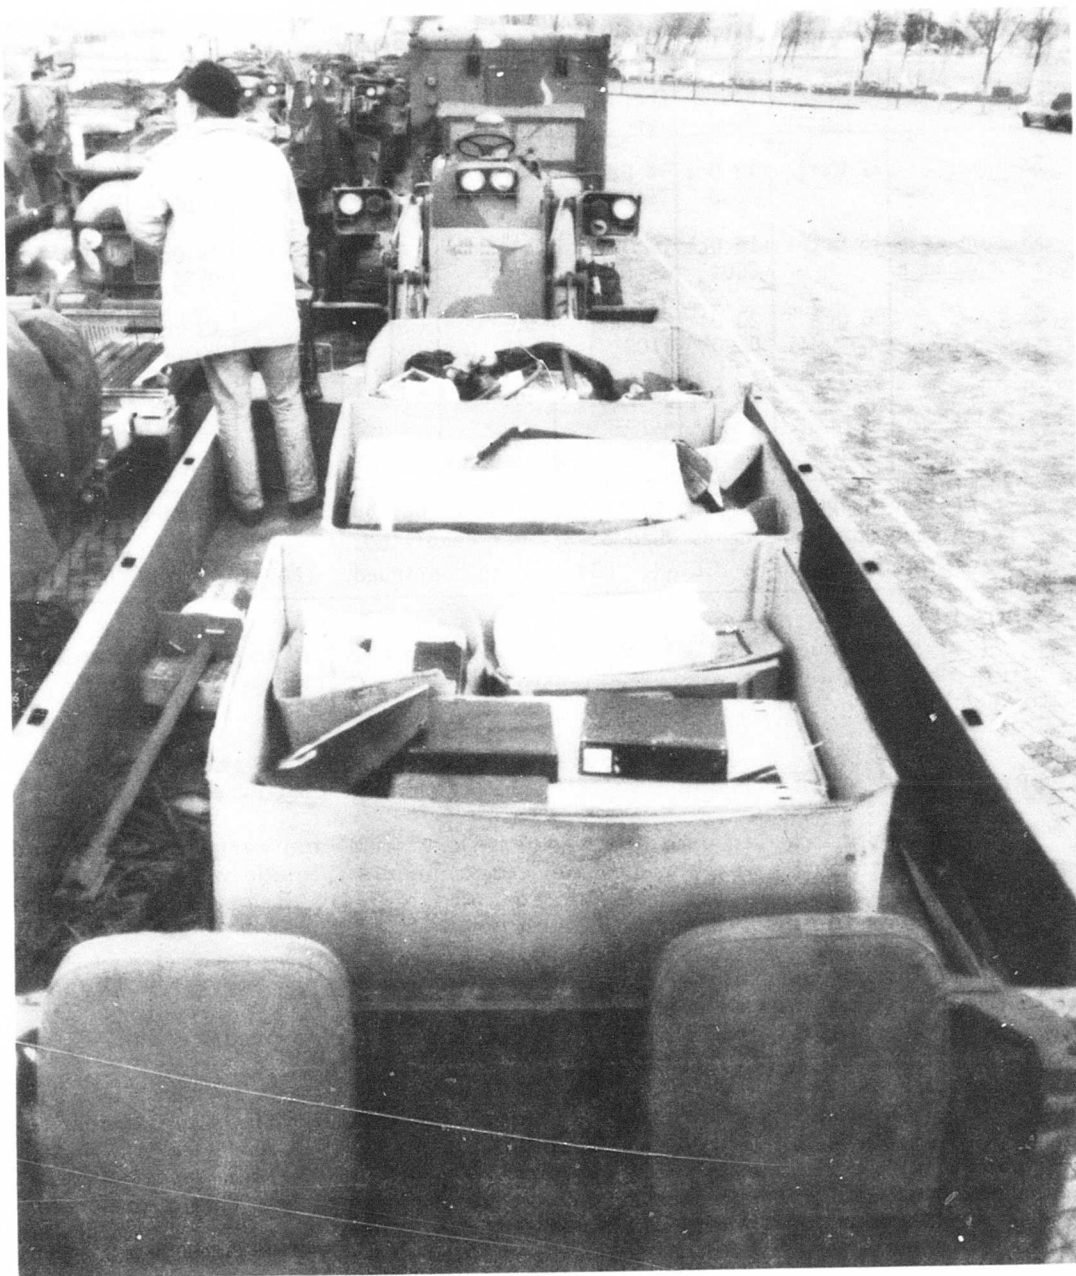
Figure 7-4. Cargo exposed to weather.

(1) Vehicles stored in staging areas over an extended period of time be started periodically to keep them in operating condition. Also, a plan be developed to check vehicles before being called forward from staging areas and to take corrective action there if needed.

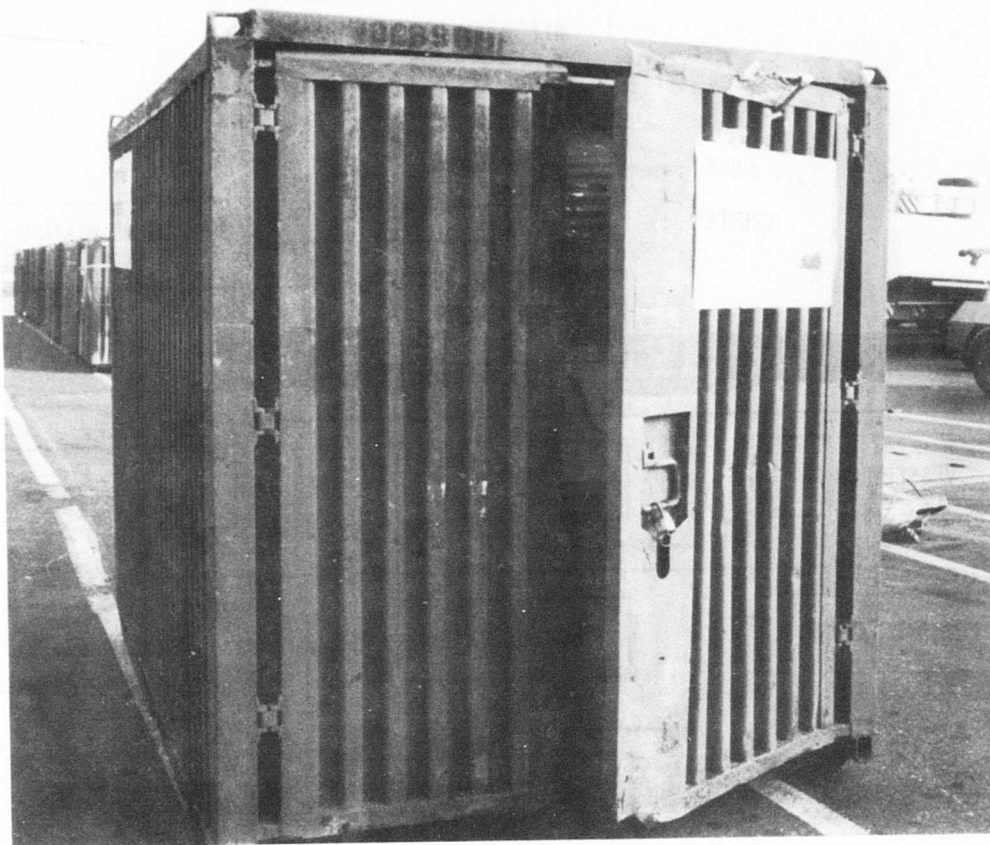
(2) The first ship to berth was the SS Buyer. Discharge operations were slowed by malfunctioning contractor's MHE. A number of vehicles had loose cargo in cargo beds. Three CONEXs, two of which were marked sensitive, arrived with open doors and no banding (fig 8-3). PSA personnel corrected these deficiencies.

Figure 8-3. Unbanded CONEX with door open.

(4) During the redeployment phase, more command emphasis be placed on insuring that returning equipment be properly and safely secured in all trailers, cargo beds, and CONEXs.

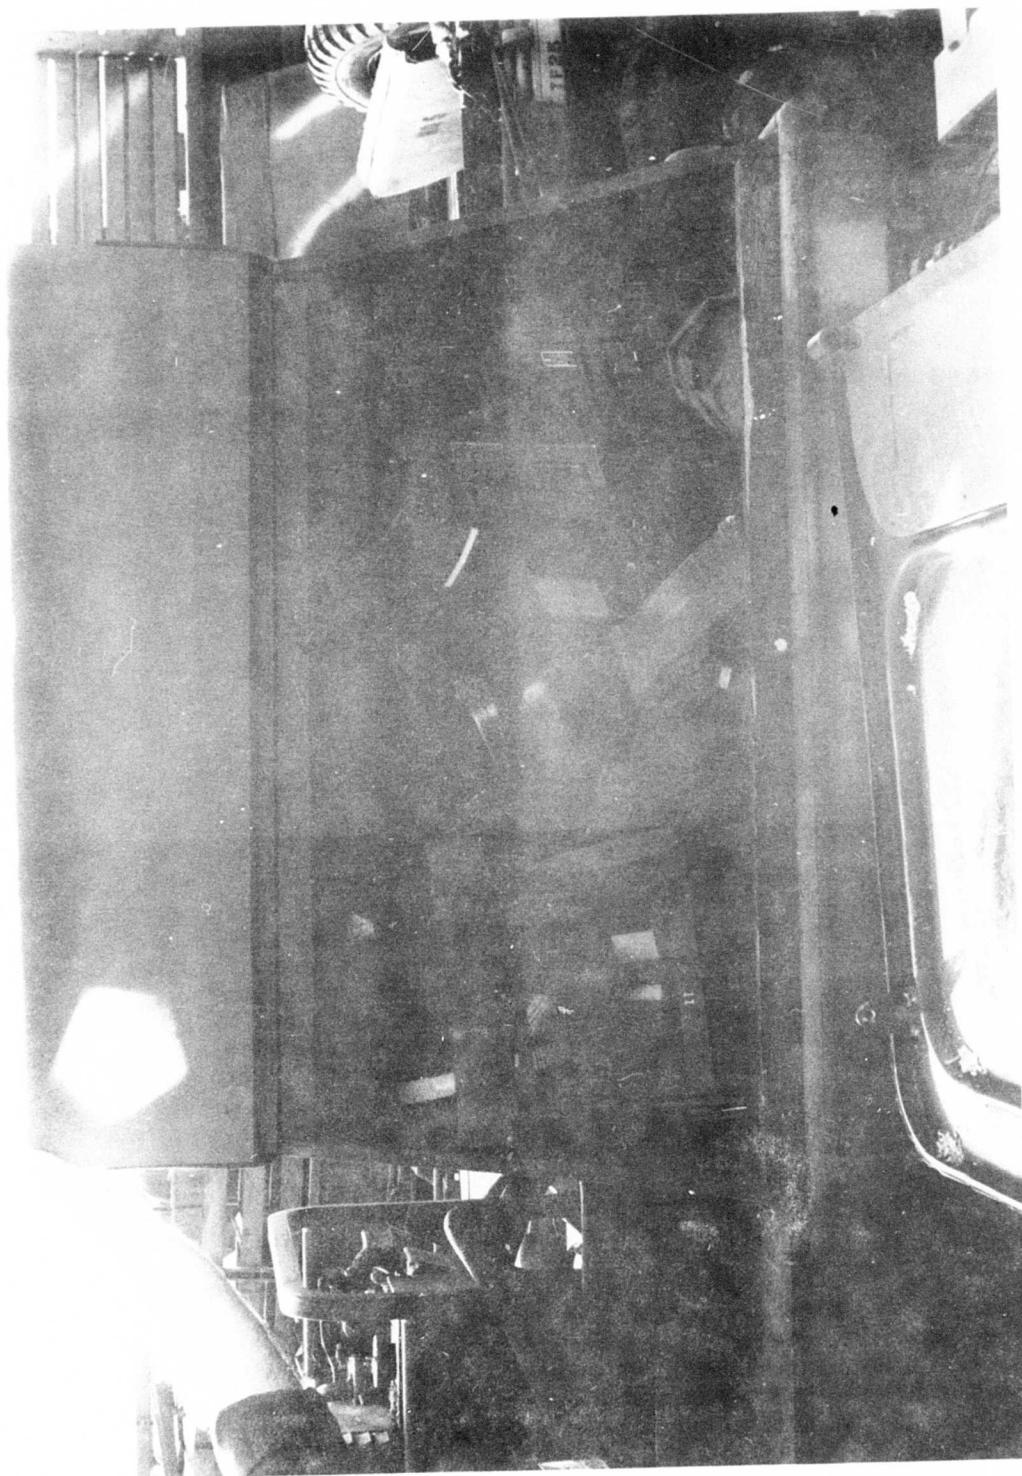
Figure 8-4. Unsecured radios in modified trailer.

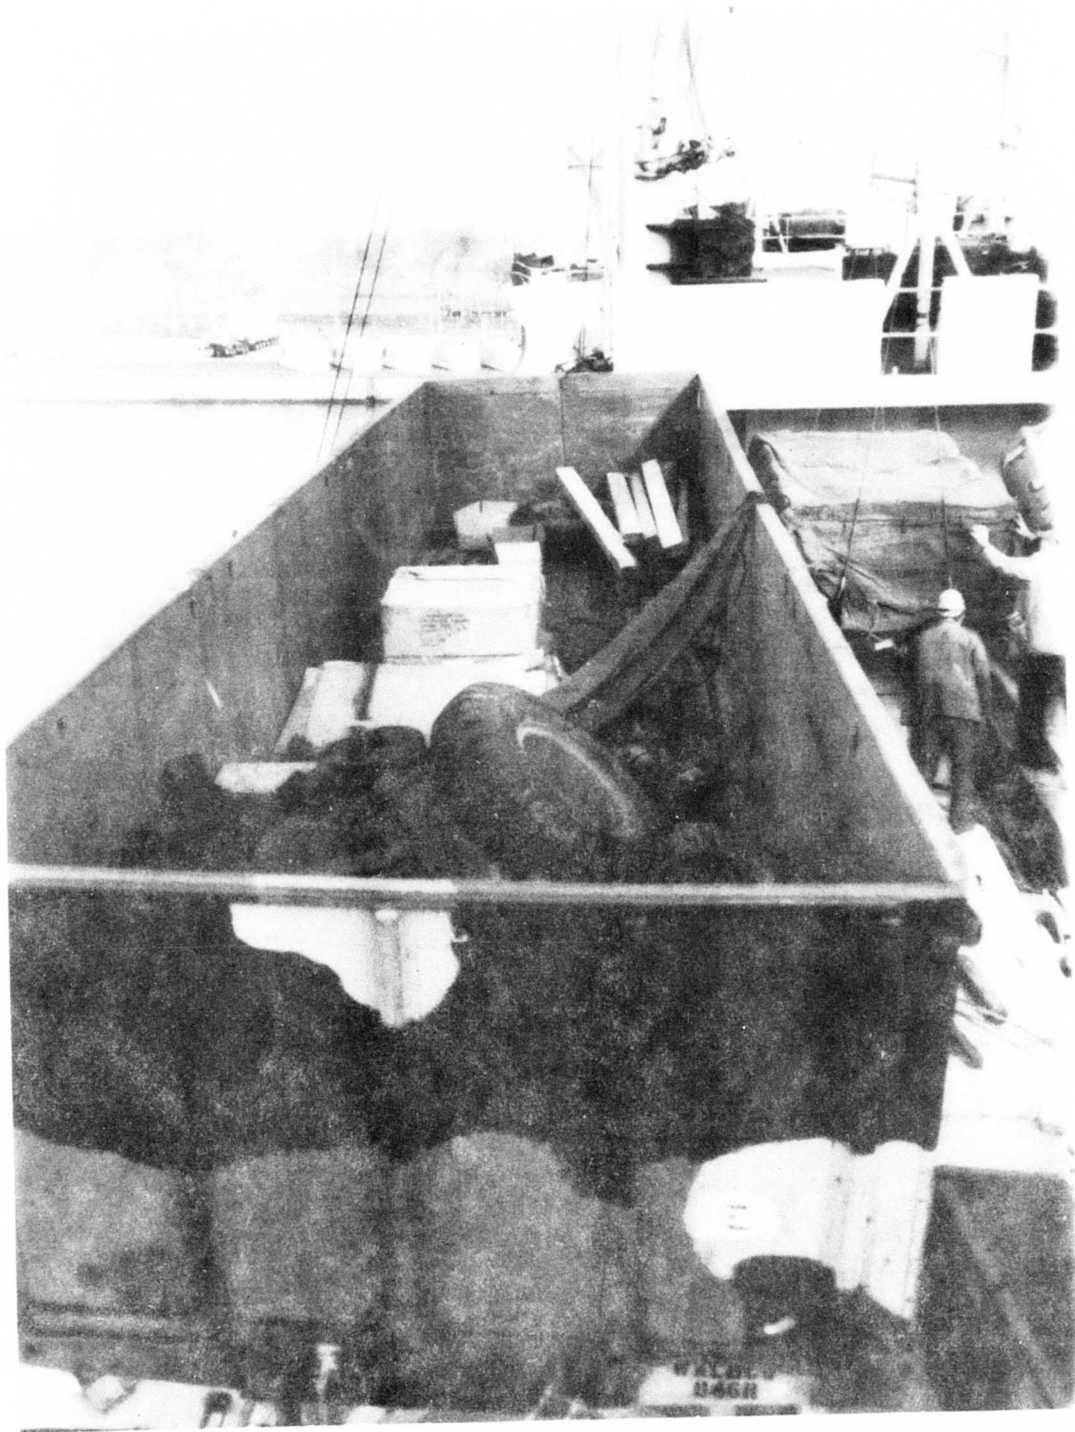
Figure 8-5. Unsecured cargo in S&P trailer.
