AL/CF-TR-1994-0056

**A HUMAN FACTORS EVALUATION OF  
THE MH-60G PAVE HAWK HELICOPTER COCKPIT (U)**

**JANUARY 1994**

**FINAL REPORT FOR THE PERIOD APRIL 1993 TO JANUARY 1994**

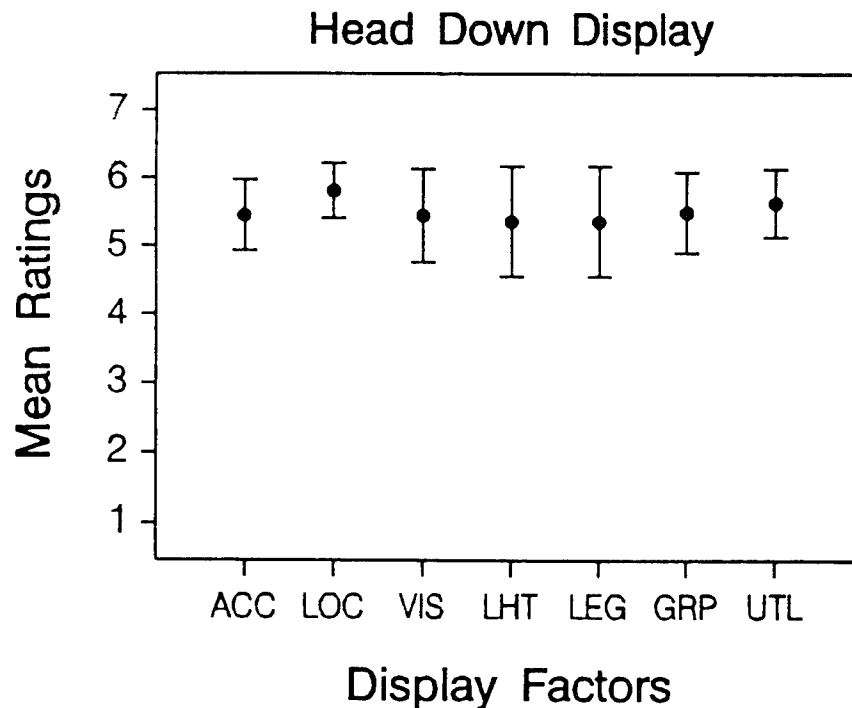
Figure 3. Mean Display Factor Rating for the Head Down Display.

The mean rating for the Head Down Display averaged across Display Factors was 5.51, the highest of all Display Type ratings. All the display factors were rated highly for this display. The pilots had very few negative comments except one pilot said that the torque power setting was hard to read, the HDD needed a Barometric Altimeter in the FLIR mode and it needed a good trim indicator. Some pilots reported that the controls should be backlit in order to make it easier to find the knobs.

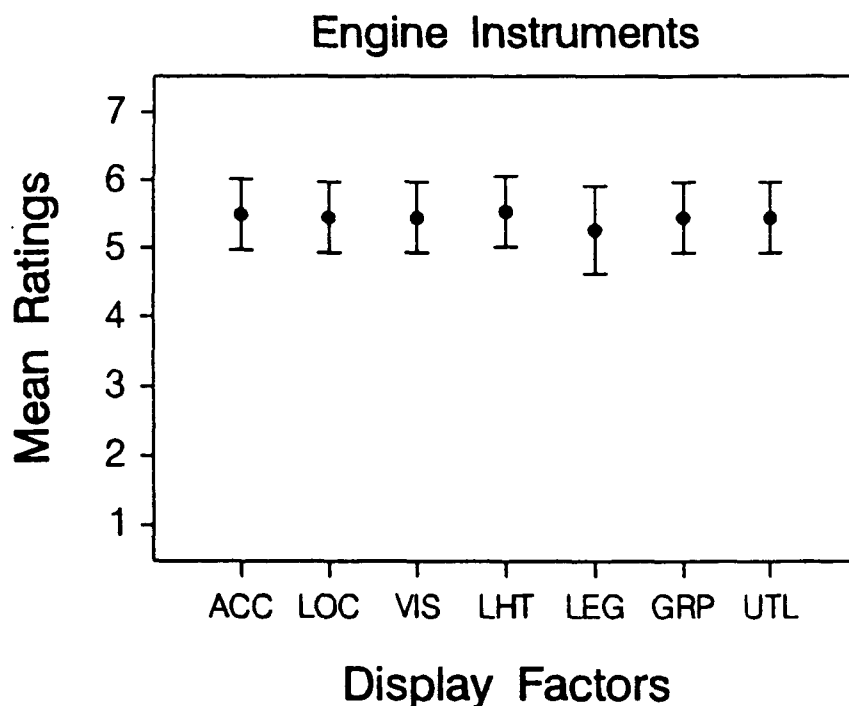
Figure 4. Mean Display Factor Rating for the Engine Instruments.

The mean rating for the Engine Instruments Display was 5.45. All the display factors were rated highly for this display. The Legibility Display Factor (5.27) was rated slightly lower than the other Factor ratings but not significantly so. The comments reflected this slightly lower mean in that pilots reported the legends were too small to read easily.

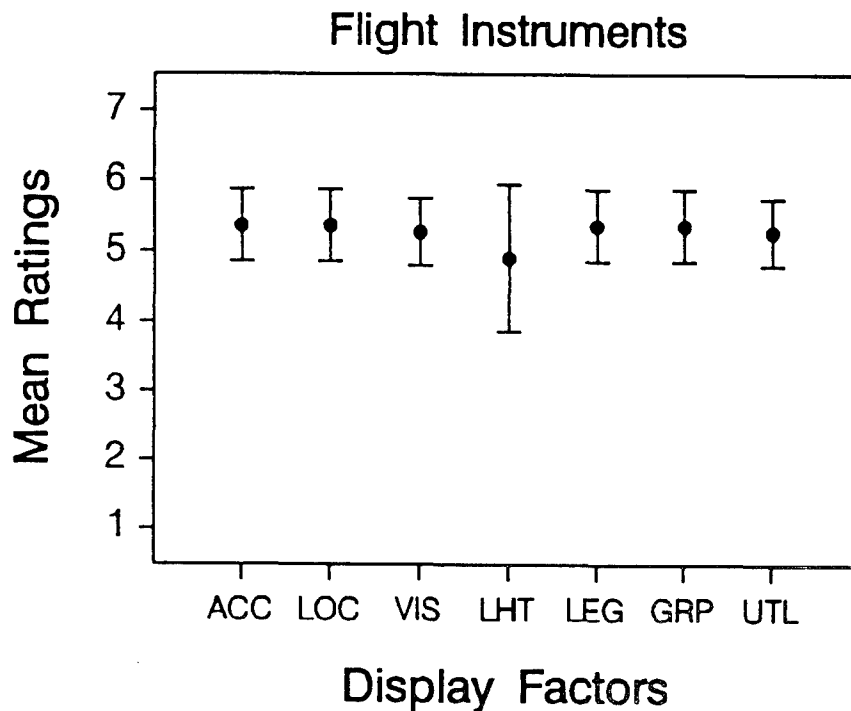
Figure 5. Mean Display Factor Rating for the Flight Instruments.

The flight instruments are located on the front console of the cockpit. The Course and Heading Select controls are used frequently. The mean rating for the Flight Instruments Display was 5.27. All of the Display Factor ratings (Avg. = 5.33) were approximately the same except for Lighting (4.90). Two pilots reported that the trim ball was poorly lit. Since it was indicated that the trim indicator on the HDD was not adequate, one of these indicators needs to be corrected to provide trim information. Trim calls are vital during hover and aerial refueling. This display must be easy to see in all conditions.

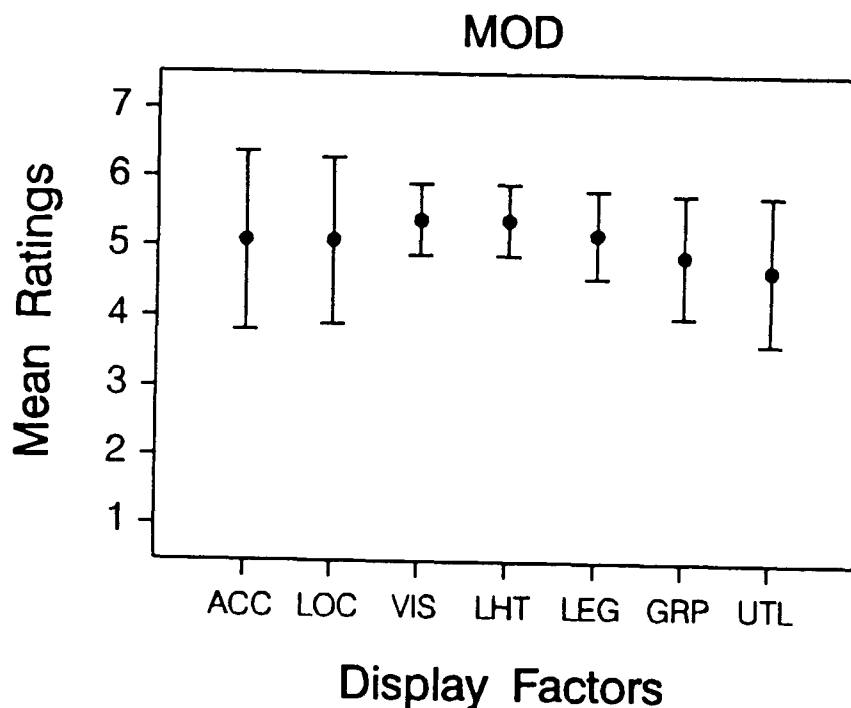
Figure 6. Mean Display Factor Rating for the Mode Select Panels.

The mean rating for the Mode Select Panels was 5.11 indicating a high level of satisfaction with these panels, overall. None of the Display Factors was significantly different from each other within these panels. Comments concentrated on the fact that the NAV Mode Select shows "ILS" when flying a TACAN approach. Pilots thought this was both confusing and dangerous. They also reported that a problem resides in the fact that the CIS Mode Select panel used to select NAV/HDG/ALT was not accessible to the left-side pilot. There is adequate space to install CIS Mode Select Panel on the co-pilots side of the front console. The pilot has priority in selection, but he must deselect in order for the co-pilot to engage his CIS Select switches.

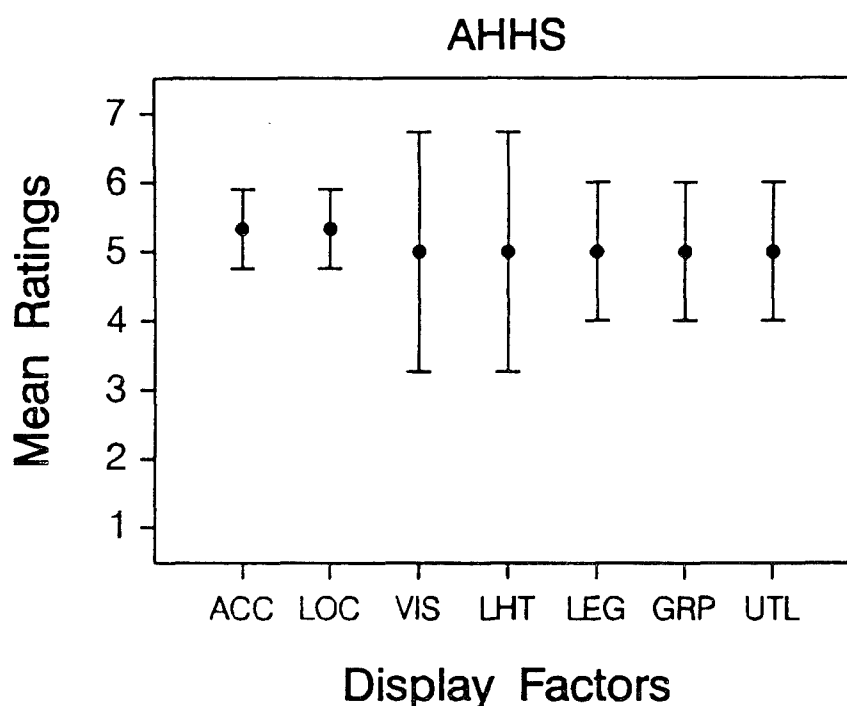
Figure 7. Mean Display Factor Rating for the Altitude Hold Hover Stabilator.

Only three of the eleven pilots queried responded to this panel because the others had never used this new system before. The three that did respond, however, gave it a mean rating of 5.09. None of the Display Factors was significantly different from one another. Those that have used the AHHS report that they liked it. Most of the other pilots reported that they were looking forward to the installation of this system because it will help reduce the difficulty of hovering steadily over water at night. This is reported to be one of the most difficult high workload tasks for the MH-60G pilot. The installation of this system will greatly reduce the workload associated with this highly critical task. However, as with any other subsystem, the system must be integrated intelligently into the cockpit. The logical place for this control is on or near the collective. The placement of the control in the cockpit should not be on a "space available" basis.

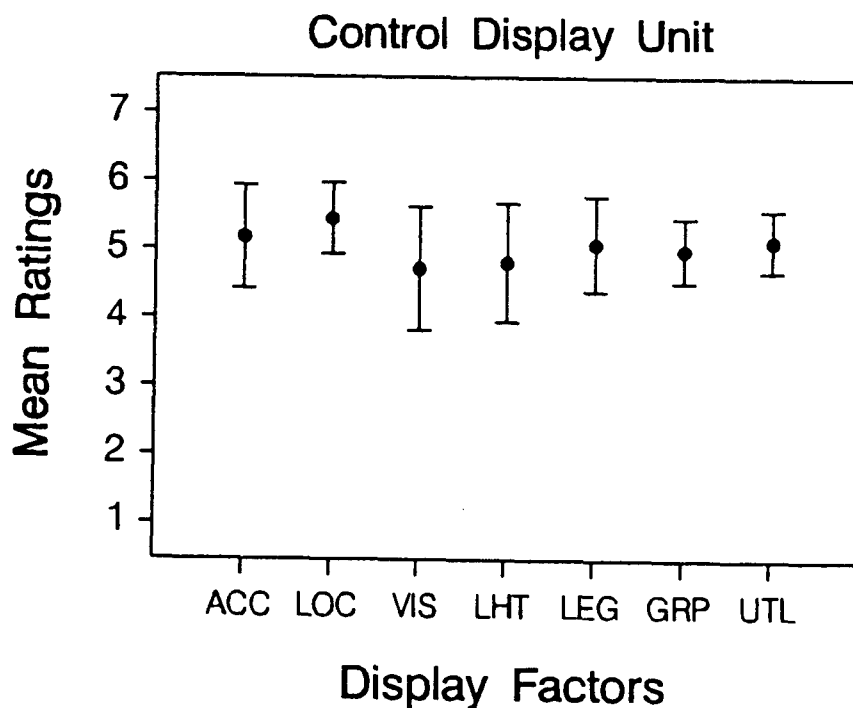
Figure 8. Mean Display Factor Rating for the Control Display Unit.

The overall mean rating for the CDU was 5.06. Within this Display Type the Location Factor was rated highest at 5.45. Visibility and Lighting were rated the lowest at 4.73 and 4.82, respectively. These means were not significantly different. One problem reported by the pilots was that the keypad for data entry was a non-standard keypad which necessitates learning new key positions and could affect data input performance in times of high stress. Several reported that they had to lean over and position their head directly above the display to read it and they still had to use finger lights. Suggestions were: 1) tilt the display toward the pilot/copilot and 2) improve lighting so finger lights would not be necessary.

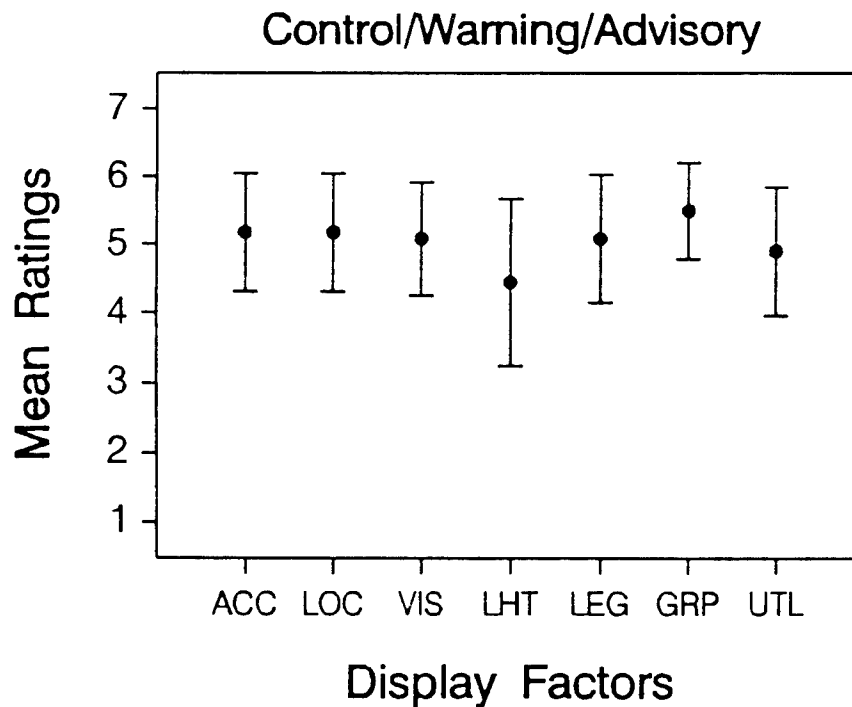
Figure 9. Mean Display Factor Rating for the Caution/ Warning/ Advisory Panel.

The overall mean rating for the CWA was 5.05. Both the Lighting and Utility factor means (4.45 and 4.91, respectively) were found to be significantly lower than the functional grouping mean (5.50). Several lighting factors were considered inadequate by the pilots. The blinking of the "Auxiliary Fuel" light was called "unacceptable, distracting and sometimes dangerous." Pilots report that poor lighting and legibility made the panel difficult to read in bright sunlight or low level lighting. Several pilots indicated this panel needs to be made NVG compatible. Proper lighting of this panel is critical. This is a safety of flight issue that needs to be corrected.

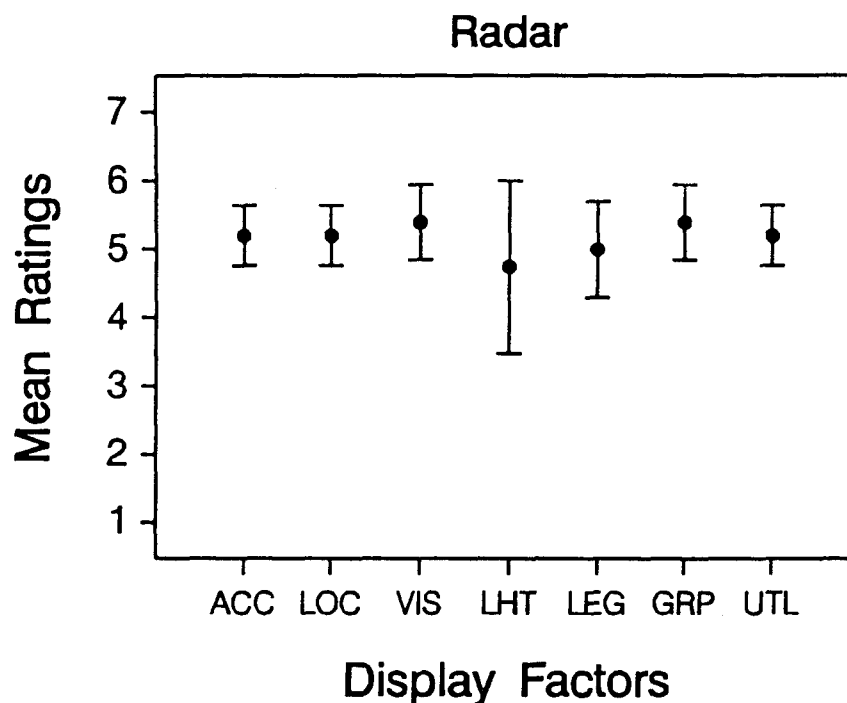
Figure 10. Mean Display Factor Rating for the Radar panel.

The overall mean rating for the Radar panel was 4.96. None of the means associated with the display factors was significantly different from one another. Lighting was rated the lowest (4.75) and Grouping and Visibility were rated the highest at 5.40 each. Most pilots comments indicated they had no problems with this panel, although a couple said it was not lighted and should be.

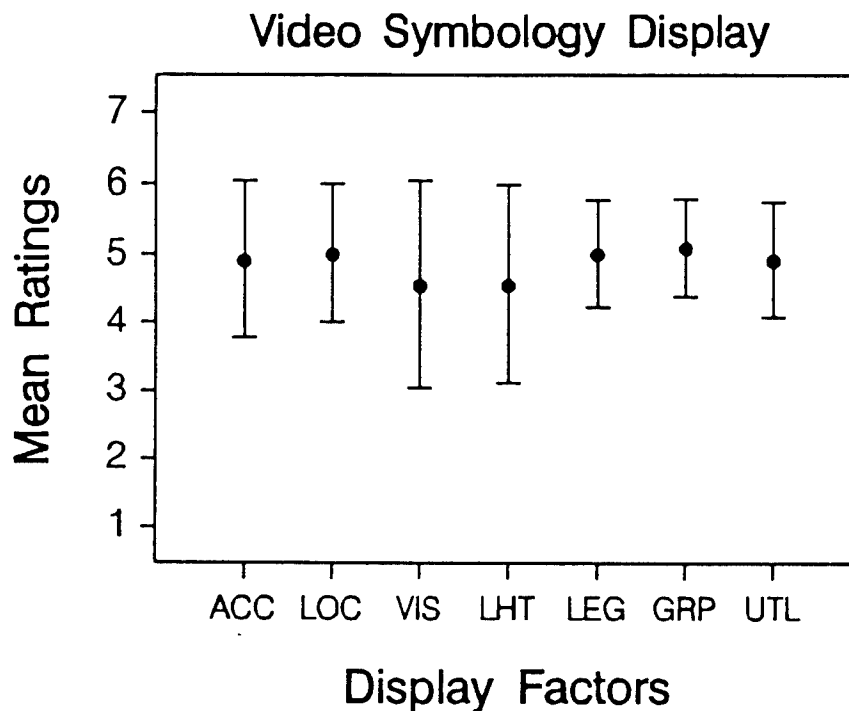
Figure 11. Mean Display Factor Rating for the Video Symbology Display System.

The overall mean rating for the Video-Symbology Display System was 4.86. None of the display factor means was significantly different from one another. Both Lighting and Visibility were rated the lowest (4.54 each) and Functional Grouping was rated the highest (5.09). One pilot commented that having to take his hands off the control stick to switch the VSDS into declutter mode was unsafe. Most other pilots reported no dissatisfaction with this panel.

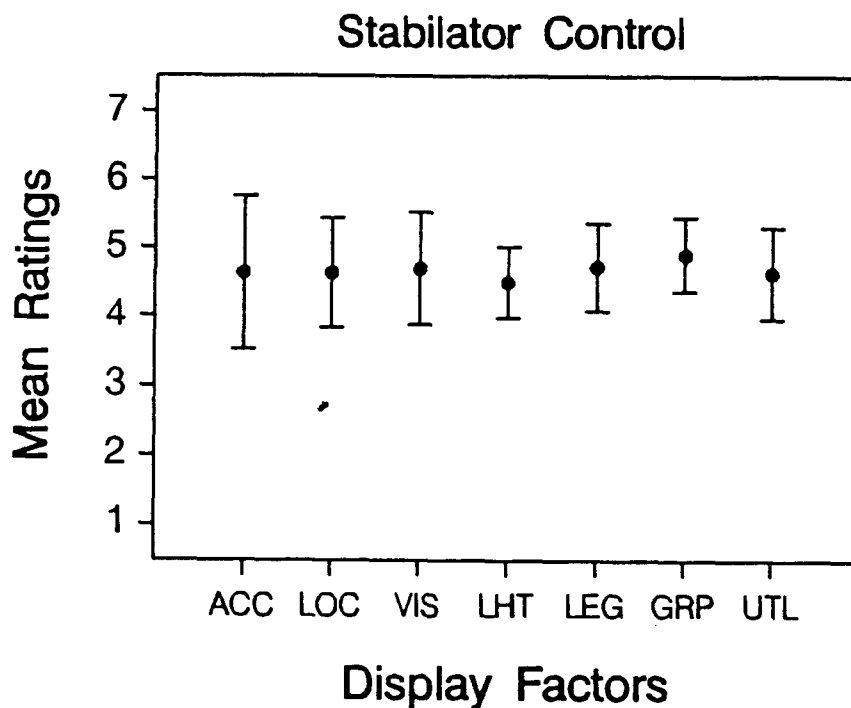
Figure 12. Mean Display Factor Rating for the Stabilator Control Panel.

The overall mean rating for the Stabilator Control panel was 4.68. None of the Display Factor means was significantly different from one another. Lighting was rated the lowest at 4.50 and Functional Grouping the highest at 4.91. Comments for this panel indicated that most pilots thought there were no problems except that the panel itself was not standardized among aircraft. A couple of pilots said that the accessibility was a problem for the pilot. Accessibility and Location were both rated second lowest (4.64) among the Display Factors.

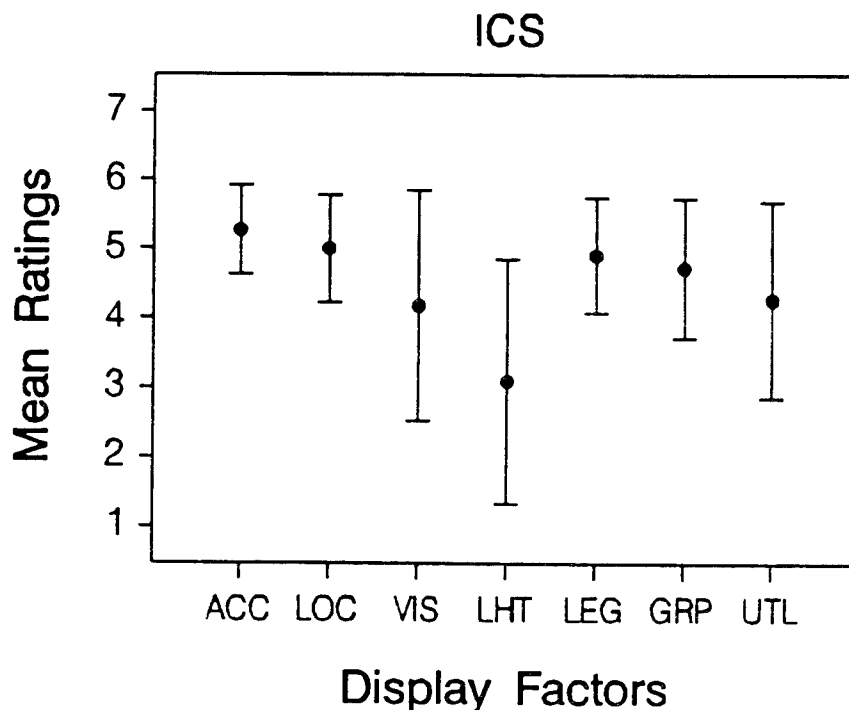
Figure 13. Mean Display Factor Rating for the Inter-communication System.

The overall mean rating for the Intercommunication System was 4.49. As can be seen in Figure 13 below, the mean rating for the Lighting factor (3.09) was lower than all the other factor means (4.18 - 5.27). These differences were significant ( $p = 0.024$  through  $0.002$ ). Utility was significantly lower than Accessibility ( $p = 0.0014$ ). A majority of the pilots complained that this panel was not backlit and therefore, could not be read at night. They considered this condition to be dangerous and mission threatening. Another complaint was that the volume could not be turned up loud enough and that the audio transmission needed to be a lot clearer (free of noise). One pilot reported that 20 - 30% of the time he doesn't completely hear what is transmitted. These are problems that must be addressed as soon as possible. The amount of crew coordination and communication required in the Pave Hawk mission demands a reliable intercommunication system.

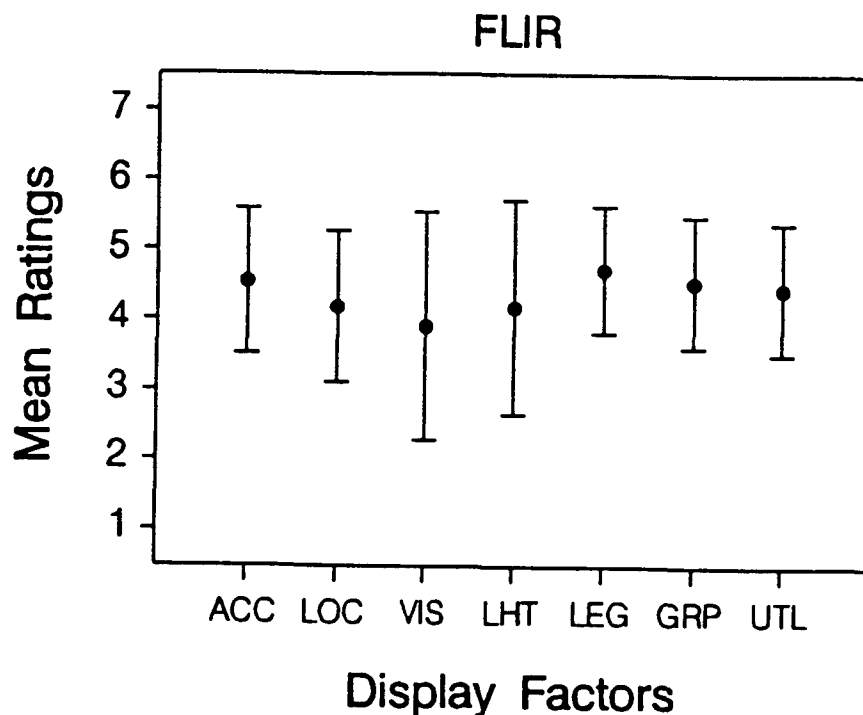
Figure 14. Mean Display Factor Rating for the Forward Looking Infra-Red Panel.

The overall mean rating for the FLIR control panel was 4.36. No Display Factor means were significantly different from one another. Visibility was rated the lowest (3.91) and Legibility the highest (4.73). This control panel is located on the aft panel, which makes it hard to access both physically and visually. Also, new capabilities have been added to the panel which has resulted in a relabeling of several buttons. This has required more memorization on the part of the pilots. Increased memorization requirements plus any carry over effects from previous configurations could very likely increase the cognitive workload associated with operating this panel. The control panel should be moved to a more accessible location. Crew members should receive additional ground training to become familiar with the new FLIR system capabilities to alleviate the negative transfer of training effects.

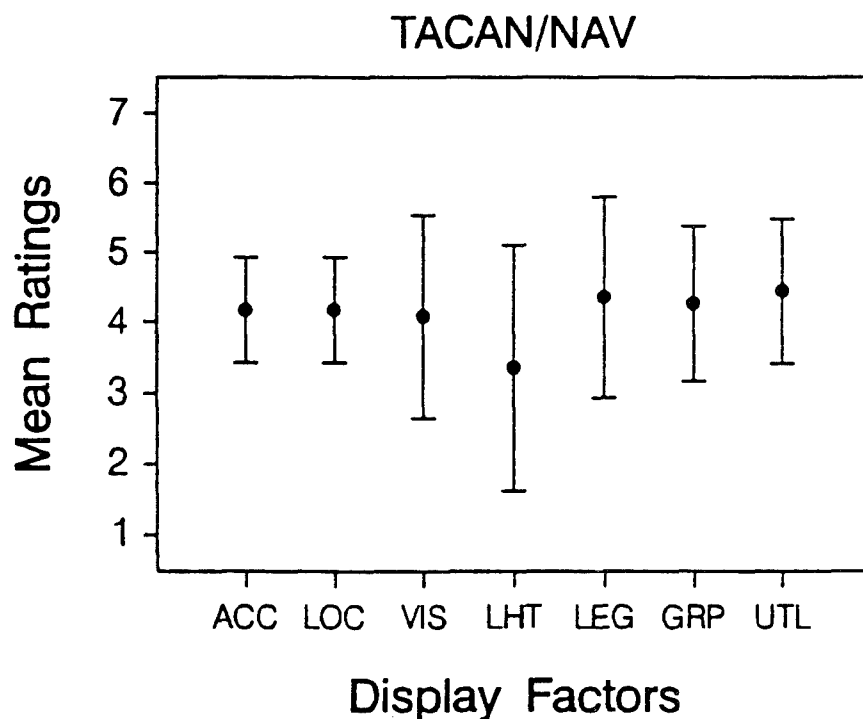
Figure 15. Mean Display Factor Rating for the TACAN/NAV Panel.

The overall mean rating for the TACAN/NAV panel was 4.13. Lighting was the lowest rated factor at 3.36. The difference between Lighting (3.36) and Visibility (4.09) was significant ( $p = 0.012$ ). The difference between Lighting and the other factors was just as great or larger, however, the variability of those mean ratings was too great for them to be significantly different in the statistical sense. The largest complaint was that the lighting was very poor for night operations. The lighting is presently not NVG compatible but needs to be. Another complaint was that the steps required to provide a TACAN, VOR or ILS guidance update combined with the way the switches are marked make this task too difficult. The pilot said it was easy to forget or miss a switch.

Modify the steps necessary to provide a TACAN, VOR or ILS guidance and the switch markings to reduce both the task difficulty and likelihood of forgetting or missing a switch.

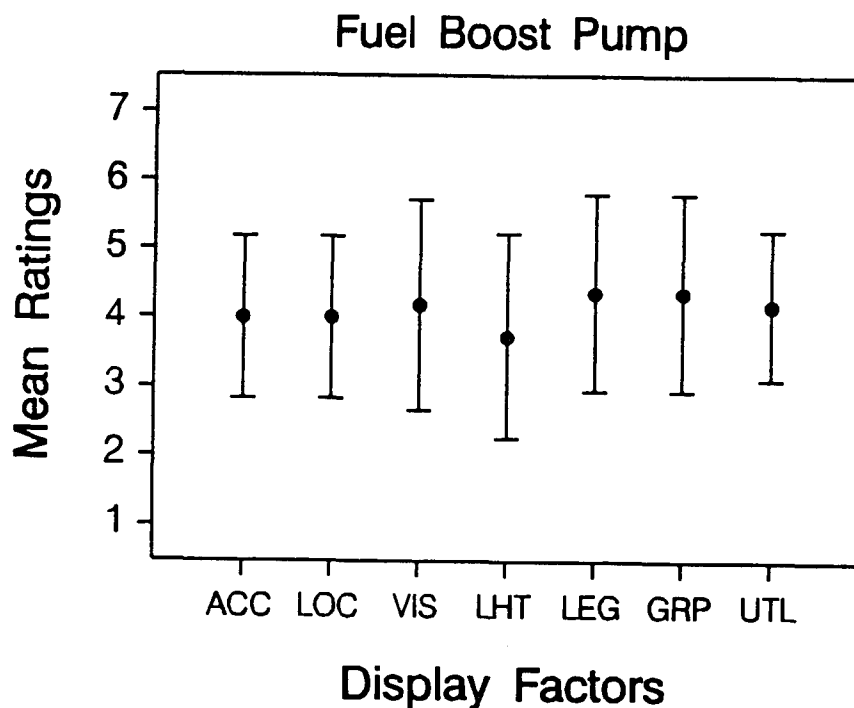
Figure 16. Mean Display Factor Rating for the Fuel Boost Pump panel.

The overall mean rating for the Fuel Boost Pump panel was 3.71. Lighting was again the lowest rated factor (3.72) while Legibility and Functional Grouping were the highest (both 4.36). None of the Display Factor means were significantly different from one another. Location was rated second lowest of the Display Factors at 4.00. Pilot comments reflected this in that most of the complaints centered around the poor location of this panel. Most complained that it was difficult to reach. Others complained that it was mounted upside-down so the labels would match the right engines.

Although the location might not be an issue due to the fact that the panel is not used much, one pilot reported that during Emergency Engine Shutdown/Failure with the Fuel Direction in "cross-feed" it was easy to turn off the wrong switch. This could be a fatal error. Another consideration is that during fuel supply system specific emergencies it becomes a critical control and must be accessed quickly and easily. It's location should be changed to one that is more accessible.

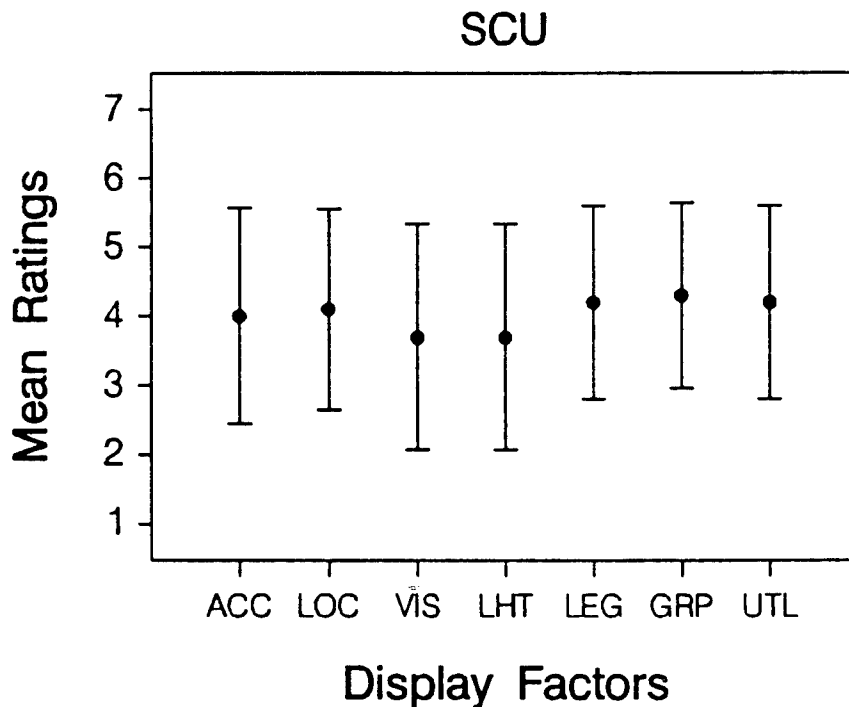
Figure 17. Mean Display Factor Rating for the System Control Unit.

The overall mean rating for the System Control Unit was 4.03. Lighting and Visibility were the lowest rated Display Factors at 3.70 each. Functional Grouping was the highest at 4.30. None of the Display Factor means were significantly different from each other. Comments concerning this panel indicated that the pilots thought that it needed back lighting for night operations and that the location of the panel (on the aft console) was bad. This control panel needs to be moved to a more forward location and the lighting needs to be improved.

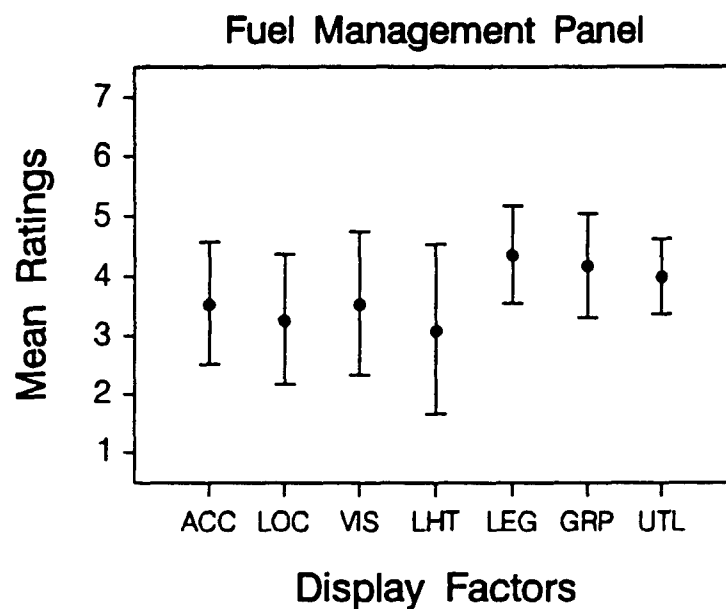
Figure 18. Mean Display Factor Rating for the Fuel Management panel.

The overall mean rating for the Fuel Management Panel was 3.71. The ratings for the two lowest rated display factors for this panel, Lighting (3.09) and Location (3.27), were both significantly lower than the two highest rated factors (Functional Grouping (4.18) and Legibility (4.36)) (Lighting:  $p = 0.04, 0.02$ ; Location:  $p = 0.005 \& 0.006$ , respectively). Accessibility was found to be significantly lower than both the Legibility ( $p = 0.01$ ) and Functional Grouping (0.026) factors. It was found, however, that only five of the 11 respondents actually rated Grouping higher than Accessibility while the remaining six rated Grouping and Accessibility the same. This casts some doubt on whether the two group means are truly different from each other for this particular panel. A graph of these results is located in Figure 18 on page 27.

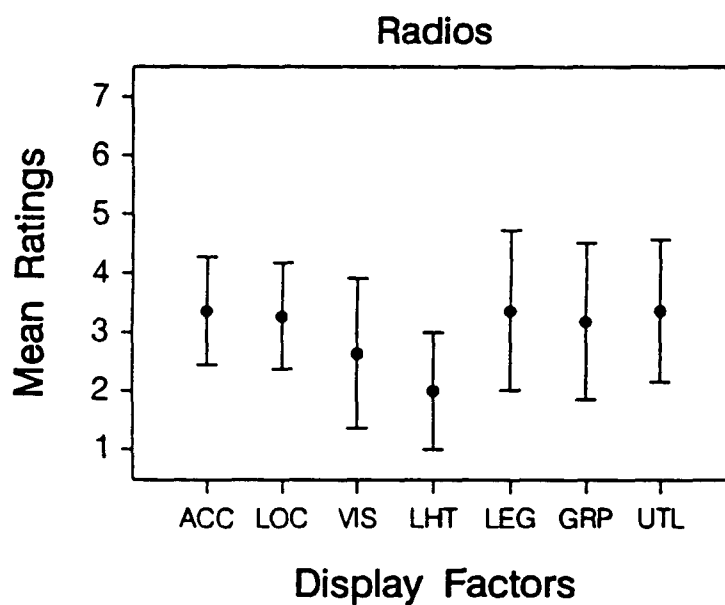
Figure 19. Mean Display Factor Rating for the Radios

There were several complaints about this panel. The most prevalent complaint concerned the location of the radios. Most pilots reported that the radios were spread out all over the cockpit. Pilots presently have to turn their heads to the back to operate most of the radios, which takes their eyes away from the "outside." This is extremely hazardous when flying low level at night. All the pilots recommended that the radios be integrated into one communication unit. This would not only reduce the difficulty of finding and operating the radios but also create more space on the forward section of the aft console. The integrated communications unit could be placed on the forward section of the aft console. This would leave space on the back portion of the aft console for displays and controls that are not used frequently and/or are not critical to mission completion.

The second most prevalent complaint was the radio controls were very difficult to read during night operations. The poor Lighting rating was reflective of the pilot's desire to have controls and display backlit at an NVG compatible level for night operations.
