Advance Restricted Report E5B07

EFFECT OF PROGRESSIVE RING FAILURE ON PISTON DESTRUCTION

By Max J. Tauschek and Lester C. Corrington

Aircraft Engine Research Laboratory  
Cleveland, Ohio

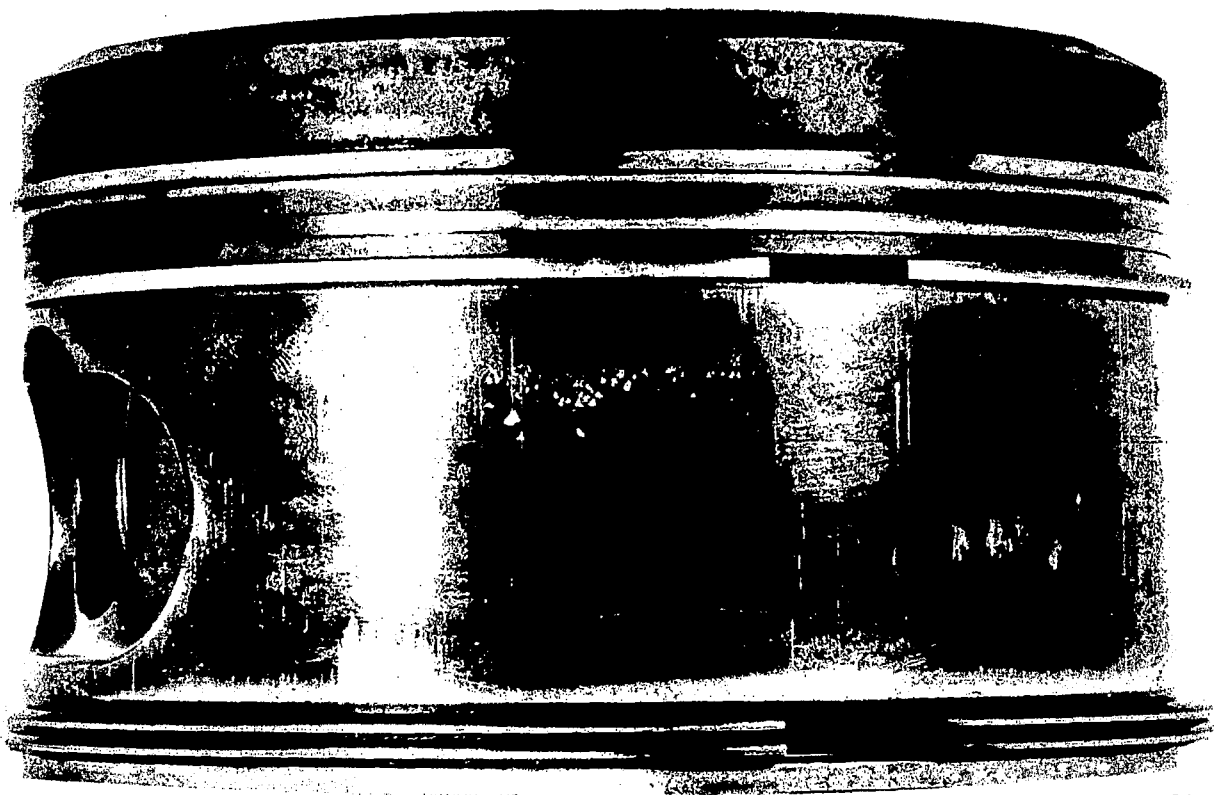
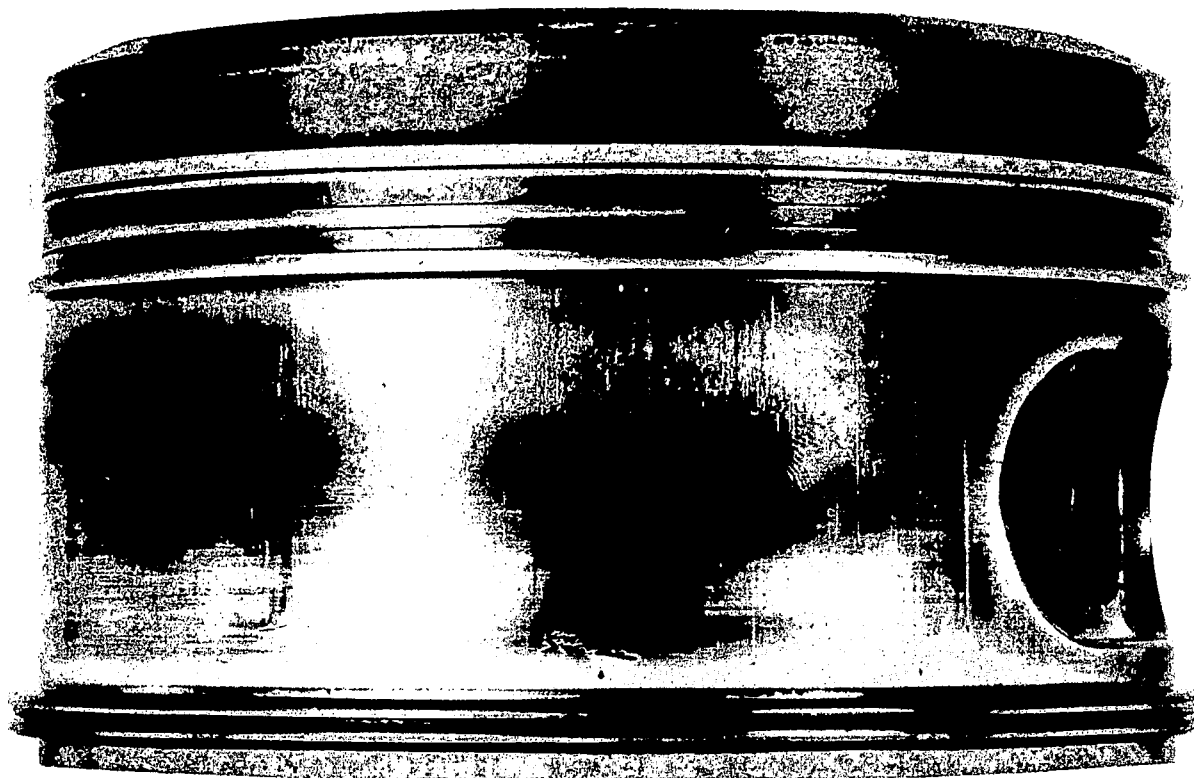
The piston used in the first test had previously been used to obtain preignition data in connection with another project. These tests comprised about 15 hours running time. The severe operating conditions encountered in the preignition tests resulted in breaking of the top ring and sticking of the second ring. Figure 1 shows the piston prior to installation in the cylinder at the beginning of the endurance test. A clean used piston equipped with new piston rings was used for the second test.

*Figure 1. - Piston and ring assembly just before the first endurance test. Failure of top and second rings has taken place.*

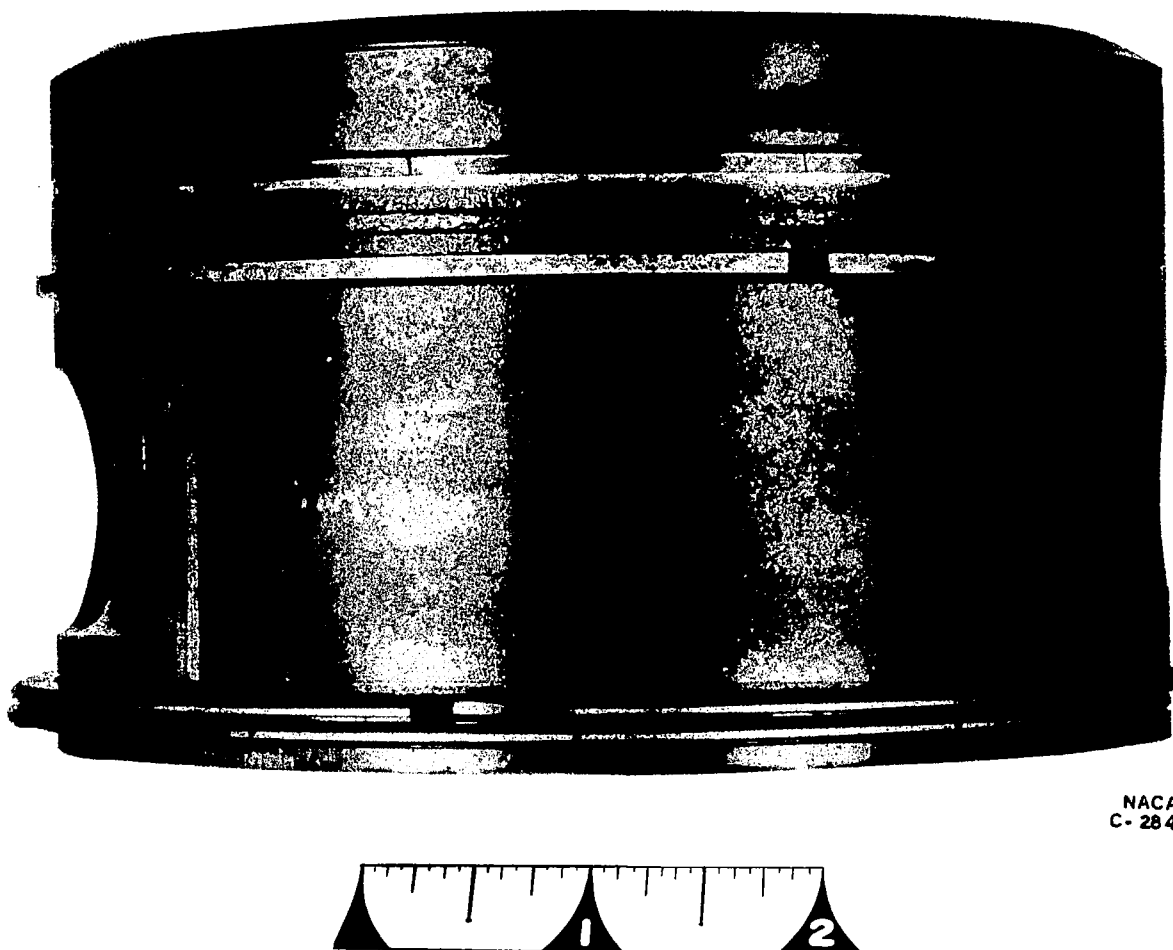
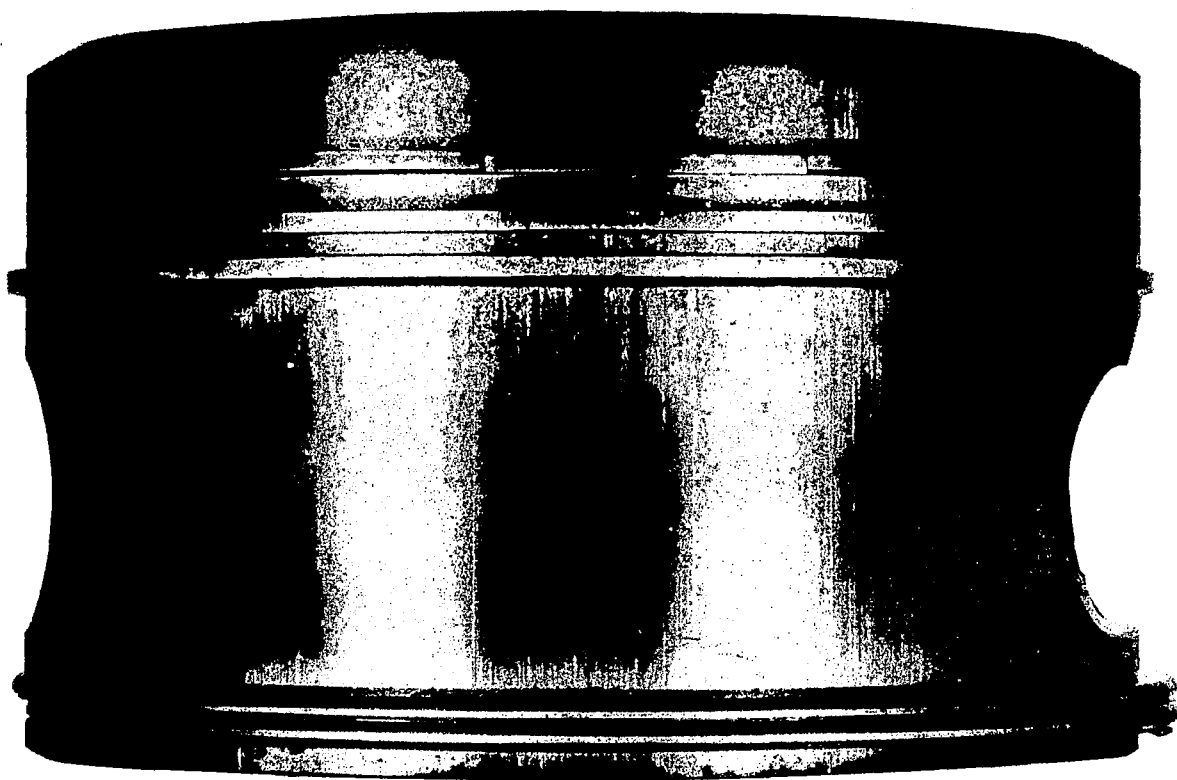
At the end of 7.5 hours the piston was removed for inspection. By this time complete failure of the compression rings had taken place but the oil rings were still in reasonably good condition (fig. 2). The piston and ring assembly was reinstalled and the test continued. After an additional 10.6 hours, the inlet-air pressure was increased to determine the power level at which immediate and complete piston failure would take place. This failure occurred at an inlet-air pressure of 68 inches of mercury absolute with the results shown in figure 3. The total test time was 33.1 hours including the preignition tests conducted previous to the endurance run.

time of the inspection when all the compression rings had failed (fig. 2), which suggests that the oil-control rings had a considerable effect in sealing the combustion chamber.

Figure 2. - Piston and ring assembly after 7.5 hours of first endurance test. All compression rings have failed.

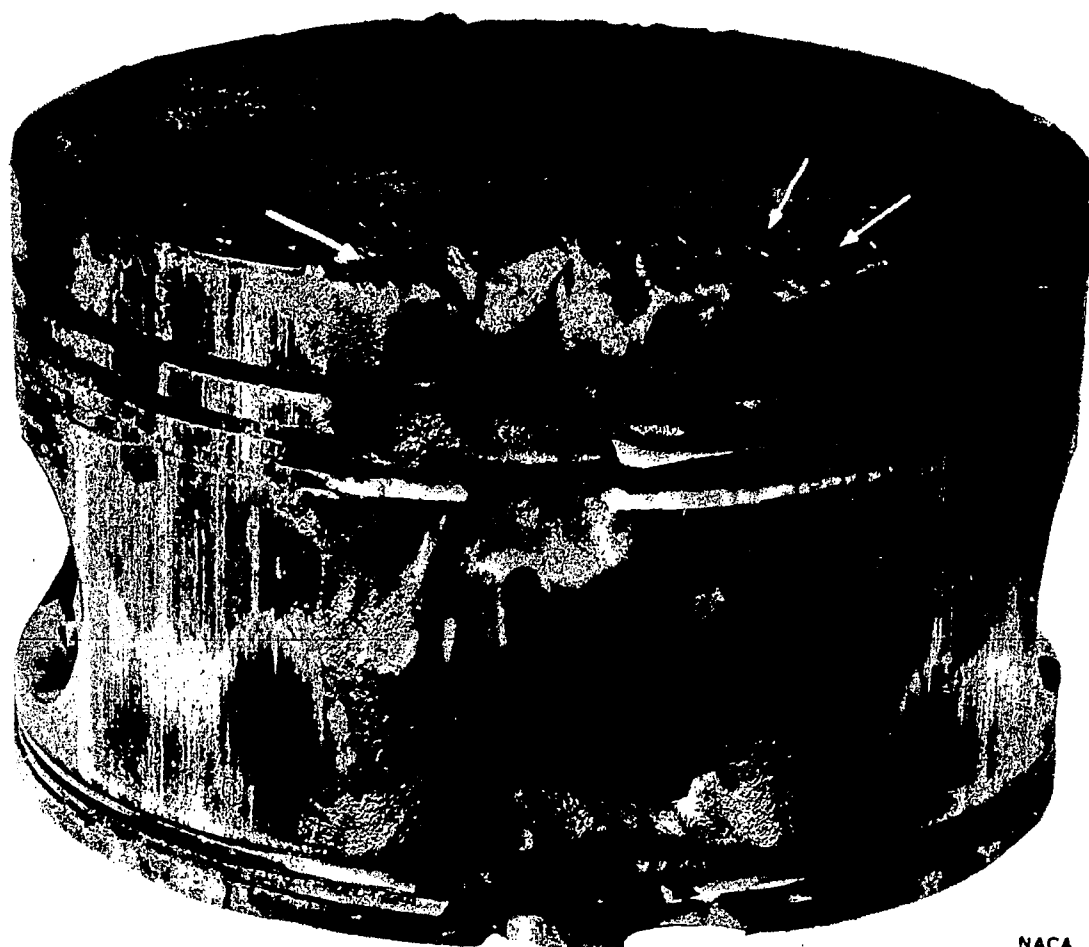
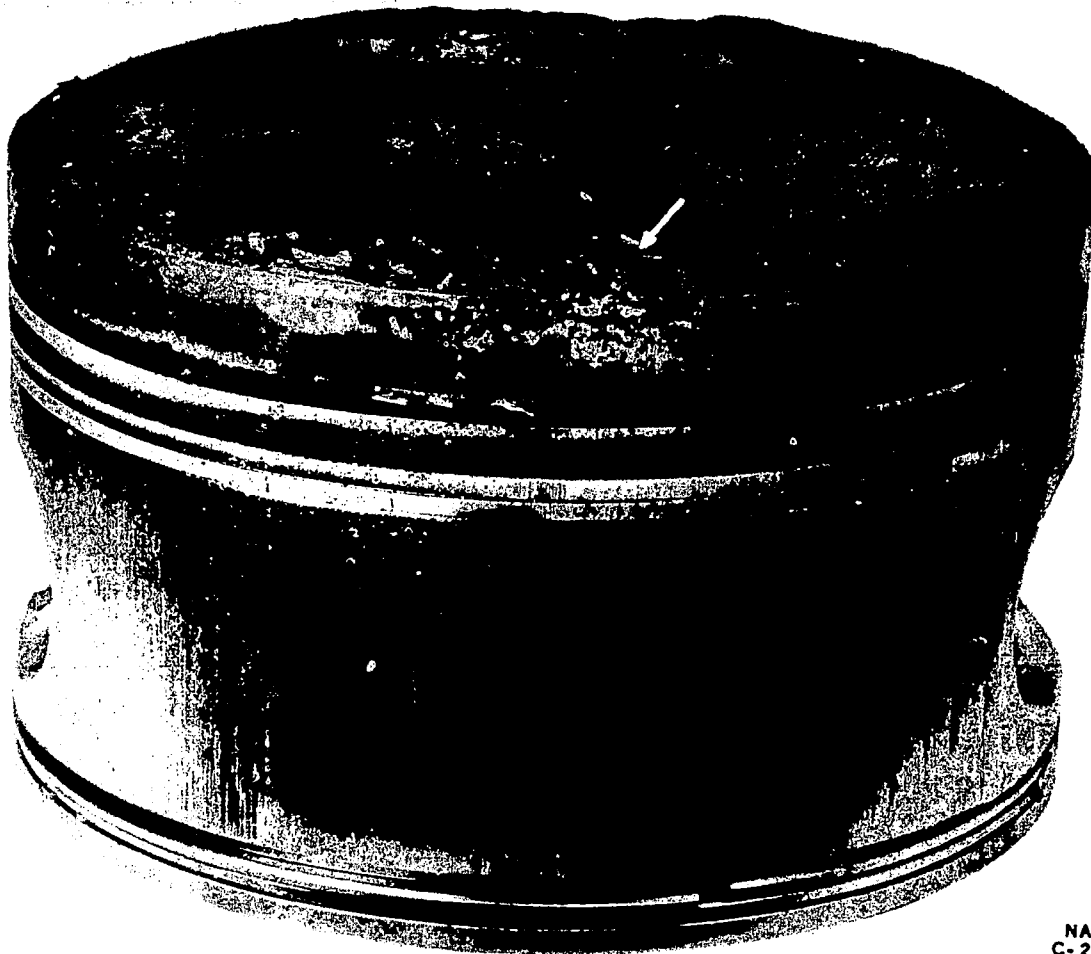
Analysis of failed piston. - Figure 3 shows the piston and ring assembly after the final failure of the first test. A wide deep channel has been burned down the entire length of the piston and a hole has been made through the piston skirt above the oil rings. This damage was confined to the minor thrust face of the piston; the major thrust face remained comparatively unharmed.

The ultimate failure was most likely caused by the action of high-temperature gases against the side of the piston, probably taking place over a relatively long period of time. Figure 7 shows the ring belt of a piston that had been operated under severe conditions in another test program. The large flow of high-temperature gases resulting from compression-ring failure has begun an erosion of one of the ring lands, which probably would have resulted in a large channel similar to figure 3 if operation had been continued long enough. These high-temperature gases are not necessarily all blow-by gases. A portion of these gases leaks by all the rings as blow-by gases, whereas part of them travel down and back up past the ineffective rings as the pressure in the combustion chamber is alternately increased and decreased. The net result is a scouring action, which in all probability causes the erosion shown in figures 3 and 7.

Further evidence that this channeling took place over a prolonged period of time is found in the fact that the entire top ring and parts of the second ring are missing from the piston in figure 3. The channel in the face of the piston provides the only escape path for these ring pieces. Because the broken rings were partly stuck in the grooves, the time required for them to work their way along the grooves to the channel would probably be quite appreciable. The pieces of rings imbedded in the top of the piston at the end of the test (shown by arrows in fig. 3) were covered with a coating of carbon, indicating their presence on the top of the piston for a considerable length of time. The preignition in the engine previously mentioned may have been caused by these ring pieces in the combustion chamber or by the ends of the compression rings left exposed by the formation of the channel down the side of the piston. The fact that particles of aluminum alloy were found lodged in the oil-ring groove, displaced as much as  $90^{\circ}$  from the channel in the face of the piston, lends further support to the supposition that the channeling of the piston took place over an extended period of time.

The final destruction of the piston occurred without any forewarning other than the high blow-by rates and did not extend beyond a few engine cycles. The piston skirt had been weakened by the channeling and by the increased temperature and the full pressure of the combustion chamber was acting on the sides of the channel.

The stresses in the aluminum became so great and the temperature so high that the skirt collapsed and permitted the free flow of burning gases into the crankcase.

*Figure 3. - Piston and ring assembly at end of first endurance test. Total test time 33.1 hours. Arrows indicate pieces of piston rings imbedded in piston.*

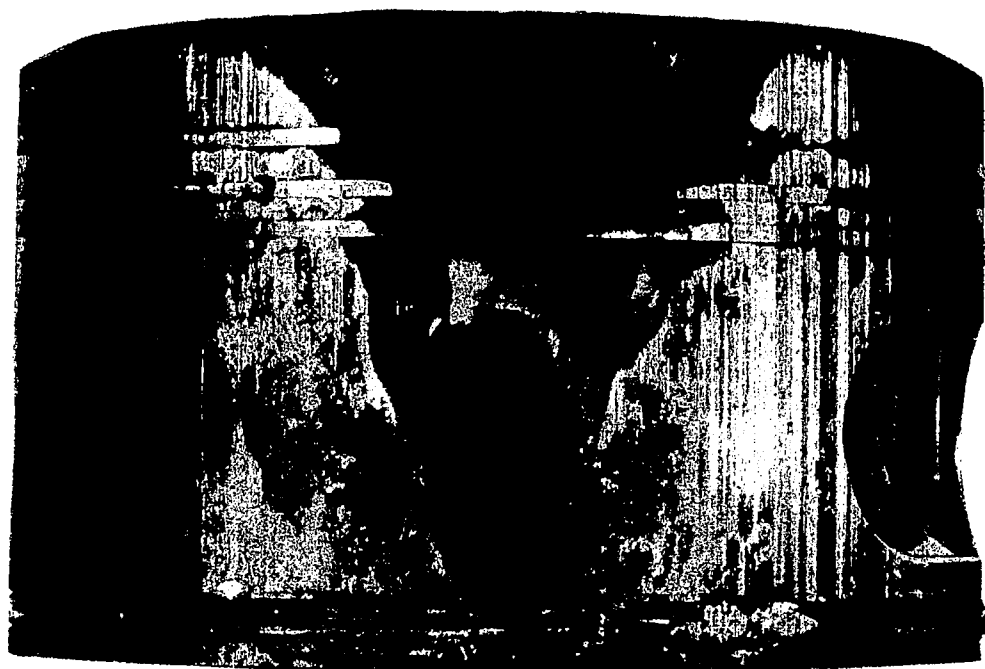
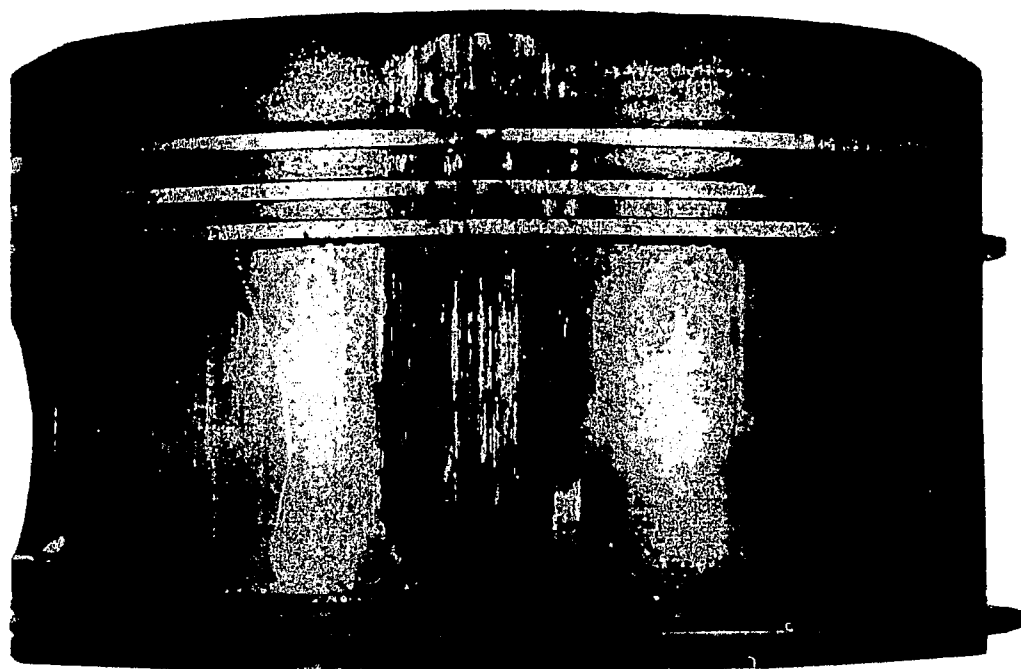
Analysis of failed piston. - Figure 9 shows the piston at the end of the second test. The failure was quite similar to that of the first test. In this case, however, much of the top two compression rings was still in the ring grooves, probably caused by the rings' being more severely stuck than in the first test and therefore not so free to rotate in the grooves.

Particles of aluminum alloy were found in the oil-ring groove displaced a considerable distance from the point of failure. Here again is evidence that the channeling of the piston took place over an appreciable period of time. It appears unlikely that these aluminum particles could have moved so far along the groove at the instant of final failure.

Figure 9. - Piston and ring assembly at end of second endurance test. Total test time, 84.25 hours.
