FIRST REPORT ON ASSAULT TANK T14

FIRST REPORT ON ORDNANCE PROGRAM NO. 5621

Feb 44

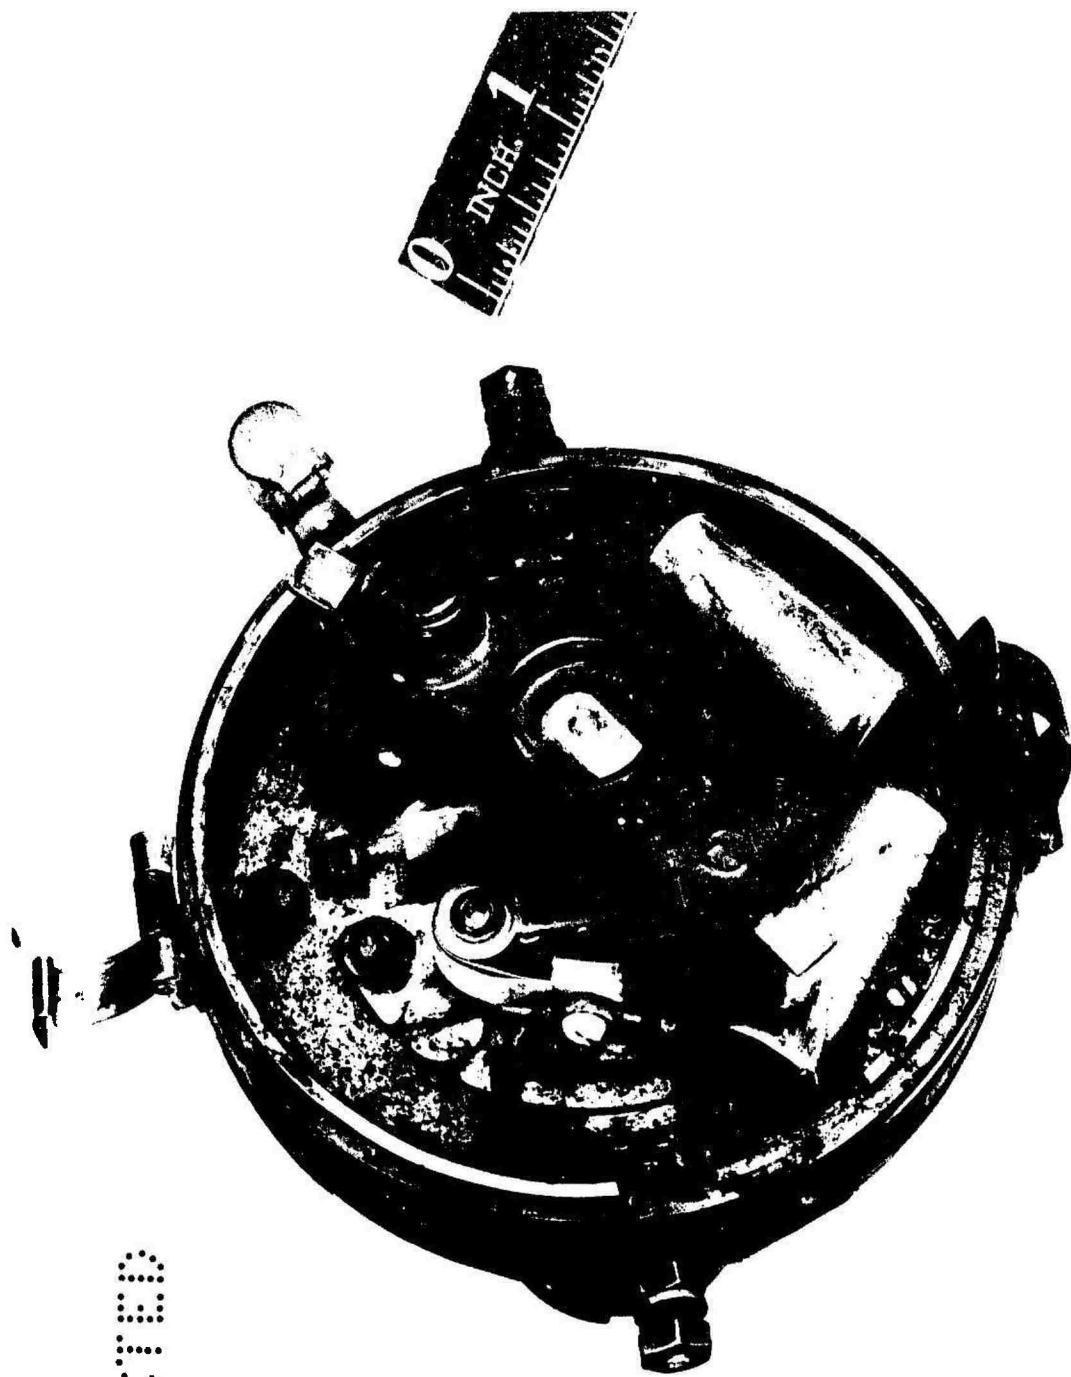
(1) When received, both Assault Tanks were equipped with the Autolite distributors shown in APG Photograph #93209. After brief operation of Assault Tank T14 #1 on the dusty course in the Palmer Area, however, it was found that this distributor became filled with dust in a very short time, which resulted in burned points and general malfunctioning of the distributor. See APG Photograph number 91234 in Appendix "A". The Autolite dust-proof distributor (see APG Photograph number 93208) was then installed. This latter distributor functioned quite satisfactorily for the remainder of the test operation, although it was not 100% dust-proof, as shown in APG Photograph number 92919.

Dirt in distributor, 46 miles after cleaning.

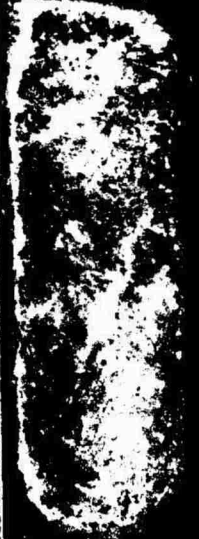
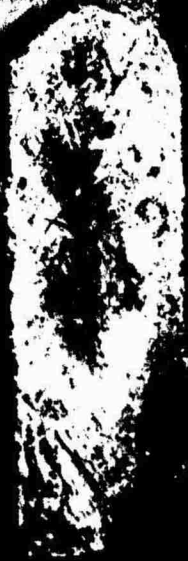
d. One track block was broken during the test of the first pilot vehicle. See APG Photograph number 92096 in Appendix "A". It is believed that the failure was caused by a combination of tight tracks and hard road operation.

RESTRICTED - Proj. 3-14-1. Assault Tank, T14, #1. Broken track block, left track.

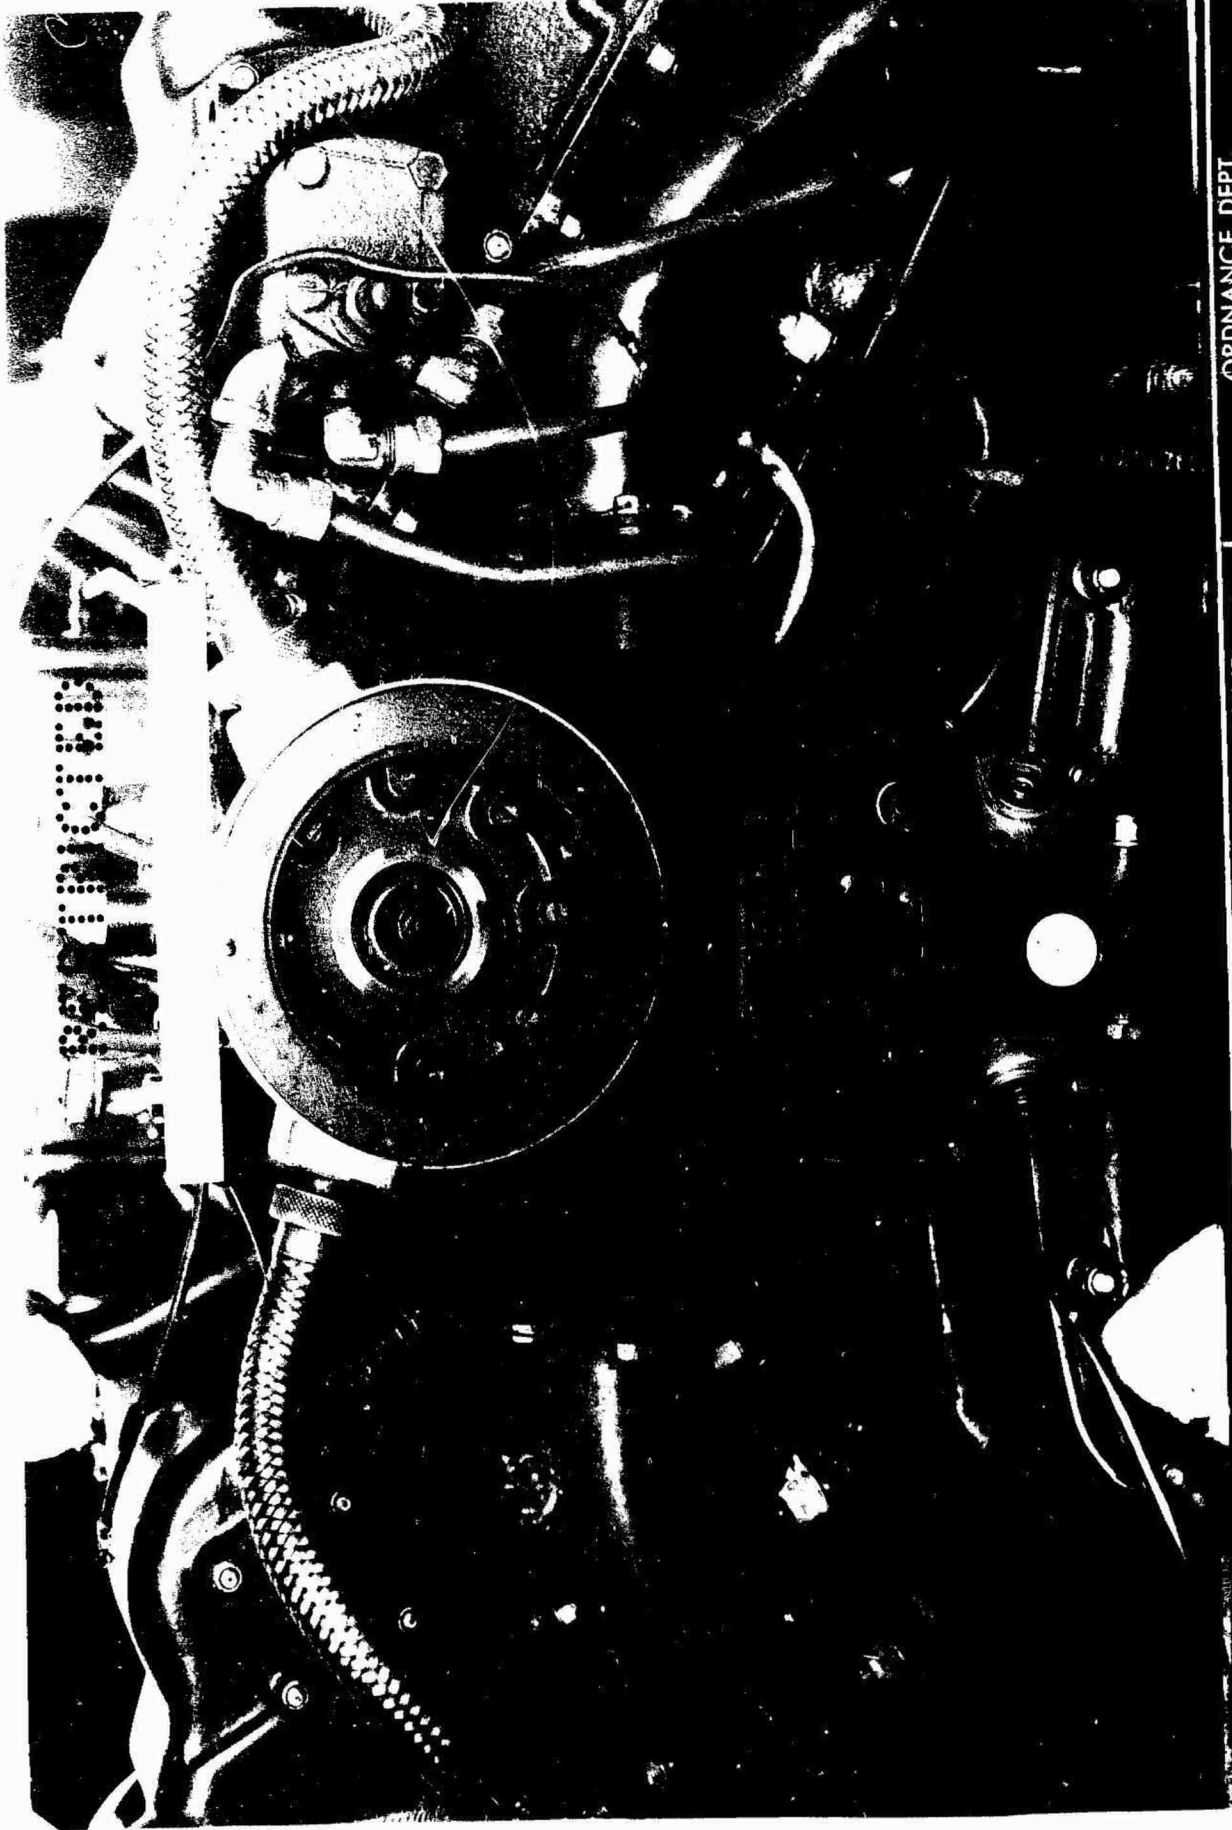
932018 9-26-43

Proj. 3-14-1. Assault Tank, T1, M1 (Pilot). Autolite Dust Proof Distributor for Ford Engine, Model GAZ.
