MULLER MIXER FIRE  
"LESSONS LEARNED"

MORTON THIOKOL, INC.

Longhorn Division

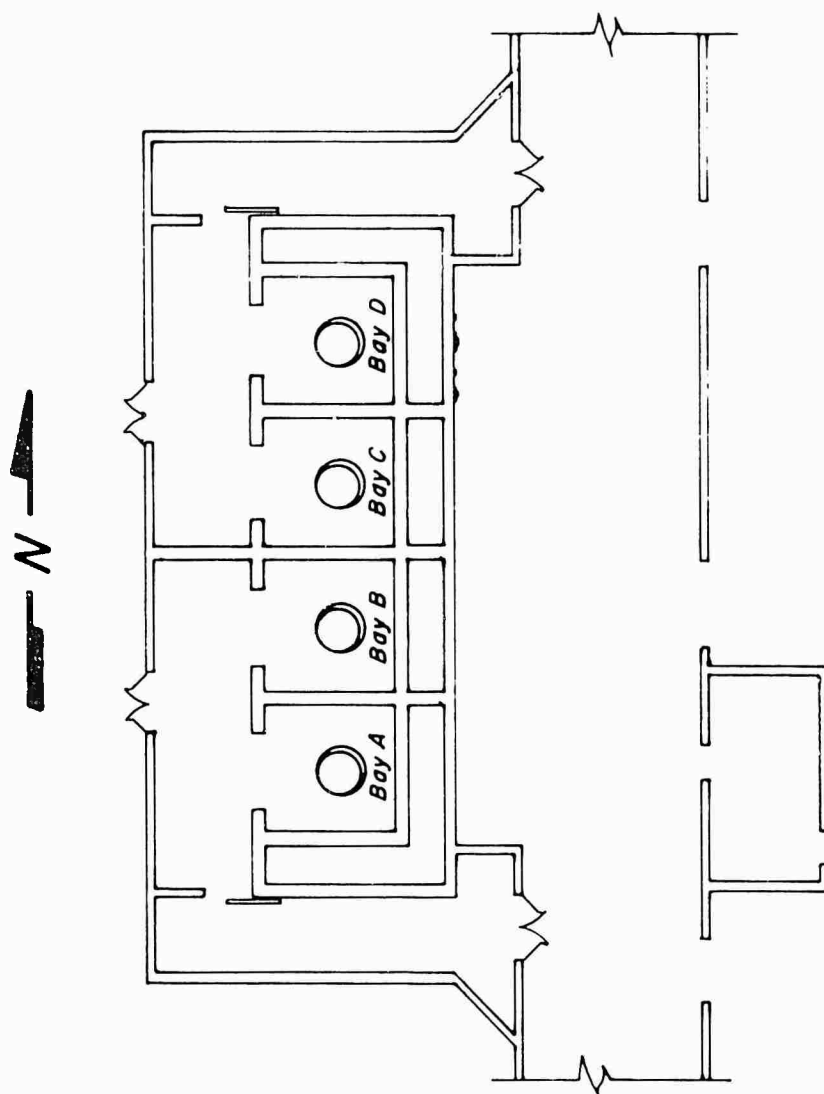
Figure 1

Longhorn AAP has used this blade to bowl contact mulling procedure since the mid-60's. The mixer wheels/plows revolve at approximately 18 RPM and are driven by an 1800 RPM 3 H.P. motor through a double belt sheave and gear box. The bowl diameter is approximately 39 inches and 12 inches deep with the mulling wheels/plows geared to move in a counterclockwise rotation. All bays are equipped with closed circuit TV monitors, Backarack explosive vapor alarms, Detronics UV rapid acting deluge and fusible link wet pipe fire protection systems with electrically interlocked emergency exit doors, fire door and vapor alarms to remote controls. Also provided is 100 percent make up air with temperature and humidity control, vapor/dust removal systems connected to an external wet type Rotoclone dust collector that is electrically interlocked to the control panel. Walls between bays and control room are substantial dividing walls of 12 inch thick reinforced concrete with three feet of sand fill between bay and control station walls. (Figure 1 illustrates B11 configuration)

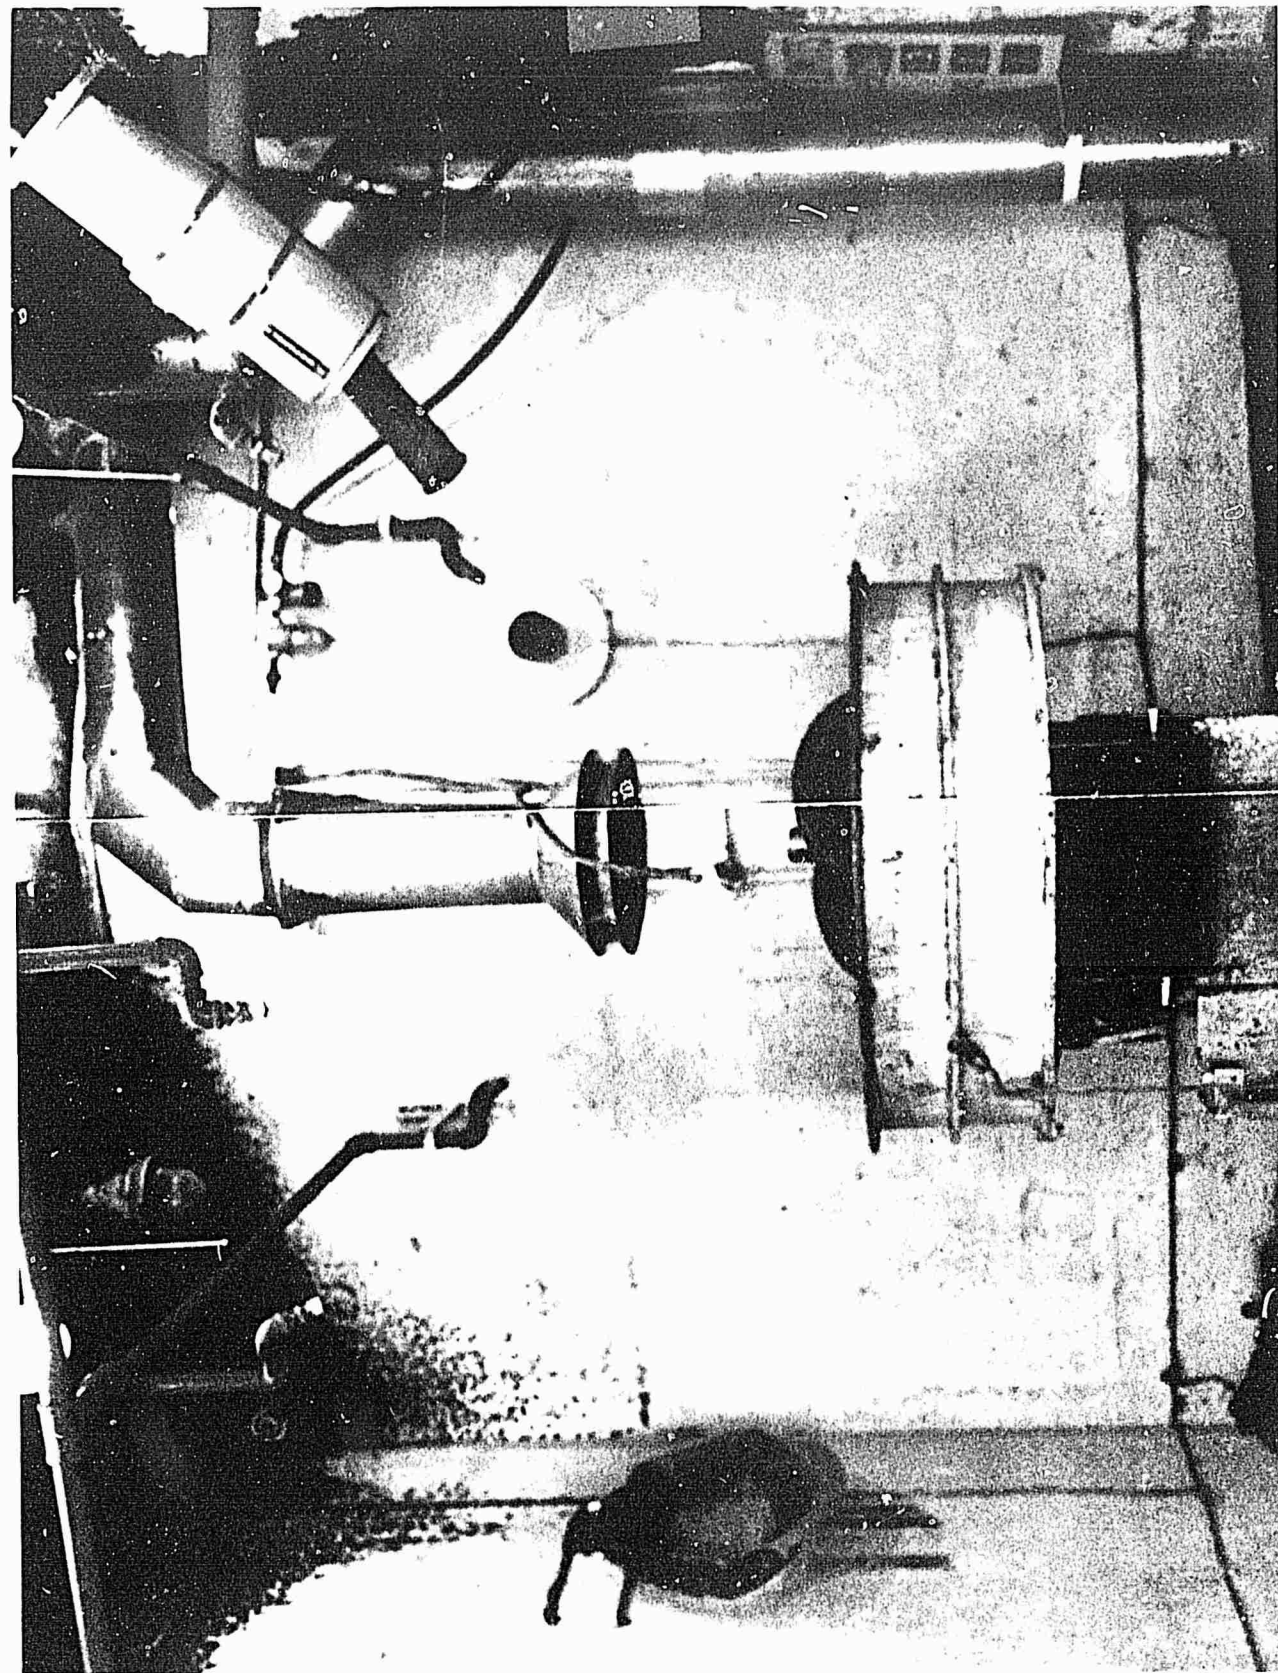
Figure 2

At the time of the incident, Bays A and B were inactive while Bay C was in same mix cycle as Bay D. The pyrotechnic being manufactured was a M22 flash composition mix which is composed of Magnesium (93.75 lbs.), Teflon (12.5 lbs.), and Viton Binder (18.76 lbs.) dissolved in Methyl Ethyl Ketone (44 lbs.). This was the first mix of the day with bowls in both Bays C and D being charged with only the Magnesium and the dissolved Binder. No Teflon had been added. The remote mix operation had run approximately 7 of the 10 minutes when the flash fire occurred. The fire caused superficial damage to Bay D and equipment with most of the production material either being consumed or tossed out of the bowl by deluge system. No personnel injuries were incurred. The fire ball did not propagate to Bay C due to the rapid acting deluge system but was

forced into the back corridor and out the emergency exit nearest Bay D. The fire ball also vented over the top edge of the sliding corridor fire door igniting contaminated surface along the fire door track and ceiling. In interviewing the operator who was supposed to have been watching the TV monitors, there was no indication of a problem before she heard a boom and looked up and to see Bay D engulfed in flames on the TV monitor. (Figure 2 shows damage in Bay D)
