TITLE: The Inadequacy of Safe-Life Prediction: Aero-Engine Fan and Compressor Disk Cracking

# The Inadequacy of Safe-Life Prediction: Aero-Engine Fan and Compressor Disk Cracking

B.J. Wicks, R.A. Antoniou, S.L. Slater and J. Hou  
Aeronautical and Maritime Research Laboratory  
Defence Science and Technology Organisation  
Department of Defence  
Box 4331 GPO  
Melbourne 3001  
Australia

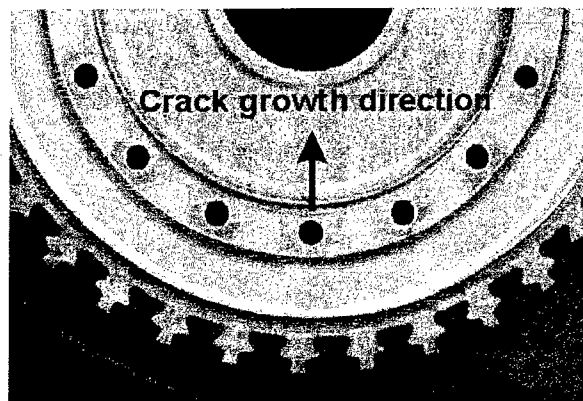
Following the detection of a crack emanating from a bolt-hole in an engine disk, an investigation was undertaken to determine the subsequent crack growth behaviour. The disk geometry and observed crack direction are shown in Figure 1. The radial crack emanating from the bolt-hole was cut from the disk and opened, revealing the crack face shown in Figure 2. The cracking was found to be due to fatigue which had started within the bore of the hole and away from the corner. The crack markings were examined using both optical and scanning microscopy and the crack growth rate was predicted using both numerical and analytical methods and compared to the measured growth rate.

Figure 1: Disk geometry and crack growth direction.

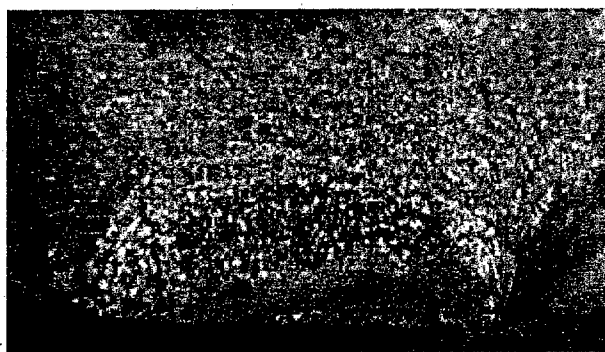
The metallographic studies indicated the presence of a surface deformed layer, with a depth of approximately 0.6 mm, and the crack growth progression measurements on the fracture surface showed rapid crack growth through the deformed layer from multiple surface cracks all around perimeter of the hole. Furthermore the presence of tungsten carbide was detected at the surface, presumably from a piece of tooling.

The fatigue cracks originated in alpha case particles in the microstructure of the hole surface, indicative of localised overheating. It was concluded from these observations that an abusive hole drilling or reaming operation caused overheating and localised damage.

Figure 2: Radial bolt-hole crack using optical microscopy.

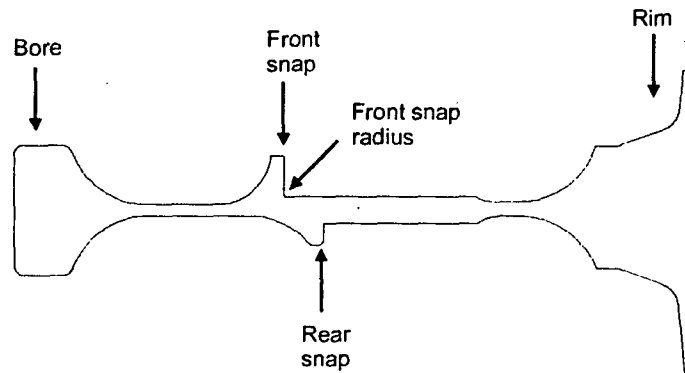
A finite element (FE) method was utilised to analyse the mechanical and thermal stress in a 4<sup>th</sup> stage Low Pressure Compressor (4th LPC) disk assembly in an aircraft gas turbine engine(6). This FE analysis indicated that the critical region for fatigue is at a front snap radius. The geometry of the disk is shown in Figure 7.

It was found that the maximum principal stress at the front snap radius dropped rapidly from 800 MPa at the free surface to 350 MPa at a depth of 0.5 mm.

Figure 7: Schematic cross-section of a compressor disk.

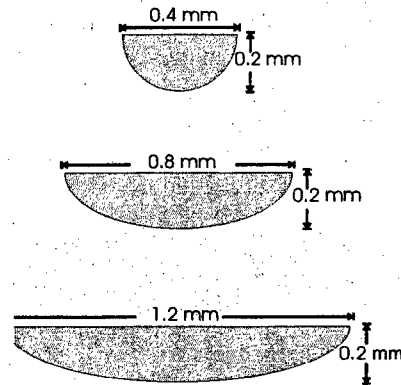
Semi-circular and semi-elliptical surface cracks with a depth of 0.2 mm were inserted perpendicular to the front snap radius at the peak stress location, 25 degrees from the radius

Figure 8 Initial crack profiles used in the analysis

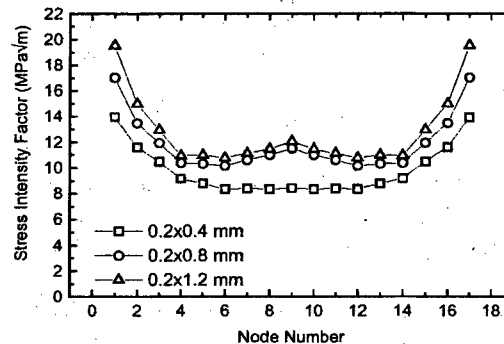
runout (Figure 8). Stress intensity factors (SIF's) were then calculated using the J-integral method. The SIF values at the both free surface ends increase with crack length whilst the crack depth remains constant (Figure 9). Therefore, a crack initiated at the front snap radius is expected to grow preferentially in the circumferential direction and to grow at a slower rate in the radial direction.

Figure 9: Stress Intensity Function distributions for initial crack profiles.
