# TECHNICAL MEMORANDUM

EVALUATION OF RUBBER-ASPHALT BINDER FOR SEAL COATING ASPHALTIC CONCRETE, NPTR EL CENTRO, CALIFORNIA, MARCH 1974 - JULY 1977, by

R.B. BROWNIE,

AUGUST 1977.

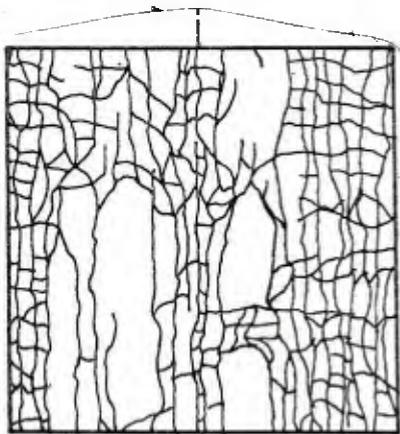
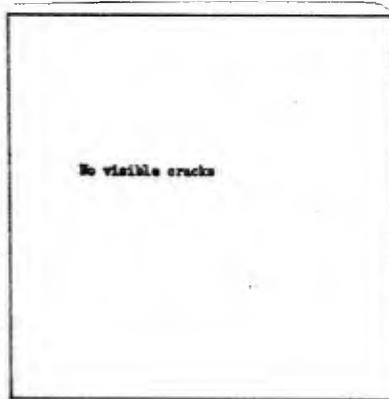
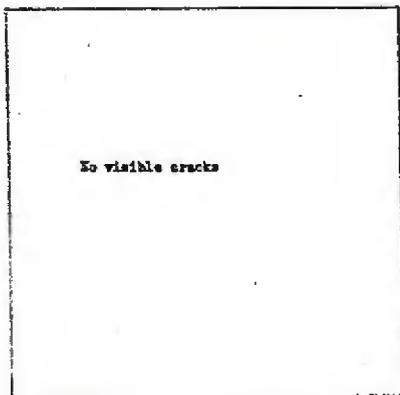
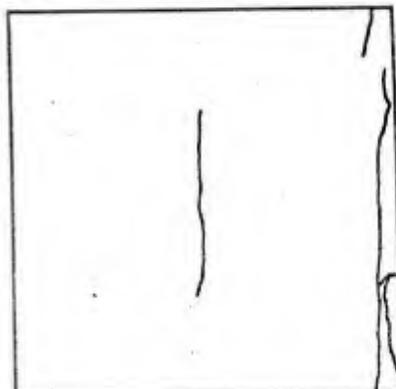
Figure 2. Crack Survey Plots, Taxiway A  
NPTR El Centro, California

these severely distressed areas is planned in the near future by NPTR El Centro. Test plot 1 of Taxiway A and test plot 1 of Taxiway D exhibited the "self-healing" effect noted in Reference 1, and this is shown graphically in Figure 8.

Plot 1  
Taxiway A  
Seal Coated 14-15 October 1975

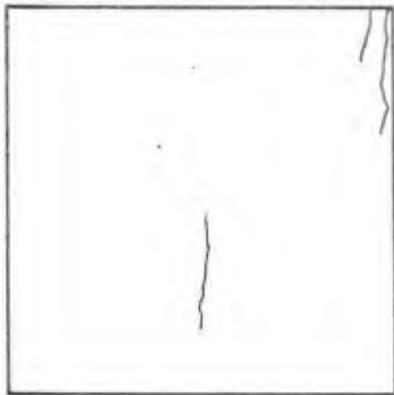
Figure 2a. Crack Survey Plots, Taxiway A  
NPTR El Centro, California

Plot 1  
Taxiway A  
Seal Coated 14-15 October 1975

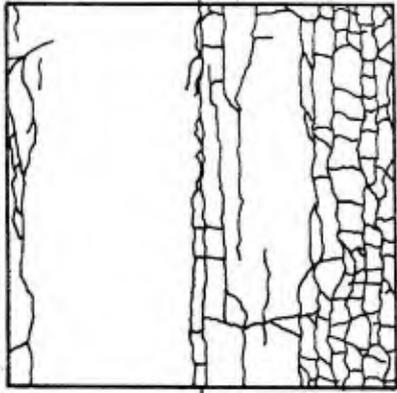
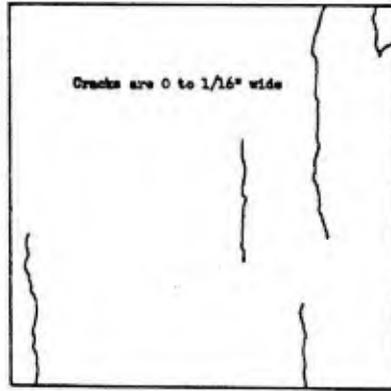
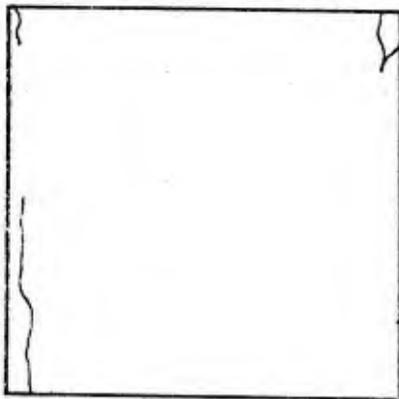
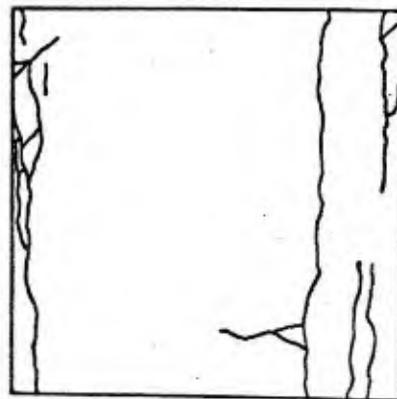
Figure 7. Crack Survey Plots, Taxiway D  
NPTR El Centro, California

Plot 1  
Taxiway D  
Seal Coated 20 October 1975

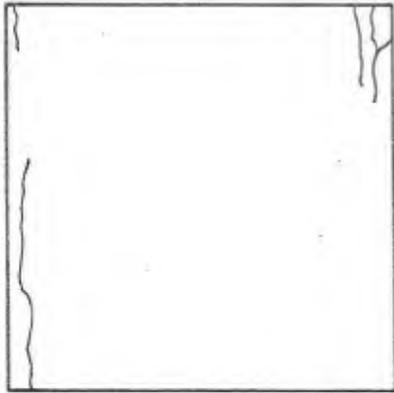
Figure 7a. Crack Survey Plots, Taxiway D  
NPTR El Centro, California

Plot 1  
Taxiway D  
Seal Coated 20 October 1975

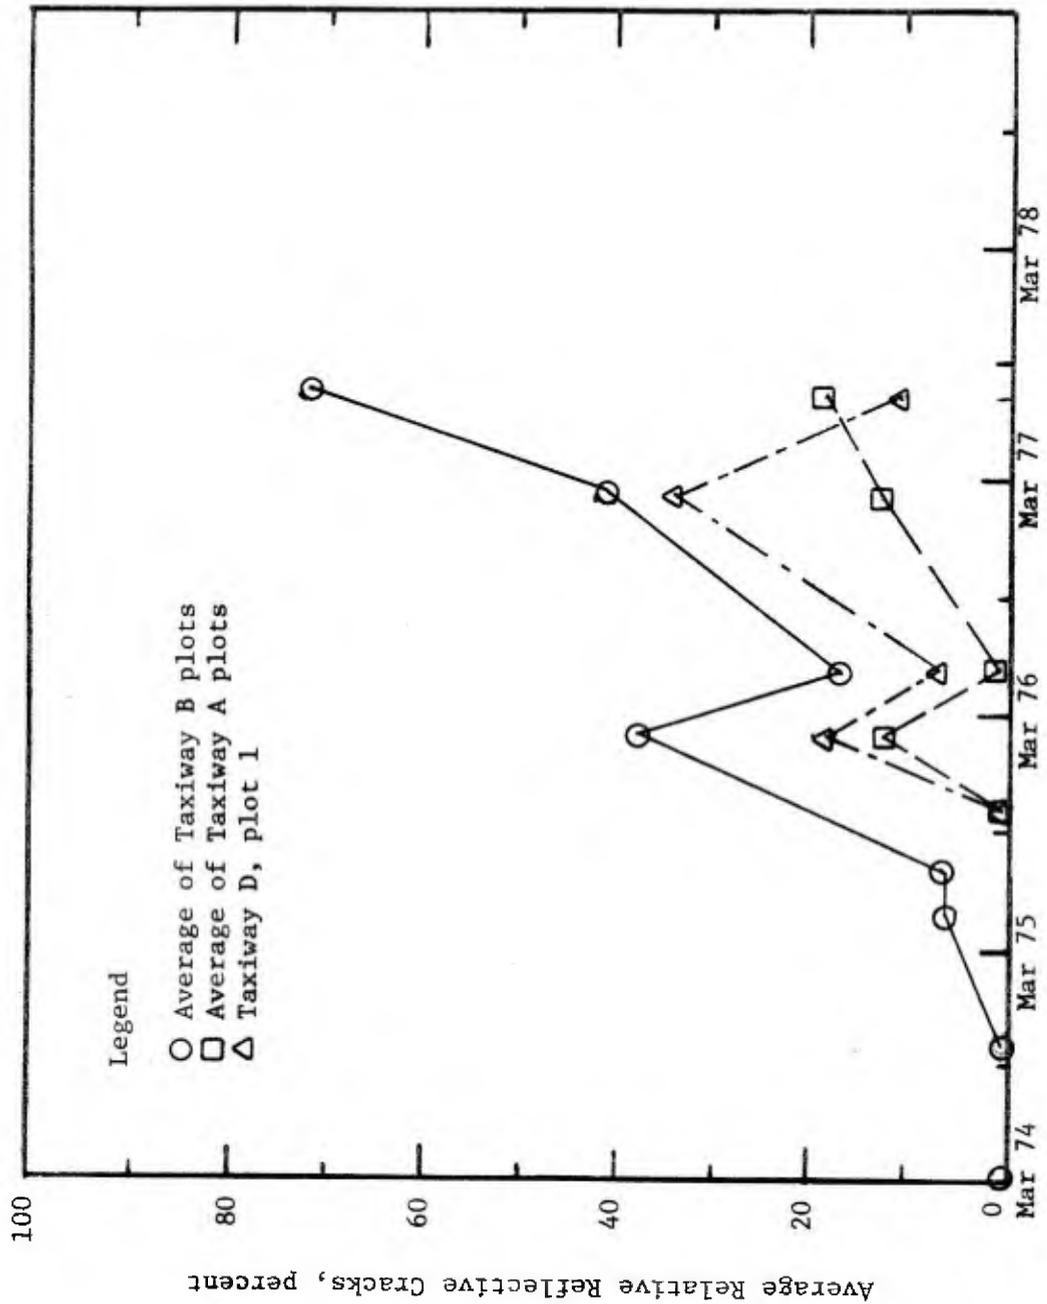
Figure 8. Average Relative Reflected Cracks versus Time, NPTR El Centro, California

At NPTR El Centro, the majority of cracking was fatigue-type pattern cracking with a few longitudinal construction joint cracks. As shown in Table 1 and Figure 8, reflection cracks began to appear after the seal coats were 6-13 months old. The amount of reflection cracking has been cyclic, reaching a peak in mid-winter and then dropping dramatically during the summer until the July 1977 inspection. All test plots on Taxiway B and test plot 2 of Taxiway A showed increased reflection cracking in the summer of 1977. All of these areas exhibited substantial amounts of rutting and evidence of incipient load-related failures (Figures 9 and 10). Replacement of

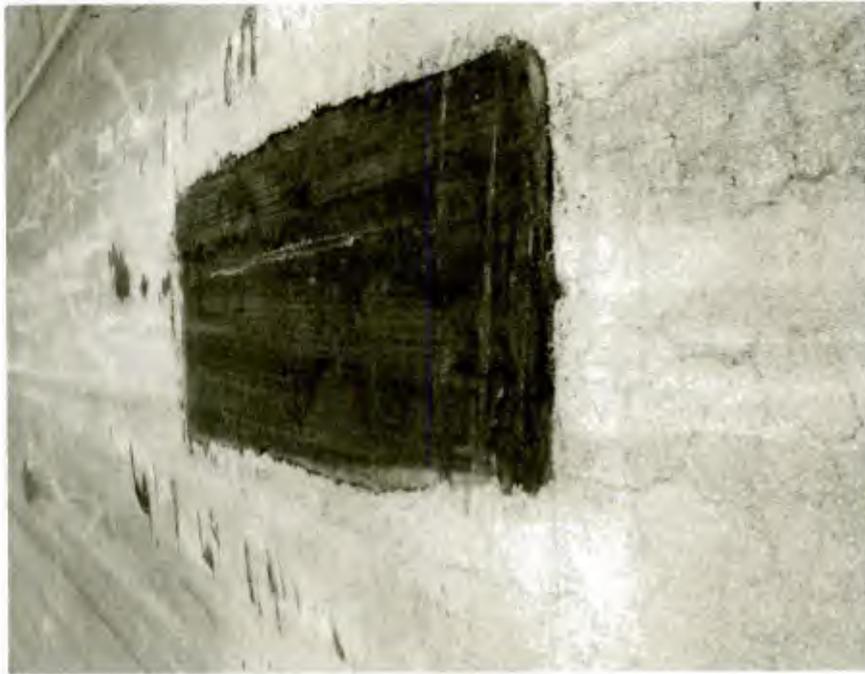
1662-77

Figure 10. Patched load failure and associated pattern cracking.

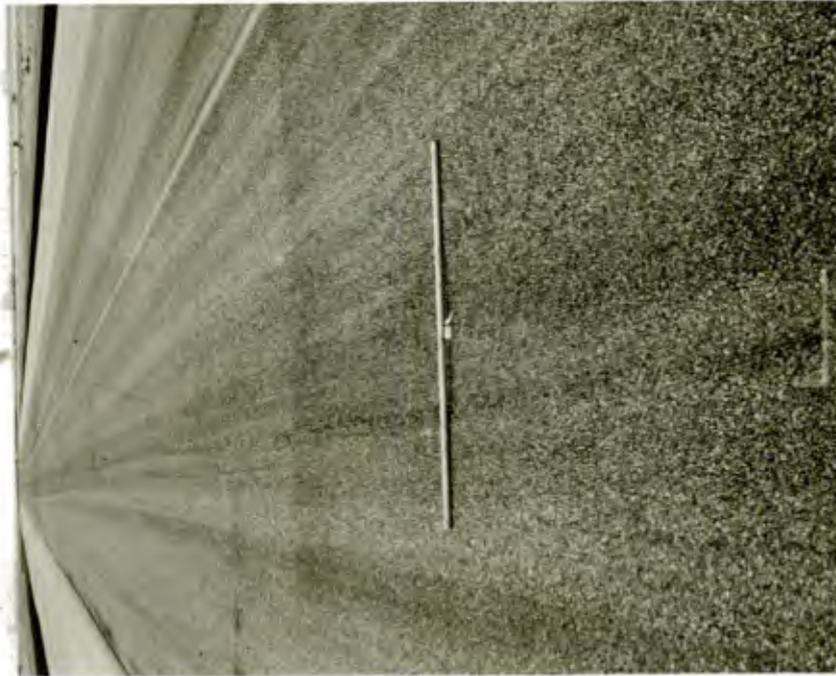
1593-77

Figure 9. One-inch deep rutting in wheelpath of Taxiway B.
