**US Army Corps
of Engineers®**
Engineer Research and
Development Center

Alternatives for Large Crater Repairs using Rapid Set Concrete Mix®

Lulu Edwards, Haley P. Bell, and Marcus L. Opperman

June 2021

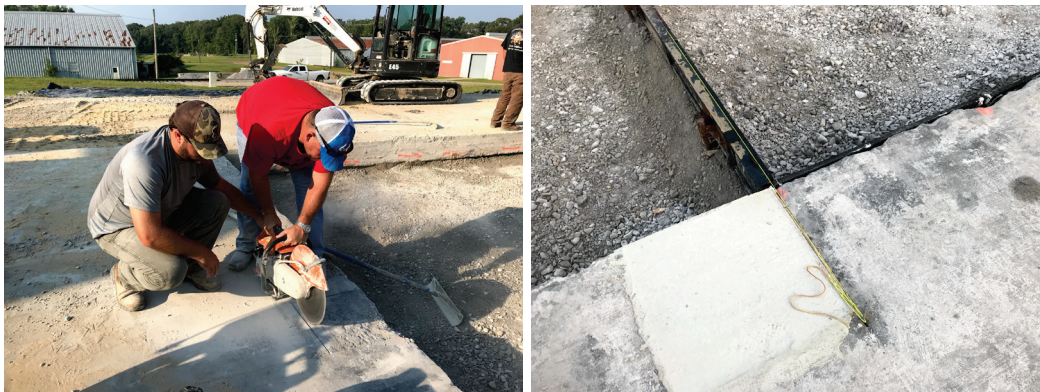
Figure 34. Patching high-severity joint spalls on the parent slabs adjacent to the repair area.

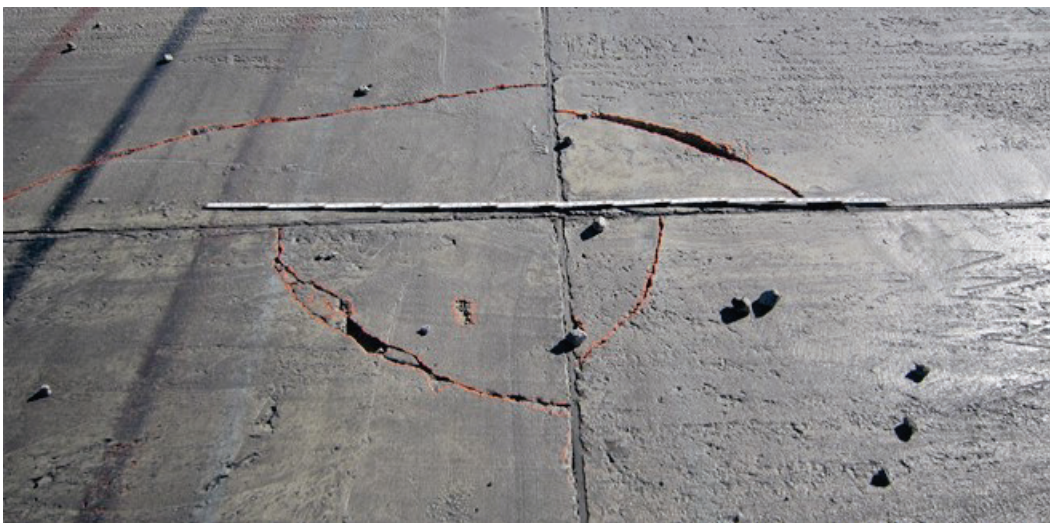
Figure 36. Large 2-in. FOD after 1,680 passes, in the center of Repair 1.

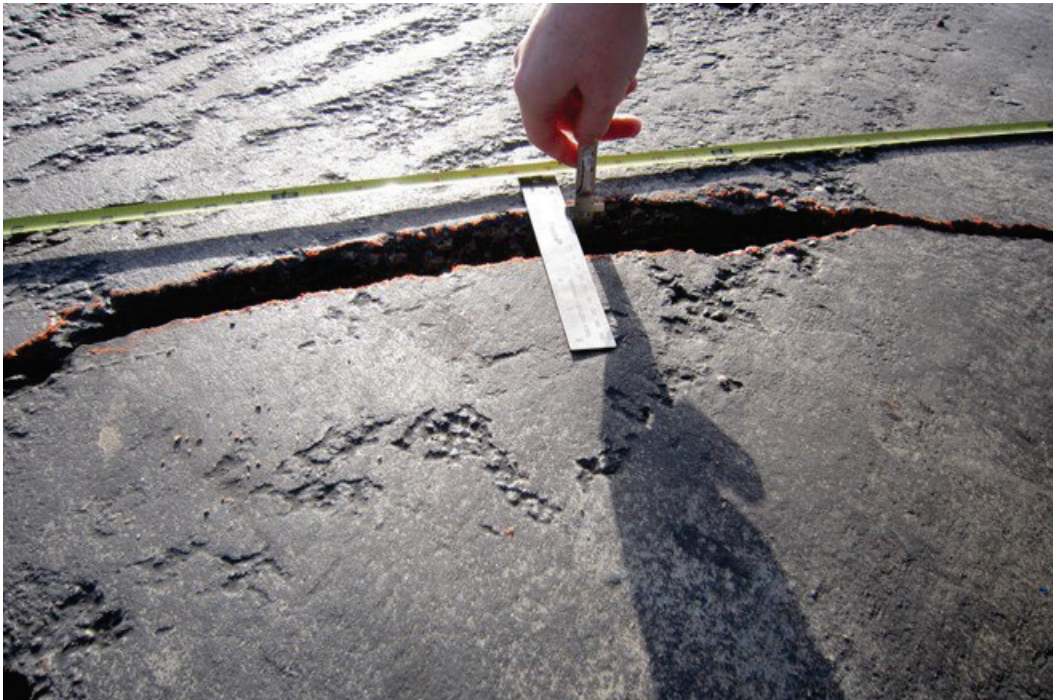
Trafficking was stopped after 3,584 passes (3,063 coverages) due to a tire hazard on one of the interior corner breaks, which was approximately 3.25 in. wide and 3.25 in. deep (Figure 35 [c] and Figure 37). Figure 35 (d) shows the spalling on the east edge at 3,584 passes (3,063 coverages).

Figure 37. Measuring center crack depth.

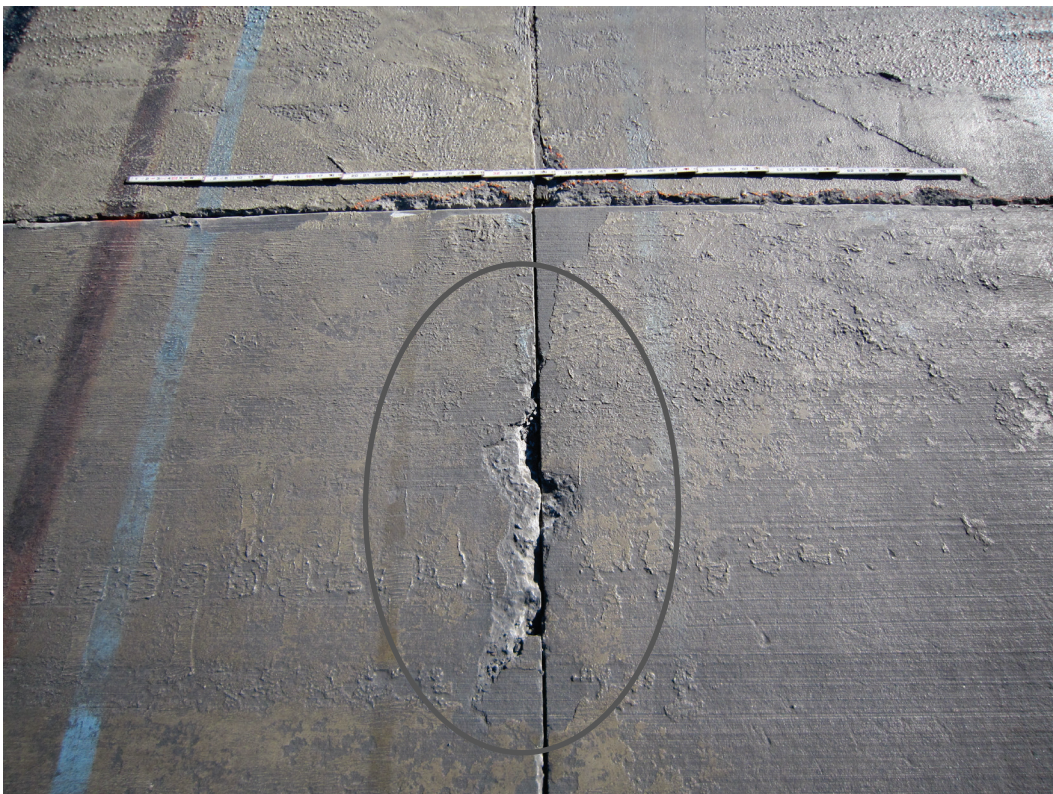
Figure 38. Parent slabs adjacent to the repair started to spall after 1,680 passes.

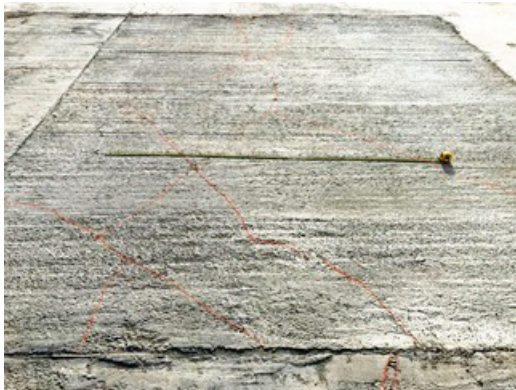
(b) Low severity shattered slab at 112 passes

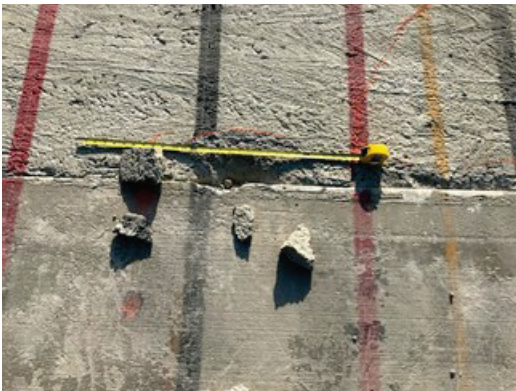
(c) FOD and spall on the western edge at 112 passes

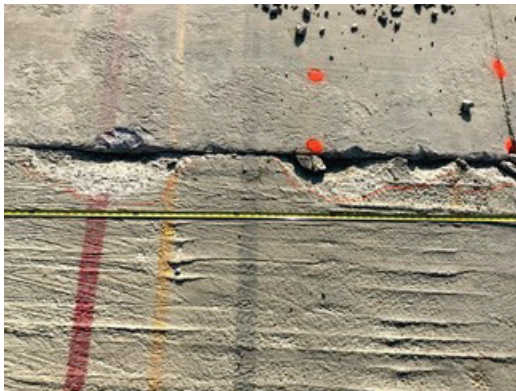
(d) FOD on the eastern edge at 112 passes

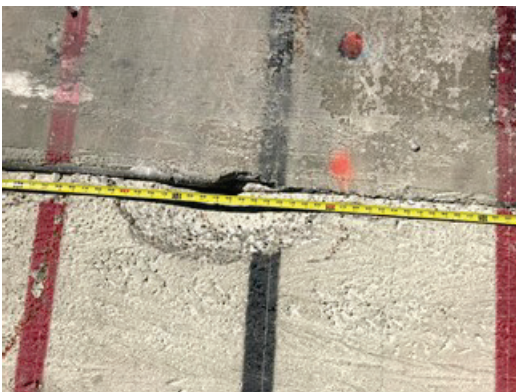
(e) Spall on the western edge at 224 passes

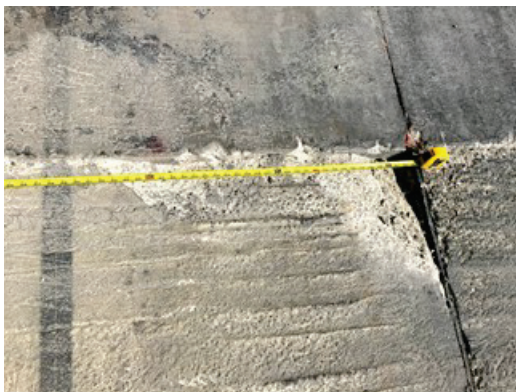
(f) Spall on the eastern edge causing failure at 224 passes.

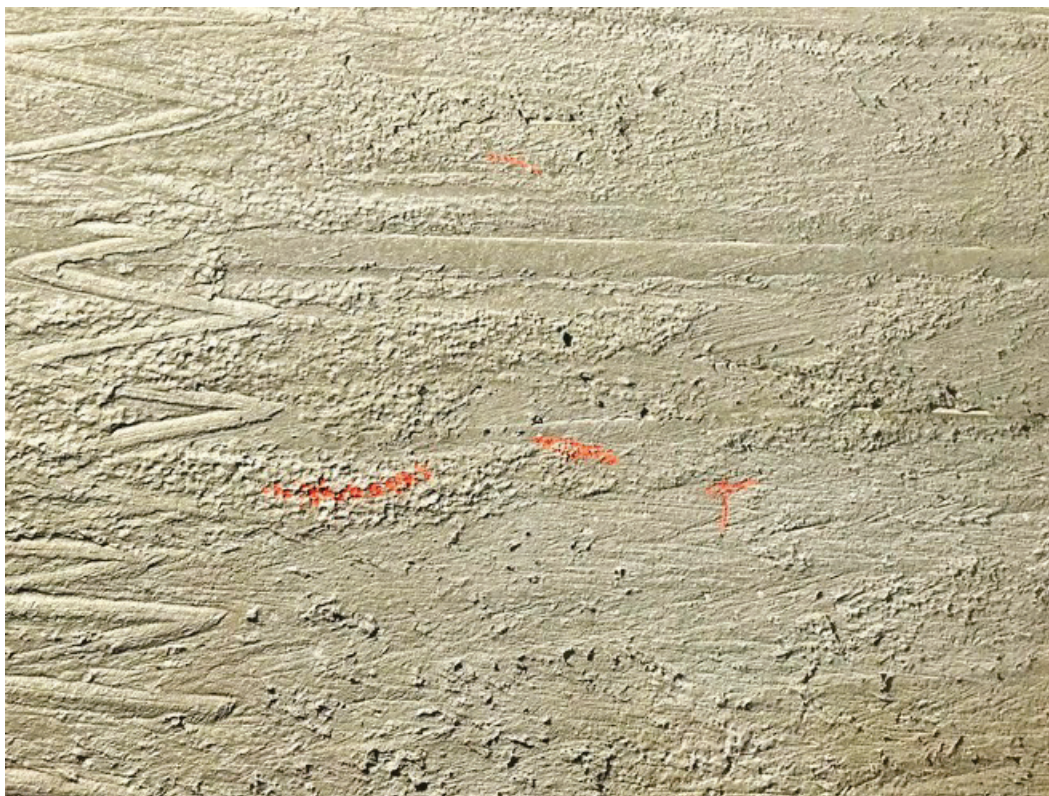
Figure 40. Minor shrinkage cracking at 0 passes.

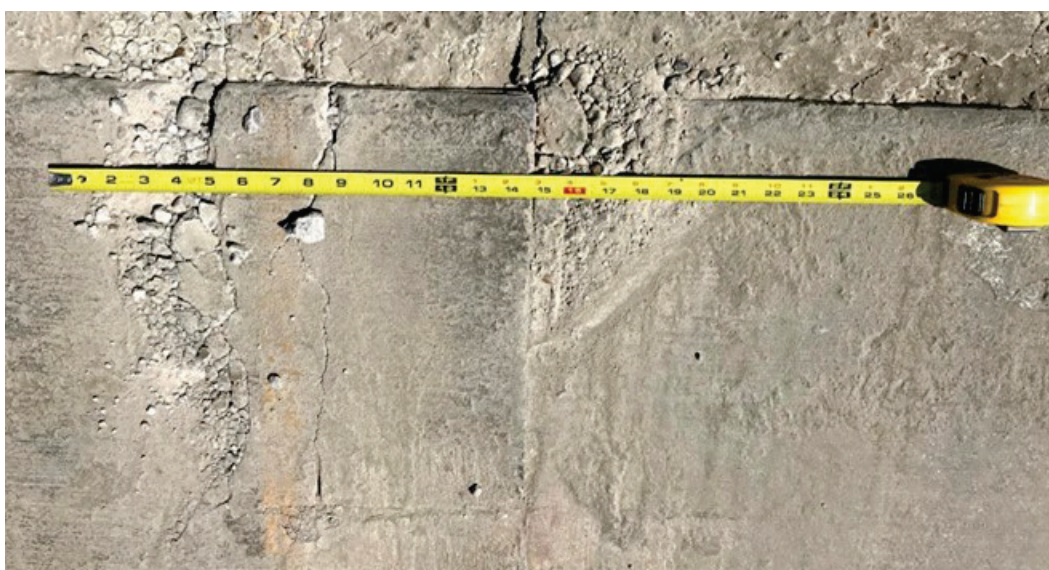
Figure 41. Spalling on parent slab in the trafficking area at 224 passes.

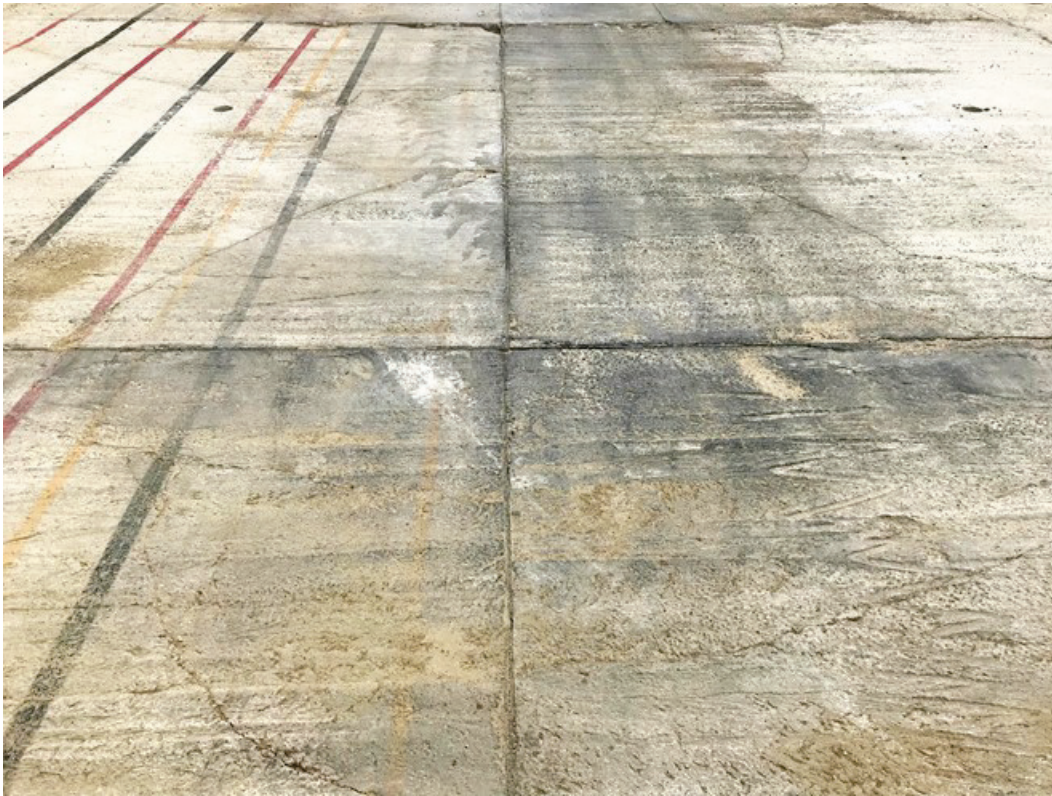
Figure 42. Cracking in the center of Repair 2 at 224 passes.

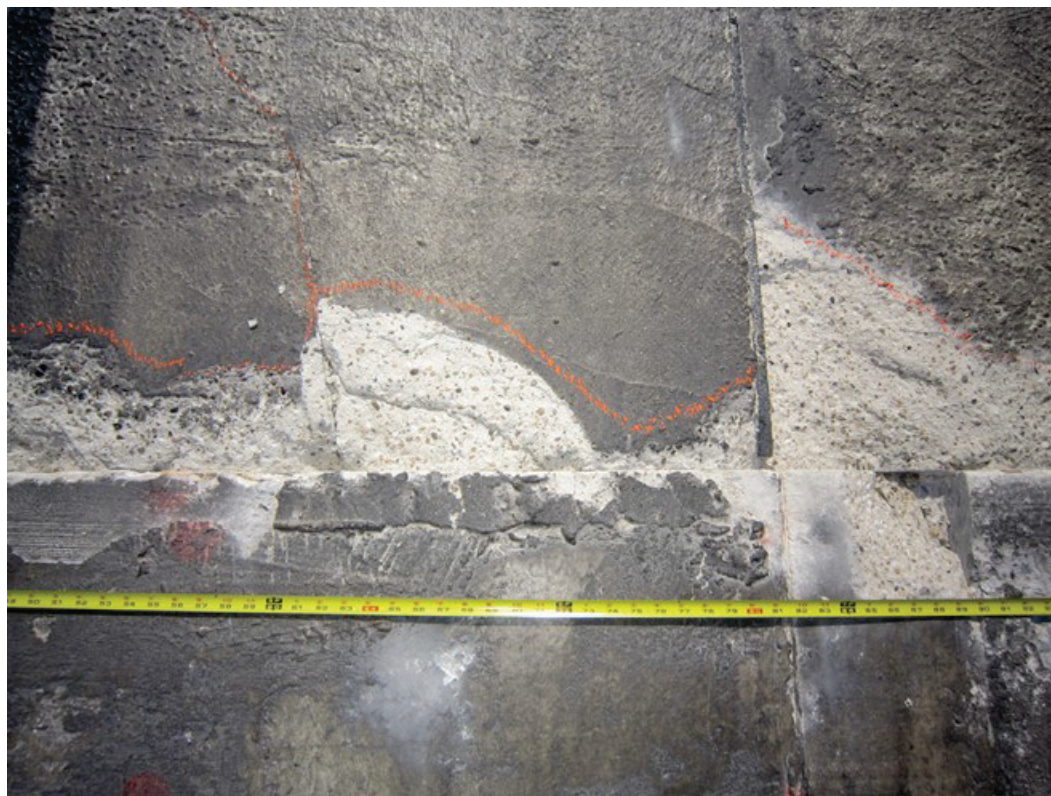
Another 112 passes (96 coverages) were applied to the repair after failure. No new cracks developed; however, the pre-existing cracks became more severe (Figure 47). Additional high-severity joint spalling developed along both the eastern and western trafficked edges. After 500 passes (427 coverages), the linear cracks had not progressed in severity; however, the joint spalls did continue to deteriorate.

Figure 47. Western edge of Repair 4 after 336 passes.

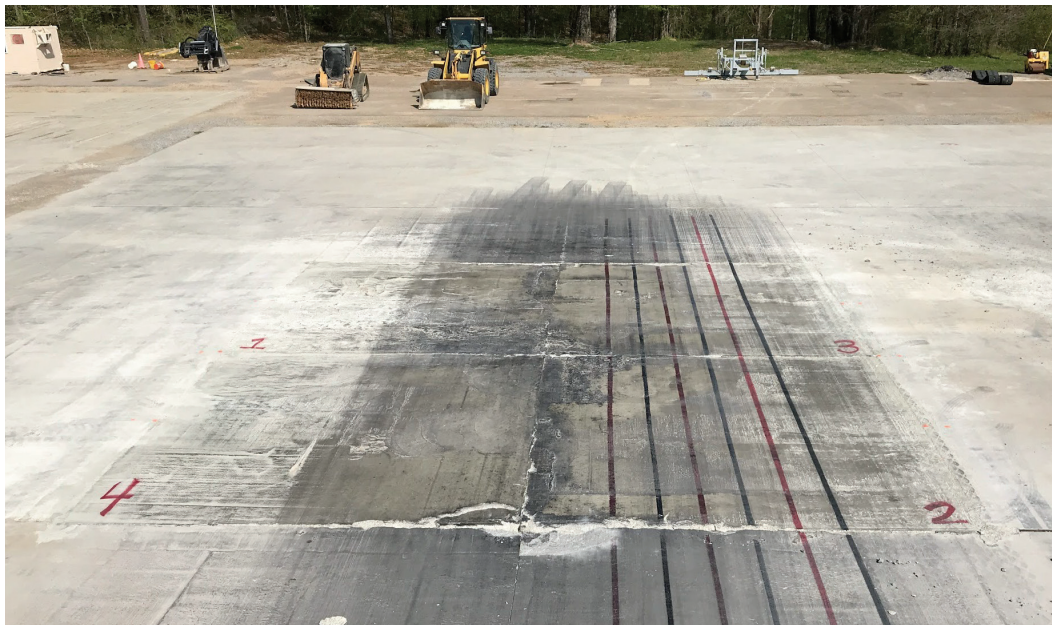
Trafficking continued after failure. After 274 passes (234 coverages), no new cracks developed (Figure 49). The joint spalls were slightly more severe. The west side of the repair was more deteriorated than the east side. After 336 passes (287 coverages), the joint spalls and cracking had not progressed significantly, but the parent slabs on the west edge were heavily spalled. The spalling on the western edge can be seen in Figure 49. The parent slab joint spalls did not seem to affect the condition of the repair during trafficking.

Figure 49. Overview of Repair 5 at 274 passes.

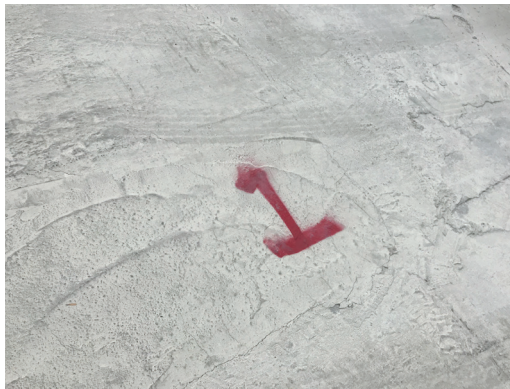
(a) Shrinkage cracks at 0 passes

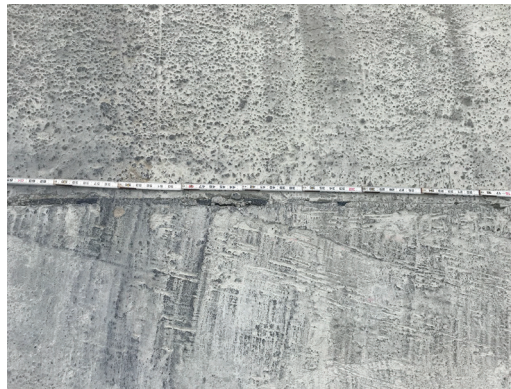
(b) Paste at joint starting to break up at 112 passes

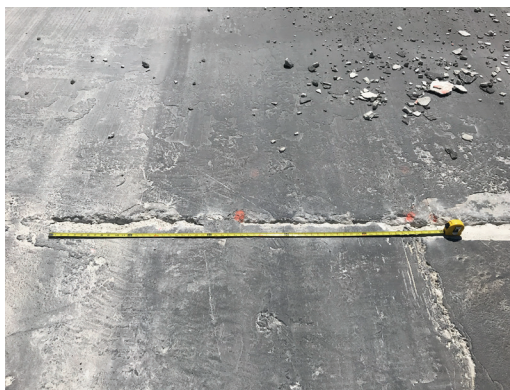
(c) Spalling at joint on Quadrant #1 at 224 passes

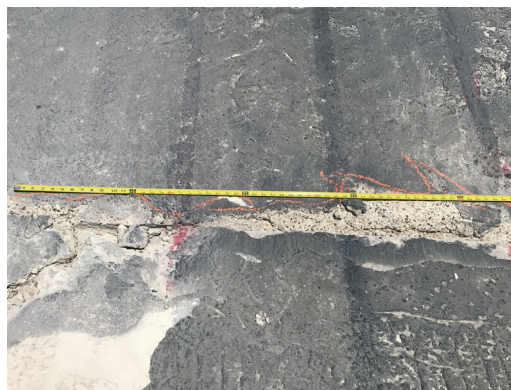
(d) Spalling on Quadrant #2 at 768 passes

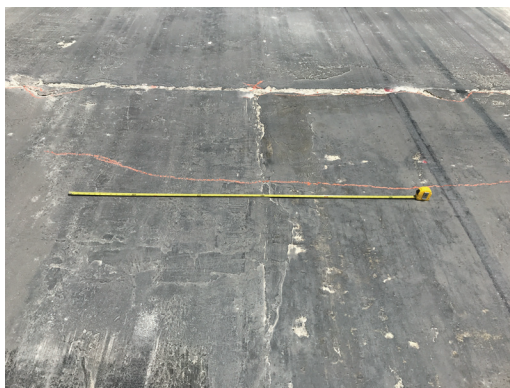
(e) Crack from Quadrant #1 to #3 at 768 passes

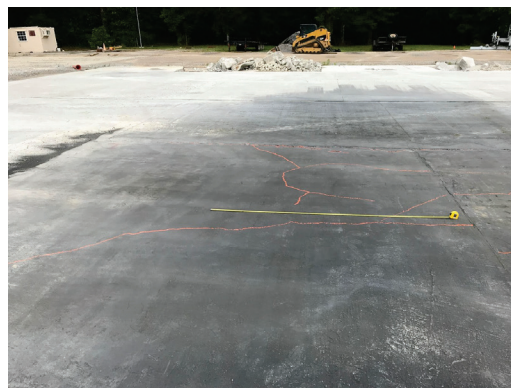
(f) Low-severity shattered slab in Quadrant #1 at 1,664 passes

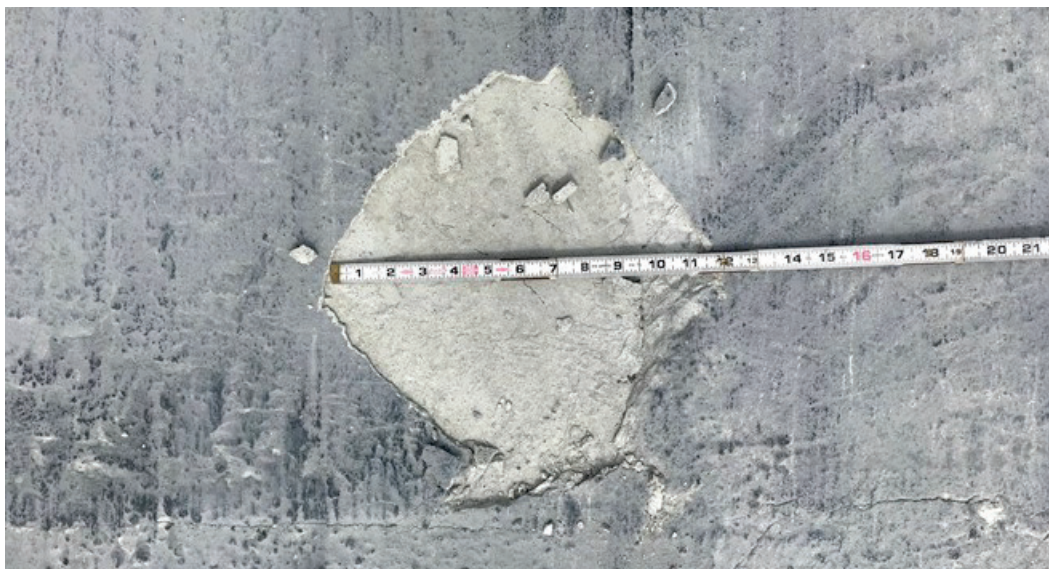
Figure 51. Surface paste observed up to 112 passes.

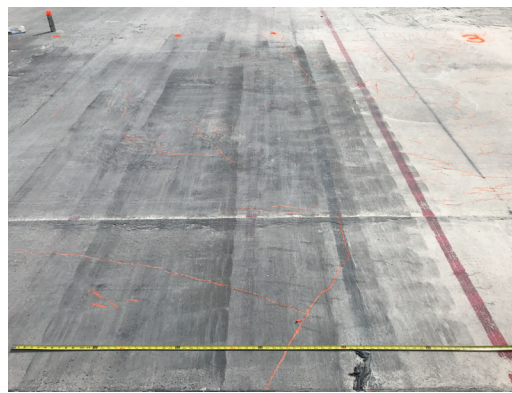
(b) Cracking in the paste at 112 passes

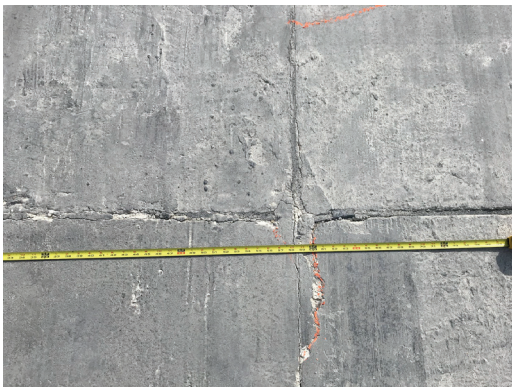
(c) Small corner break in center of repair at 112 passes

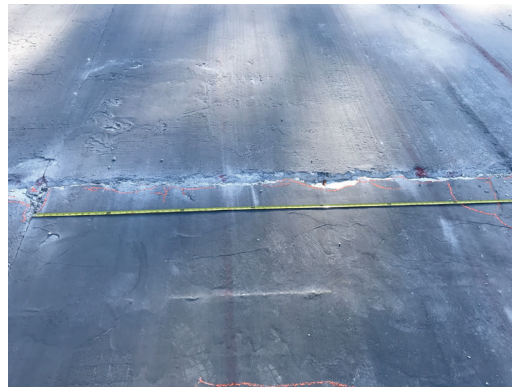
(d) Spalling in Quadrant #3 at 448 passes

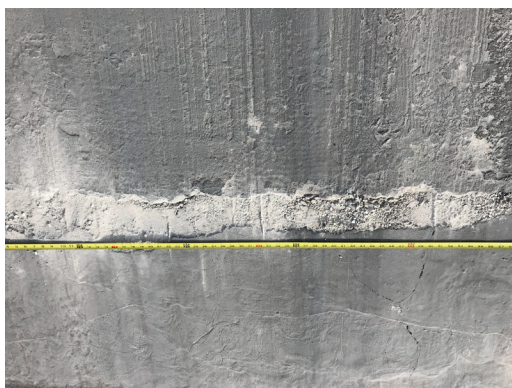
(e) Spalling in Quadrant #3 at 784 passes

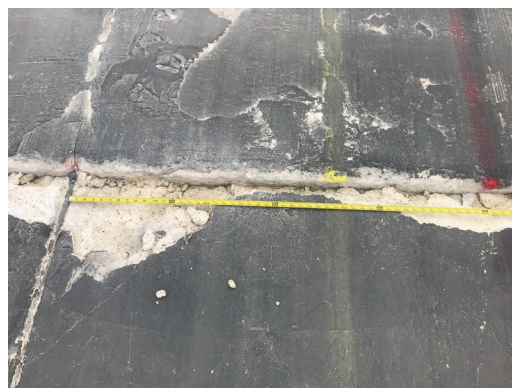
(f) Spalling in Quadrant #3 at 896 passes
