**SIGAR 20-21 Inspection Report**

## Kajaki Dam Irrigation Tunnel: The \$27.3 Million Tunnel Is Not Operating Properly Due to Construction Deficiencies and a Maintenance Issue

**JANUARY  
2020**

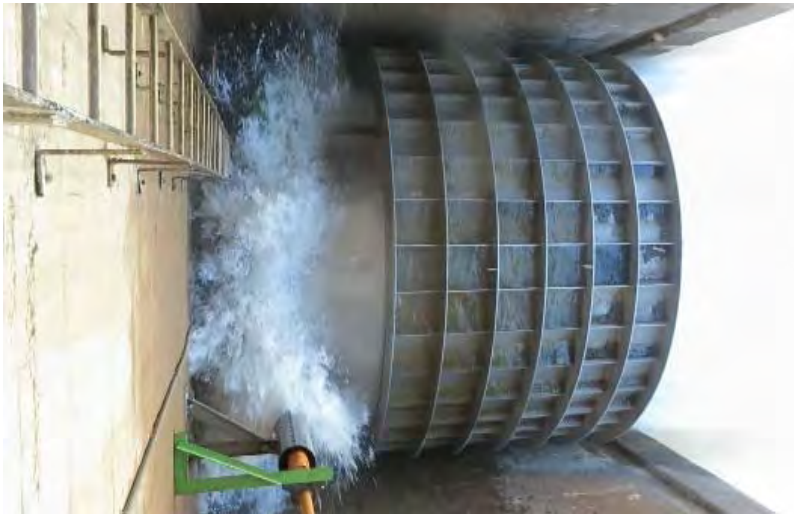
expected the holes to infuse air into the water discharged from the concentration hood to help reduce the force on the valves and compensate for the missing aeration tube assemblies and the vibration in the valve bodies. METAG modified the concentration hood on valve 1, which caused a high volume of water under high pressure to escape from the holes. This formed a backwards jet, known as backsplash, toward the valve and the mechanism controlling the valve (see photo 1).<sup>7</sup> As a result, all of the elements inside the concrete vault supporting the valve's functions were constantly impacted by an unexpected and large amount of backsplash from the aeration holes travelling at high velocity (820 gallons per second traveling at 33 miles per hour).<sup>8</sup>

**Photo 1 - New Cone Valve with Excessive Backsplash**

Because the contract performance specifications required all cone valves to be functional from 0 to the 100 percent open position without backsplash and vibration, METAG still did not have a workable solution. In March 2017, USACE approved another METAG proposal to install a fixed hood over each cone valve to manage the water flowing backward from the aeration holes. However, this solution also proved ineffective, and USACE issued METAG a stop-work notice in April 2018. USACE suspended all construction work related to the cone valves due to the continued deterioration in their performance and the

During our site visit, we observed that the backsplash increased as the valve opening percentage rose. Excessive backsplash not only forces the water backwards, it also floods the chamber, preventing access to the valve during an emergency. In addition, the constant flow of high-pressure backsplash exposed the cone valves, hoods, and other equipment to ongoing, unplanned, and severe vibration. This vibration on the valve body could cause the concrete pedestals supporting the valves or the valves themselves to crack. Further, in low temperatures, backsplash will cause ice to form, which could further degrade the cone valve's functionality.

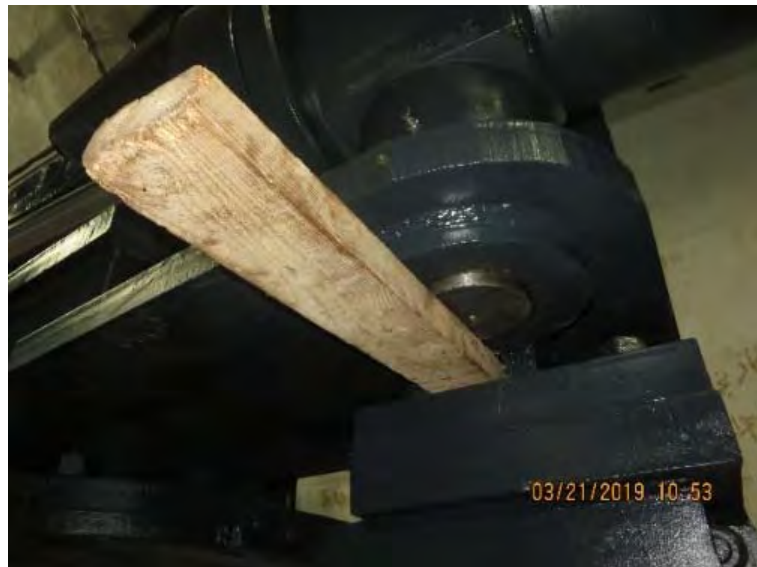
During our March 2019 site visit, we found that the Kajaki Dam's irrigation tunnel was operating and adequately diverting water for irrigation. However, we found one maintenance issue that affects the proper operation of the tunnel. Specifically, we determined that the pins on the three emergency closure valves that connect the hinge on the valve body to the lifting cylinder were not properly fastened and unable to stay in the intended position, either open or closed. As a temporary solution, MEW maintenance staff were using a board to support the pins (see photo 2). According to the machine operator, METAG installed the pins correctly, but the pins loosened overtime; MEW staff could not explain how this happened. If an emergency occurs that requires operating the valves, they will not work because the pins are not in place.

**Photo 2 - Lumber Supporting the Emergency Closure Valve Pins**

To correct this maintenance issue, an engineer with the company that manufactured the hydraulic system would need to evaluate the system and determine why the pins failed. Based on our discussions with MEW maintenance staff at the dam, we found that they do not have the level of technical training and experience required to inspect, understand, evaluate, diagnose, and make the needed repairs. In addition, the diagnostic instruments and specialized tools needed for the job and the replacement parts are not manufactured or readily available in Afghanistan.
