SIGAR 19-55 Inspection Report

**Afghanistan's Ghulam Khan Road Project:
Construction of the Road and Bridge Generally
Met Contract Requirements, but Deficiencies
Have Created Safety Hazards for Users**

**AUGUST
2019**

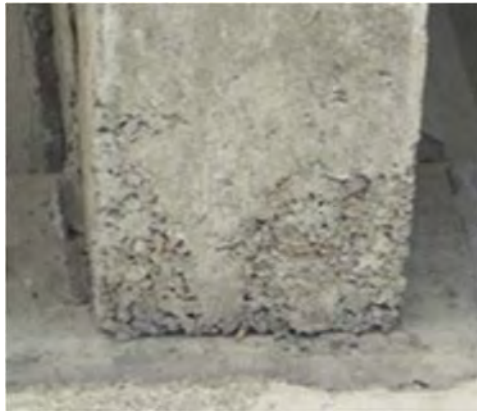
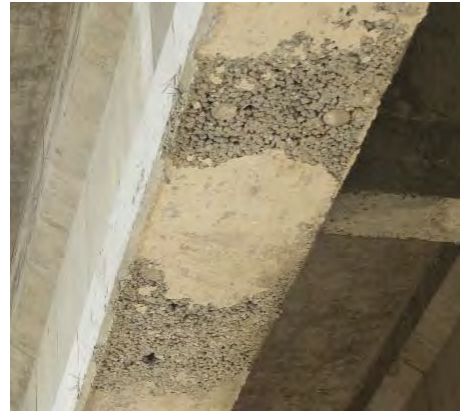
During our July and November 2018 site visits, we found that the bridge's support beams contain honeycombing as a result of BDCI's poor workmanship (see photos 1 and 2).³ The bridge is supported by five concrete columns. The bases of these columns are submerged below ground and extend vertically to the bridge's road surface. The support beams, which consist of concrete and steel reinforcing rods, extend the length of the bridge and sit on top of the columns. The columns and beams provide structural integrity to the rest of the bridge.

The contract required BDCI to ensure that all of the bridge's concrete work was free of defects. If any faulty work existed, for example honeycombed concrete, BDCI was to repair the concrete to ensure that it had a smooth finish that matched the surrounding concrete. Honeycombed concrete is porous; if it is not repaired, moisture will enter the concrete and cause the reinforcing steel rods to rust and the concrete to disintegrate. This situation could cause the concrete beams to fail, which would affect the bridge's structural integrity and could cause it to collapse.

Photo 1 - Bridge Support Beam with Honeycombed Concrete

Photo 2 - Bridge Support Beam with Honeycombed Concrete

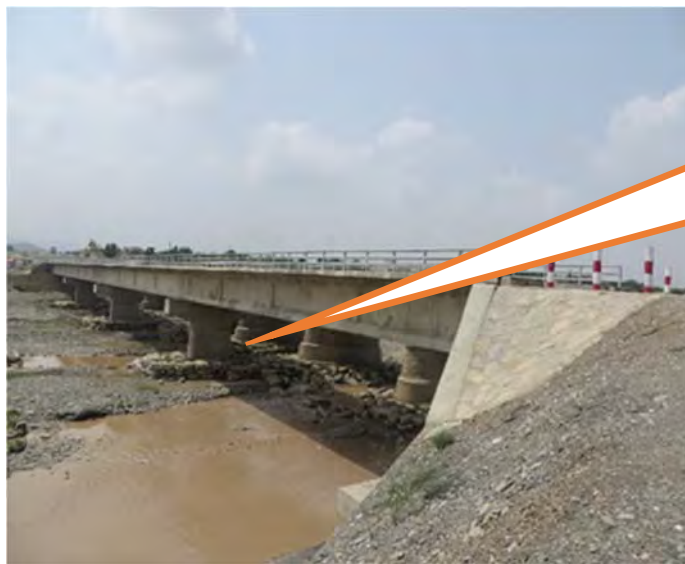
The contract required BDCI to build a 4.1-foot-tall stone filling around each of the bridge's foundations. This stone filling helps prevent soil erosion around the column foundations, which stabilize the bridge. However, during our July and November 2018 site visits, we found that BDCI only loosely stacked the stones and to about 3 feet high (see photo 3). As a result, some of the stones have washed away from the column foundations and the soil has eroded. In particular, we found that soil erosion around the east end of the bridge has placed abnormal pressure on the abutment foundation, which could affect the bridge's stability (see photo 4).⁴

Photo 3 - Stones Stacked Around Bridge Foundations

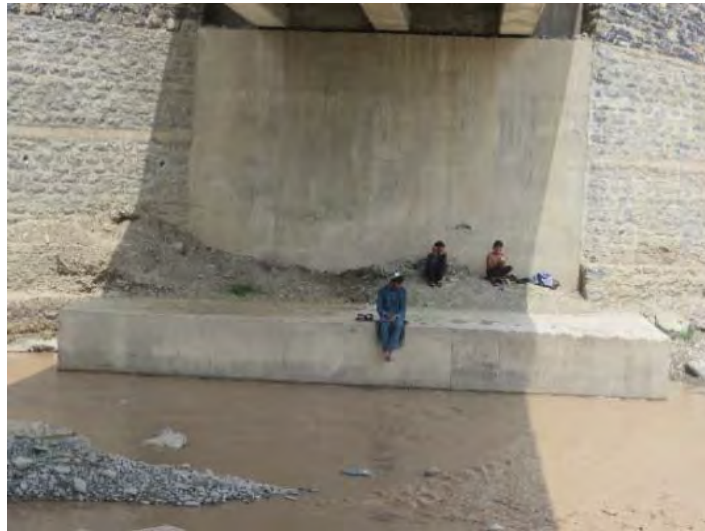
Photo 4 - Bridge Abutment with Exposed Foundation Due to Soil Erosion

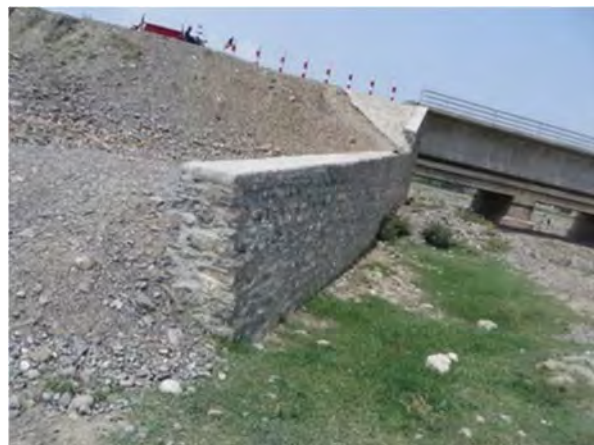
The contract required BDCI to construct retaining walls at each end of the Ghulam Khan bridge. The walls were to be 13.1 feet tall on the ends closest to the bridge and decrease to 6.6 feet on the ends farthest from the bridge. During our July 2018 site visits, we found that BDCI constructed the four retaining walls and that the walls were the required 13.1 feet on the ends closest to the bridge. However, BDCI constructed the farthest ends of the walls to about 5.1 feet tall, about 1.6 feet lower than required (see photo 5). Retaining walls are designed to hold back any material, usually earth, and prevent that material from sliding or eroding. Because the end of the bridge's retaining walls are shorter than required, the bridge's foundations could be exposed to erosion, which would weaken the bridge's stability.

Photo 5 - 5.1 Feet Bridge Retaining Wall

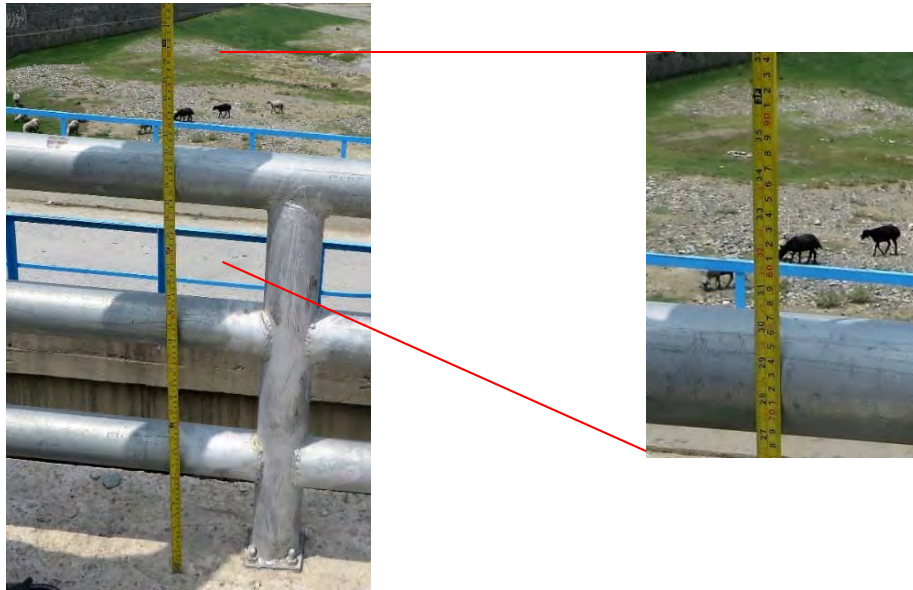
During our July 2018 site visits, we found that BDCI constructed the bridge's pedestrian and cyclist railings, which are bolted on the sidewalk's concrete surface, about 30 inches tall (see photo 6). However, the contract required BDCI to follow the American Association of State Highway and Transportation Officials' standards for bridge design. The standards require pedestrian railings along bridges to be at least 42 inches tall and bicycle railings to be at least 54 inches tall. Although BDCI built the sidewalks on each side of the bridge to accommodate pedestrians and cyclists as required, the low railings create a safety hazard by increasing the risks that they might fall from the bridge.

Photo 6 - 30-Inch High Bridge Railing

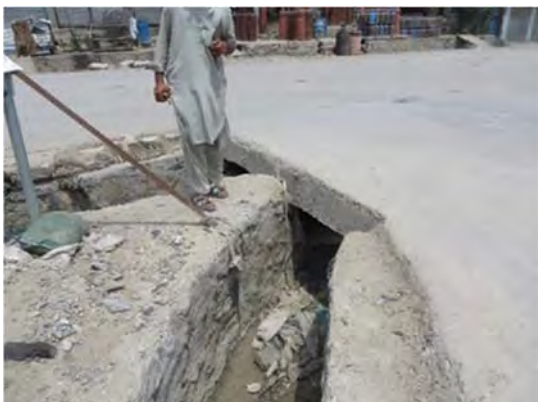
The contract required BDCI to construct 21 culverts under the roadway. Each culverts was to have 2.3-foot-high protective walls known as parapets, which are designed to ensure that vehicles and pedestrians do not fall into the culverts, thereby enhancing safety.⁵ However, during our July 2018 site visits, we found that BDCI did not construct protective walls around two road culverts: culvert 1 and culvert 16 (see photos 7 and 8, respectively). Without these walls, vehicles and pedestrians are more at risk of falling into the culverts, which could damage vehicles and injure drivers and pedestrians.

Photo 7 - Culvert 1 Missing Required Protective Walls

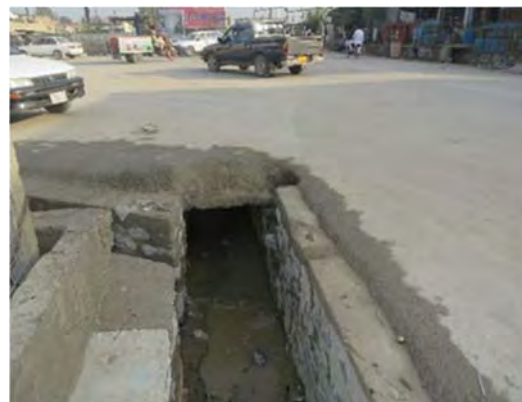
Photo 8 - Culvert 16 Missing Required Protective Walls
