SIGAR 19-16 Inspection Report

Marshal Fahim National Defense University: Phase III Construction Generally Met Contract Requirements, but Five Deficiencies and Inadequate Maintenance Increase Safety Risks for Building Occupants

JANUARY
2019

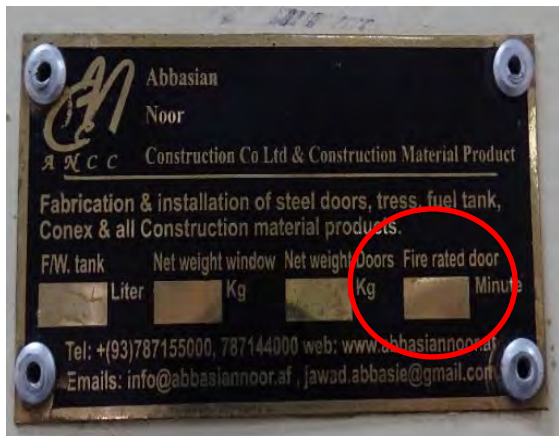
USACE approved State Corps to install 662 fire doors manufactured by either Artella Ahsap Kapi Sistemleri, a Turkish firm, or Abbasian Noor Construction Company, an Afghan firm.⁸ In addition, USACE approved Assist Consultants to install 748 fire doors manufactured by Abbasian Noor Construction Company. However, we determined that neither Artella Ahsap Kapi Sistemleri nor Abbasian Noor Construction Company was certified by one of three certification agencies to manufacture fire doors. Further, during our site visits, we randomly selected and examined 10 doors from each of the 21 buildings—8 buildings that State Corps constructed and 13 that Assist Consultants constructed—requiring fire doors, and found that none of the doors complied with the IBC or NFPA standards.⁹ Specifically, we found that the door labels (1) did not provide fire rating information or display the name and trademark logo of a certifying agency, or (2) were painted over and could not be read (see photos 1, 2, and 3). We also found that none of the doors had the required threshold (see photo 4).

Photo 1 - Door Label with No Fire Rating or Name and Logo of a Certifying Agency

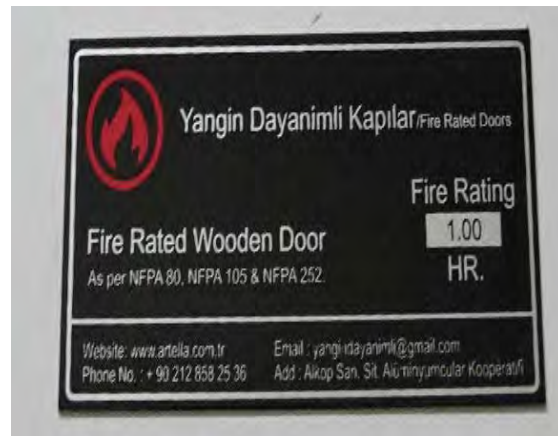
Photo 2 - Door Label with No Name and Logo of a Certifying Agency

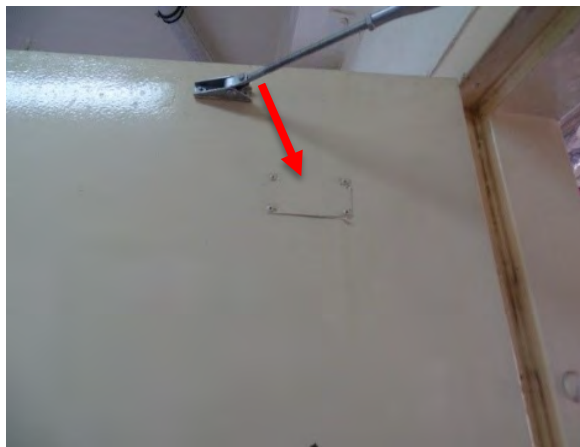
Photo 3 - Door with Label Painted Over

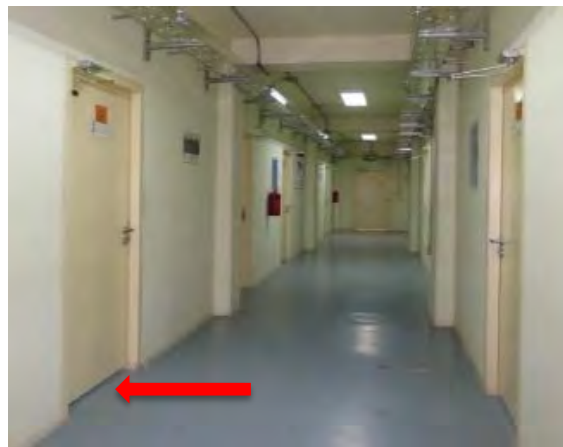
Both MFNDU phase III construction contracts required State Corps and Assist Consultants to install certified fire doors in all 21 buildings in accordance with the International Building Code (IBC) and National Fire Protection Agency (NFPA) standards. The IBC requires fire door manufacturers to have their products tested and certified to meet NFPA standards by one of three independent testing and certification agencies: Underwriters Laboratories, Factory Mutual Engineering and Research, or Warnock Hersey International. The IBC also requires the fire door manufacturer to affix a permanent label to the door at the factory showing the manufacturer's name, the door's fire protection rating in minutes, and the certifying agency's name or trademark logo.⁶ Further, the IBC and NFPA require a threshold with each fire door assembly.⁷

Photo 4 - Door without Threshold

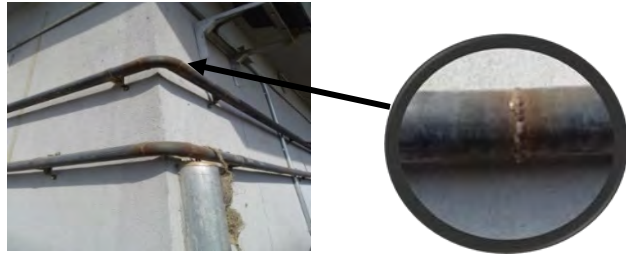
Assist Consultants' contract required the company to install 50-millimeter propane supply gas pipes in the DFAC. The NFPA requires pipes measuring 50 millimeters or less to be connected with threaded fittings.¹⁴ During our site visits, we found that Assist Consultants installed 50-millimeter propane supply gas pipes as required, but it welded the pipes together instead of using threaded fittings as required (see photo 5). In August 2018, USACE said its gas pipe installation met NFPA 58 requirements and was not a safety issue. However, we responded that the welded fittings do not comply with NFPA, which requires threaded fittings for pipes measuring 50 millimeters or less. These welded connections create a safety risk for personnel in the DFAC because the welded connections are more likely to form pores, or pinhole gaps, that result in gas leaks, which could cause an explosion and fire.

Photo 5 - Welded Propane Gas Supply Pipe Outside the DFAC Kitchen

USACE stated that it agreed that the contract required DFAC propane supply pipes 50 millimeters or smaller to be threaded, but that the pipes installed were welded instead. USACE stated that although the contractor did not meet contract requirements, it did meet another NFPA code requirement for pressure testing of pipes. USACE added the propane system met this code because it was pressure-tested, no leaks were detected, and it does not pose any safety hazards. However, USACE did not provide any documentation of pressure testing during our inspection and in its comments. As a result, we maintain that these noncompliant pipes do pose a safety hazard.

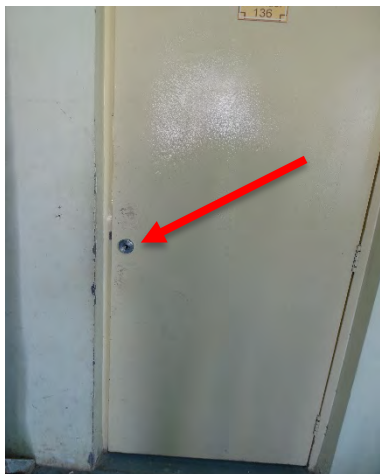
During our site visits, we found broken or missing interior door lock assemblies (see photo 6), empty fire extinguishers (see photo 7), and nonoperational smoke detectors in all of the phase III buildings. Not maintaining these items exposes building occupants to increased safety risks in the event of a fire. We also found that all of the phase III buildings contained counterfeit fire extinguishers. We inspected 190 of the 306 required fire extinguishers in all of the 21 phase III buildings and found that each was counterfeit. For example, all of the fire extinguishers had Buckeye Equipment Company labels displaying duplicate serial numbers (see photo 8). Genuine Buckeye fire extinguishers have a unique serial number on their labels. We could not determine whether State Corps and Assist Consultants installed the counterfeit fire extinguishers during construction, resulting in a construction deficiency, or whether someone replaced them after CSTC-A transferred phase III to the MOD. Either way, the counterfeit fire extinguishers expose building occupants to increased safety risks because they may not work properly in the event of a fire. As mentioned earlier, in April 2017, USACE issued a bulletin to multiple recipients, including CSTC-A, expressing concern about the number of counterfeit fire extinguishers installed in Afghanistan since 2012.¹⁷

Photo 6 - Missing Door Lock

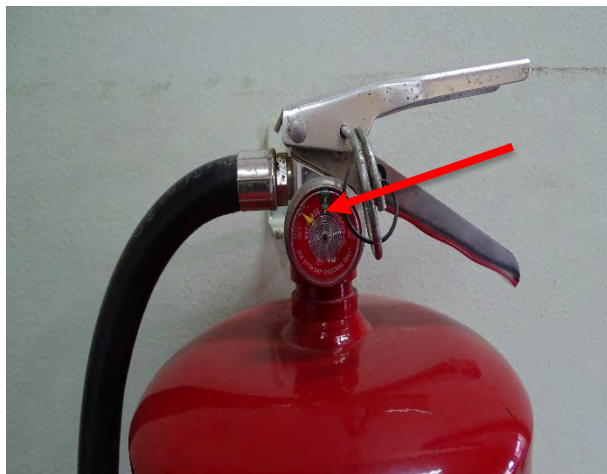
Photo 7 - Empty Fire Extinguisher

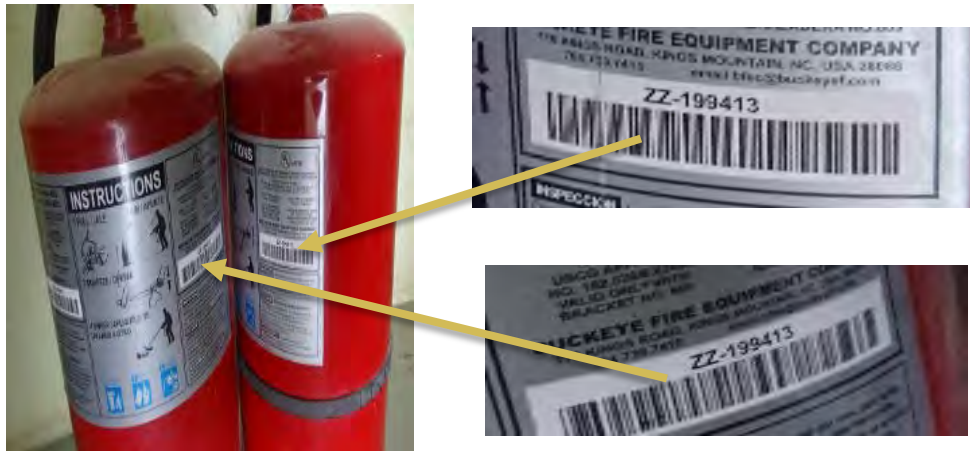
Photo 8 - Fire Extinguishers with Identical Serial Numbers
