# SIGAR

**SIGAR 15-25 Inspection Report**

## ANA Camp Commando Phase II: Power Plant and Fuel Point Not Fully Operational Nearly Two Years after Project Completion

JANUARY  
2015

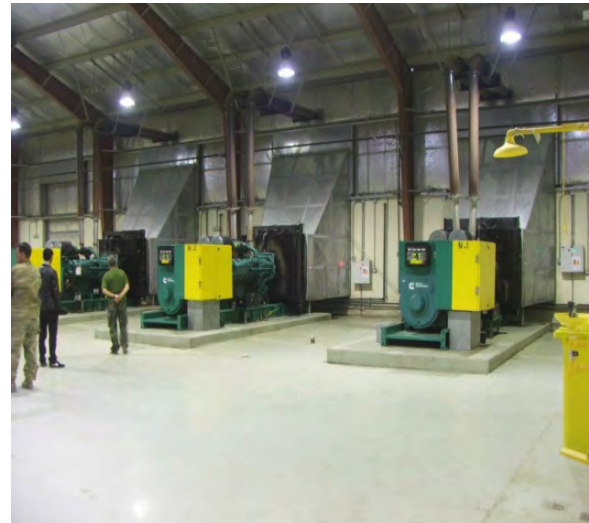
In its final payment certificate, dated February 18, 2013, USACE's contracting officer's representative stated that all contract requirements had been satisfactorily met. However, during our two site visits in 2014, we discovered that deficiencies existed. For example, the power plant's master control panel and switchgear were not functioning as required for parallel operation of the generators. Among the problems was the software for synchronizing the generators, which was not working properly. As a result, only one of the four primary generators could operate at a time.

Further, changing power from one generator to another could not be completed without interruption. Also, since the power changeover could not be done electronically, as required, it had to be completed manually.

In comments on a draft of our report, USACE stated that an improper and unauthorized connection to a transformer damaged equipment in the power plant and caused the problems with the electrical system that we observed during our inspection. Specifically, ANA personnel made an improper connection to a transformer on or around July 6, 2012, resulting in damage to two transformers, several sections of medium voltage cables, and the main power distribution panel for the plant. USACE noted that the damage caused by the ANA occurred after USACE and the power plant's operation and maintenance (O&M) contractor performed a warranty inspection and found the power plant constructed by the Phase II contractor fully operable. USACE determined that the damage to the electrical system was beyond the control, responsibility, or liability of the Phase II contractor. The O&M contractor was able to repair the transformers and cables, but not the main distribution panel.

**Photo 1 - Power Plant with Generators**

We found that the power plant's generators did not run in parallel as intended, and only one generator could run at a time, rather than four. This meant that Camp Commando only had 25 percent of the intended power availability that it should have at any given time to accommodate peak demands or other contingencies. In addition, because the generators did not run in parallel, the camp's power supply had to be interrupted to allow manual change-over from one operating generator to another for maintenance, or during emergencies. To compensate for the power shortage, Camp Commando used "spot" generators to provide power to key areas, including garrison perimeter security systems, the Special Forces compound, and some areas within the School of Excellence.<sup>13</sup> U.S. mentors stated that the camp had 19 spot generators, but that some of them were not functioning because they needed repair.

In October 2014, USACE officials provided us with documentation showing that it paid a new contractor about \$2.1 million in Phase III to complete work on or make repairs to the camp's power system. The officials noted that the initial contract to repair the power plant's electrical system was awarded for approximately \$1.9 million. This was followed by two modifications to address additional problems with the power system, including the need to replace the original master control panel, repair the generators, and synchronize the generators to allow for parallel operation so that the power plant could operate up to four generators simultaneously. These additional issues had a combined price of about \$243,000. The modifications also called for the purchase of some new equipment, such as the purchase and installation of a sixth generator. According to Combined Security Transition Command-Afghanistan (CSTC-A) officials, USACE confirmed that the repairs needed to allow for parallel operation of the generators were made in Phase III.
