ARL-TN-1107 • FEB 2022

Fracture Analysis of a Laminated Window Structure

by Jeffrey J Swab and Parimal J Patel

Jeffrey J Swab and Parimal J Patel
DEVCOM Army Research Laboratory

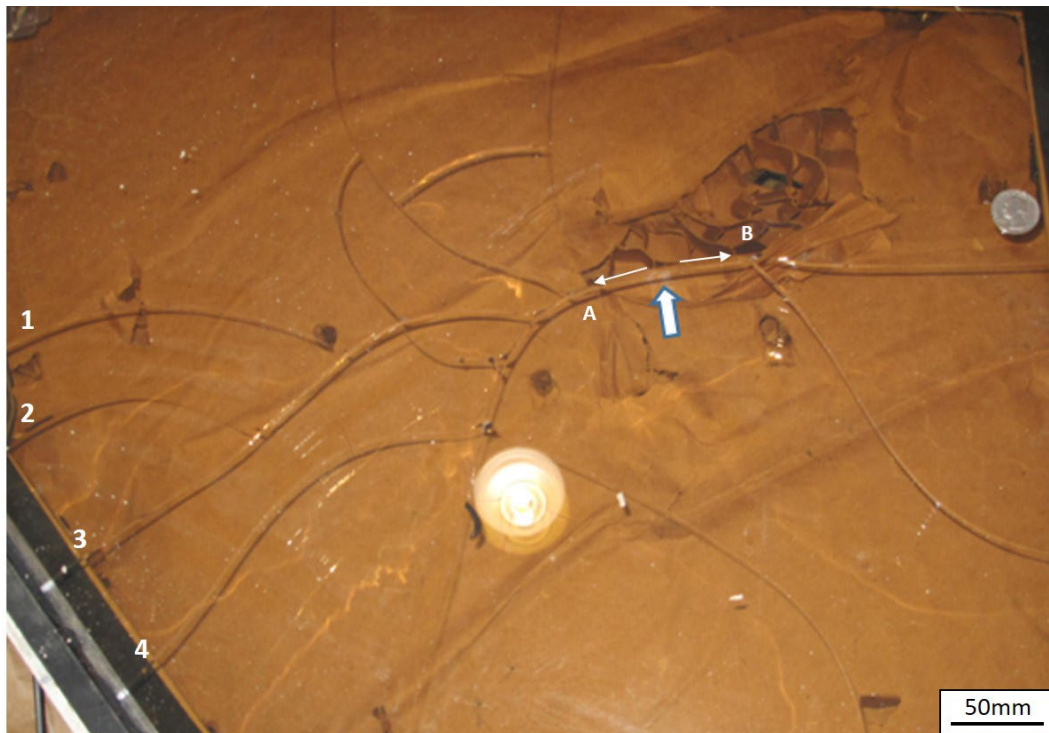
The examination included a visual examination of the crack branching pattern in the glass on an intact laminated window as well as a more detailed examination using a handheld magnifying glass. This window was large and heavy so normal fractographic tools, such optical and scanning electron microscopes, could not be used. The crack branching pattern observed in the visual examination showed that fracture initiated in the glass layer at the location highlighted by the large white arrow in Fig. 1. The crack propagated from this location approximately 50–60 mm in both directions (small white arrows in Fig. 1), and then crack branching began at points A and B. Once the branching began, the subsequent cracks tended to meander and curve, which is an indication of a thermally driven fracture process (thermal stresses from the diurnal weathering were driving the crack growth). What stresses are present or develop in the laminated structure and their potential role in the crack growth behavior is unknown. There appears to be some level of tensile stress near the edge of the laminated window as the cracks labeled 1–4 in Fig. 1 all stop curving at approximately the same distance from the window edge and then propagate straight to the edge.

Fig. 1 Overall crack pattern in the glass surface of the window. Fracture initiates at the location highlighted by the large white arrow and propagates in both directions from this point (small white arrows). Crack branching occurs at points A and B.

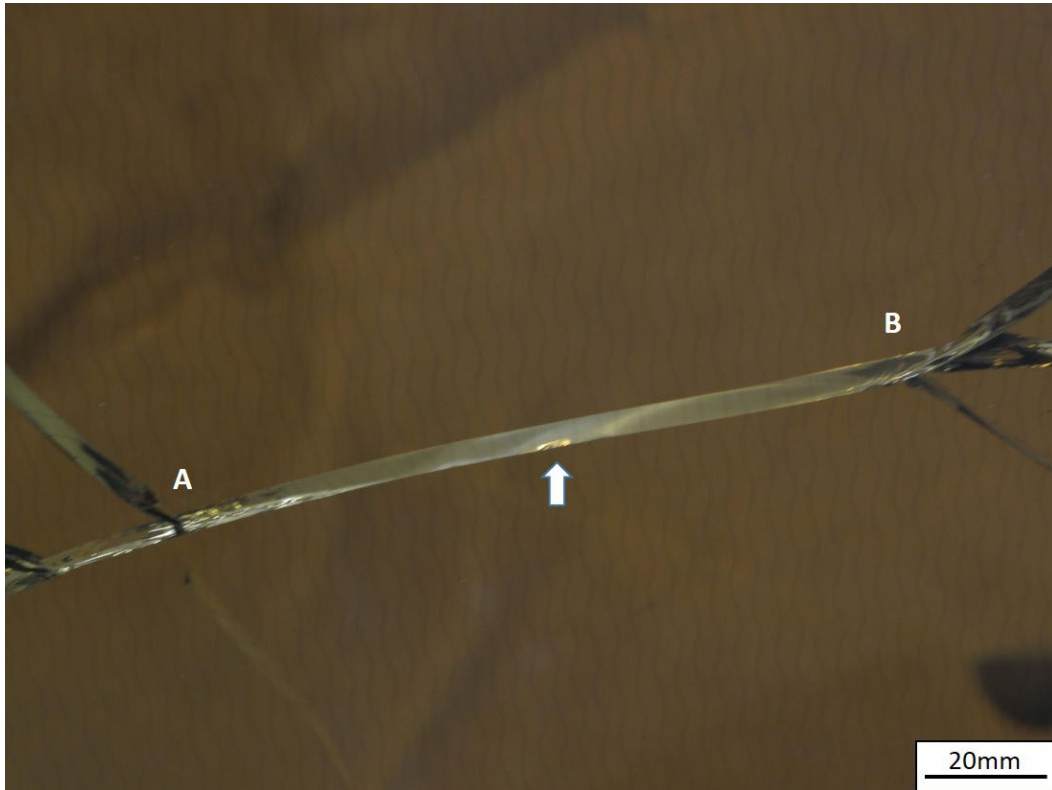
Further examination of the primary crack, shown in Fig. 1, with a handheld magnifying glass and lighting at different angles to the crack front revealed an anomalous feature (white arrow in Fig. 2) that appears to be where the fracture origin is located. There was no evidence on the glass surface anywhere in the vicinity of the primary crack indicating that an impact event occurred, corroborating the eyewitness reports. The flaw size inside this white feature is difficult to measure accurately since the glass layer and the window are both still intact, but it is estimated to be approximately 0.5 mm deep and 1 mm wide.

Fig. 2 Close-up of the likely fracture origin (white arrow) in the glass layer and the crack branching locations A and B

The equibiaxial flexure strength of a borosilicate float glass has been shown to be approximately 125 MPa for the air side and approximately 160 MPa for the tin side.⁴ These strength values are higher than any of the estimated values listed in Table 1 and are appreciably higher than the 23 MPa estimated for a 0.5-mm-deep flaw. However, the reported strength of both the air and tin side of borosilicate float glass drops significantly, to approximately 40 MPa, once a scratch has been introduced on the glass surface.⁵ This value is much more in line with many of the estimated strength values in Table 1.

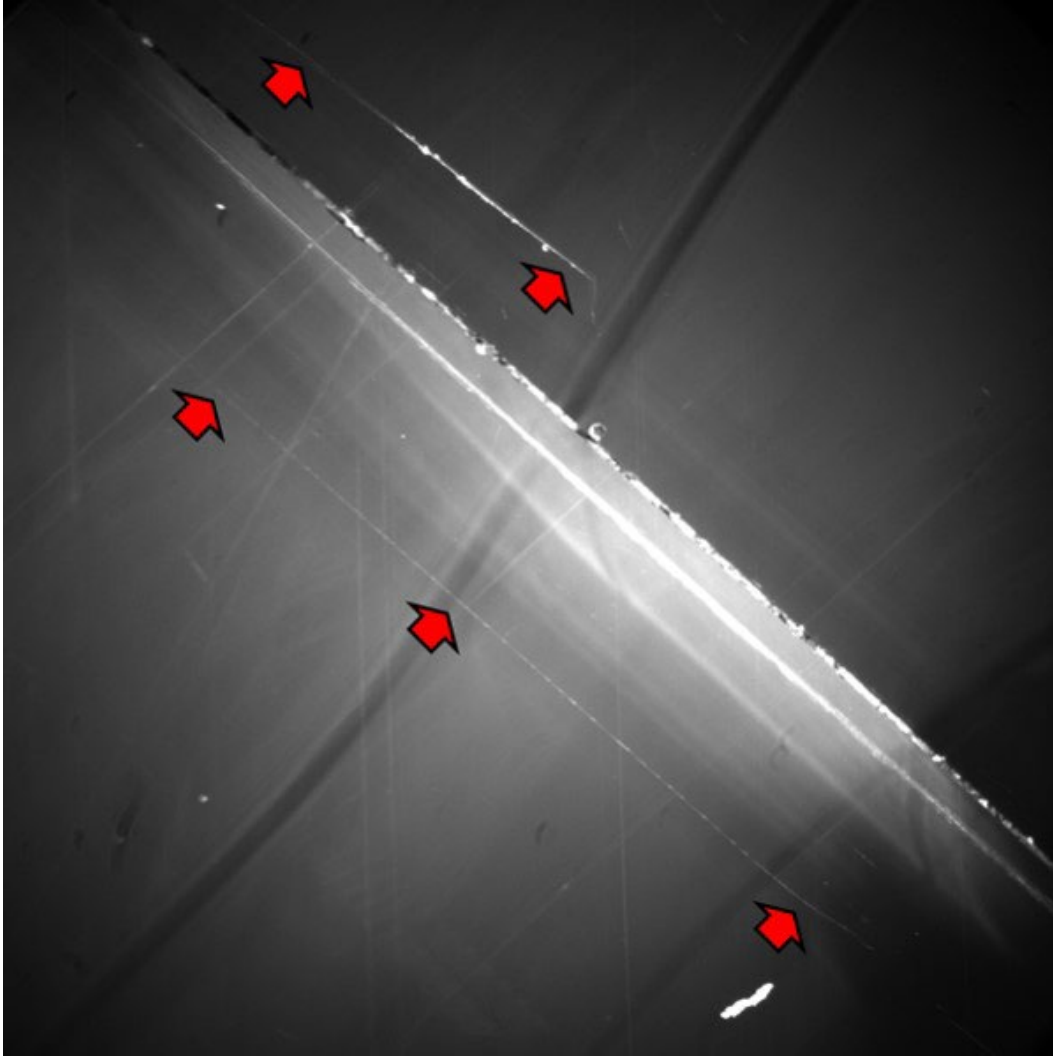
Further optical examination of the window shows that there are numerous scratches on the glass surface, red arrows in Fig. 3. Many of these scratches run parallel to each other in an arc across the window as well as being parallel to the path of the primary crack. It is possible that these scratches were created by the action of the wiper blades pulling/pushing grit, sand, or small rocks that got trapped under the blade, across the glass surface when they were in use. The hardness of float glass is very low ($\text{HK1} = 4.3 \text{ GPa}$)¹, thus it can be scratched or damaged easily by these items. The creation of scratches in glass can generate a significant amount of damage on the glass surface; this damage penetrates to varying depths beneath the surface.

Fig. 3 Red arrows highlight additional scratches observed on the glass surface
