BY THE COMPTROLLER GENERAL
**Report To The Honorable
G. William Whitehurst
U. S. House Of Representatives**
OF THE UNITED STATES

Navy Has Housing Problems At Virginia Beach And Scrap Metal Disposal Problems At Sewells Point

PSAD-80-73
SEPTEMBER 19, 1980

PHOTOGRAPHS OF SELECTED MAINTENANCE

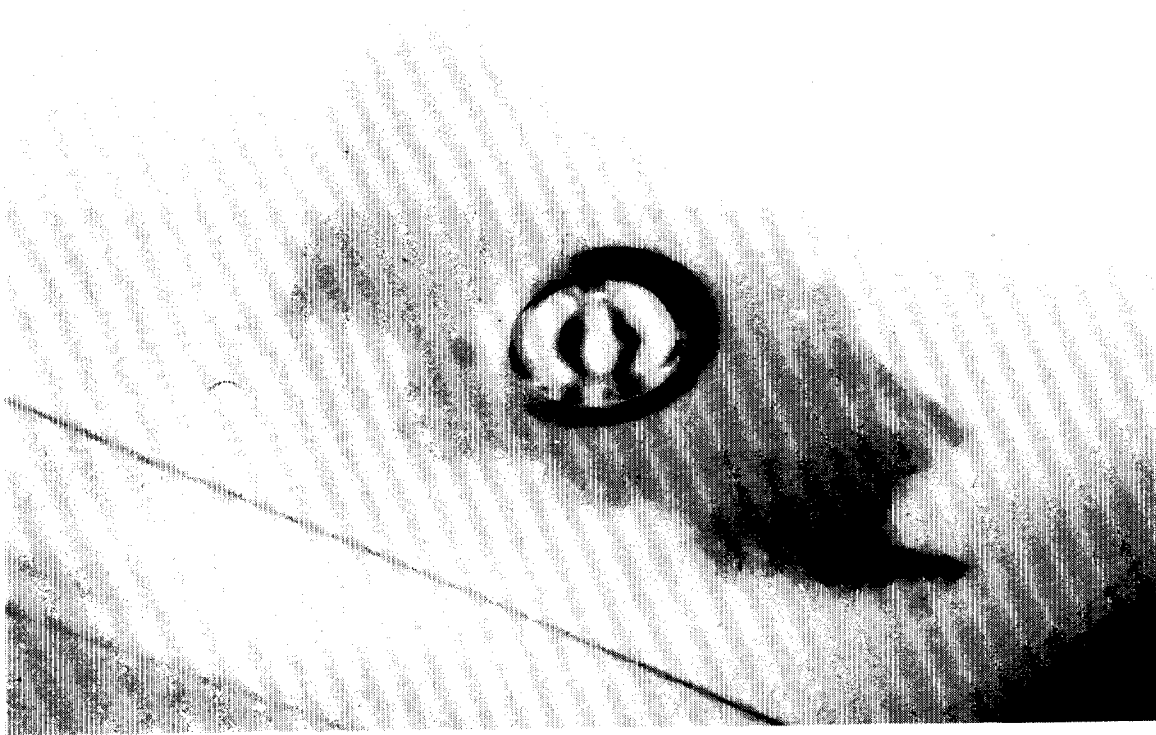
1135 GEORGIA

**CEILING DAMAGE AROUND LIGHT OVER KITCHEN SINK CAUSED BY WATER
LEAKING FROM LOOSE ESCUTCHEONS IN THE UPSTAIRS BATHROOM.**

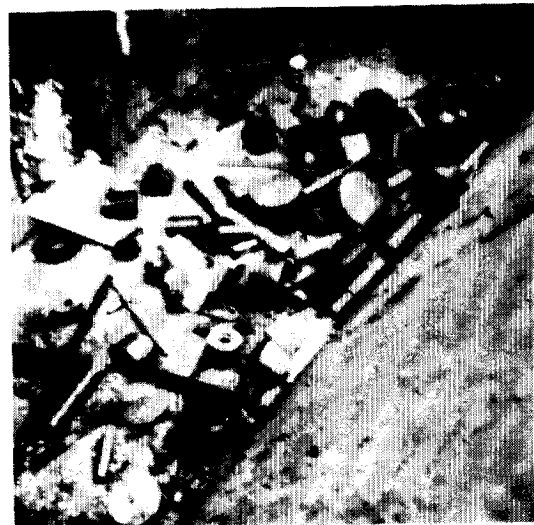
PIER 24, 12/13/79

HEAVY STEEL, HEAVY GEARS/SOC-
KETS OF VARIOUS SIZES, ESTIMATED
VALUE \$75 A TON
