**US Army Corps  
of Engineers®**  
Engineer Research and  
Development Center

## **José María Gil Adobe**

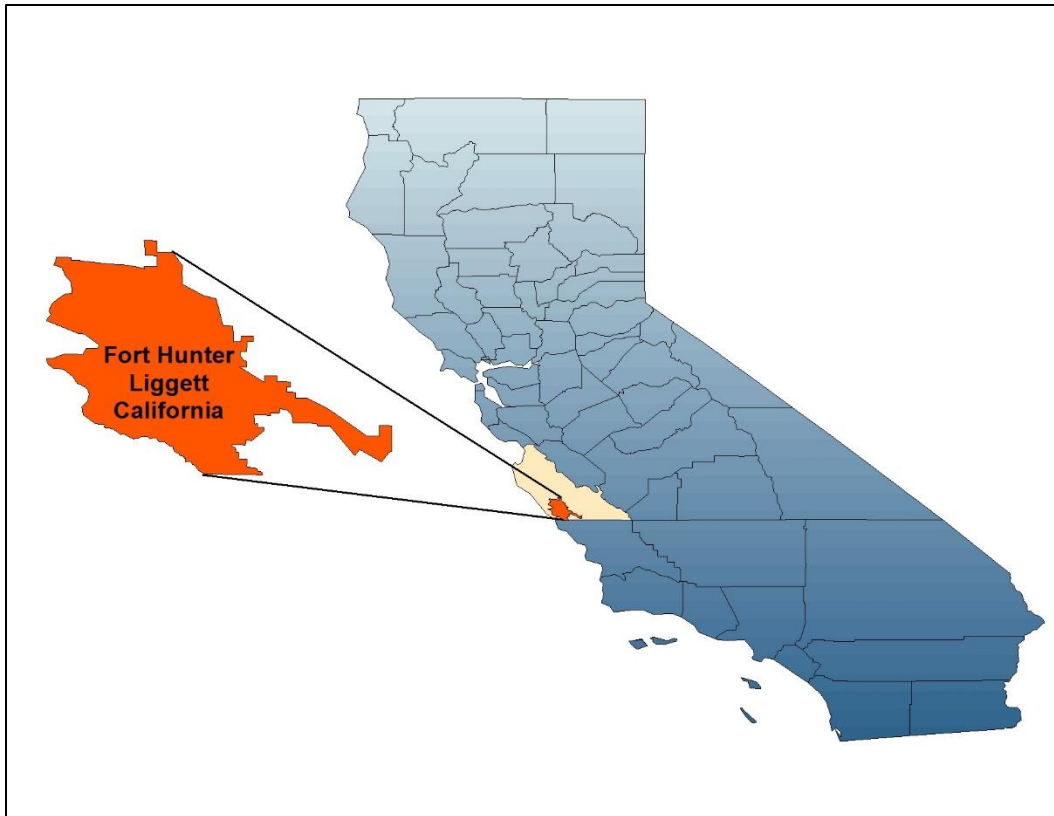
According to Stone et al., “All buildings, especially historic ones, require regular planned maintenance and repair. The most notable cause of historic building element failure and decay is not due to the historic building’s age but, rather, an incorrect or inappropriate repair and neglect of the historic building fabric.”<sup>5</sup> The José María Gil Adobe has had multiple owners throughout its existence, having been constructed circa 1860. The building was added to the NRHP in 1974 and since then has been left to decay. This report satisfies Section 110 of the NHPA of 1966 as amended and will help Fort Hunter Liggett manage this historic building

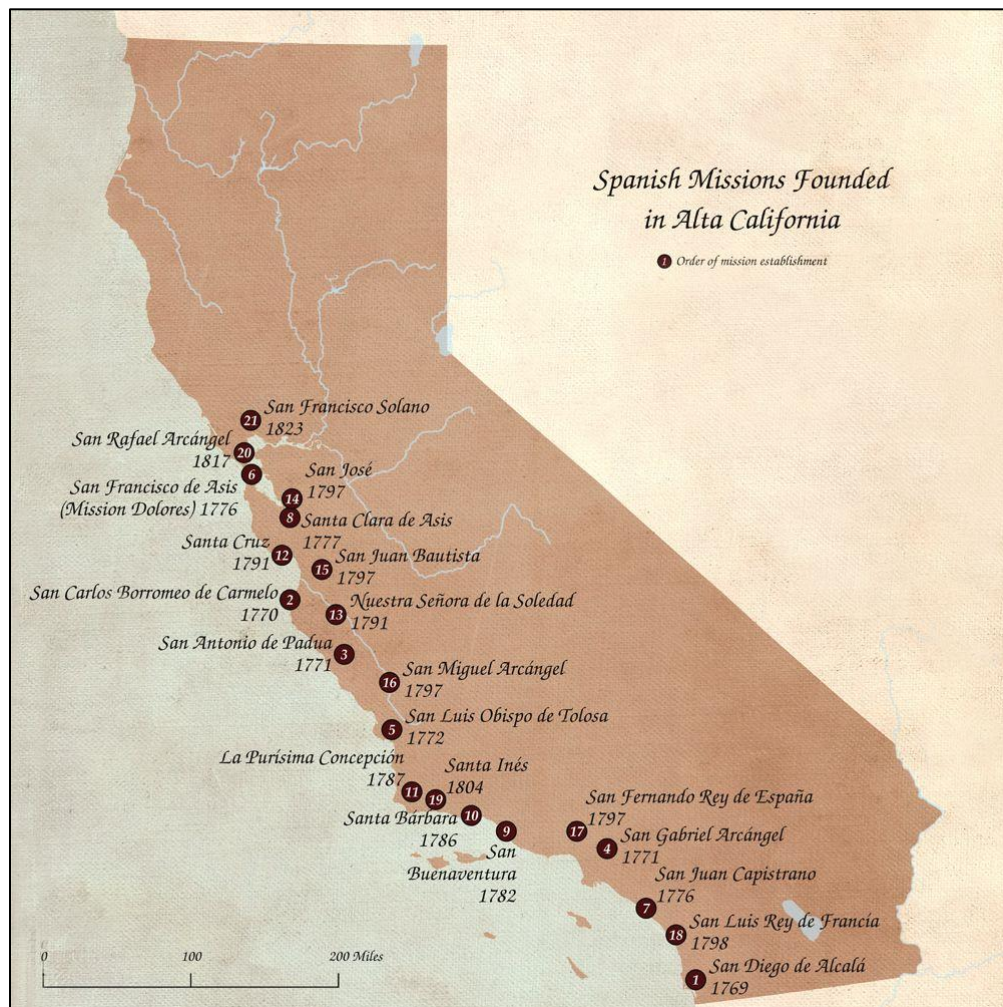
## 2.2 Adobe construction methods

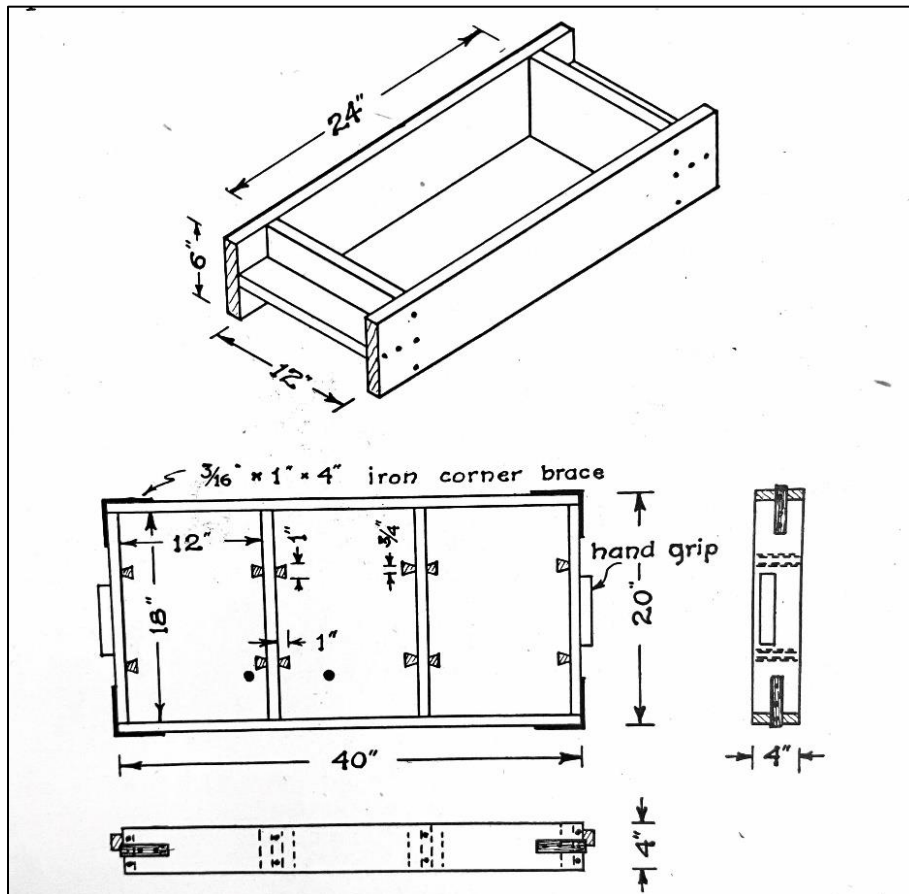
The *rammed earth method*, also known as the *Pise de Terre method*, is similar to the poured adobe method through the use of wooden forms, but the consistency of the earth mixture is where they differ. In this case, the earth material is moist enough to possess some solidity and should be able to be squeezed into a ball. However, it should be dry enough to crumble when dropped.<sup>21</sup> To ensure a smooth finish, the soil is pulverized for large stones or other debris that may cause issues once the mixture dried. The wooden forms are constructed based on the desired height and thickness of the proposed structure. The forms are constructed using small planks, some measuring 1 1/2 to 2 in. These planks are cleated together and are reinforced with long bolts and brackets to account for the immense internal pressure when the earth is being packed tightly into the form.

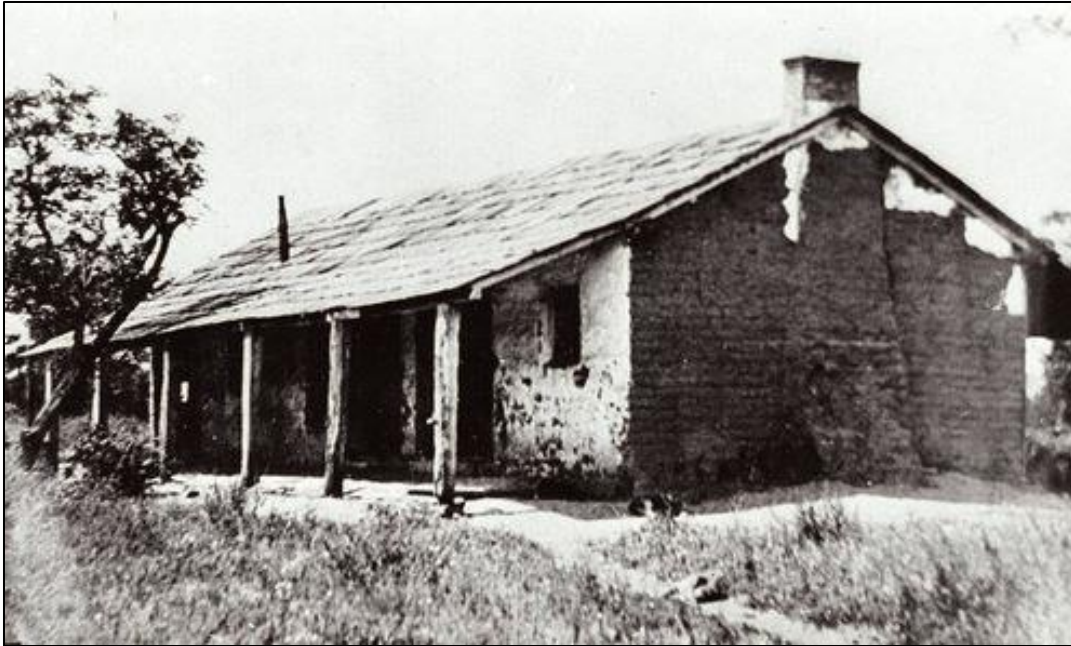
Figure 14. Pearson B. Reading Adobe, built c. 1850, showing adobe brick, chimney, wooden roof, and wooden veranda posts. (Image reproduced with permission from "Home of Major Reading," ca. 1850, Northeastern California Historical Photograph Collection. )

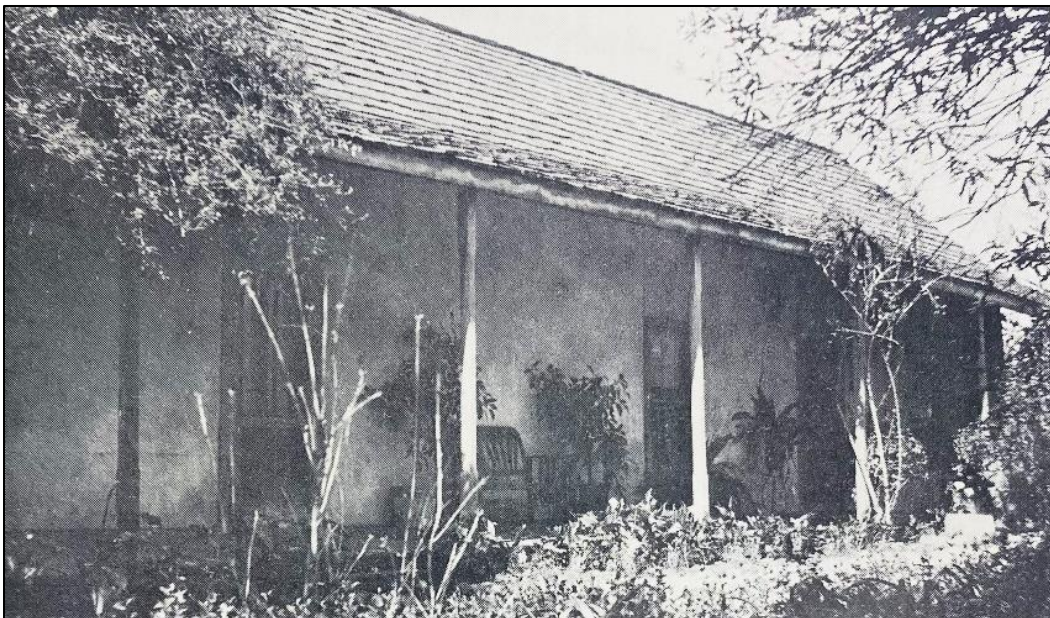
Figure 17. Roofing material crumbling at the corner of the Ignacio Palomares Adobe and plants growing into the wooden roof, no date. (Image reproduced from Giffen 1955, 84. Public domain.)

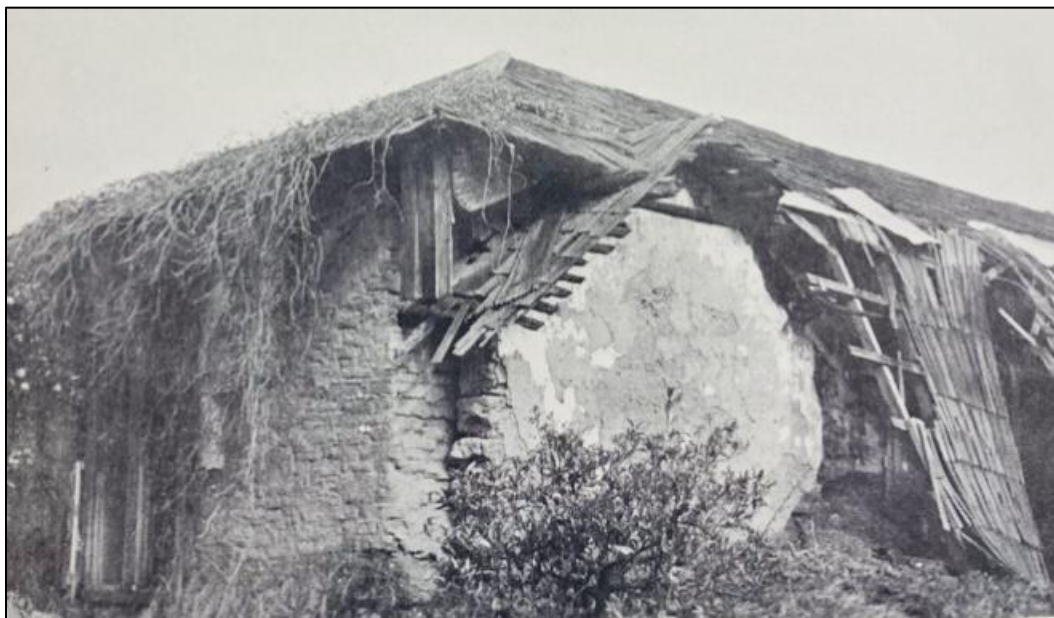
Plans for restoration began in 1934 when the Ignacio Palomares Adobe and its surrounding land were purchased by the city. The adobe structure was restored and became a public museum on life in the ranchos in 1940 (Figure 18). Based on the historic photographs, the building was in poor condition prior to restoration. During the adaptive reuse process, bricks

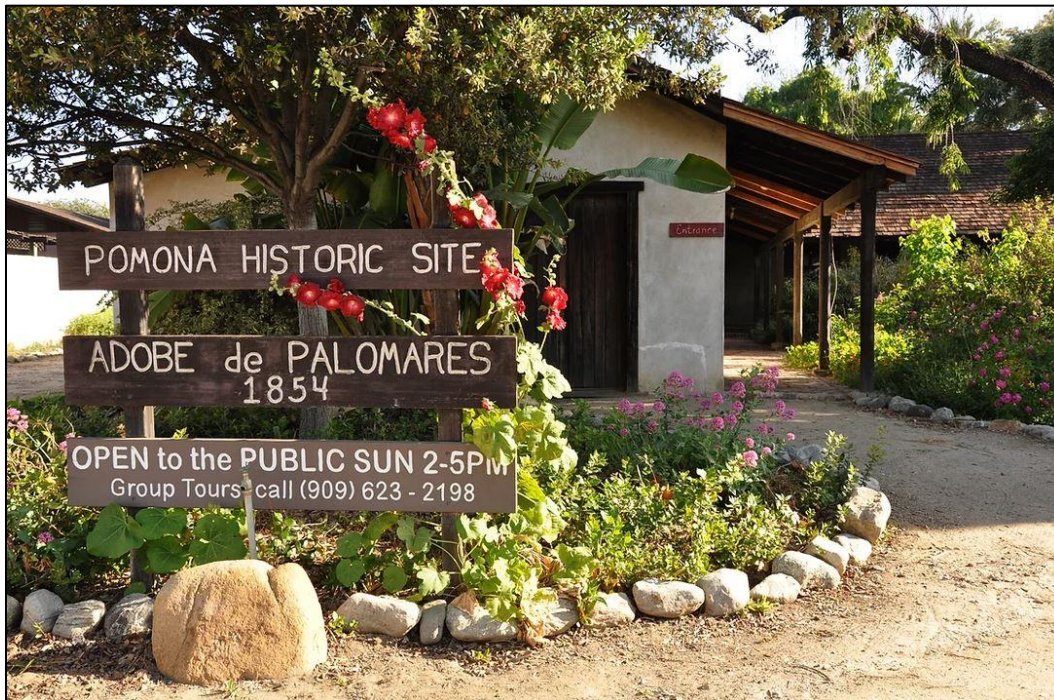
27. Giffen, *Casas & Courtyards*, 84–85.

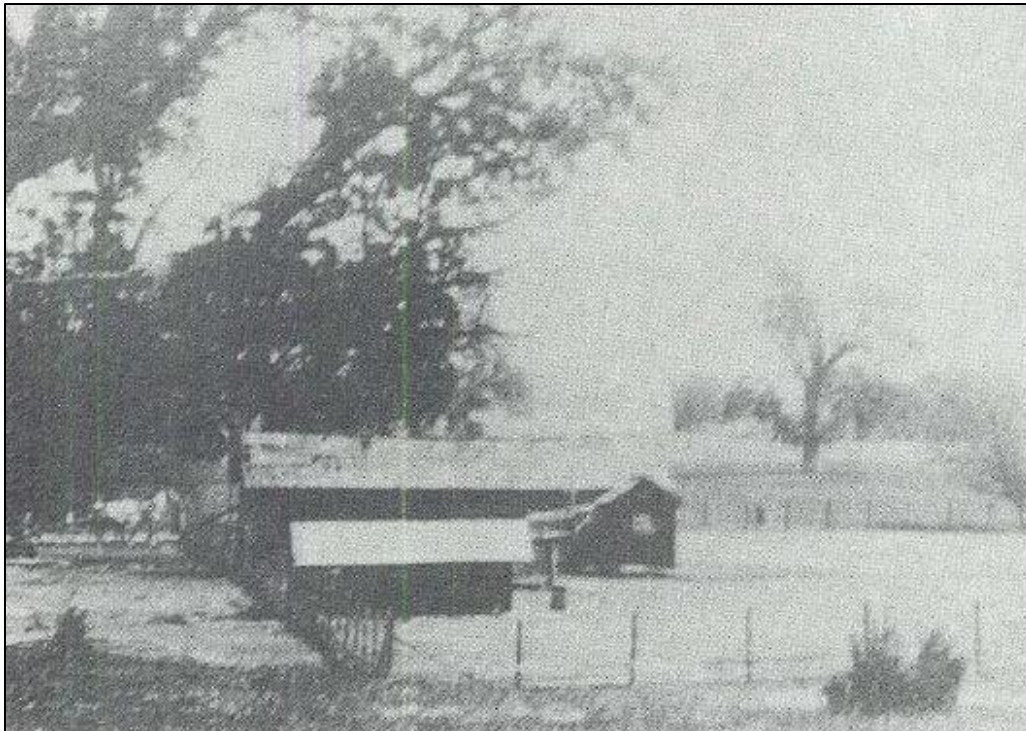
Figure 22. Outbuilding that once stood east of the José María Gil Adobe, unknown date (pre-1922). (Image reproduced with permission from San Antonio Mission Archives.)

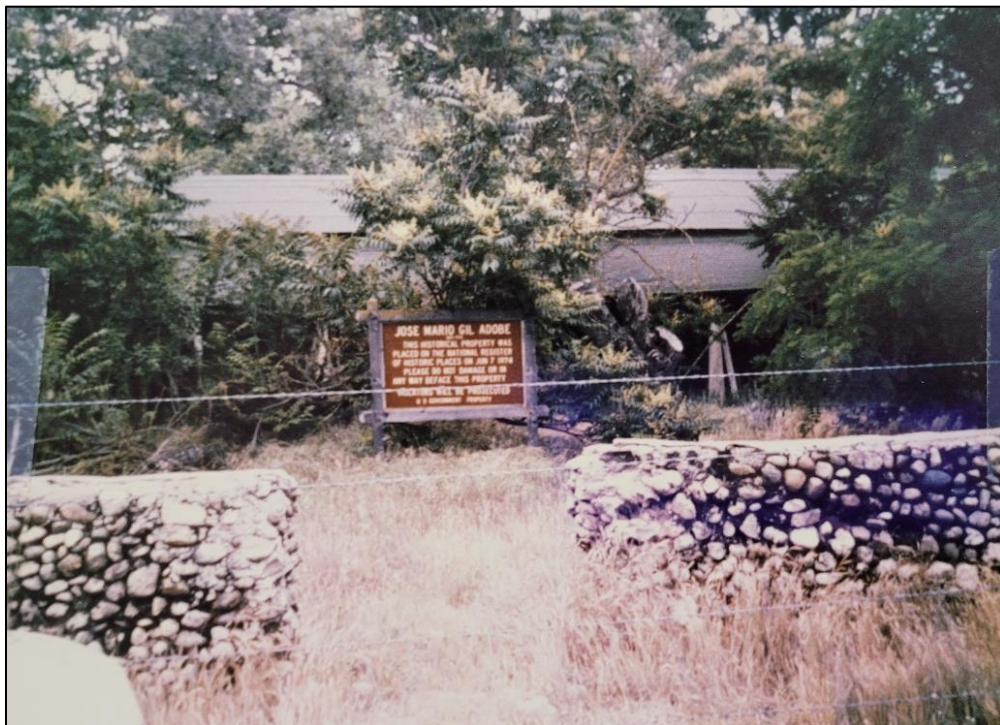
Figure 29. José María Gil Adobe in its present condition and how it was left in 1993, 2021.  
(ERDC-CERL.)

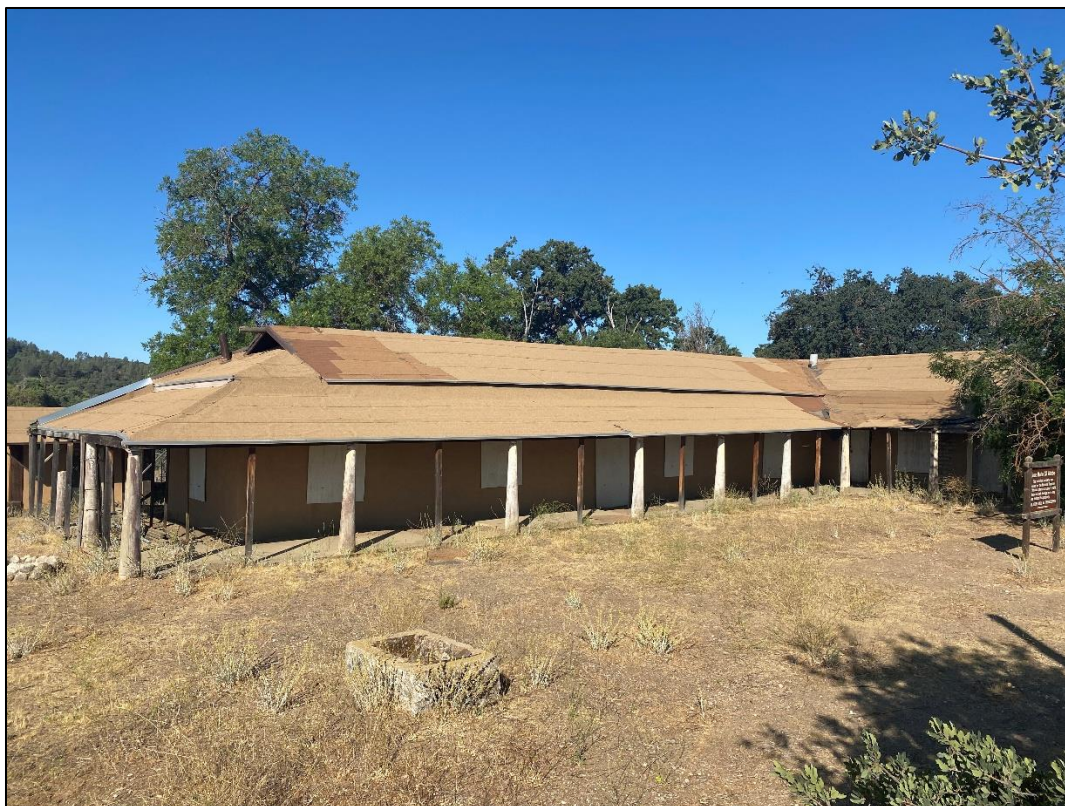
2.4 National Register of Historic Places Nomination<sup>49</sup>

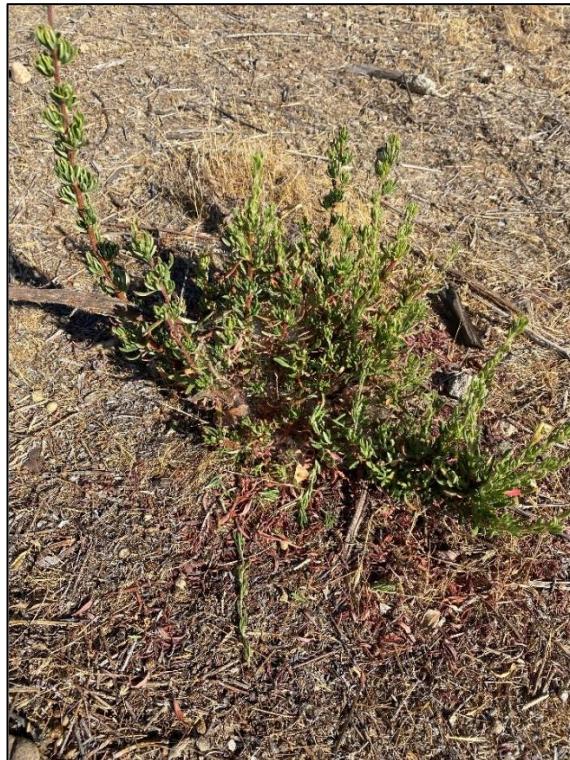
### 3.1.2 Outbuilding

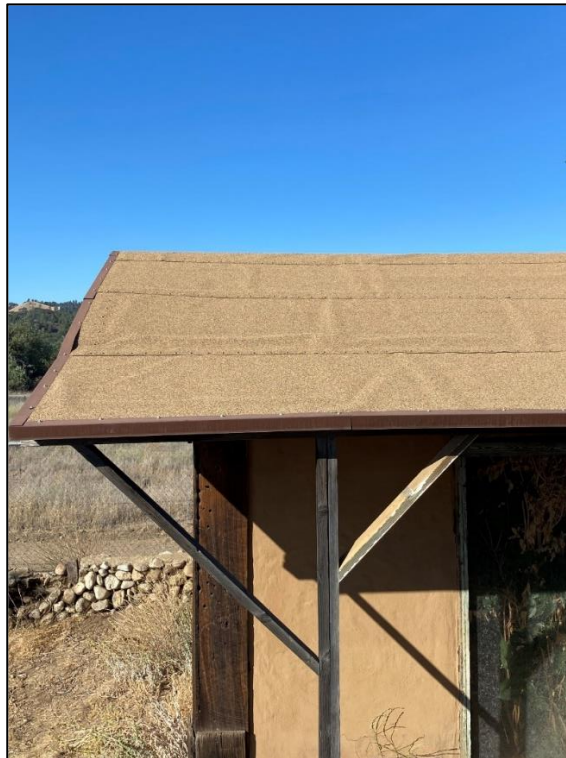
The rammed earth material seen in Figure 43 has been exposed due to a large crack on the southeast side of the cold storage building. The crack was most likely caused by a past earthquake and can be fully seen in Figure 48. The remainder of the rammed earth structure is coated in a plaster that was added during the same time period and of the same kind as the José María Gil Adobe (Figure 44).

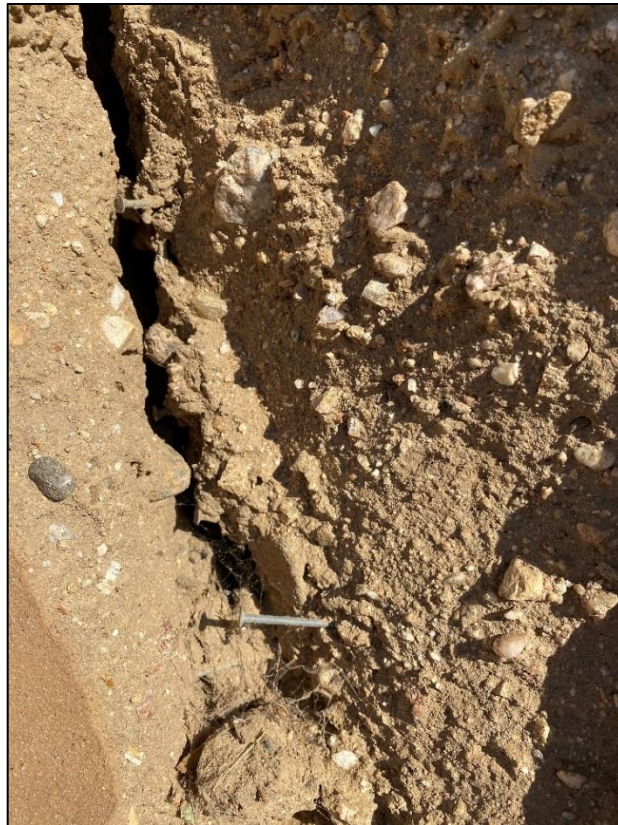
Figure 44. Plaster coating on the cold storage building, 2021. (ERDC-CERL.)

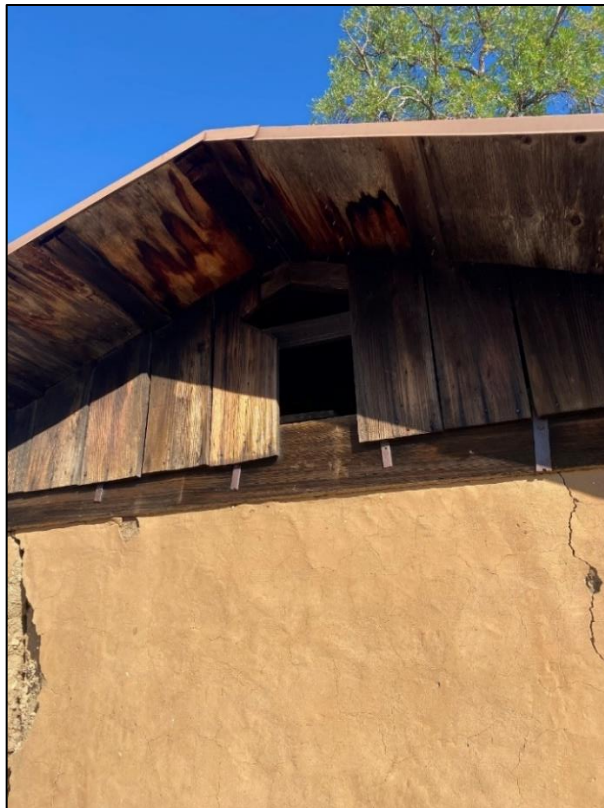
Figure 46. Wooden soffits under the roof overhang of the cold storage building, 2021. (ERDC-CERL.)

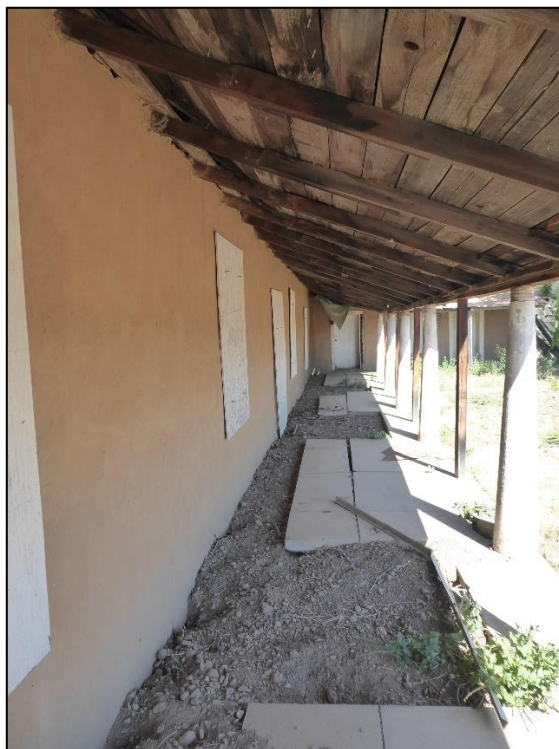
The building is constructed of adobe bricks currently coated in brown plaster (Figure 60). There are many areas on all elevations that the plaster has deteriorated, which has exposed the adobe bricks. The walls were created by hand, resulting in unique and uneven surfaces, a strong characteristic of vernacular architecture (Figure 61).

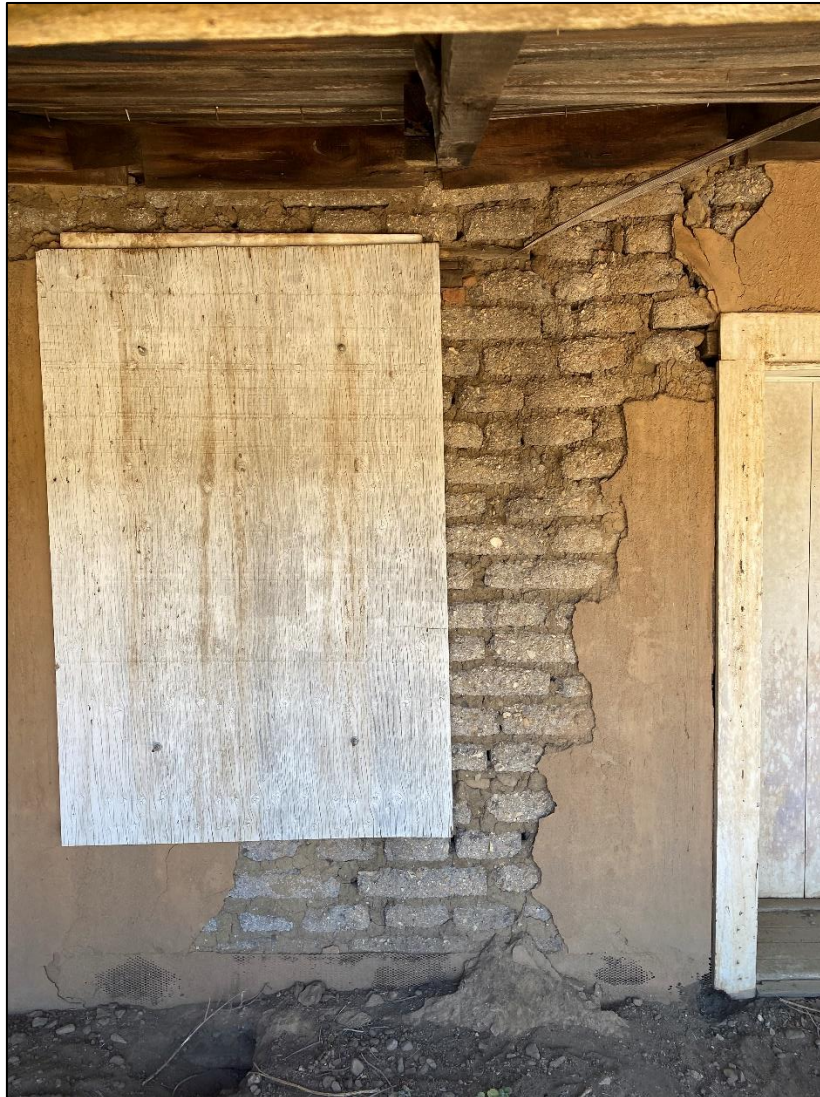
Figure 61. Uneven surface and flare of adobe wall at the base on the north corner of the José María Gil Adobe, 2021. (ERDC-CERL.)

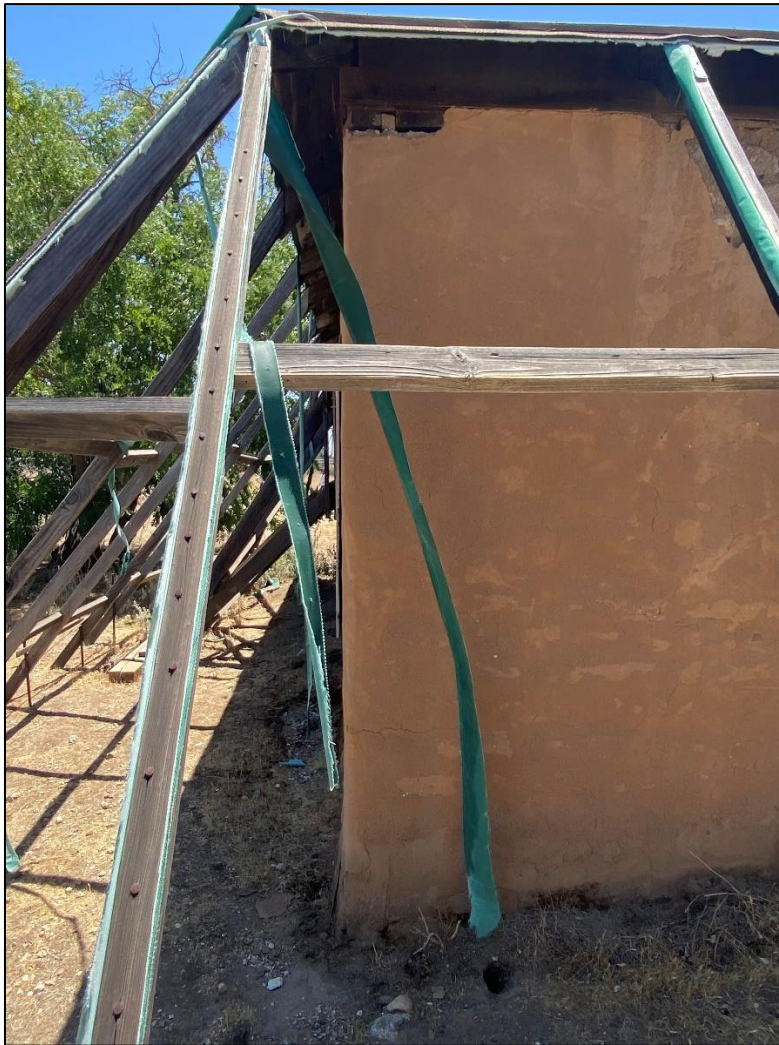
Each elevation has windows and doors that are not the same heights. Most of the window and door openings are approximately the same size; however, different sizes of wooden trim make up the edges of the openings. This is due to breakage over time or the availability of variously sized wooden members throughout the construction process. Originally, the building had six-over-six, wood-sash, double-hung windows, but today, many of the wooden window components are either broken or missing (Figure 62). There are two door types that appear on the José María Gil Adobe, one constructed of vertical boards with an X-shaped frame on the interior and one of vertical boards with a window opening in the center (Figure 63 and Figure 64). All window openings have wooden headers and sills of some form, and all wooden doors have wooden headers and thresholds.

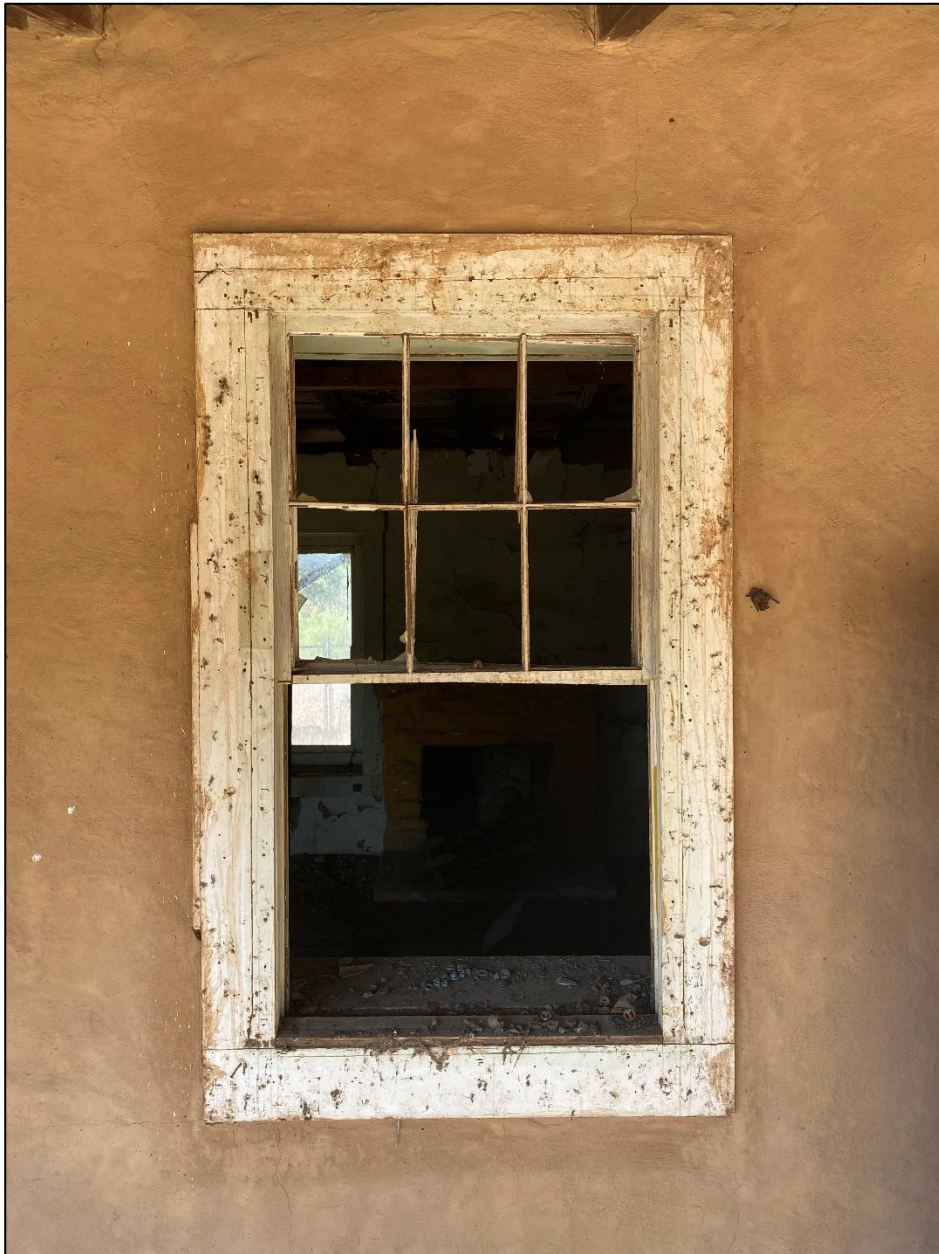
Figure 63. Exterior door type with vertical boards on the southwest side of the José María Gil Adobe, 2021. (ERDC-CERL.)

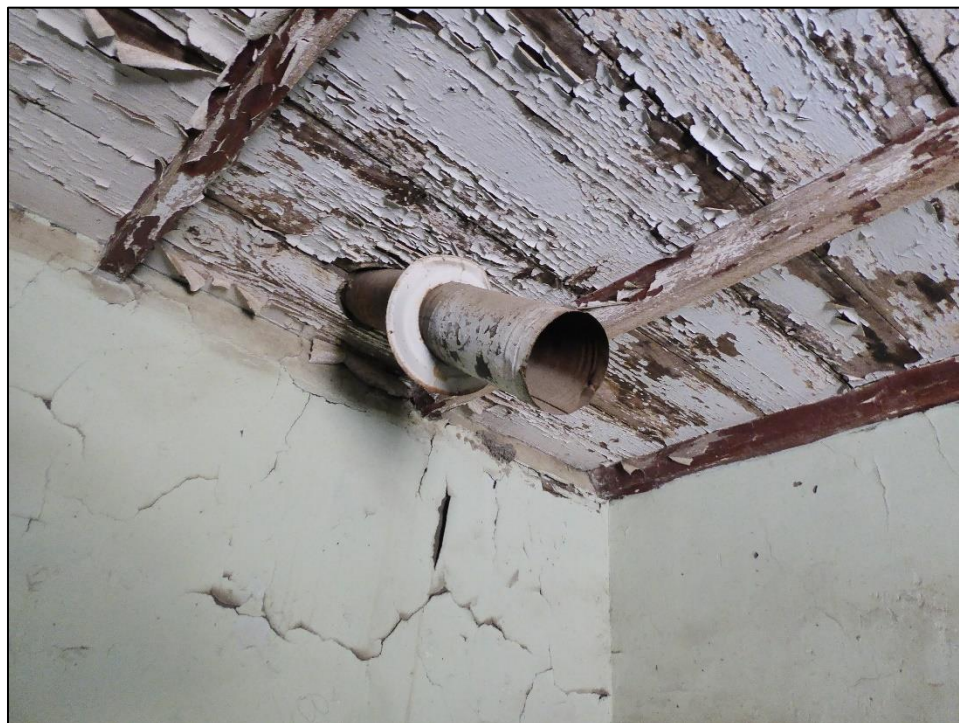
### **3.3 Current condition drawings**

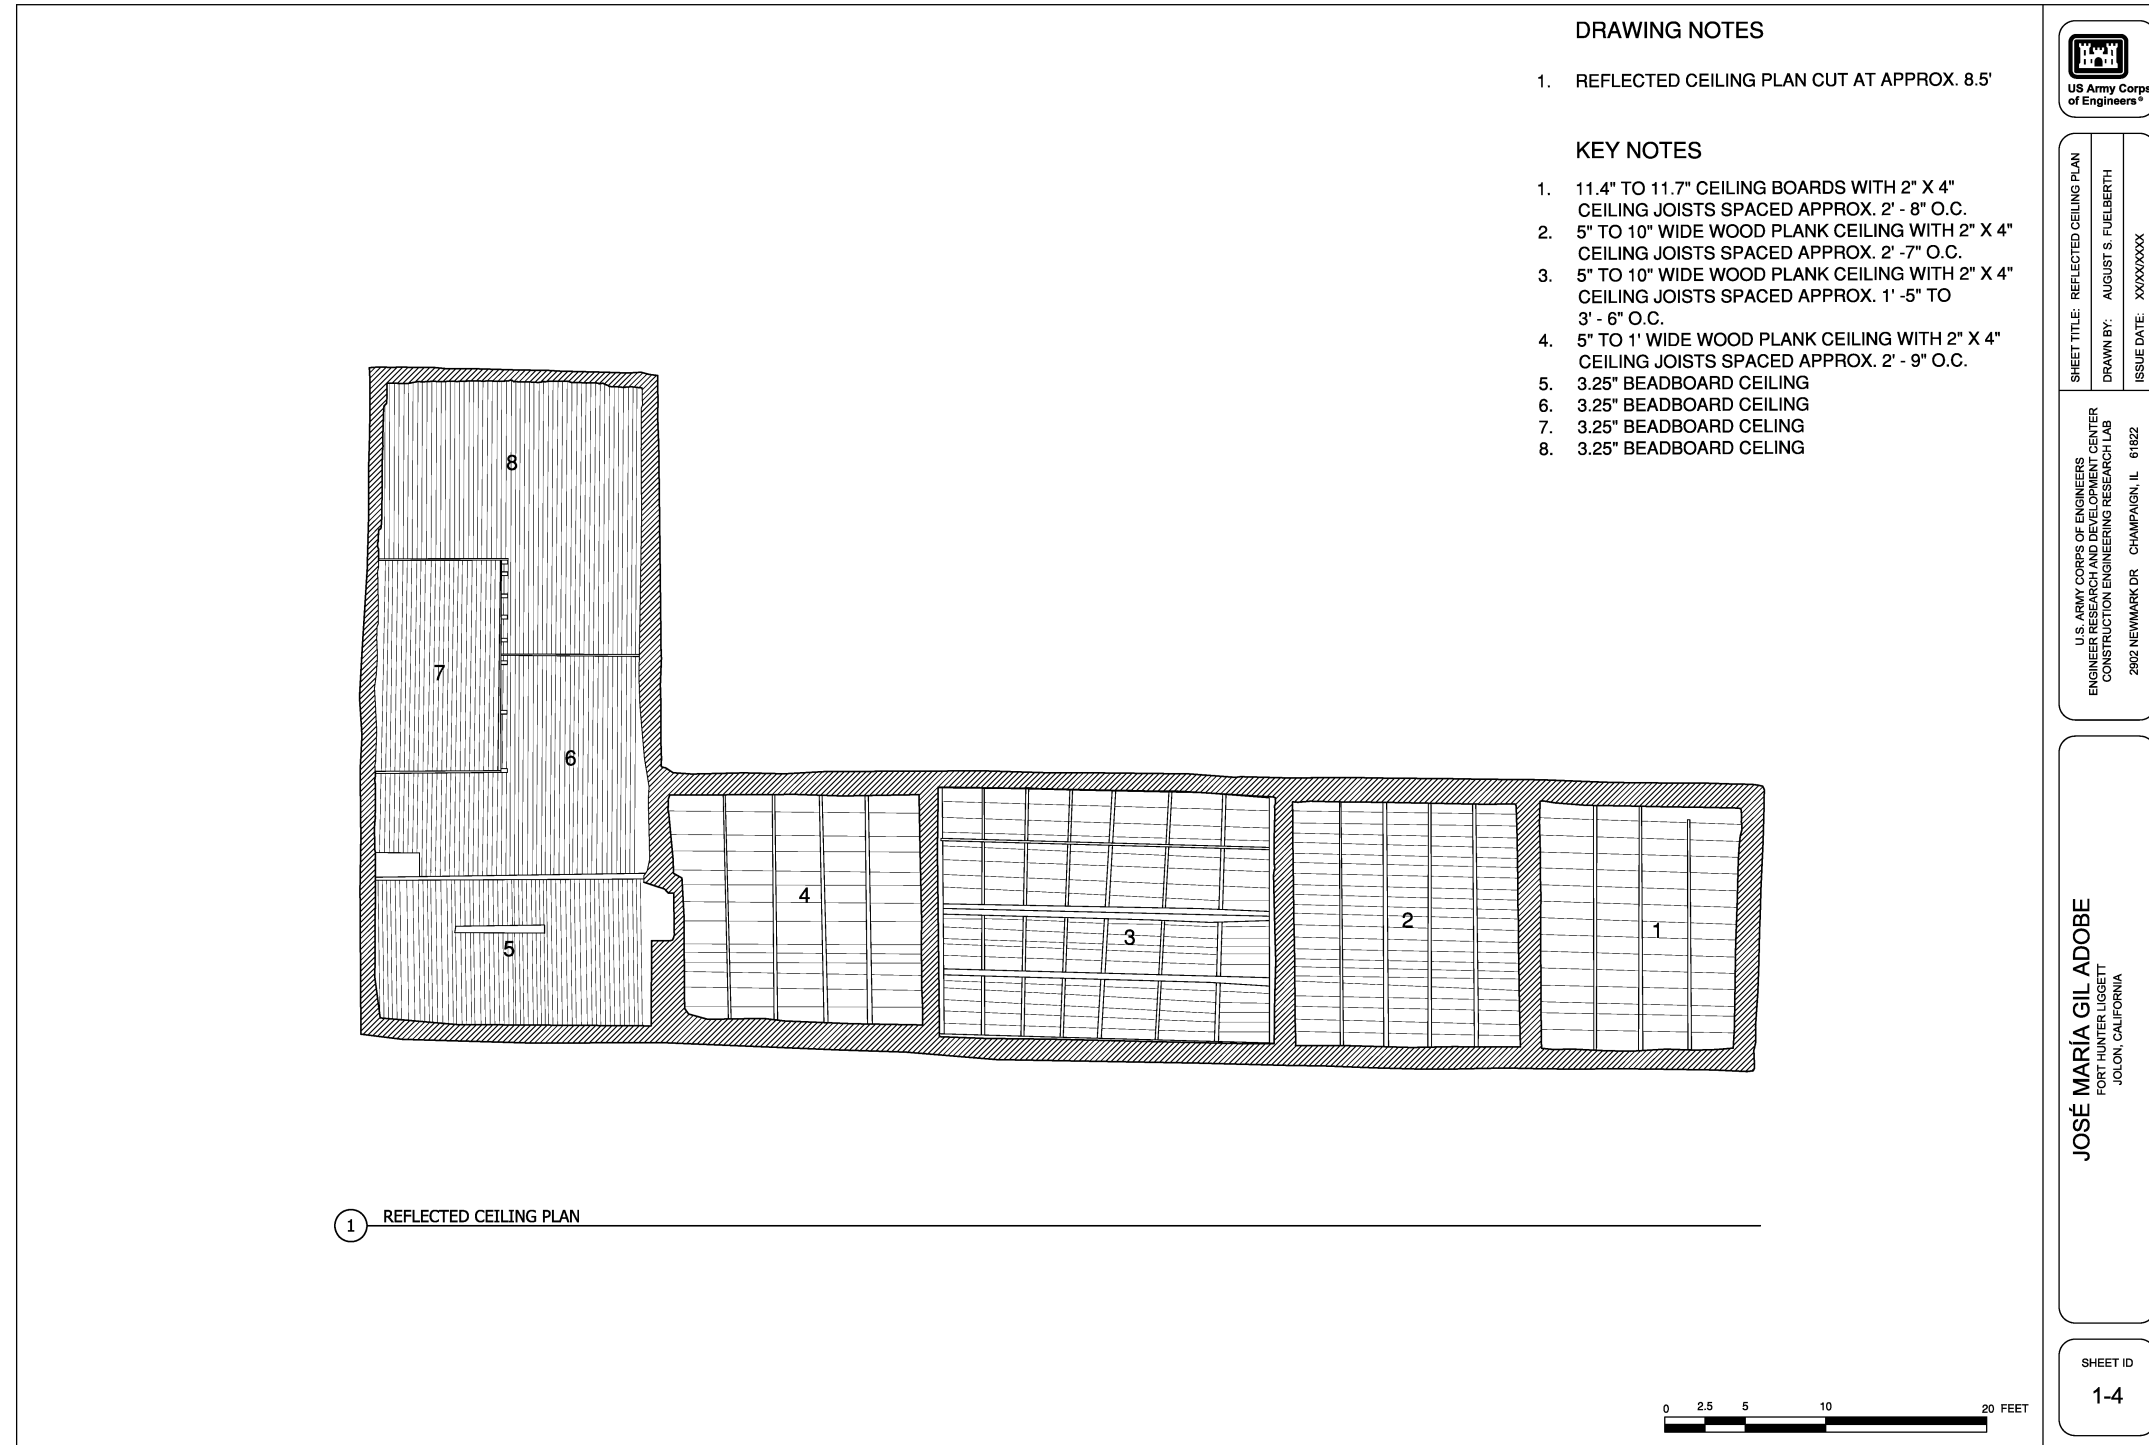
### **3.4 Archeological study acknowledgement**

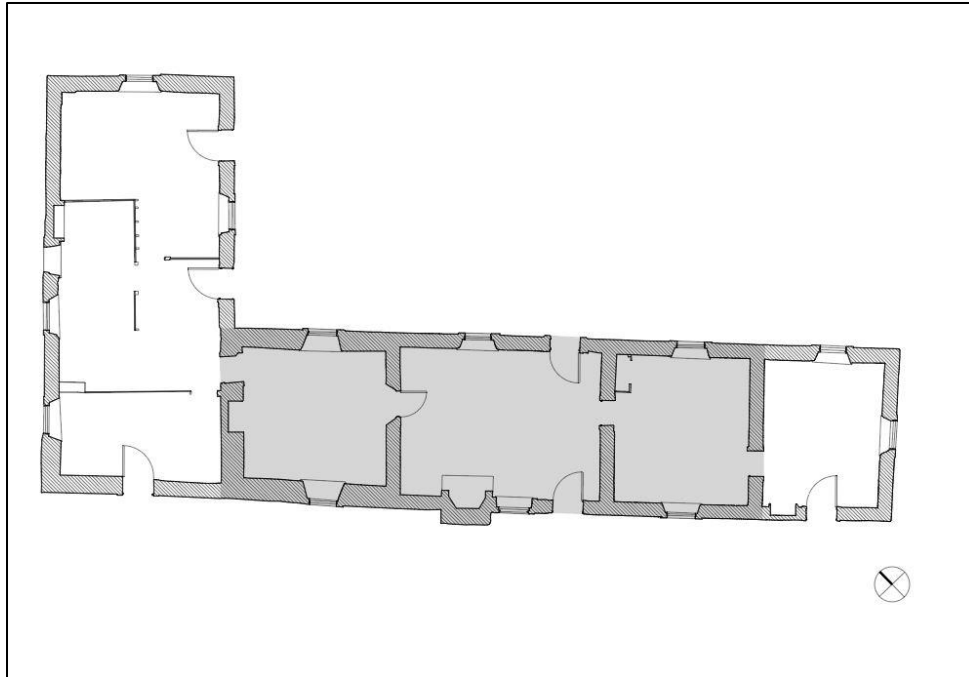
Figure 79. Illustration highlighting what could be the second addition (also showing original room) of the José María Gil Adobe based on its wall thickness, floor and window height, foundation, and other findings. (Drawn by ERDC-CERL, 2022.)

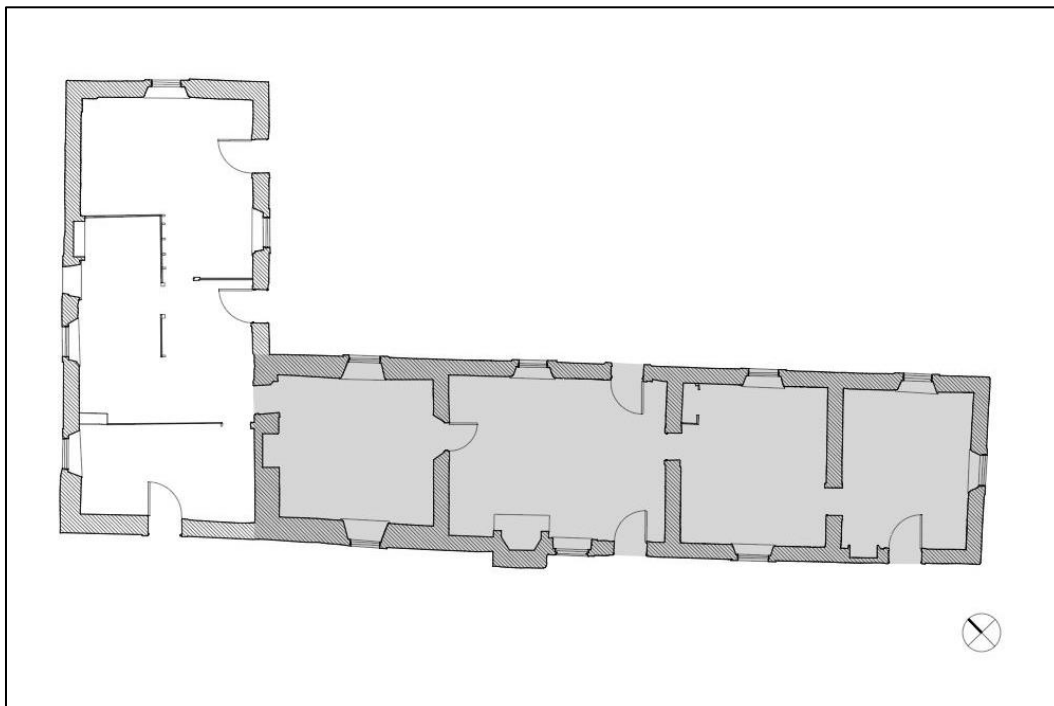
55. Allen and Sanchez, "Adaptive Reuse Study for the Jose Maria Gil Adobe Site."

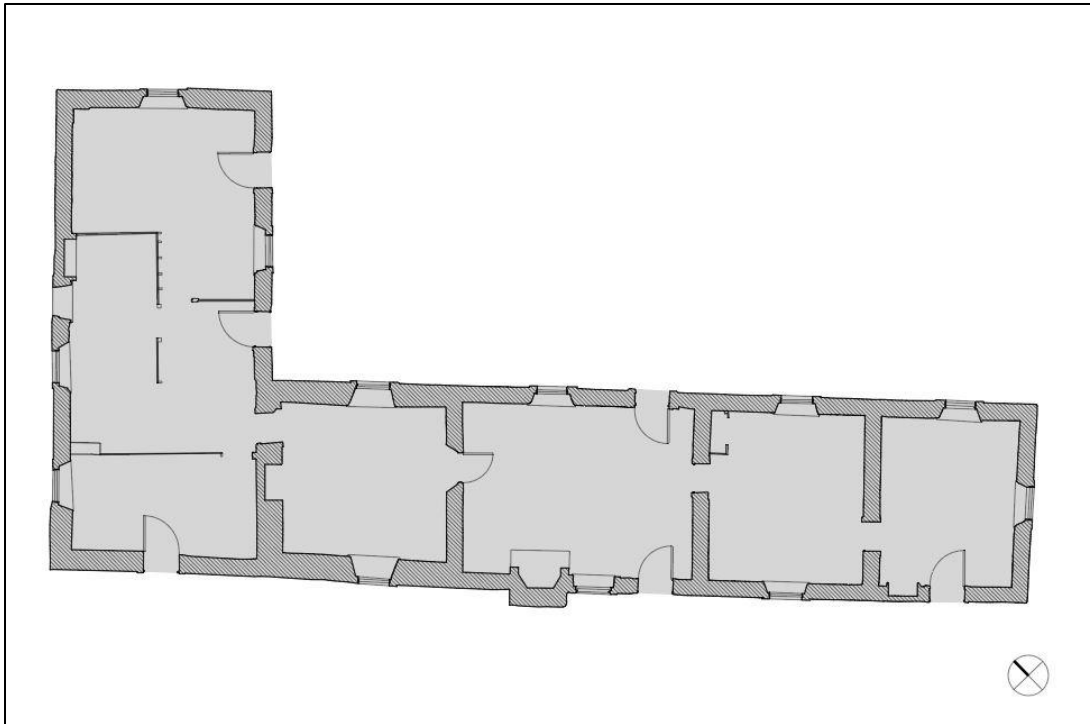
Figure 81. Illustration highlighting what could be the fourth addition. (as well as previous additions) of the José María Gil Adobe based on its wall thickness, floor height, and foundation, 2021. (Drawn by ERDC-CERL.)

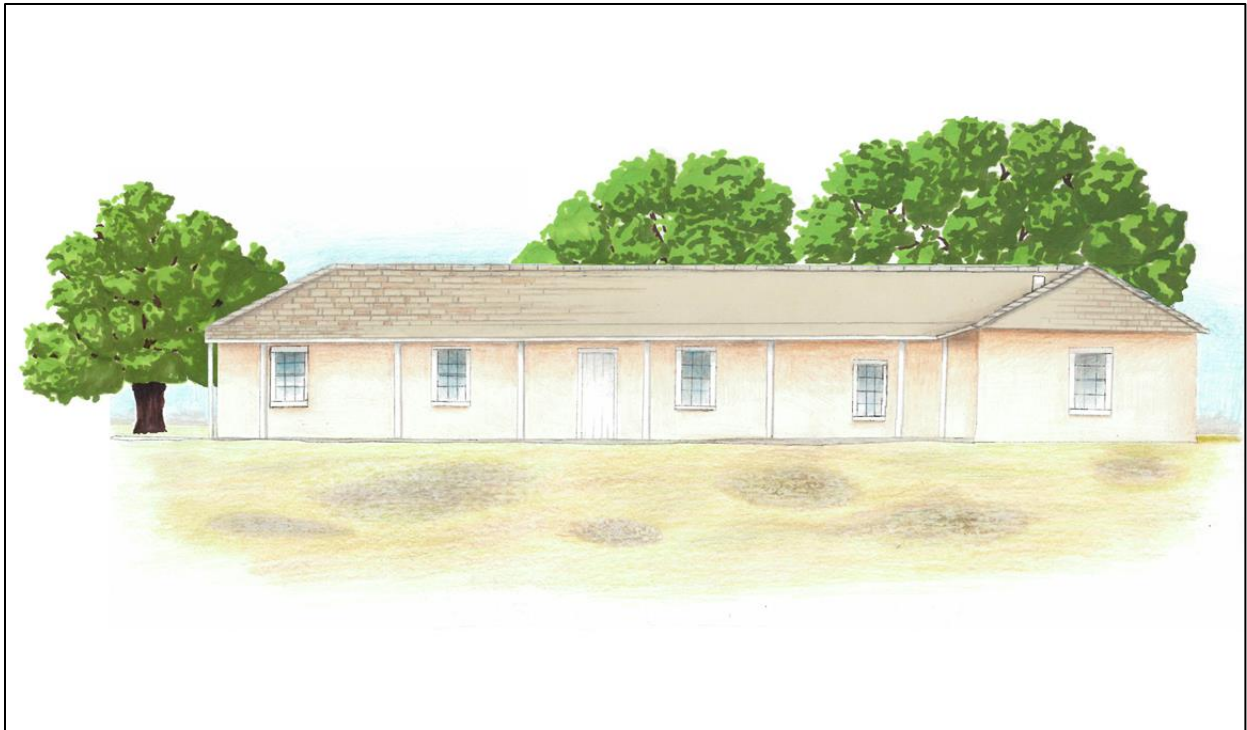
Figure 82. Elevation rendering of the José María Gil Adobe showing what the building may have looked like before the Army purchased the land in 1940, 2021. (Illustrated by ERDC-CERL.)

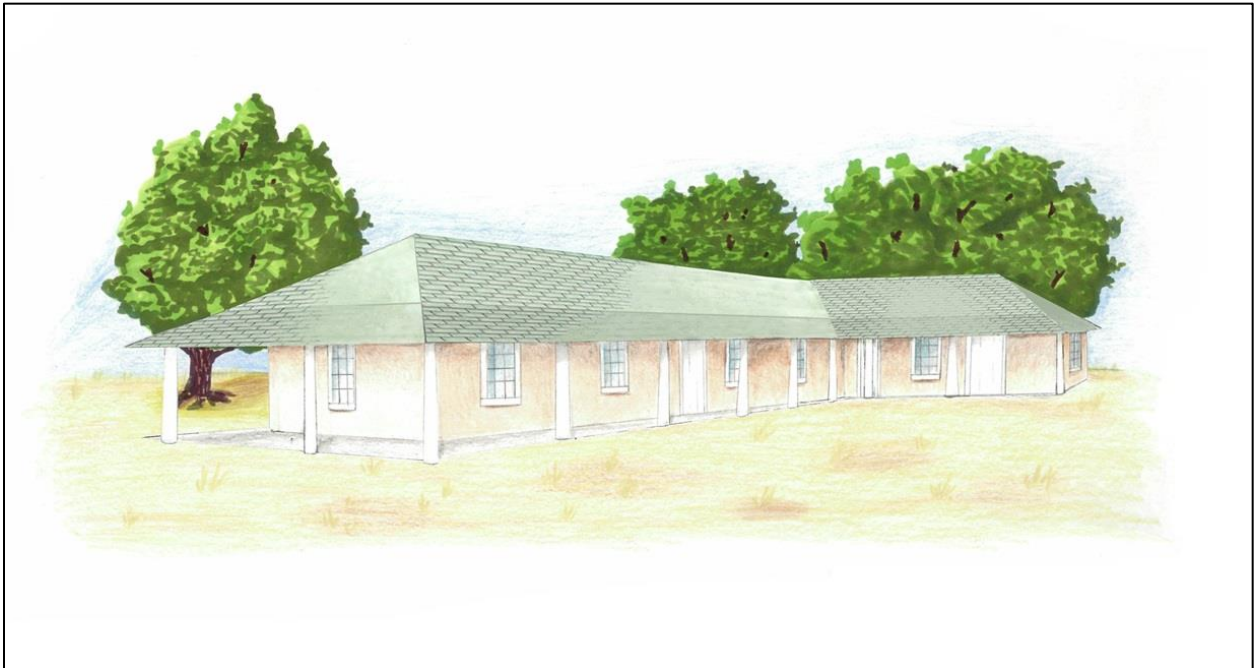
Once the Army made these changes soon after purchasing the José María Gil Adobe, the building slowly started to deteriorate. Refer back to the stabilization and mothballing activities discussed in Section 2.3.6.

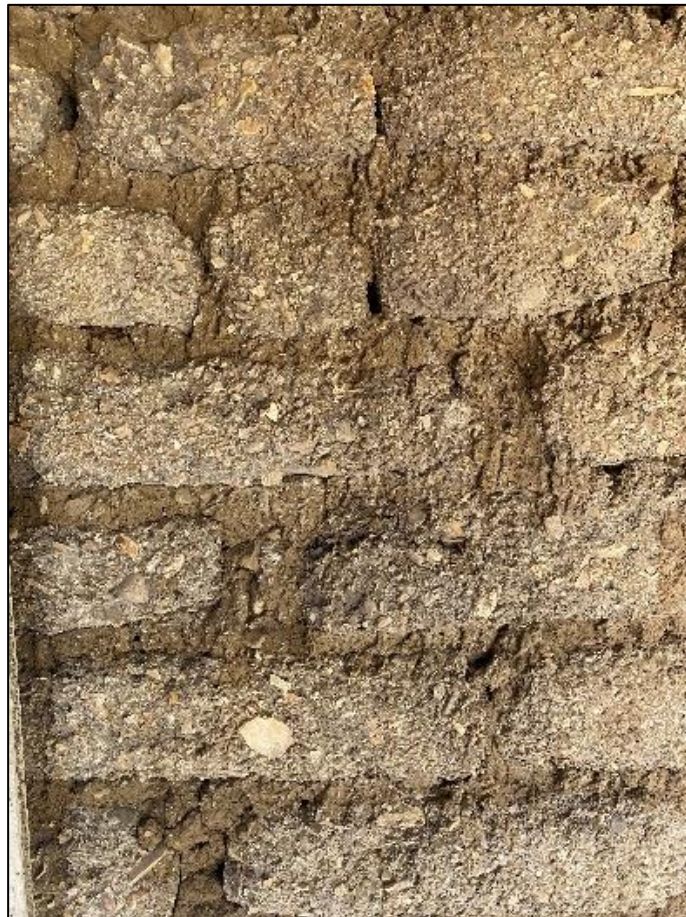
Figure 86. Large section of adobe brick between a door and window on the southeast side of the José María Gil Adobe, 2021. (ERDC-CERL.)
