**US Army Corps  
of Engineers®**  
Engineer Research and  
Development Center

## **José María Gil Adobe**

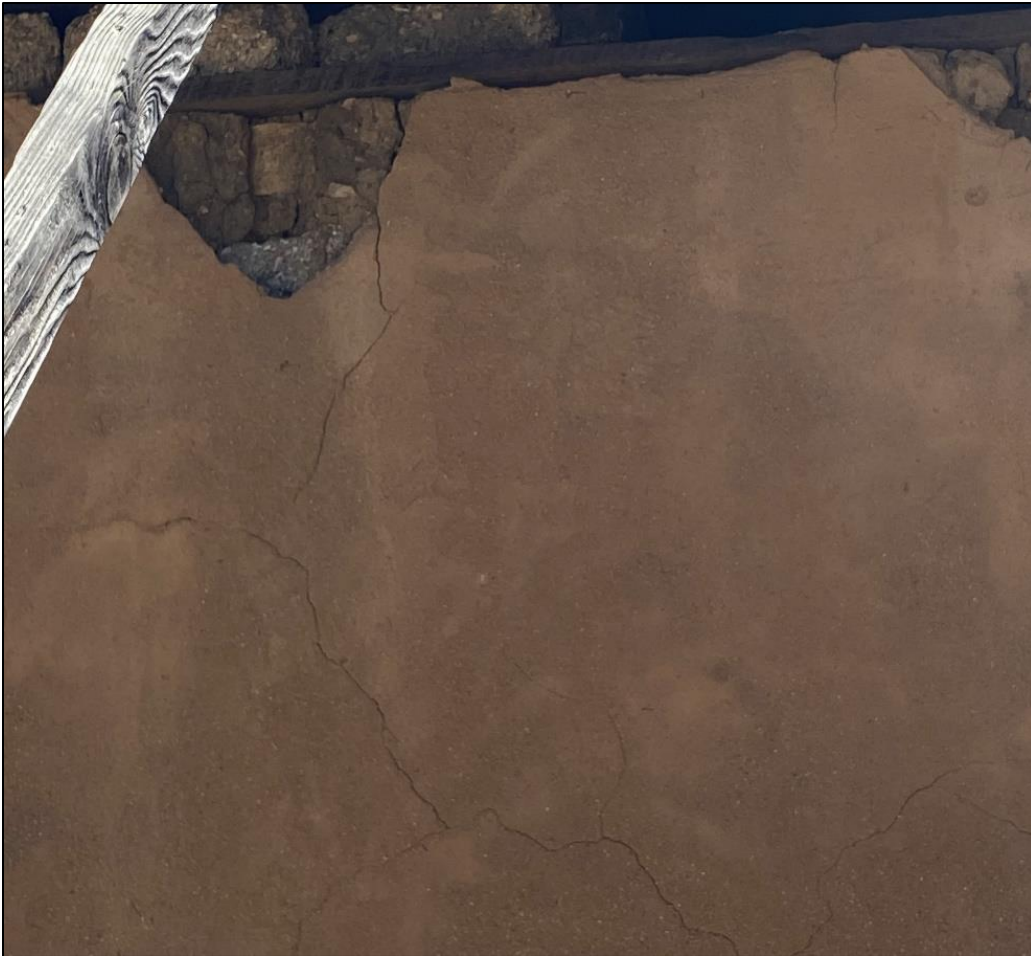
## 5.2 Interior adobe and plaster coatings

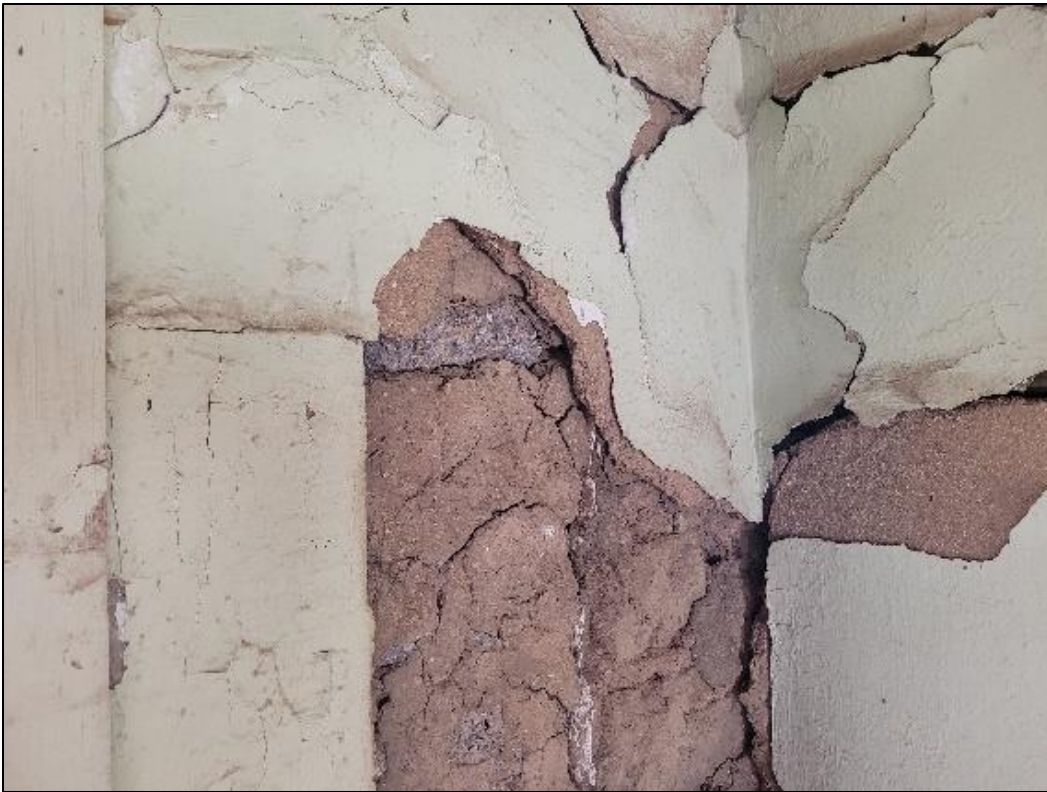
Figure 90. Cracked plaster and paint exposing wooden elements in the south wing of the José María Gil Adobe, 2021. (ERDC-CERL.)

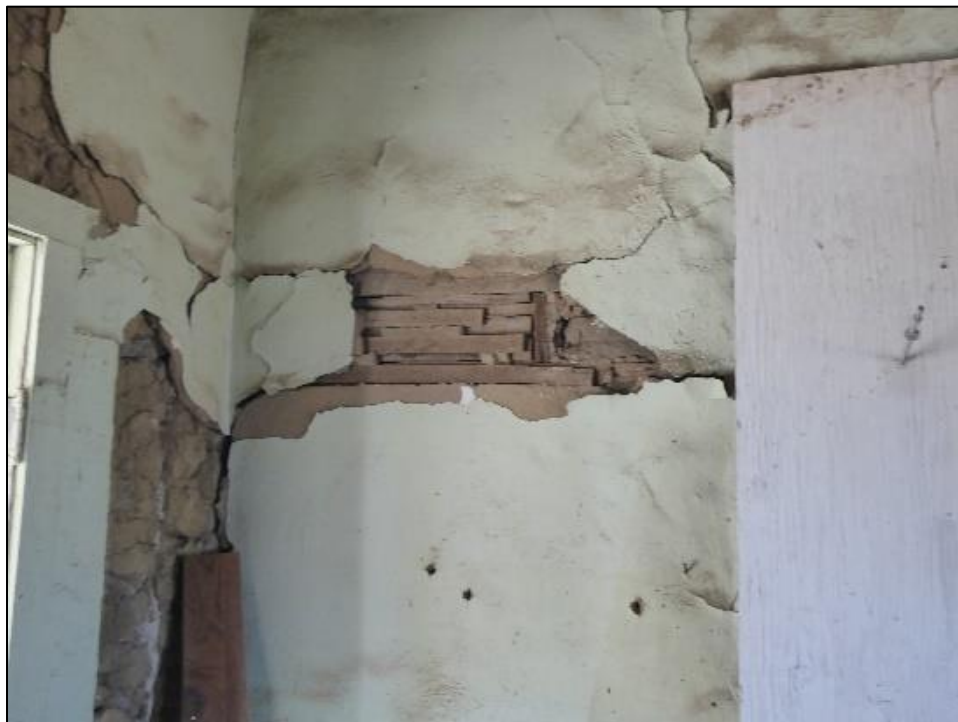
Figure 91. Intact plaster with peeling paint in the south wing of the José María Gil Adobe, 2021. (ERDC-CERL.)

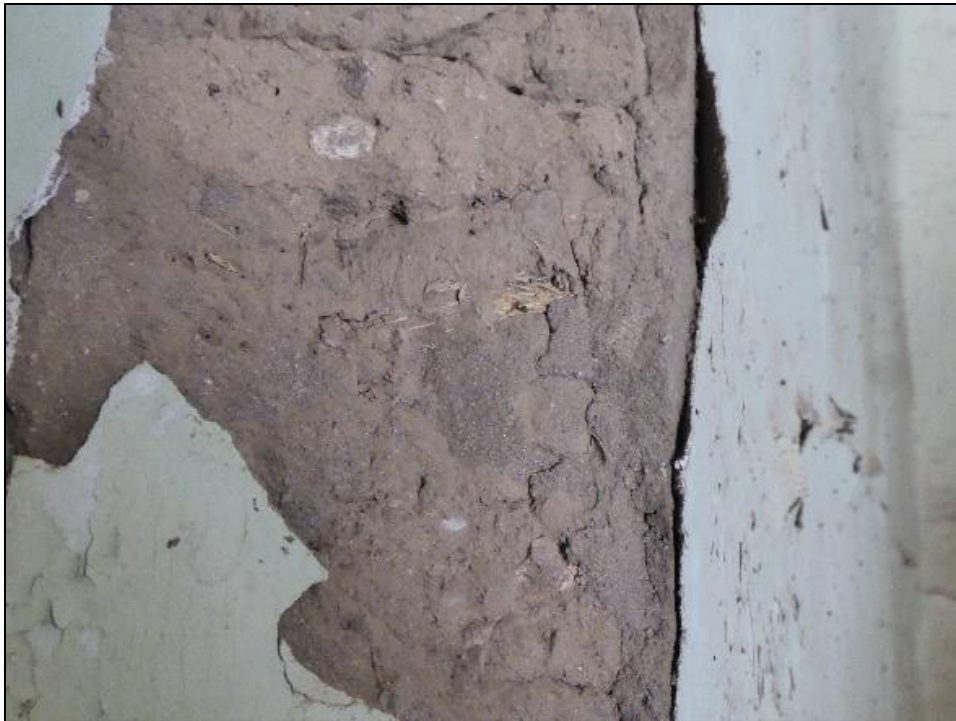
### 5.3 Treatment measures

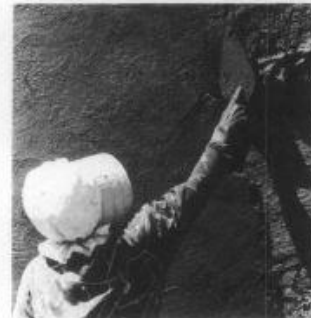
Whether built in the 17th century or in the 20th century, adobe buildings share common problems of maintenance and deterioration. This brief discusses the traditional materials and construction of adobe buildings and the causes of adobe deterioration. It also makes recommendations for preserving historic adobe buildings. By its composition, adobe construction is inclined to deteriorate; however, the buildings can be made durable and renewable when properly maintained.

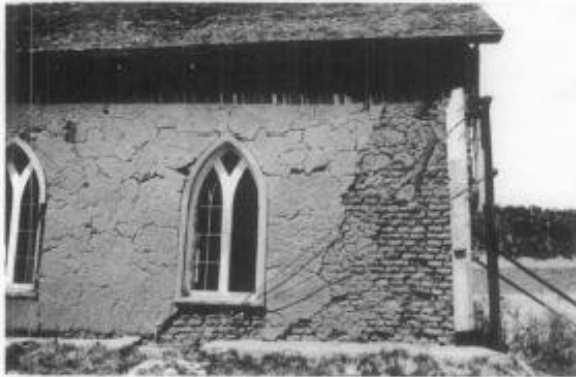
**Deteriorated Adobe Building.** By virtue of its fragile nature, the adobe building must be restored by thorough, systematic, and professional measures that will insure its future survival. (Technical Preservation Services Division)

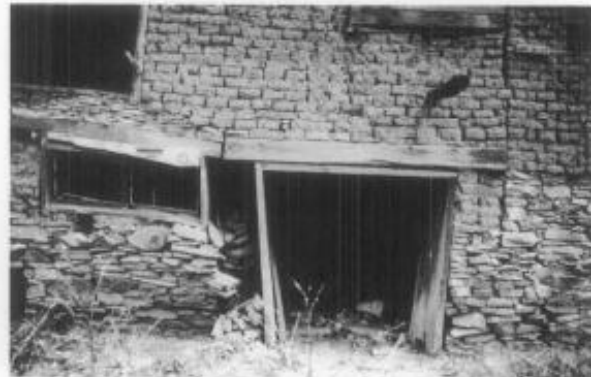
**Structural Damage and Cracking.** Sagging, bulging, and cracking of walls and roofs are signs of serious problems in the adobe building. It is always advisable to secure professional services in the repair of such problems. (National Park Service)

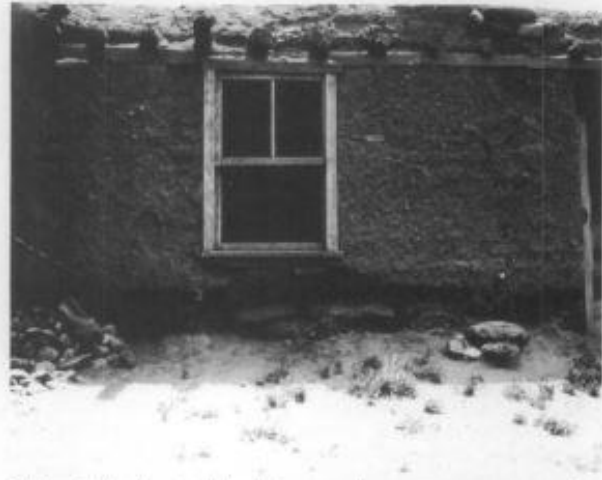
**Coving.** Salts deposited by rising ground water can evaporate and cause spalling of the adobe bricks at the base of the wall, a serious condition called "coving." Coving can also be caused and/or exacerbated by the erosion of rain splash. (National Park Service)

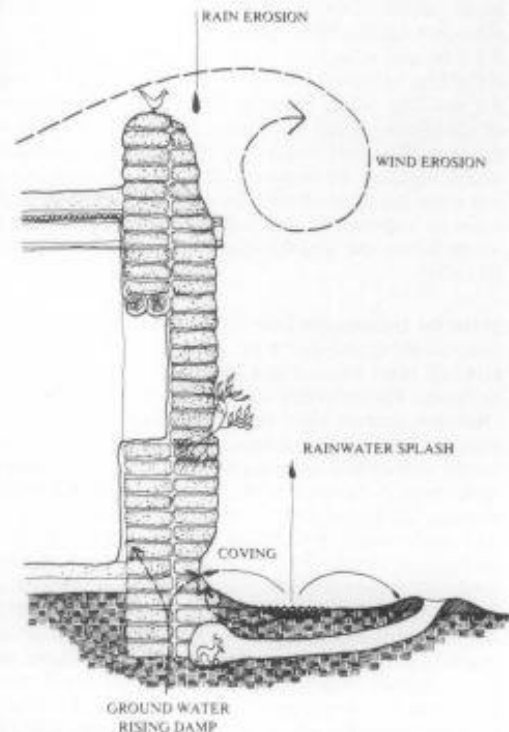
**Water, Wind, Animal, Insect, and Vegetation Damage.** Most deterioration of adobe buildings can be directly correlated with the presence of either excessive rainwater, groundwater, or both. Successful adobe stabilization and restoration depends upon keeping the adobe building moisture free, repaired, and well maintained. (Drawing by David W. Look, AIA, based on sketches by Albert N. Hopper)

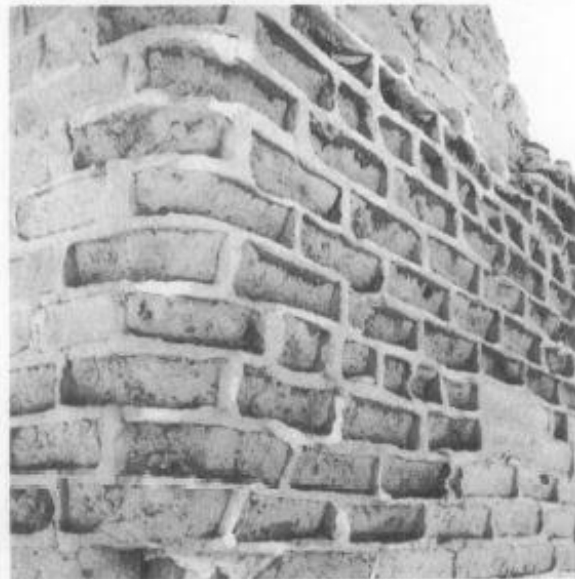
**Cement Mortar Incompatibility.** The stronger and less flexible cement mortar has caused the softer adobe bricks to crumble thus leaving a "honeycomb" of cement mortar joints. (National Park Service)

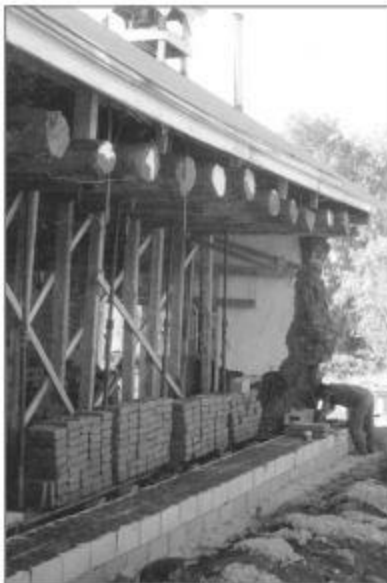
3. Rebuild the footing following the existing pattern or consult a structural engineer for a new design. In high water table situations there are a variety of methods to alleviate the water table problem. In this particular case the engineer chose to use a concrete and block footing. Traditional stone footings (below), however, are recommended for use whenever possible (see Part Three, *Installing a Subsurface Drainage System* for more suggestions regarding high water table damage).

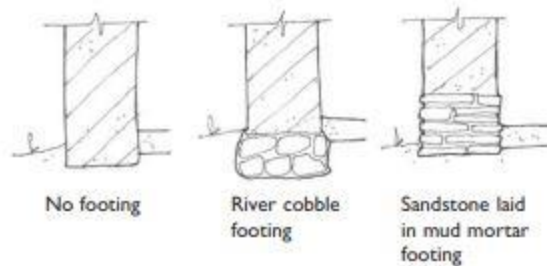
Traditional stone footings

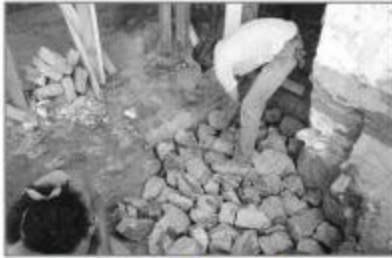
4. **Gravel Footing.** Dig a trench 12 inches in depth and the width of the wall. Evenly spread the river cobbles over the floor of the trench. Cover the cobbles with one to two inches of gravel. The first mortar joint should be laid directly on top of the gravel with no moisture barrier between. This gravel bed is an effective capillary break for ground water as well as a conduit to the permeable soils below for any water entering from above. This method can *only* be used where good drainage conditions exist on the site.

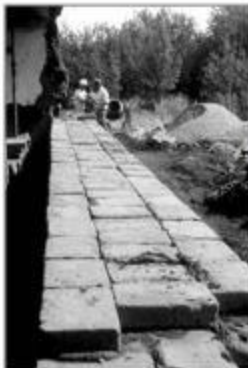
5. Determine the pattern of adobes to be laid. Match the existing pattern.

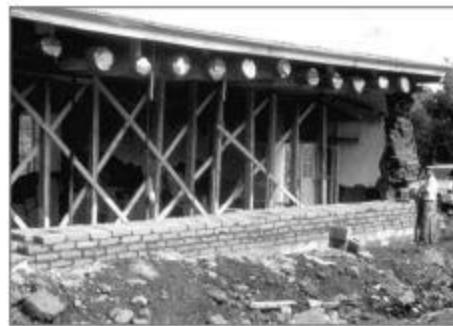
7. A maximum of three to four courses can be laid every two to three days, depending on weather conditions. Allow ample time for the mud mortar joints to dry. Adding too many courses in a short period of time may cause the adobes to shift.

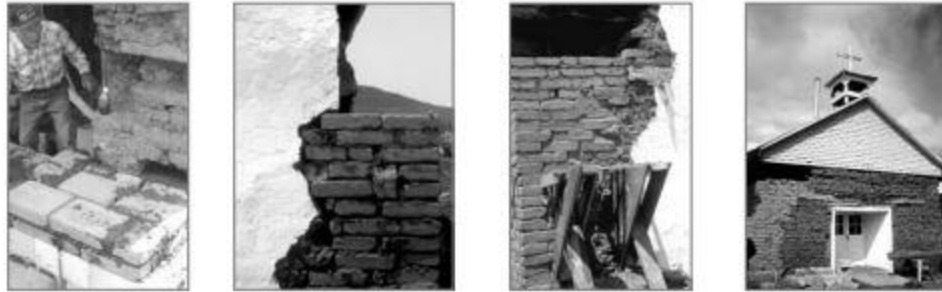
8. Determine how to best key in the new wall with the existing wall. For best results always key back to the existing wall.

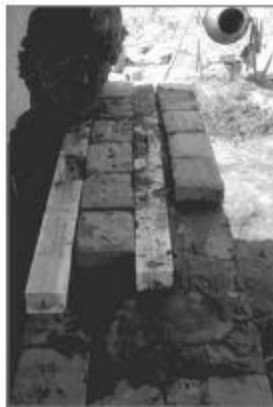
9. Replace wooden lateral and corner ties if they exist in the original construction. Fill in with full size adobes or custom cut adobes.

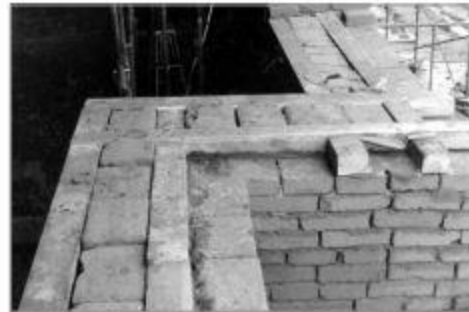
10. Use half-lap and cross-lap joints to tie in lateral ties at corner. Loosely pin them together. They should be able to move and settle with the wall.

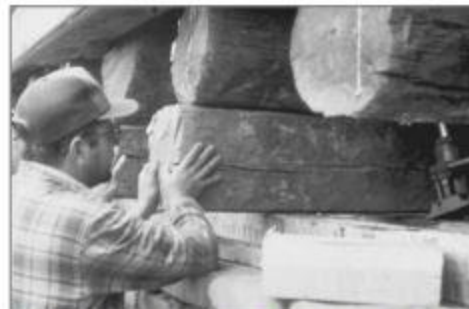
11. After placing the wooden bond beam (rough beam) to match the existing wooden bond beam if it is being replaced, reinstall the existing corbels using jacks or a pulley system to lift the vigas. Set the bond beam to the lowest measurement from the viga to allow the corbels to fit beneath the viga and rest on the bond beam. Insert shims between the corbels and the bond beam for any that do not meet the corresponding viga. Moving the roof could cause problems.

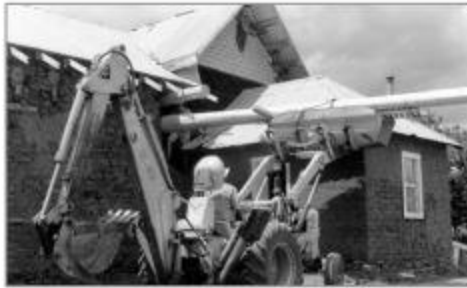
12. Replace *vigas* that cannot be spliced or repaired with new ones to match the existing. Slide the *viga* through one side of the building to the other then set the *viga* on the corbel (see Part Three, *Repairing Vigas and Corbels*).

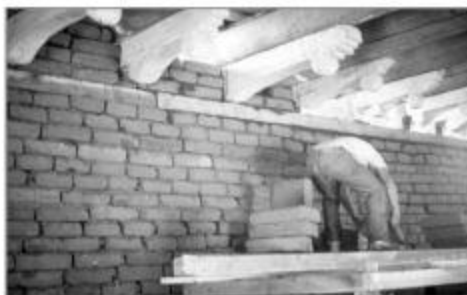
13. Infill between the corbels and *vigas* with adobe bricks and mud mortar.

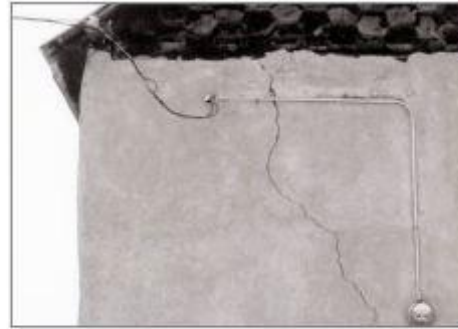
### TOOLS AND MATERIALS REQUIRED

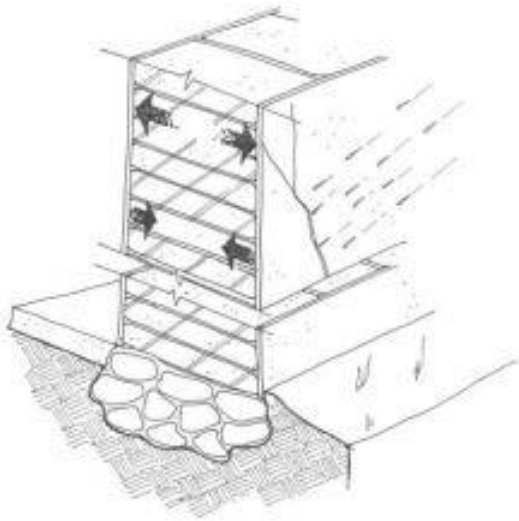
When a rigid cement plaster is applied to an adobe wall there is a high probability the plaster will crack from the thermal expansion of the wall mass. The incompatible plaster will create cracks where water can penetrate. Cement plaster moves at a different rate than does adobe when the temperature changes. This differential is a major cause of cracks in cement plaster.

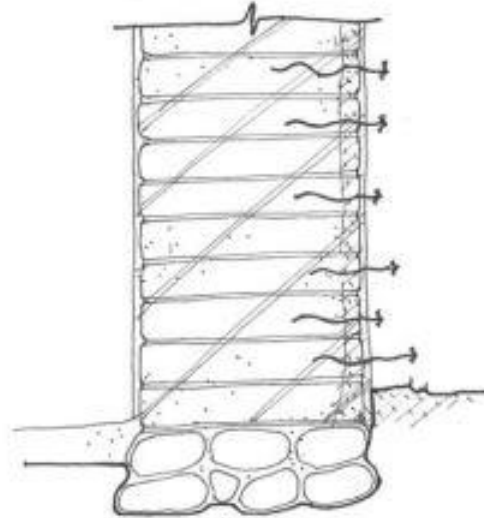
Mud and lime are more compatible with the thermal qualities of adobe. Mud and lime plasters, conversely, are permeable materials that allow the adobe walls to dry when wet.

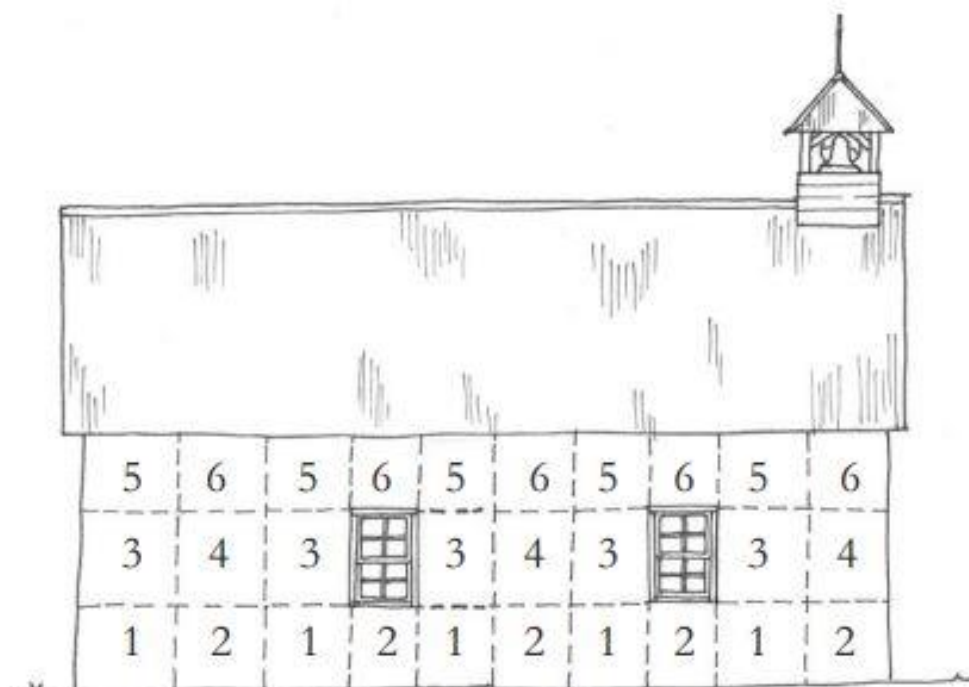
A small (3 feet by 3 feet maximum) cement plaster section at the base of the adobe wall should be cut and removed to determine the wall conditions. If the walls are either very wet or have lost more than 30% of their thickness at the base, safety shoring should be erected to carry the weight of the roof before removing any additional plaster from the walls (see Part Two, *Emergency Shoring and Repairing and Restoring Adobe Walls*). When shoring is in place, alternating sections of plaster can be removed. This will protect workers if there is a large delamination of material from above. These areas need time to dry before removing the remaining plaster at this level. Reconstruct any deteriorated areas and replace adobes from the ground up. Place additional wall shoring along the vertical plane as needed.

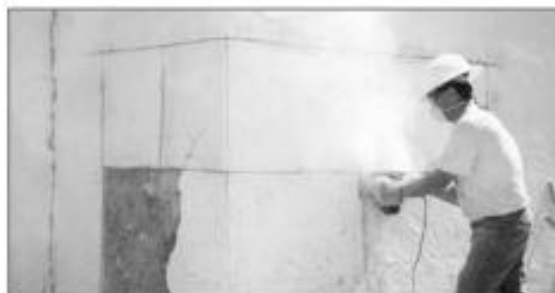
Strong, hard plaster may need to be cut into manageable sections with a circular saw and diamond-toothed masonry blades. The first priority is to remove the cement without damaging the adobe building!

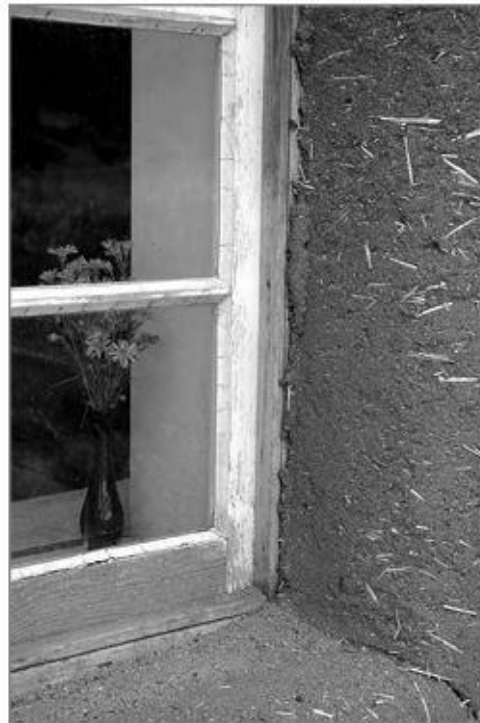
straw performs certain functions, including balancing the soil mix in adobes. Straw helps the sand and clay particles dry evenly. Omitting straw will lead to excessive cracking as the adobes dry.

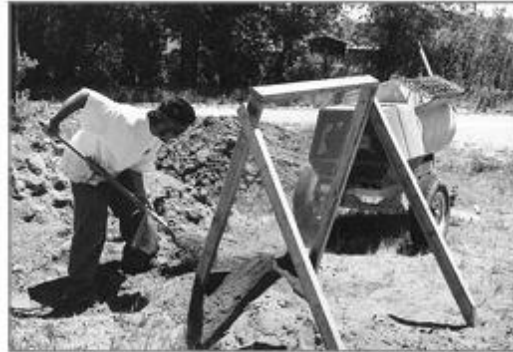
2. Screen the soil. Do not screen the soil if wet.  
(See *Building a Screen* at the end of this section.)

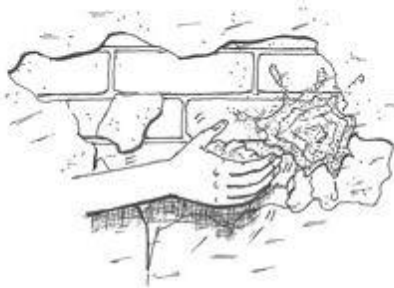
5. If no mud plaster exists, throw the mud onto the wet adobe wall surface by hand or hurl with a brick trowel. Scrape the excess mud and re-throw, filling the concave areas and following the contours of the wall. Always apply thin (never greater than 5/8-inch thick) coats to ensure adhesion. When a large void under four inches deep is encountered, fill it by hand with mud in successive layers of 5/8 of an inch or less. Be patient. Build out with several passes, allowing each layer to dry in between passes. Do not try to build up low areas with a single application of mud. If the void is deeper than four inches, new adobes will have to be inserted.

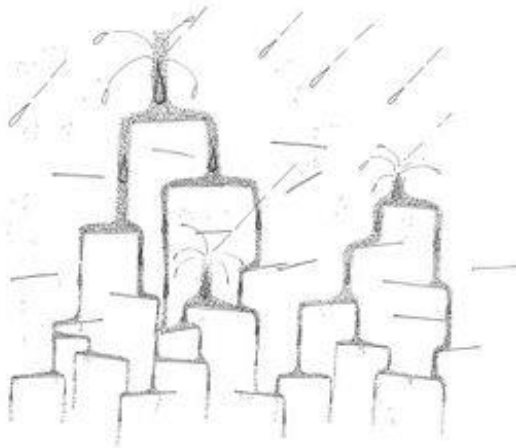
8. The rivulet beginning at parapet height encounters a straw barrier across its path and is diverted. The downward velocity is broken and erosion reduced. Straw causes water to spread out or "sheet" over the surface of the wall.

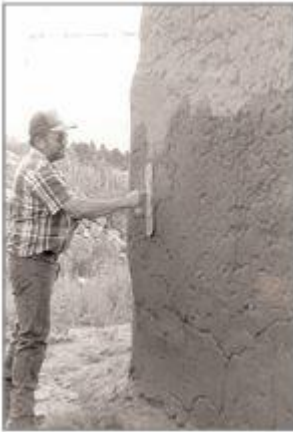
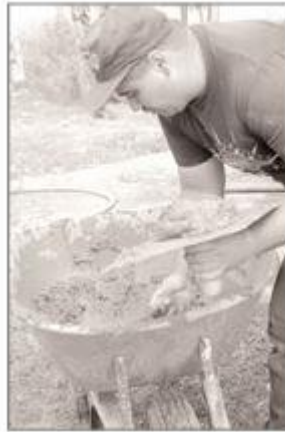
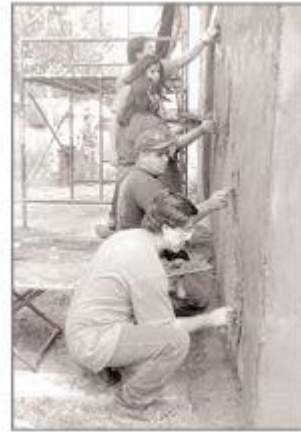
9. Apply the scratch coat approximately one- to one and a half-inches thick with a brick trowel or by hand. Allow the mud plaster to completely dry and crack one to two days before continuing. A plaster trowel may be used if mud plaster exists. Before each application wet surface of wall immediately before plastering.

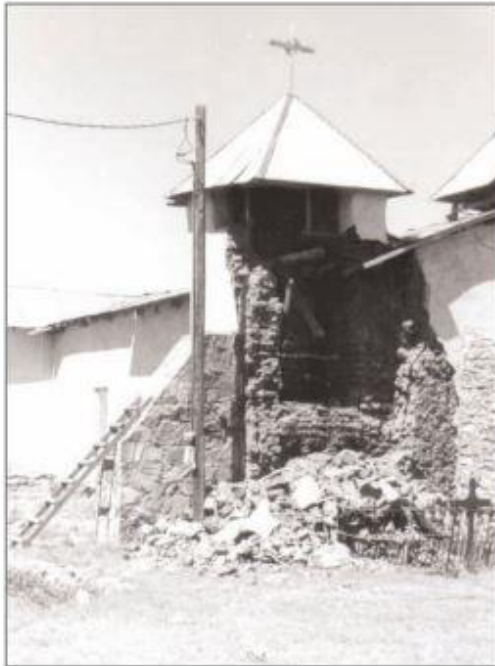
This section illustrates some of the ways in which various elements damage adobe structures. In almost every example, the problem was identified and repaired using the methods and materials described in this handbook.

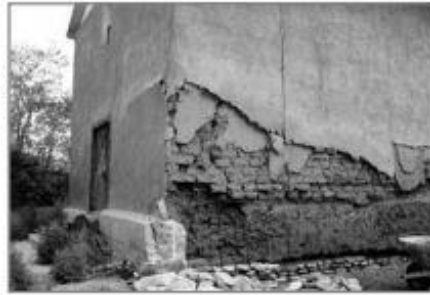
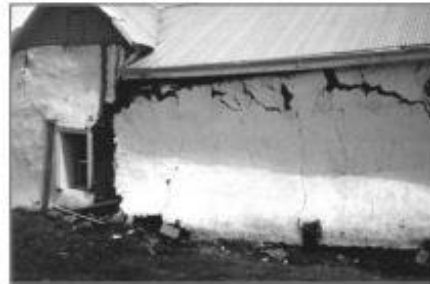
## COMMON SOURCES AND CAUSES OF DETERIORATION

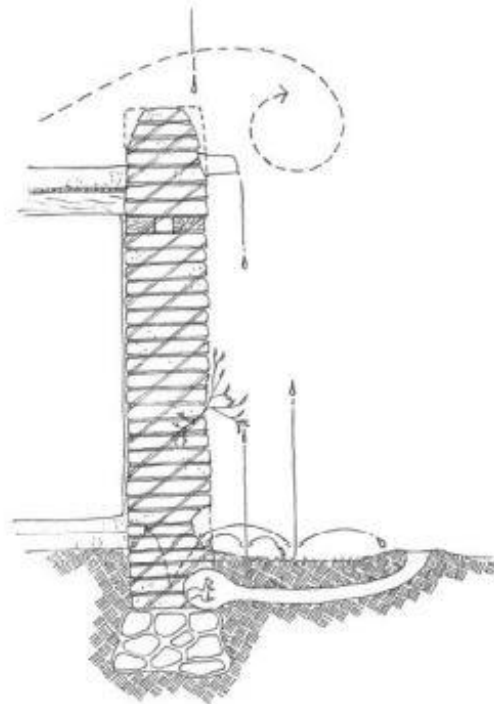
## PERFORMING A CAPILLARITY TEST

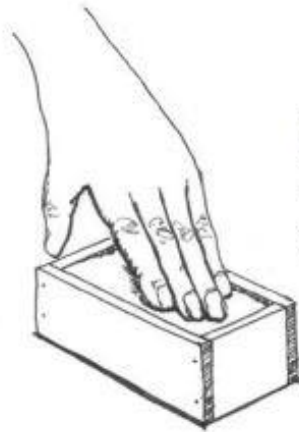
This test illustrates the movement of water from the base of an adobe brick up to its center as a result of capillary action. Cement additions prevent moisture from otherwise escaping to the surface through a breathable mud or lime plaster.

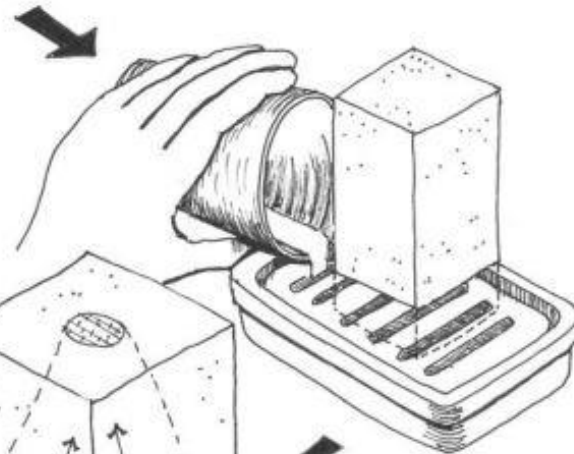
3. When the capillary movement of the water shows signs of dampness on top of the adobe brick, the adobe brick will begin to slump exactly as an adobe wall that has moisture trapped behind cement plaster or a concrete *contra pared*.

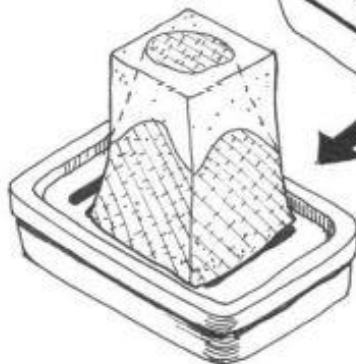
At this point, the brick is saturated with its maximum amount of moisture, and gravity prevents the water from rising higher up the adobe brick.

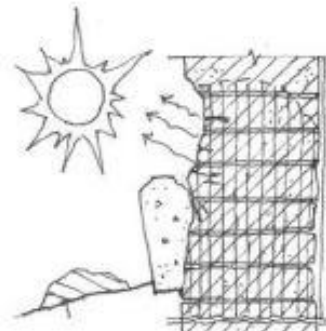
New erosion occurs above portland cement repair.

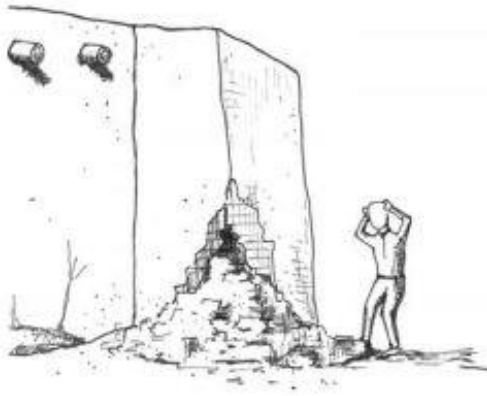
1. Corner collapse. First review the preceding chapter on the *Sources, Processes and Effects of Deterioration* to make sure you understand the forces that caused the collapse.

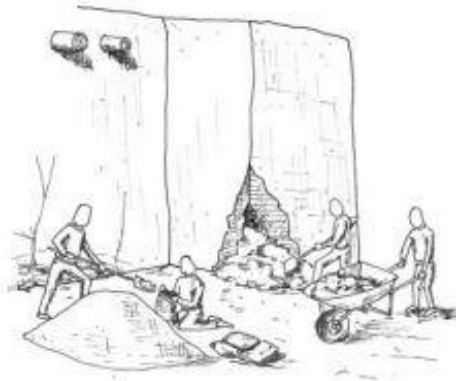
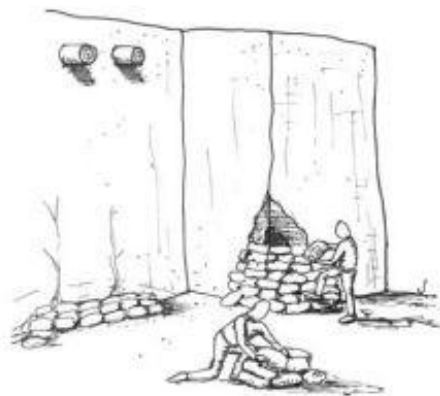
3. Pack the collapsed wall sections with sandbags to provide temporary support to the upper wall. To provide additional support, stack the sandbags outside the void into a buttress. Make sure the opening is not too large to work around it, since further collapse may occur and a different system should then be utilized. See the section on diagonal bracing on the following page for additional detail.

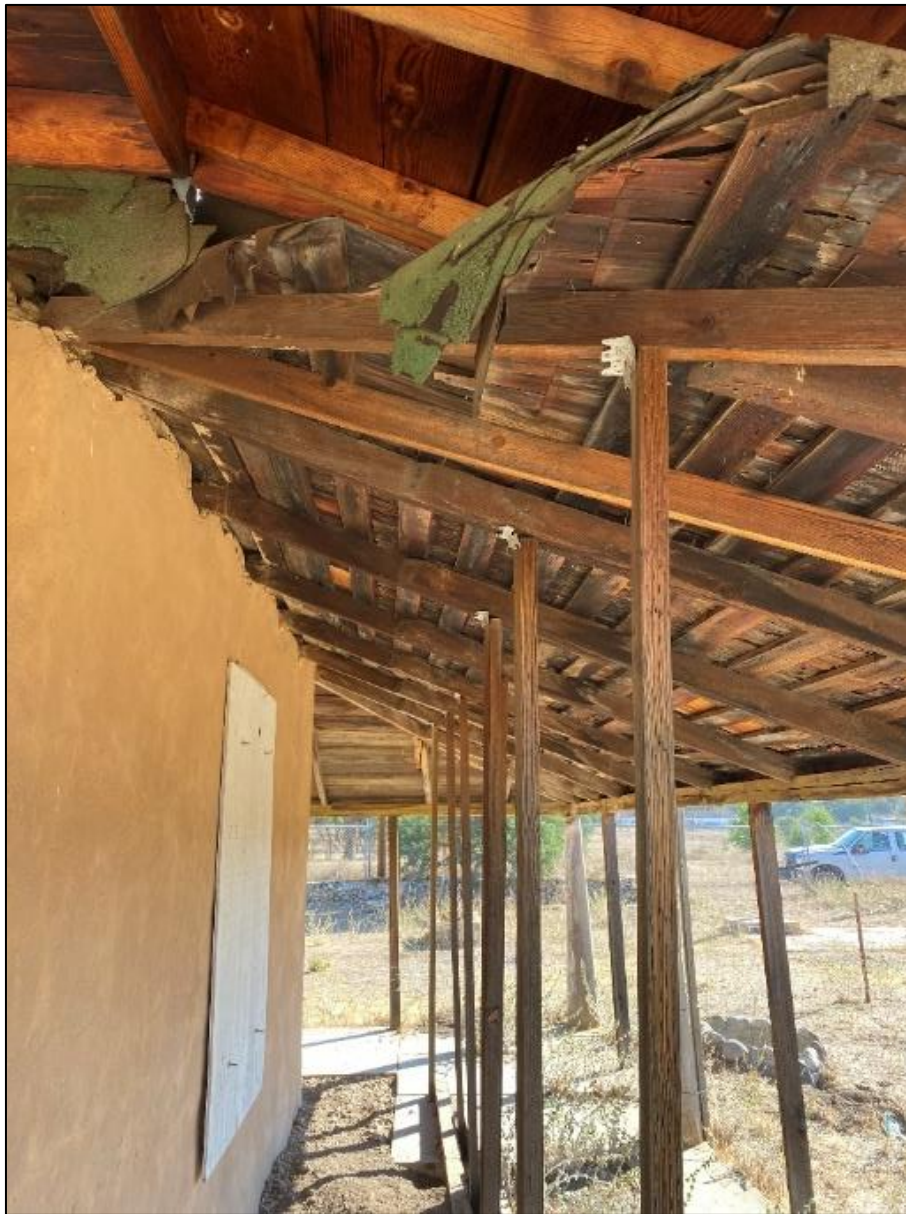
The underside of some portions of the existing veranda of the José María Gil Adobe are wooden shingles that are in “POOR” condition. These shingles are visible when standing under the veranda looking up. Figure 94 shows the shingles resting on the wooden frame without any roof sheathing, which is historically accurate for a wood-shingled roof built during the 19th century.

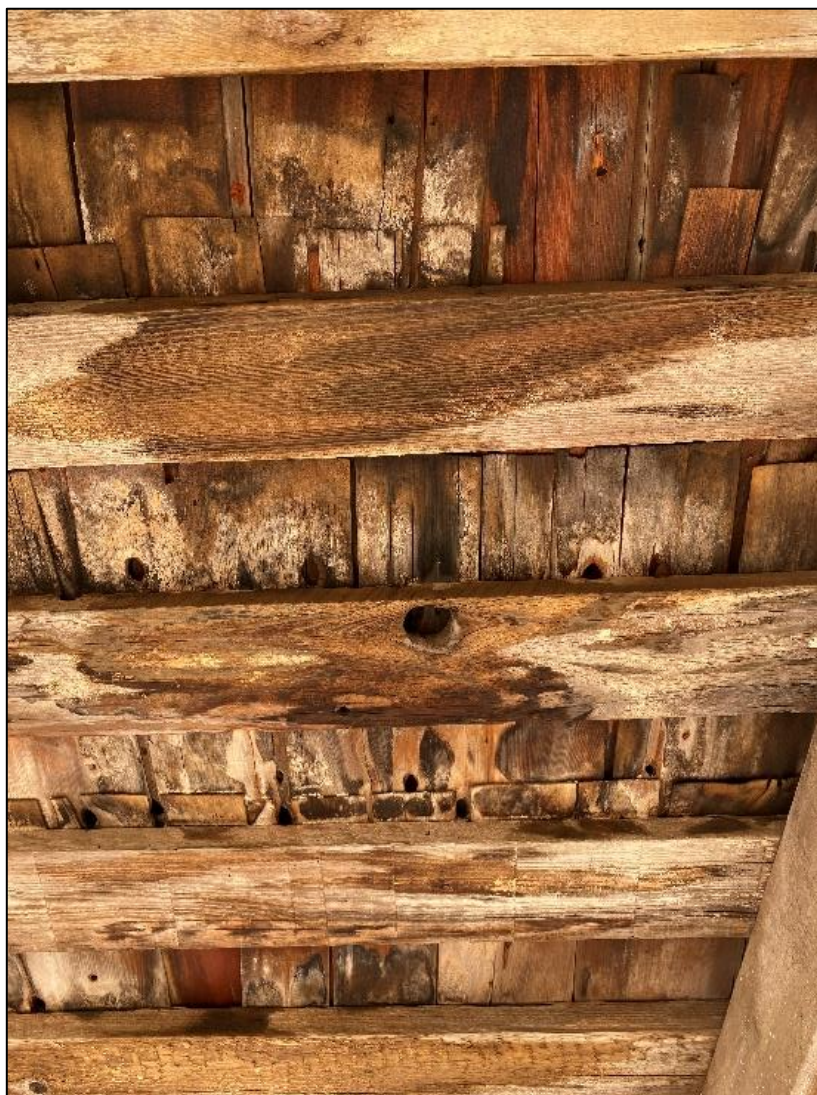
In some areas, the veranda roof is not original and was added by connecting the rafters (Figure 95). The boards extending from the structure itself may be part of the original roof overhang. The wooden members with a notch at their ends may be part of the original roof.

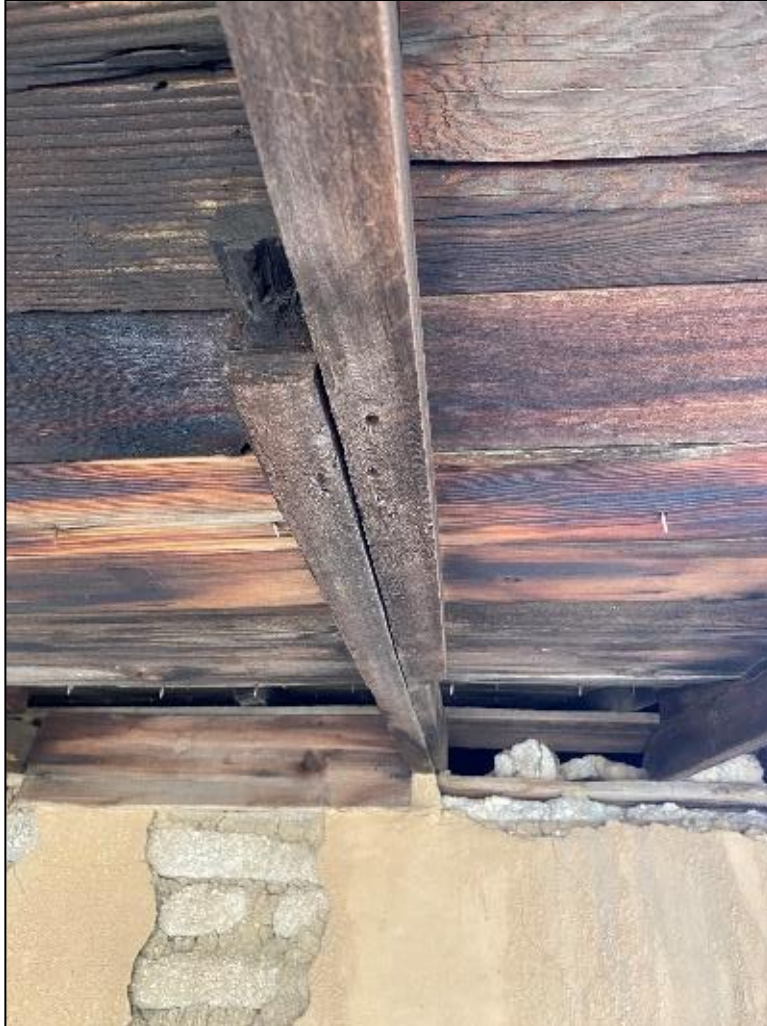
The José María Gil Adobe has multiple roofs. There are areas of the building where roofs are stacked in layers. Based on the coloration of the material, the sizes of the material, and the clear failure of the lower roof, all seen in Figure 96, the roof seen from the exterior is not the original roof. Pictured in Figure 96 is what could be the original roof, collapsed underneath the upper roof that was added in 1993.

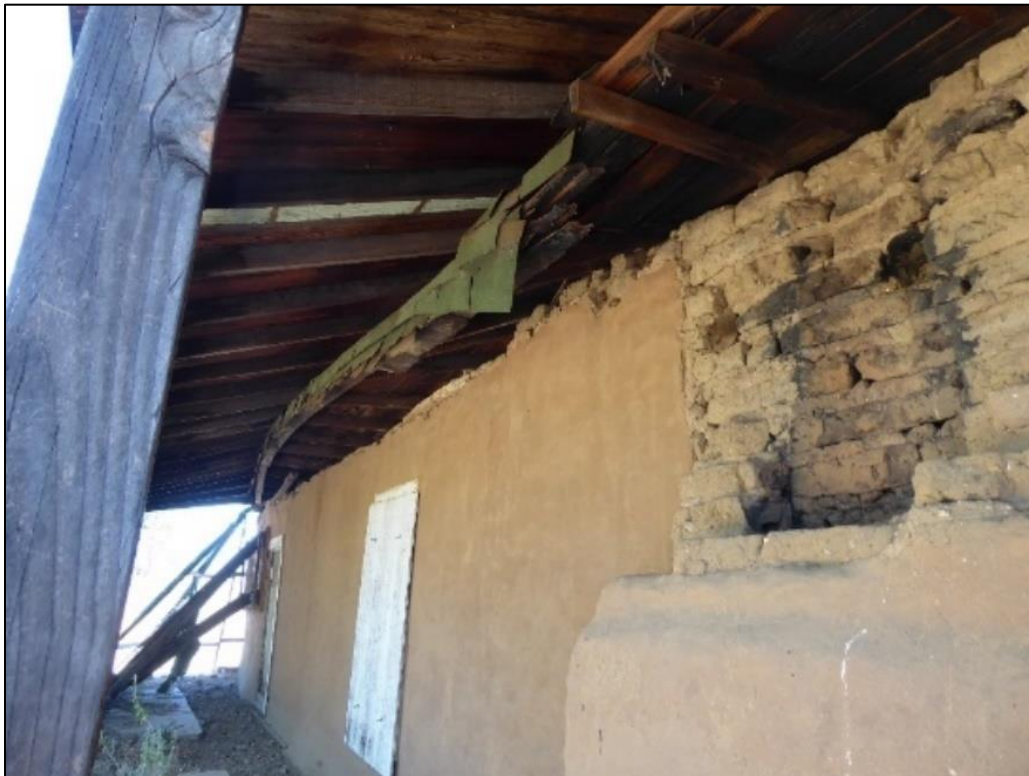
Wooden trim lines the exterior windows and doors of the José María Gil Adobe (Figure 97 and Figure 98). The trim varies in sizes from 3 to 5 in. within and between windows, meaning a single window could have a 5 in. piece of trim on the left side and a 4 in. piece of trim on the right. In some cases, the edges of the wood have split and broken off. The trim is missing in some areas, and it is also very crooked due to lack of fasteners as many have rusted away. It is important to remember that no two doors or windows are alike on this structure. This is due to the uniqueness of the adobe building, resulting in multisized window and door openings, as well as the fact that some are of different materials and ages. The windows were originally six-over-six, double-hung wood windows. Many windows are missing either some or all of their muntins (Figure 99).

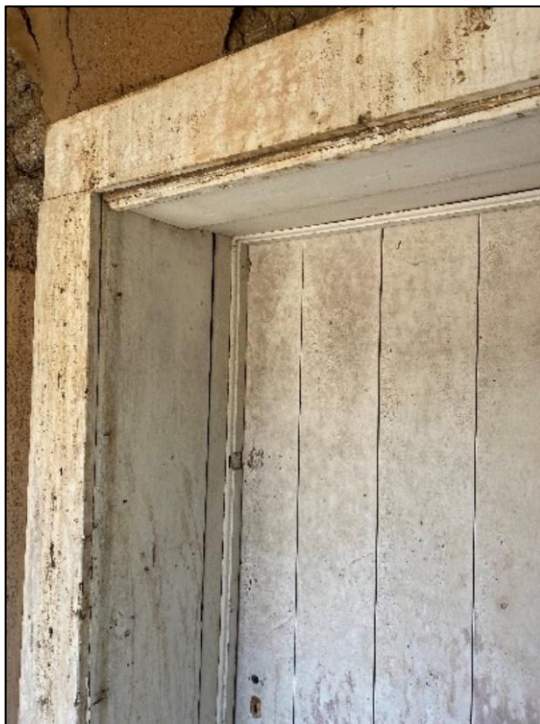
Figure 98. White-painted window trim surrounding a window on the west side of the José María Gil Adobe, 2021. (ERDC-CERL.)

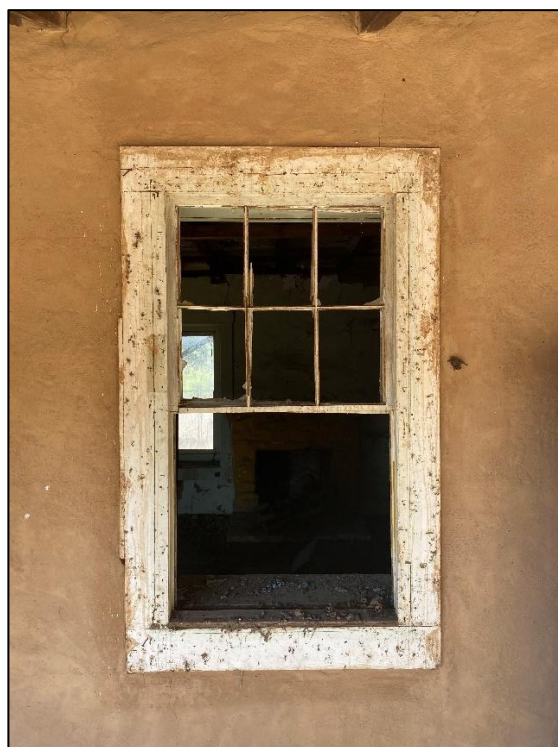
Figure 99. Sagging windows and missing muntins on the west side of the José María Gil Adobe, 2021. (ERDC-CERL.)

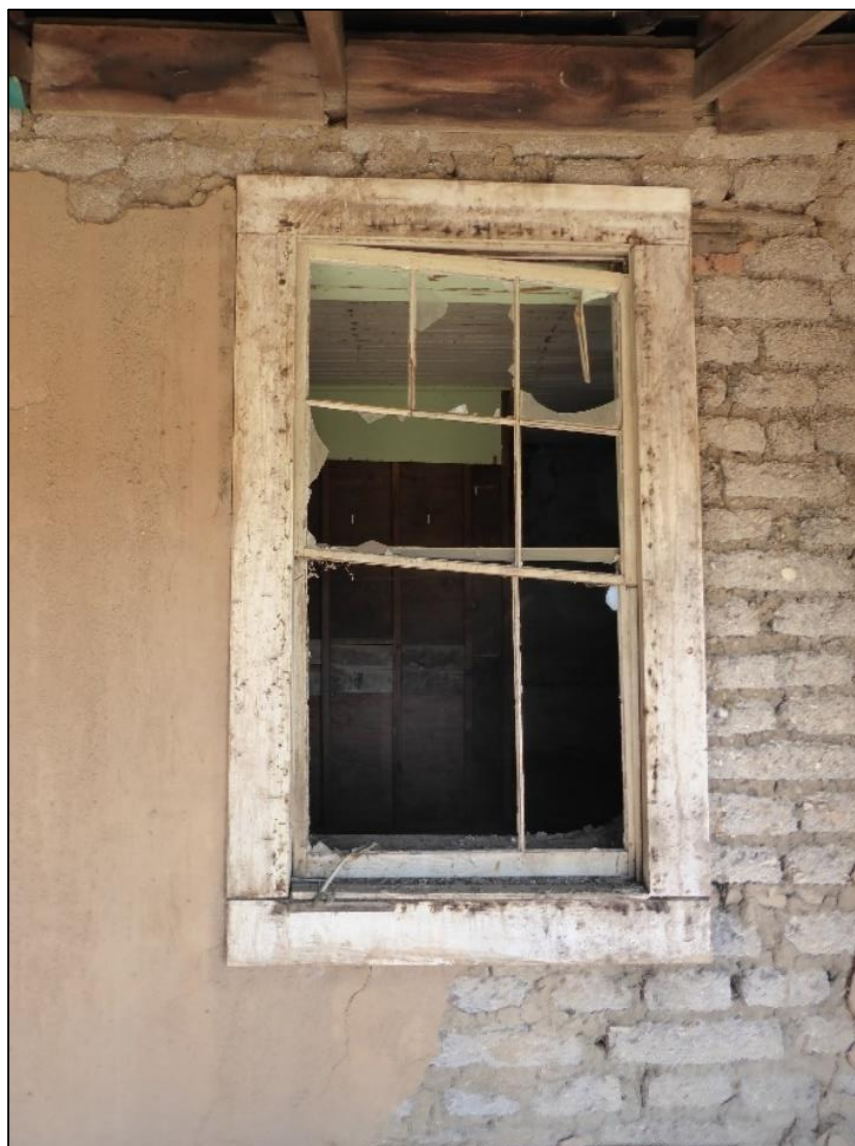
The José María Gil Adobe has two types of exterior wooden doors. The main type is a door constructed of vertical boards (Figure 100), with an X-brace on the inside (Figure 101).

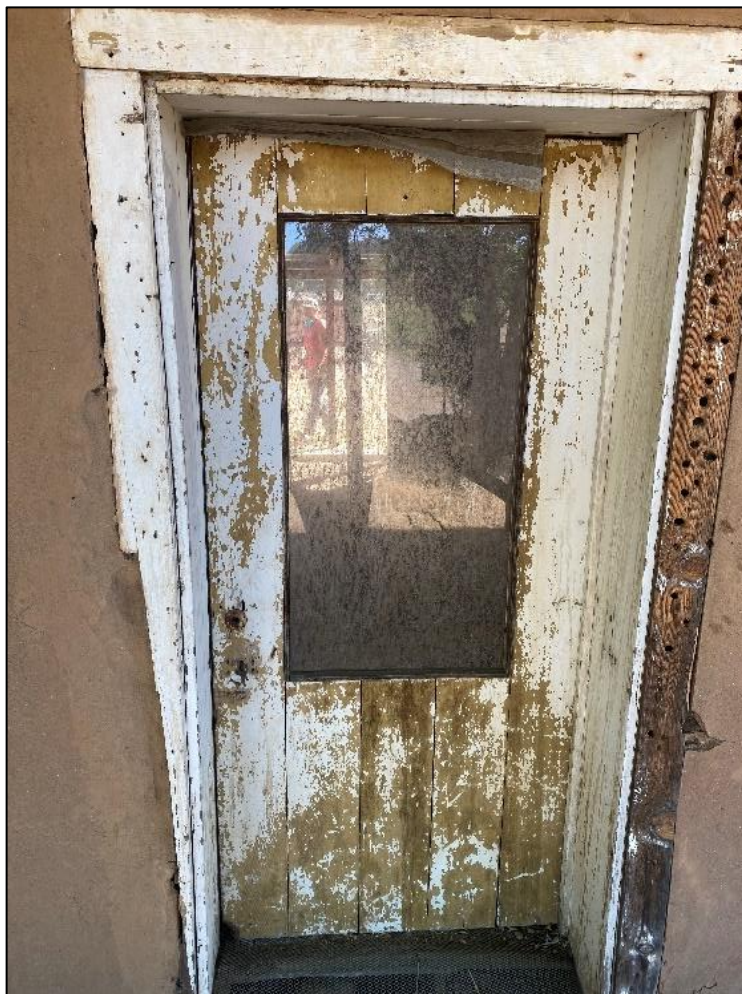
Animals digging along the perimeter of the José María Gil Adobe led to the exposure of the wooden base of the adobe wall (Figure 103). It was common for builders to use wooden members or stones to act as a foundation, though some adobes had little to no foundation.

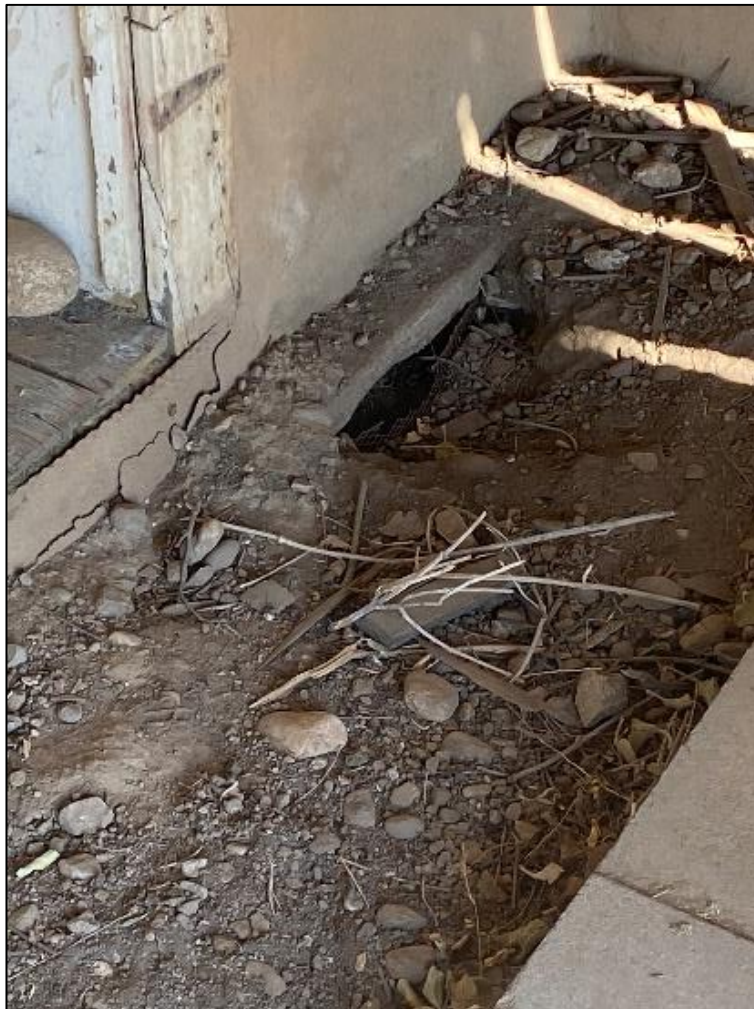
The US Army purchased the José María Gil Adobe in September of 1940 and since then has tried to keep the adobe standing by using insufficient and temporary methods. Wooden, buttress-like support braces were added on the north side of the building to prevent the walls from collapsing outward, contributing to load support in the lateral direction (Figure 104). The concrete columns on the northeast side of the building (there are crumbling columns on the south side) have been increased in height by wooden disks, most likely for leveling purposes (Figure 105). Some columns have failed and are now supported with wooden braces (Figure 106).

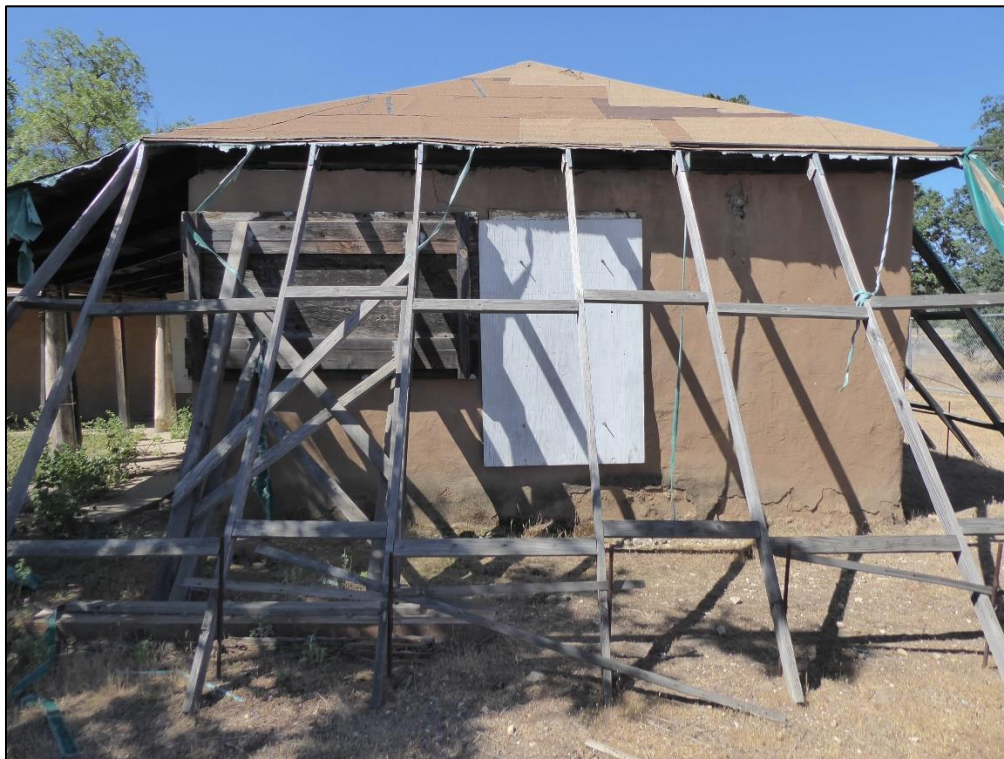
Figure 105. Wooden disks on top of the concrete columns supporting the veranda roof, possibly for leveling purposes, on the José María Gil Adobe, 2021. (ERDC-CERL.)

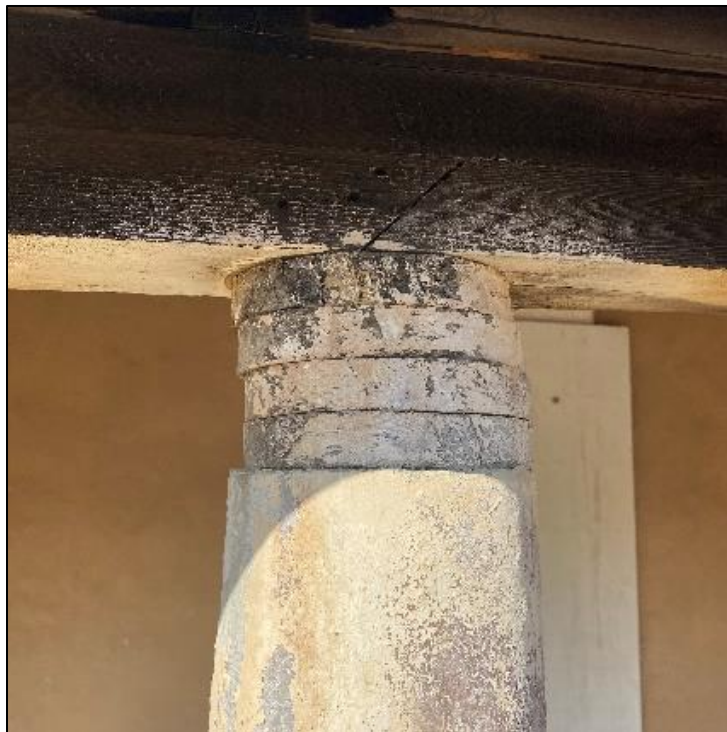
Figure 106. Two wooden 2 × 4 in. boards supporting a concrete column that is cracked in multiple places, 2021. (ERDC-CERL.)
