**US Army Corps  
of Engineers®**  
Engineer Research and  
Development Center

## **José María Gil Adobe**

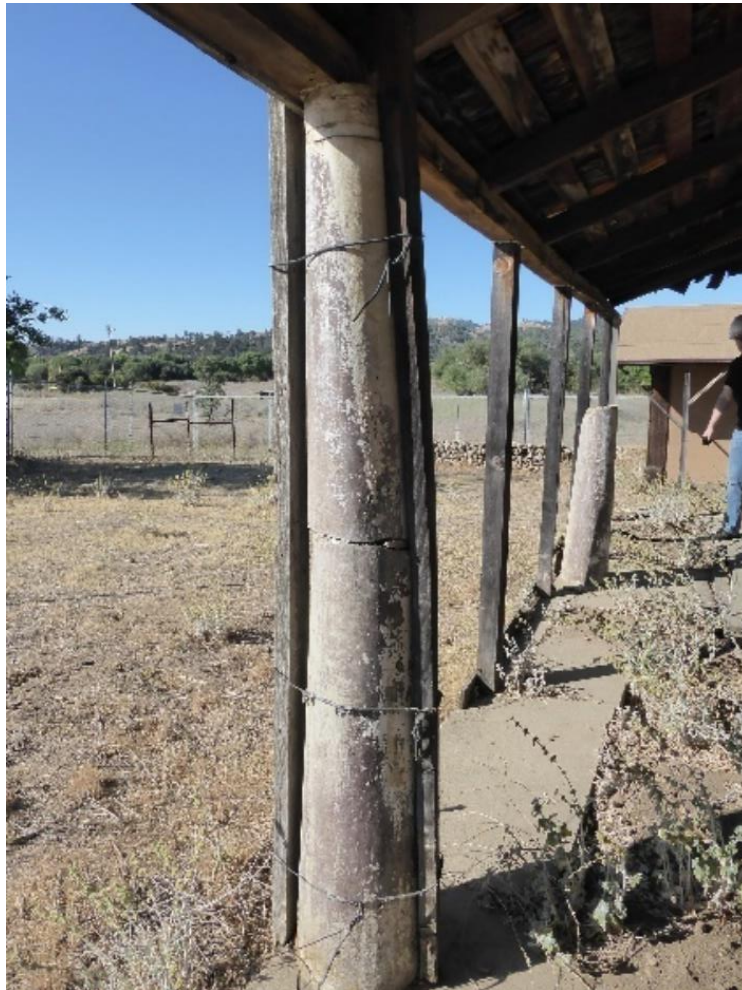
Due to the erosion on the exterior portion of the south chimney, two circular wooden posts horizontally placed into the chimney are now exposed (Figure 107). It was common to place wooden shims within adobe walls for leveling and strengthening purposes. These wooden pieces are not visible on the interior of the building.

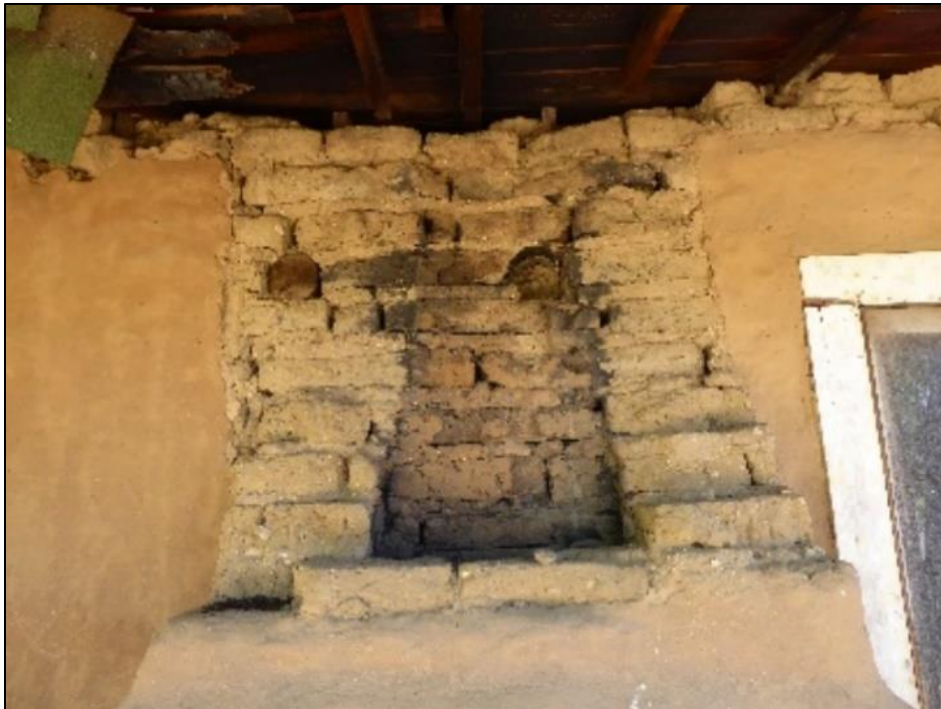
## 6.2 Interior wood features

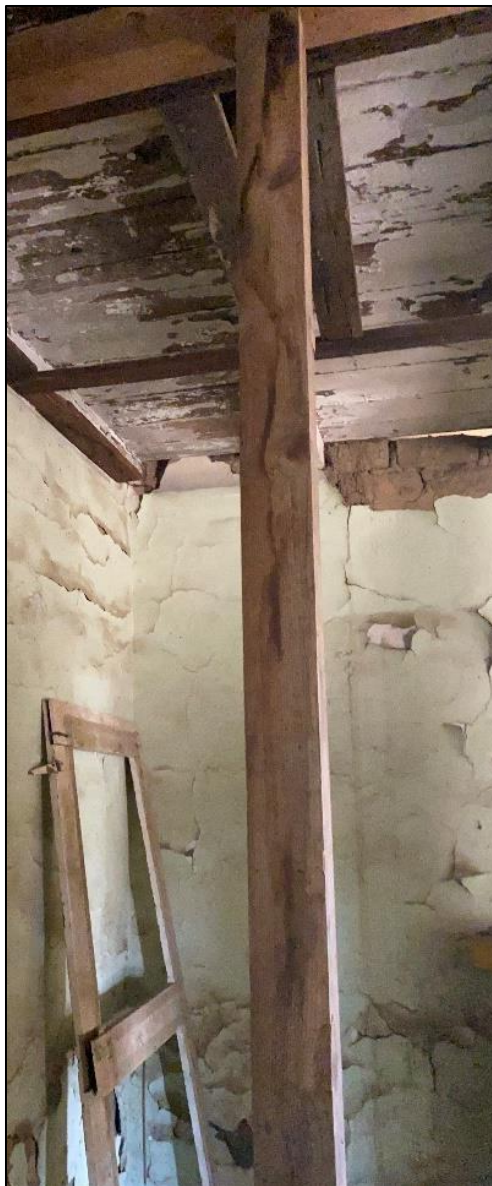
The floor of the José María Gil Adobe is wood strip flooring in some rooms and dirt in others. The wooden floors are in “POOR” condition. The majority of the floorboards are rotten due to their age and exposure to the elements due to roof leaks and wildlife. The floor is missing boards in some areas due to breakage (Figure 112, Figure 113, and Figure 114).

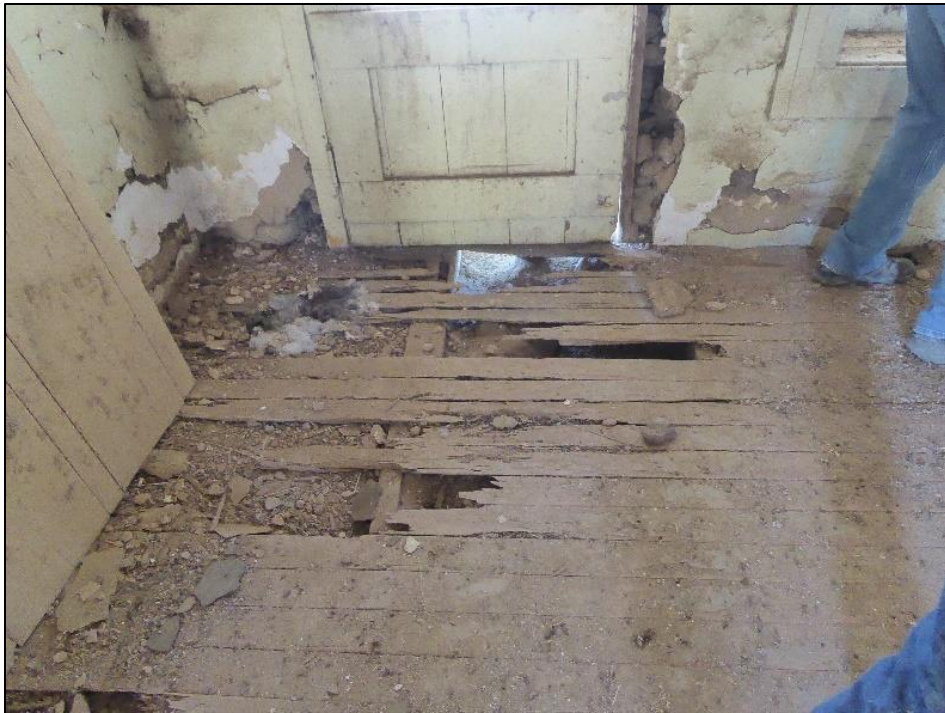
Figure 113. Wood strip flooring with breakthrough areas in a central location of a floor in the José María Gil Adobe, 2021. (ERDC-CERL.)

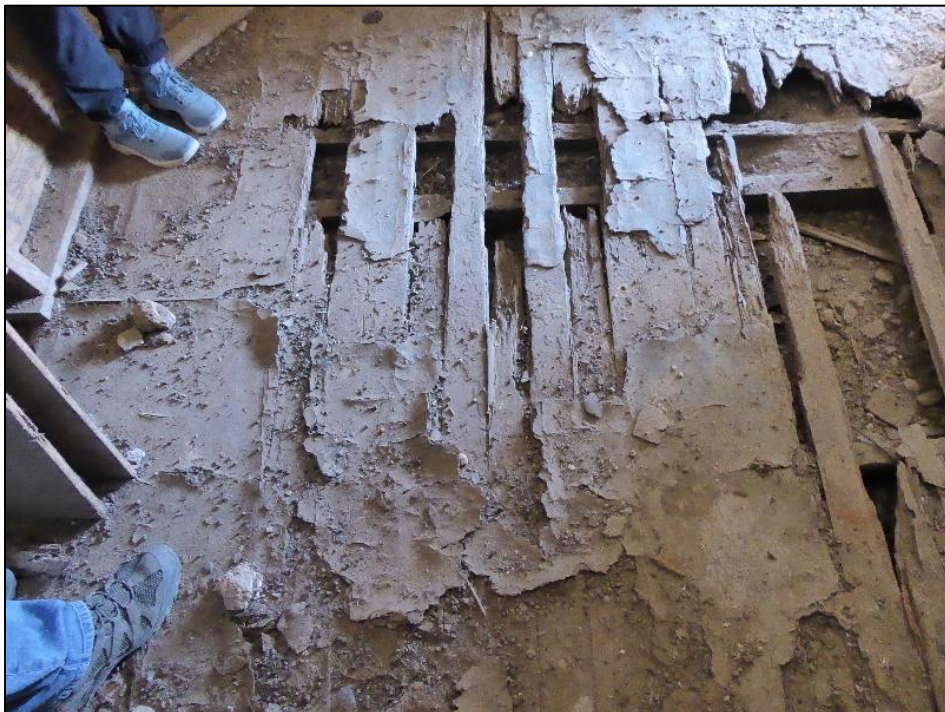
Figure 114. Broken wood strip flooring piled near exposed plumbing in the José María Gil Adobe, 2021. (ERDC-CERL.)

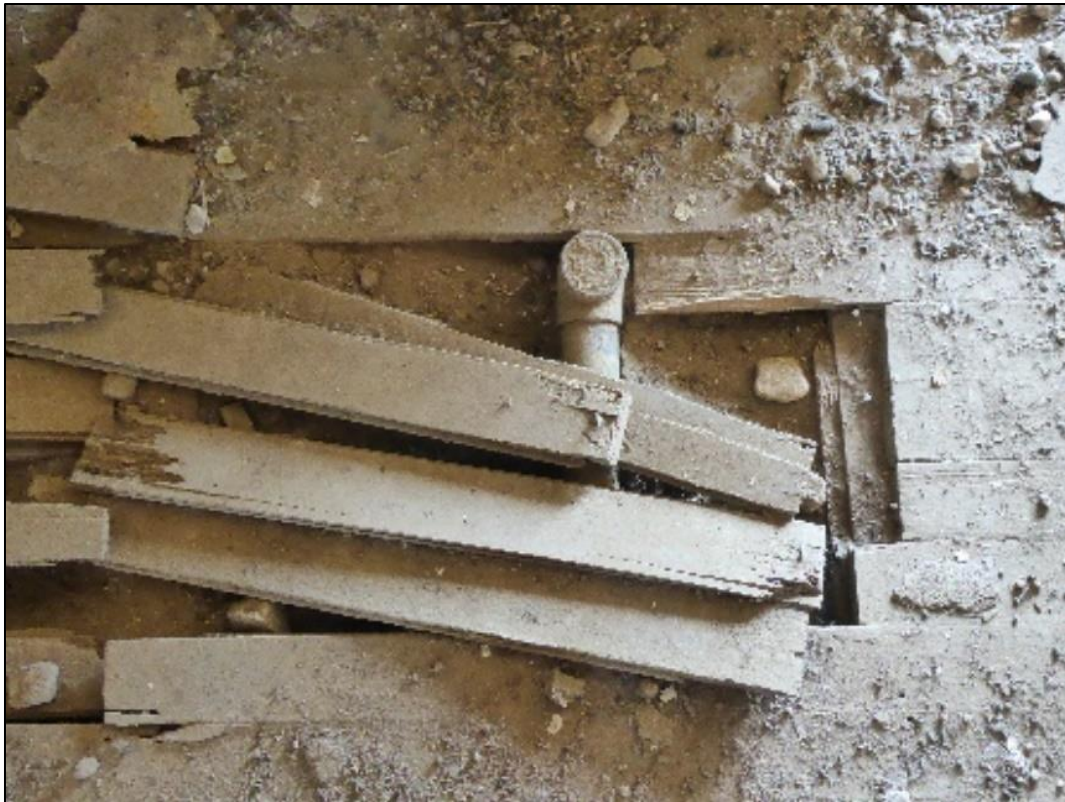
There is a wooden shelf located in the north portion of the José María Gil Adobe (Figure 115). The room with the shelf has plumbing connections, square shower floors, and a wooden toilet paper roll holder that is pictured in Figure 116. These bathroom fixtures were installed when the Army acquired the José María Gil Adobe during World War II. There is a wooden coat closet near an interior door in the south portion (Figure 117).

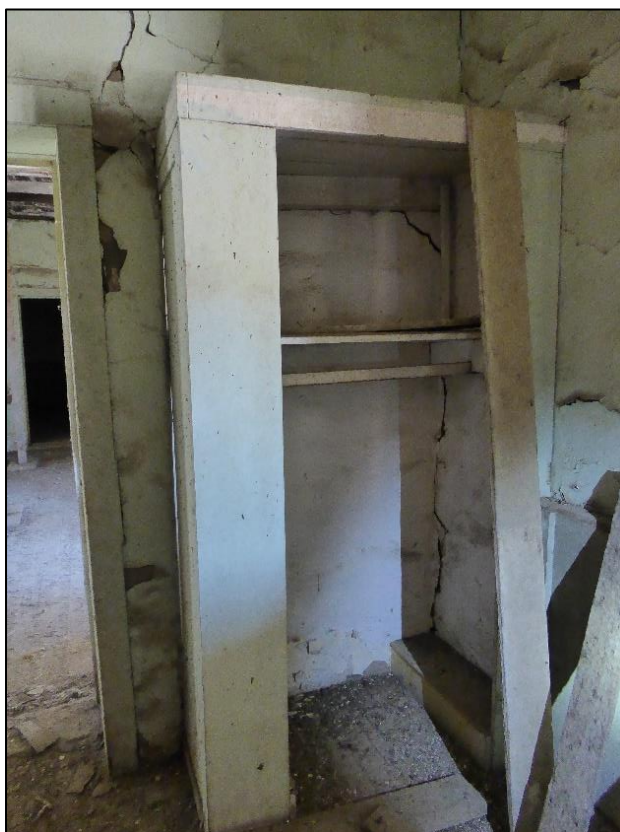
The José María Gil Adobe has wooden windows and wooden window and door trim throughout the interior of the building. There is a singular wooden door that remains on the interior of the building. There are many wooden elements within the adobe walls, such as shims or headers. The wooden trim varies in sizes throughout the building as some of the edges are broken due to splitting. There are many irregular shapes as well as crooked details due to the age of the material and the uniqueness of the openings.

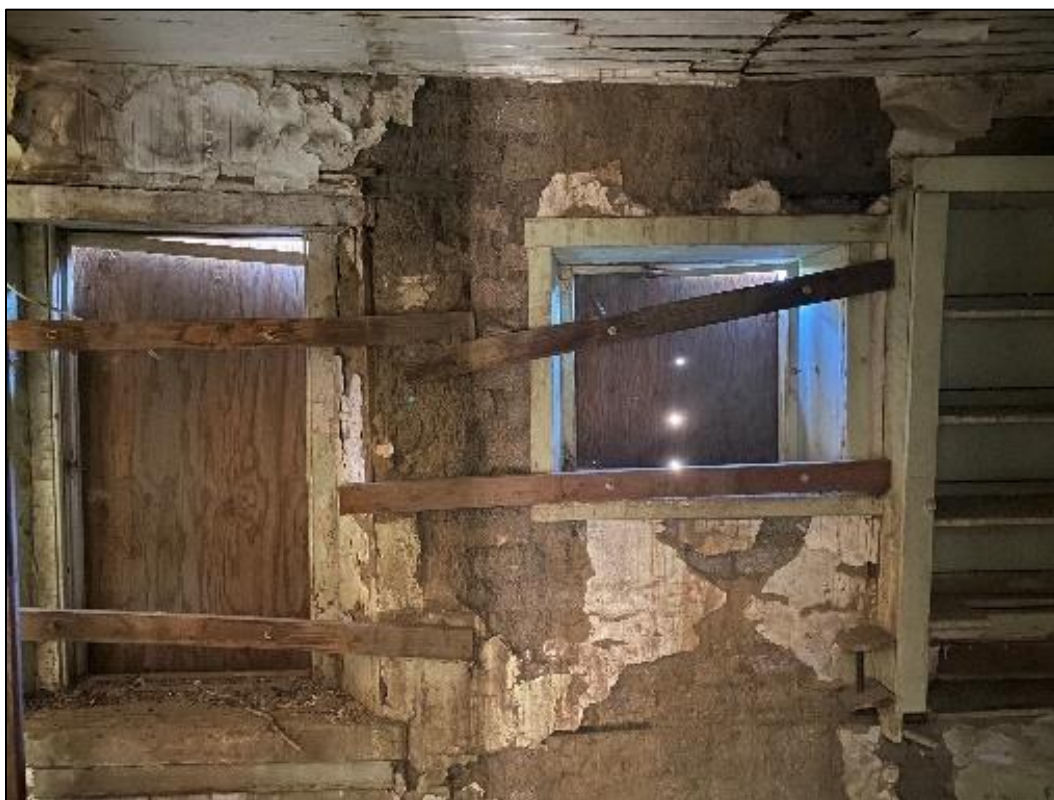
Figure 119. Interior wooden door trim with a missing board on the *right side* in the José María Gil Adobe, 2021. (ERDC-CERL.)

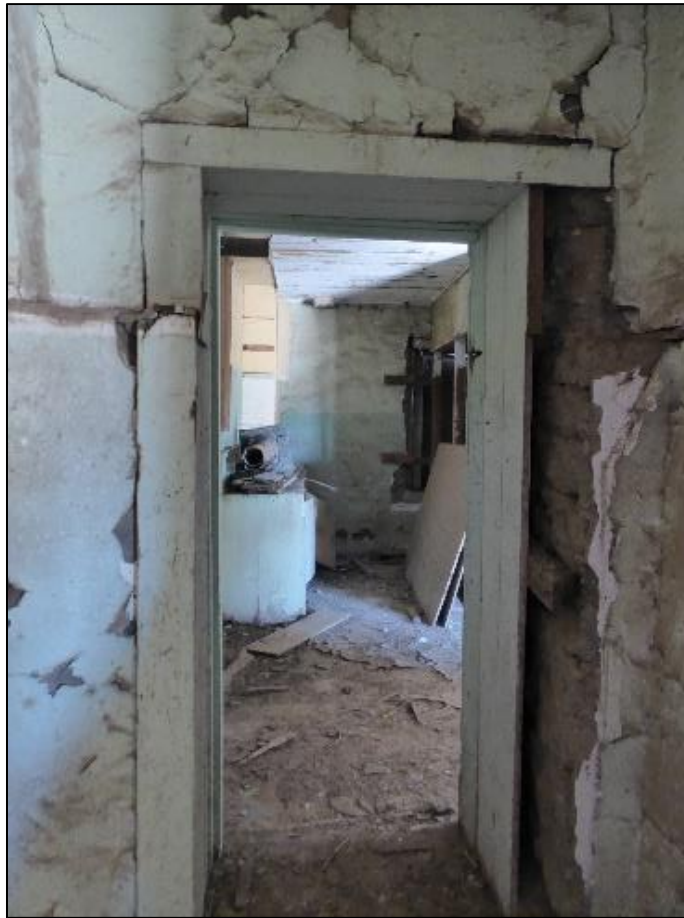
The current windows are wooden and appear to have originally been six-over-six, wood-sash, double-hung windows, though many are missing some or all of their muntins. See Figure 120, showing intact wood muntin on the top half of the window.

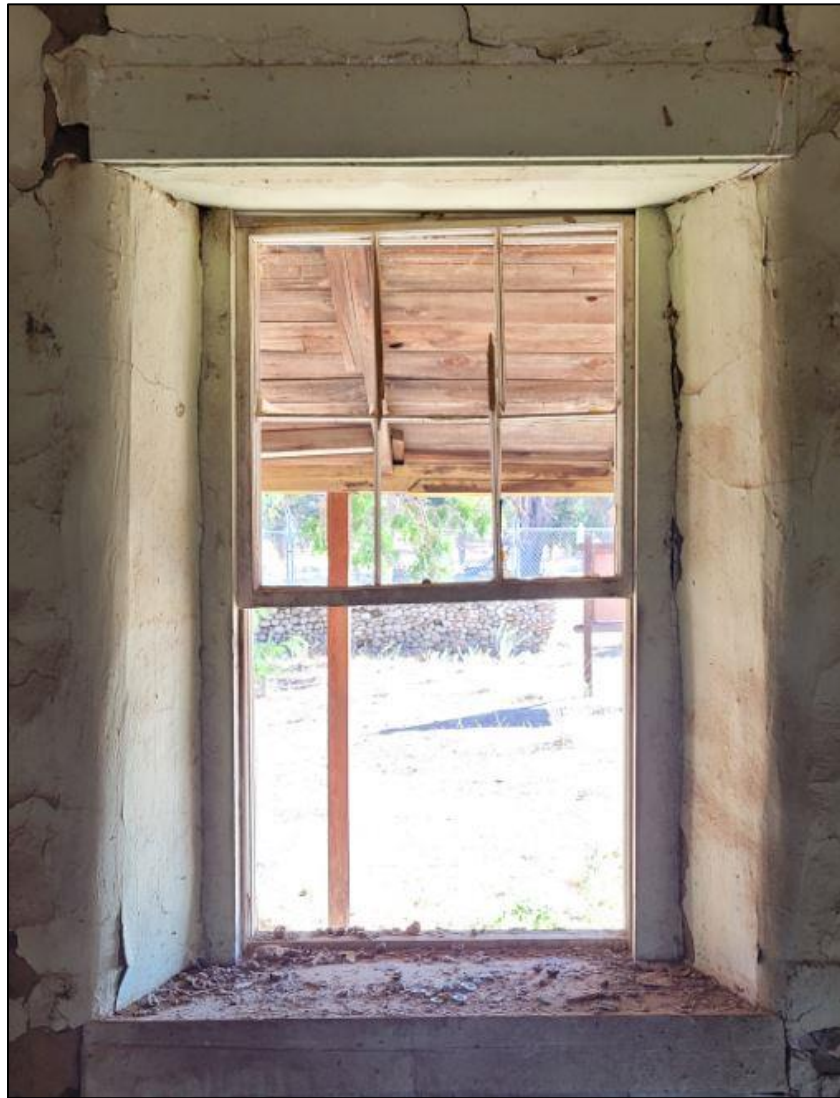
The José María Gil Adobe has wooden window and door headers throughout the building of various forms and sizes. Some header components are covered by wooden trim (see covered version in Figure 121 and exposed version in Figure 122). Most interior doors are missing; however, the wooden door headers support the thick adobe walls in the openings (Figure 123). The doors have wooden thresholds (Figure 124).

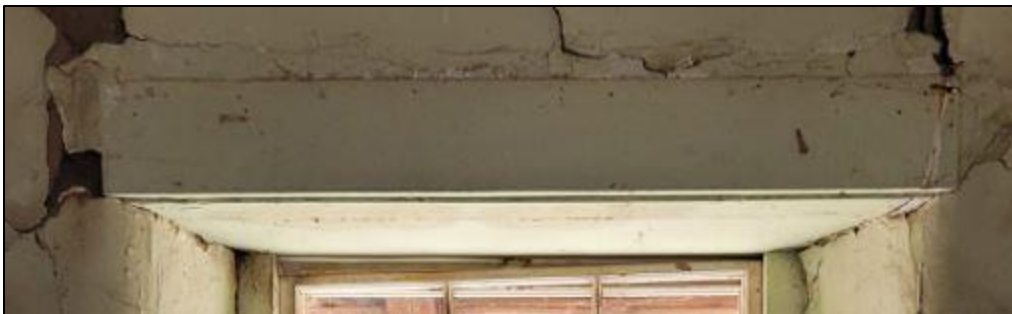
Figure 122. Exposed wooden window header in the south wing of the José María Gil Adobe, 2021. (ERDC-CERL.)

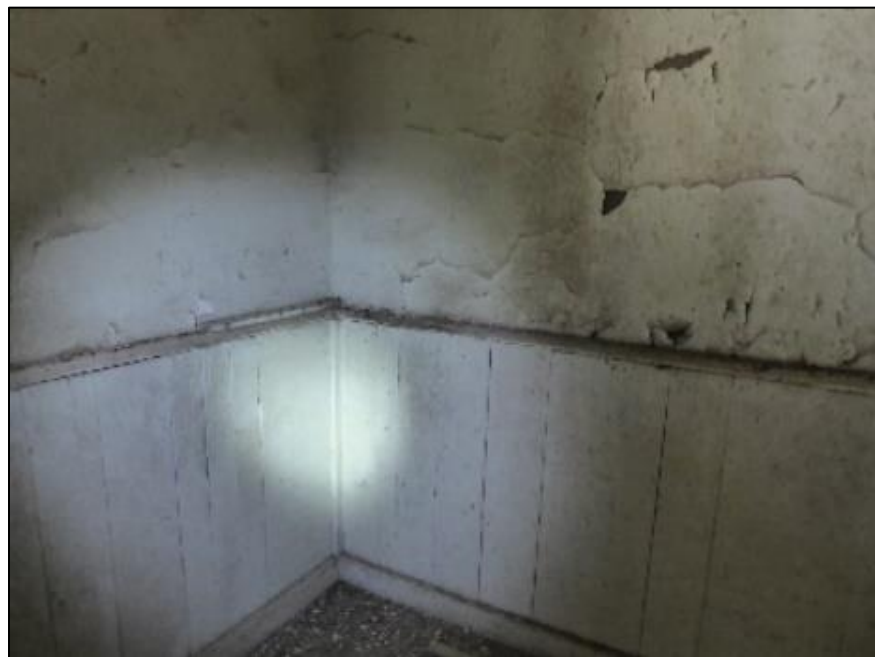
The north wing of the José María Gil Adobe was heavily modified after the building was acquired by the Army during World War II. Wooden cabinets and counters as well as partition walls were added to create kitchen and bathroom space in this wing. The wooden kitchen elements remain in “POOR” condition (Figure 128). The addition of wooden walls served a double purpose of creating the bathroom space as well as supporting roof loads in this wing. The walls were constructed using a 2 × 4 in. frame with a mixture of plywood and wood plank sheathing (Figure 129 and Figure 130). The wooden materials appear to be in “FAIR” condition.

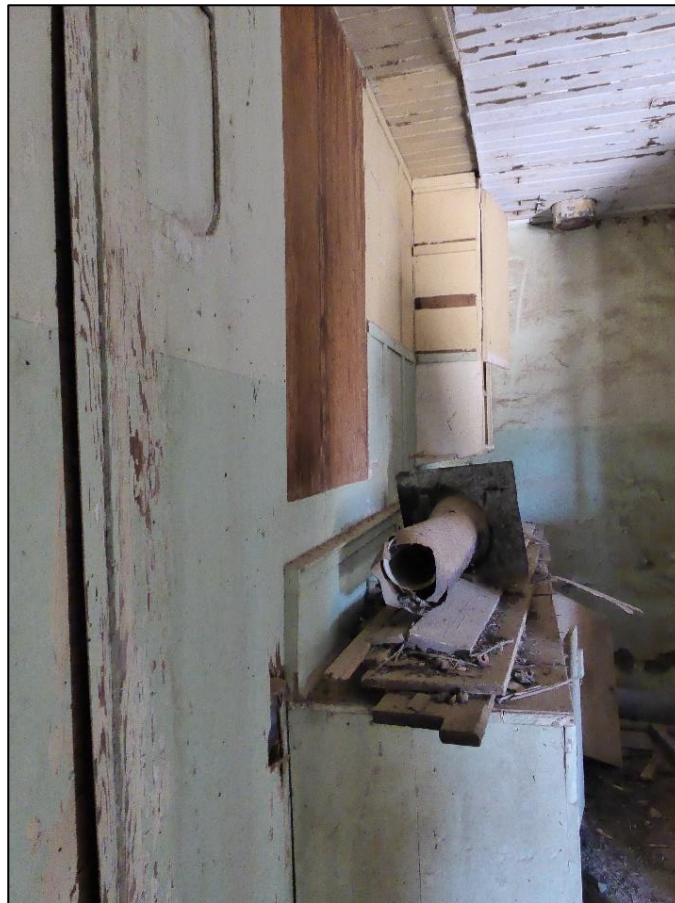
Figure 129. Wooden partition wall using plywood and studs, framing the bathroom space in the north wing of the José María Gil Adobe, 2021. (ERDC-CERL.)

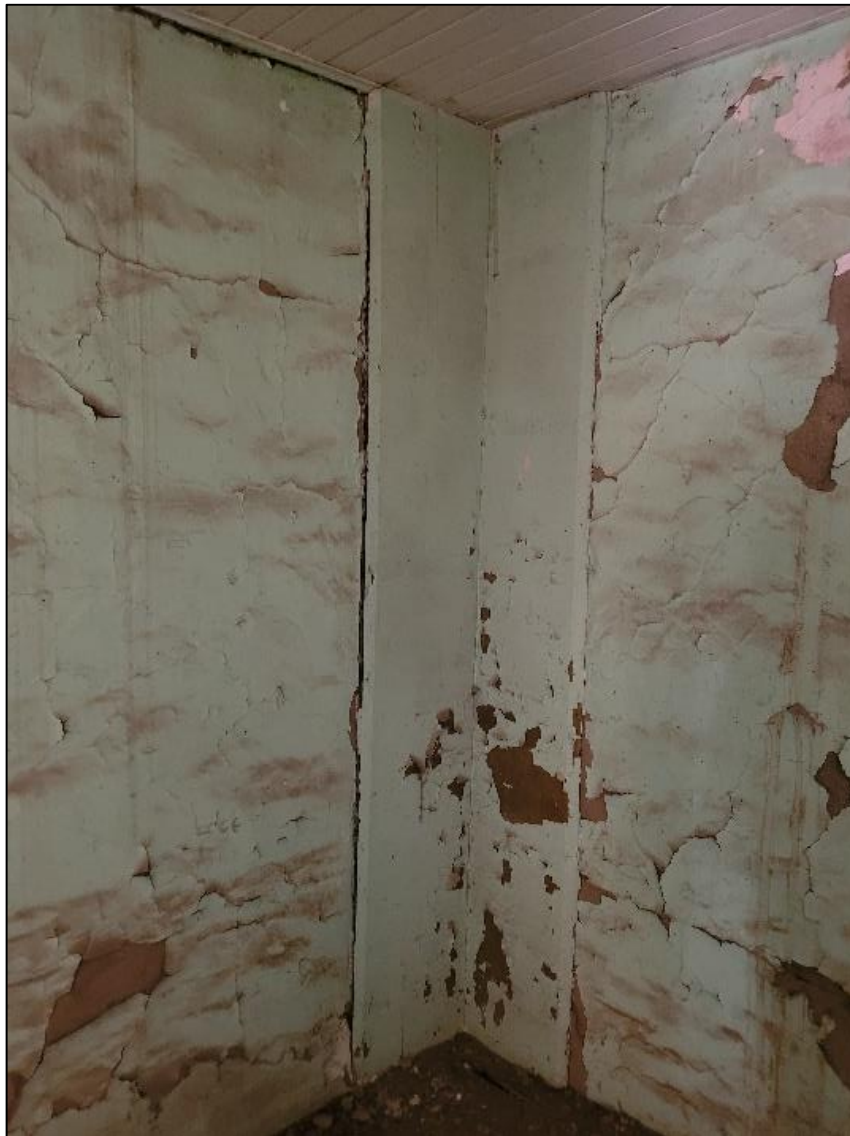
### 6.3 Treatment measures

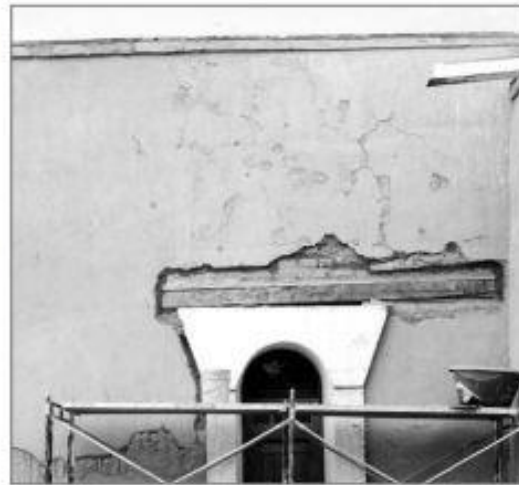
Lintel repair and replacement was an important part of the preservation project completed in 2005 at the mid-19th century mission at Socorro, Texas. (Pat Taylor, 2004)

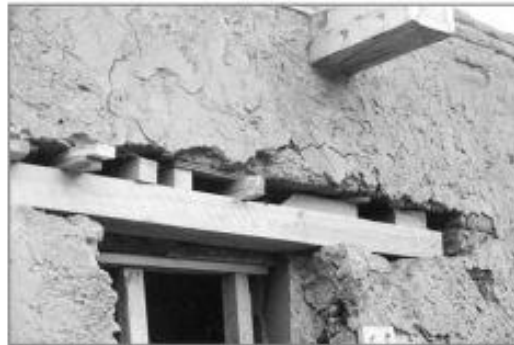
2. Determine the correct length for the replacement lintel by measuring the width of the window or door opening. The lintel must span the opening and extend beyond it on each side of the opening for a minimum of one-third of the width of the opening. For example, if the width of the opening is four feet (48 inches), then the lintel needs to extend for a minimum of 16 inches into the adjacent wall. If the opening the lintel needs to span is wider than the typical three- or four-foot window or door opening, we recommend that you consult with an experienced tradesperson or structural engineer to determine the optimum dimension for the replacement lintel.

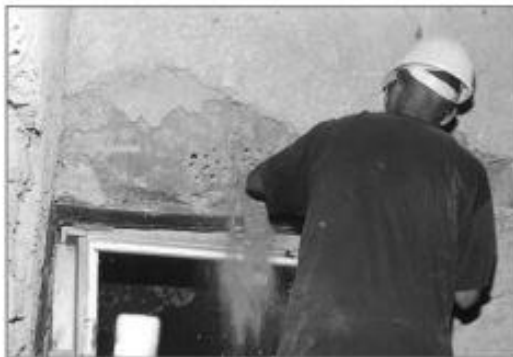
5. Remove the damaged or rotten lintel on only one side of the wall at a time. (Always remove just the amount of wall plaster and material necessary to create a space large enough to remove the old lintel and to insert the new.) If you need to remove any adobe or stone from the area in order to fit the new lintel in place, make sure you only remove them from a space equal to one-half the wall depth. This is essential for correctly transferring wall loads and for your safety. Remember: Never remove more than half the depth of the wall at any point in this process. If rough buck and window are in place, do not remove adobes first from above because they help support the wall load. In that event, remove adobes from the opposite side first.

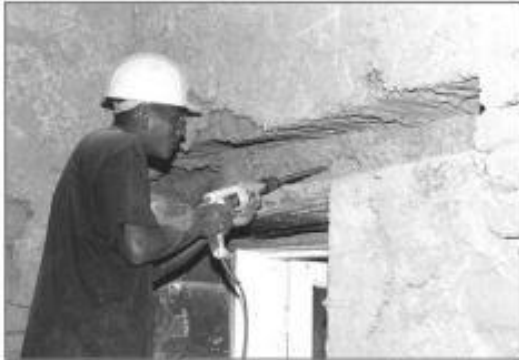
6. A wrecking bar, hammer, trowel, and/or a drill with a masonry bit can be used to remove material. It is very important to keep vibrations to a minimum when removing material. Do not do any heavy banging on the wall. If the material is too difficult to remove, the drill and masonry bit can help in drilling out the mortar joints in order to get started. Clean out the opening with a whiskbroom as soon as one side of the old lintel and any extraneous wall material have been removed.

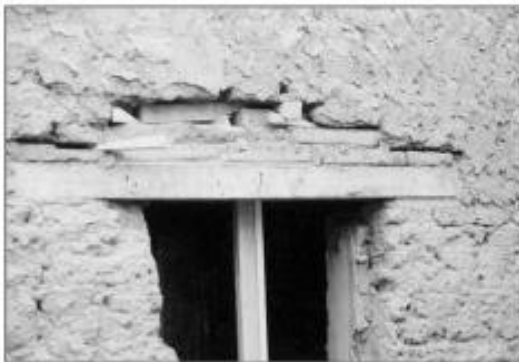
8. When you are certain the new lintel fits well into the space and is level, lift it out of the space and wet all of the wall surfaces around the space where the lintel will fit and lightly wet the surface of the lintel. Spread a thin layer of mud mortar (no more than 3/4 of an inch thick) on the surfaces of the opening and then insert the lintel into the space. Place wood shims between the top of the lintel and the walls every four to six inches. Make sure they are snug and tight and then allow the wet mortar to dry.

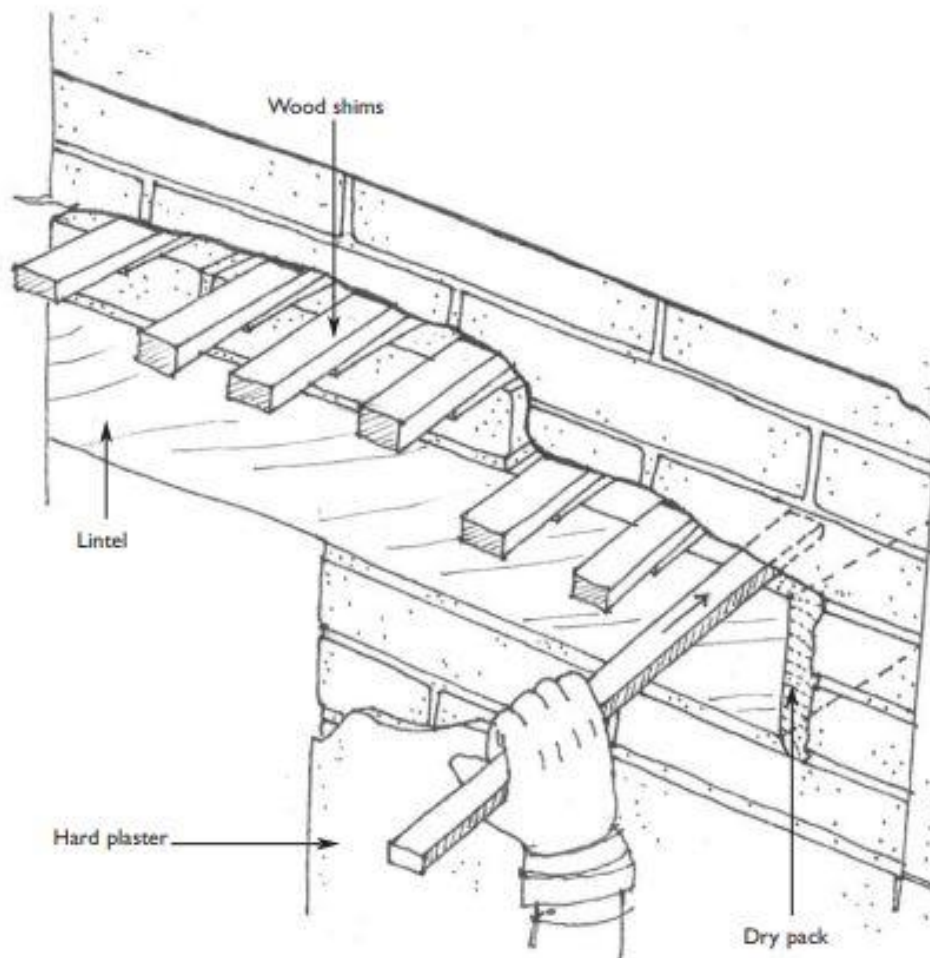
10. Using a 3/8-inch margin trowel push the dry-pack mortar into the space around the lintel. Do not remove your shims just yet. Make sure the dry-pack is pushed the entire way back into the space around the lintel. A push stick may be needed to get this material all the way to the back. As you push this material in, you want to pack it tightly and slowly build it out to the face of the lintel. Double check that you have it forced back all the way and that it is well compacted and keeps its shape.

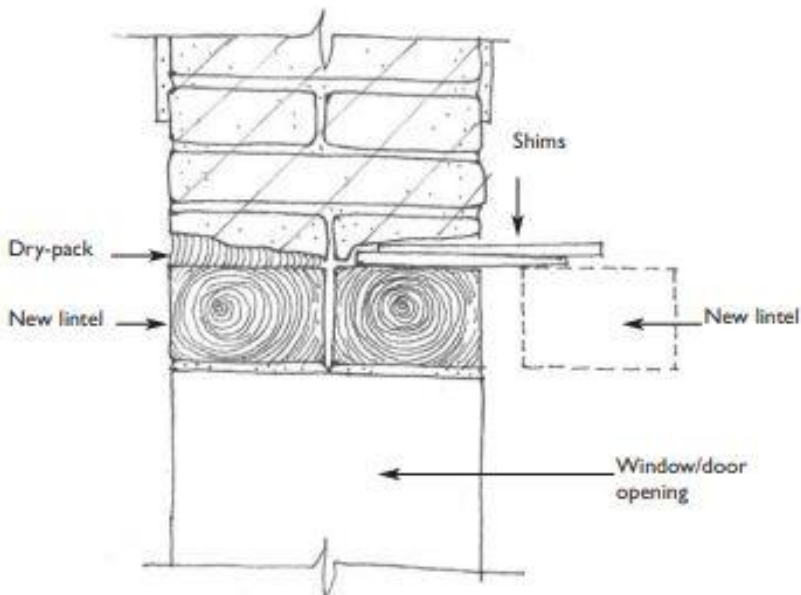
12. If you need to set in another piece of lintel on this side of the wall, repeat the steps followed for inserting and dry-packing the first piece of the lintel.

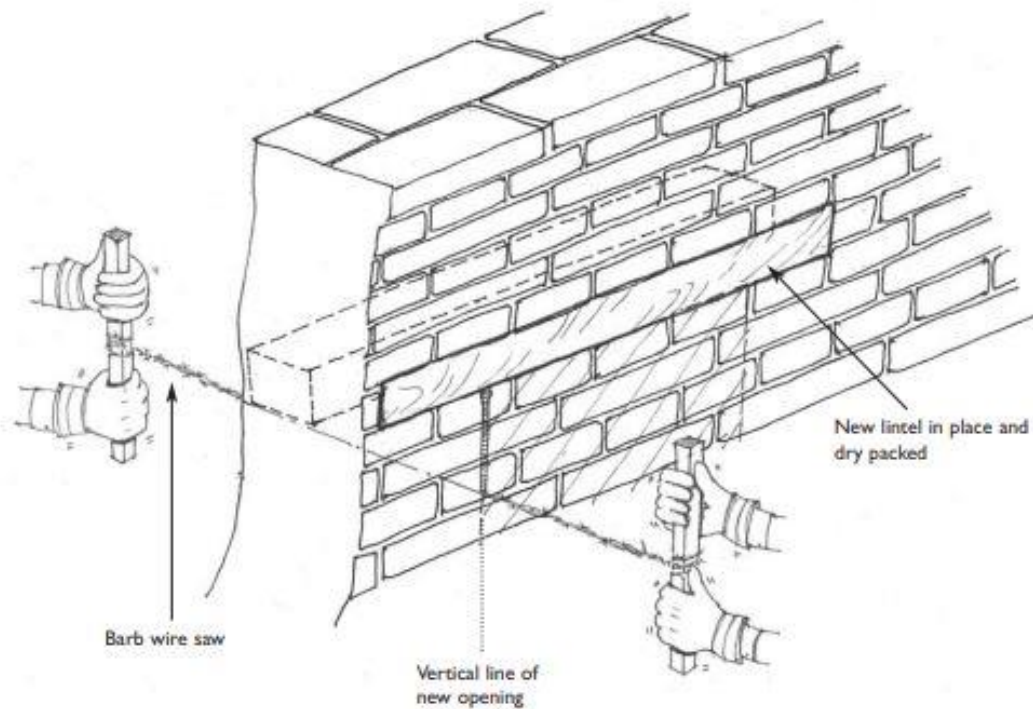
12. Once you have installed the lintels on both sides of the wall you can cut out the opening for the new door or window. There are several ways to do this. In an adobe wall the easiest way is to make a saw out of several strands of barbed wire twisted together and fastened to wooden handles at each end. The "saw" will need to be at least three feet longer than the depth of the wall in order to prevent you from scraping your hands and fingers against the rough wall as you pull the saw back and forth. First cut a hole that is just big enough to get the barbed wire saw through just below the lintel and at the edge of the opening. Once the barbed wire saw is ready to go locate someone to help you on the other side. Then just start sawing back and forth keeping an eye on the vertical line drawn for the opening.

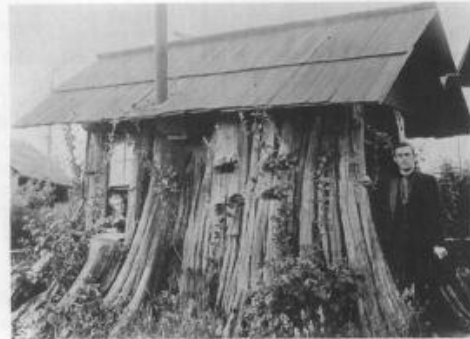
The Secretary of the Interior's "Standards for Rehabilitation" call for the repair or replacement of missing architectural features "based on accurate duplication of features, substantiated by historic, physical, or pictorial evidence rather than on conjectural designs." On a wooden shingle roof, it is important not only to match the size, shape, texture, and configuration of historic shingles, but also to match the craftsmanship and details that characterize the historic roof. Proper installation and maintenance will extend the life of the new roof.

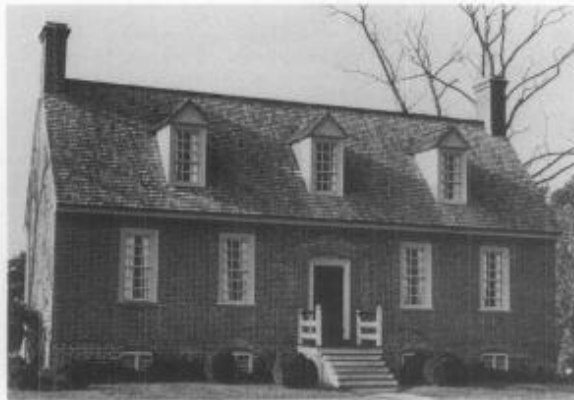
1. The Rolfe-Warren House, a tidewater Virginia property, was restored to its 18th-century appearance in 1933. The handsplit and dressed wooden shingles are typical of the tidewater area with special features such as curved butts, projecting ridge comb and closed swept valleys at the dormer roof connections. Circa 1970 Photo: Association for the Preservation of Virginia Antiquities.

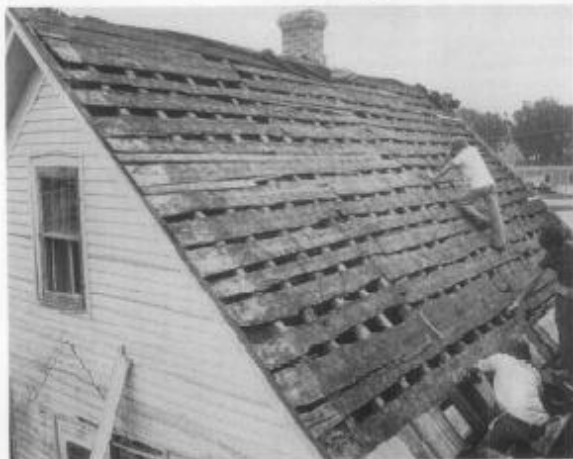
7. The reshingling of the circa 1856 Stovewood House in Decorah, Iowa, revealed the original open sheathing boards and pole rafters. Sawn cedar shingles were used as a replacement for the historic cedar shingles seen still in place at the ridge. A new starter course is being laid at the eaves. Photo: Norwegian-American Museum, Decorah, Iowa.

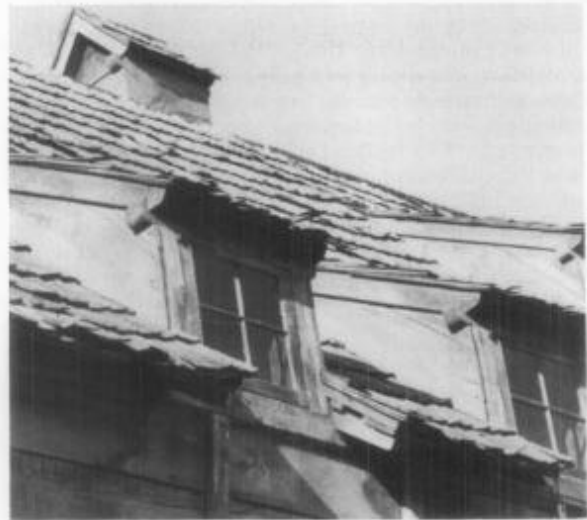
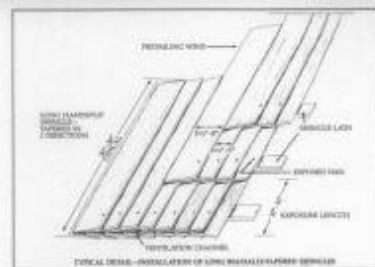
8. The long biaxially tapered handsplit shingles on the Ephrata Cloisters in Pennsylvania were overlapped both vertically and horizontally. The insert sketch shows channels under the shingles that provided ventilation and drainage of any trapped moisture. The aged appearance of these handsplit and dressed shingles belies their original smoothness. Replacement shingles should match the original, not the aged appearance. Photo: National Park Service; Sketch: Reed Engle.

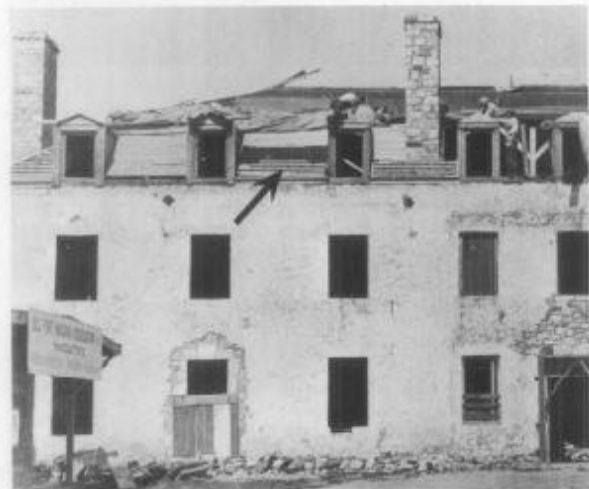
9. This 1927 view of the reshingling of the French Castle at Old Fort Niagara, N.Y., shows the wooden sleepers being laid (see arrow) over solid sheathing in order to raise the shingles up slightly to allow under-shingle ventilation. Note that the horizontal strips are not continuous to allow airflow and trapped moisture to drain away. This cedar roof has lasted for over 60 years in a harsh moist environment. Photo: Old Fort Niagara, Assoc. Inc.

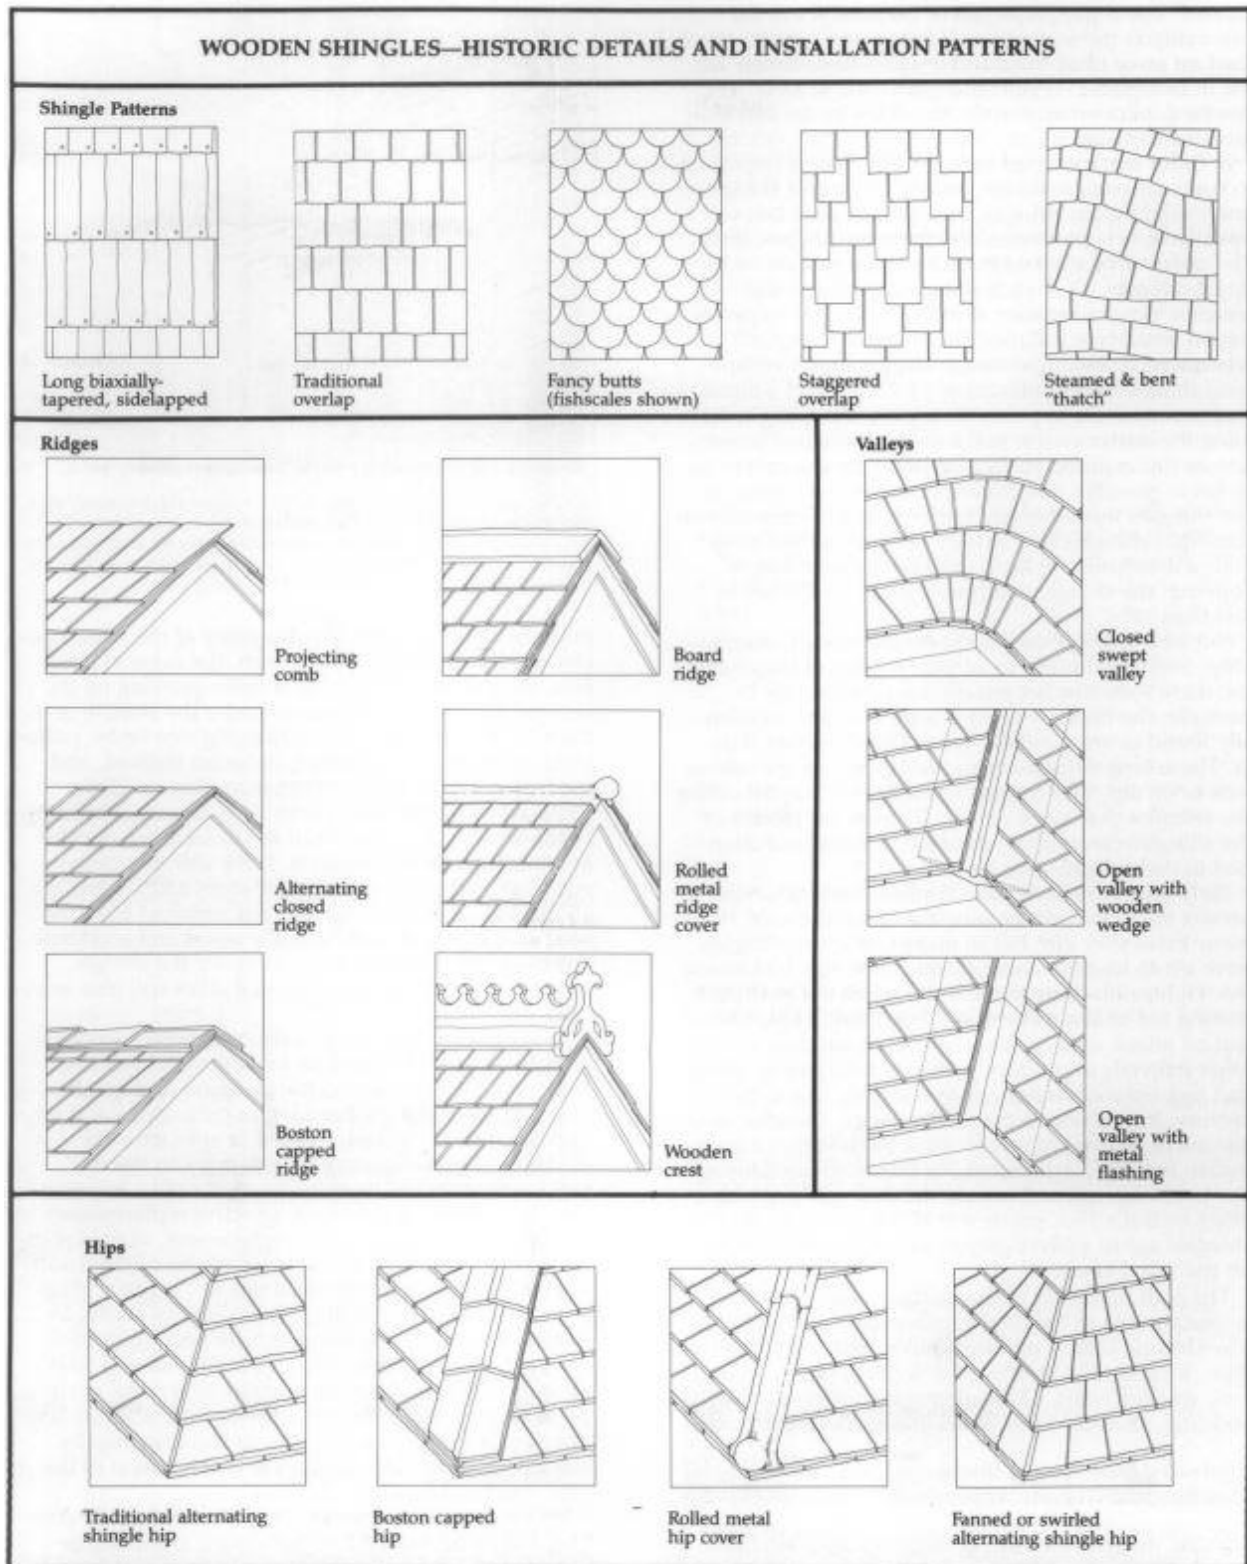
10. The Historic Details and Installation Patterns Chart illustrates a number of special features found on wooden roofs. Documented examples of these features, different for every building and often reflecting regional variations, should be accurately reproduced when a replacement roof is installed. Chart: Sharon C. Park; delineation by Kaye Ellen Simonson.

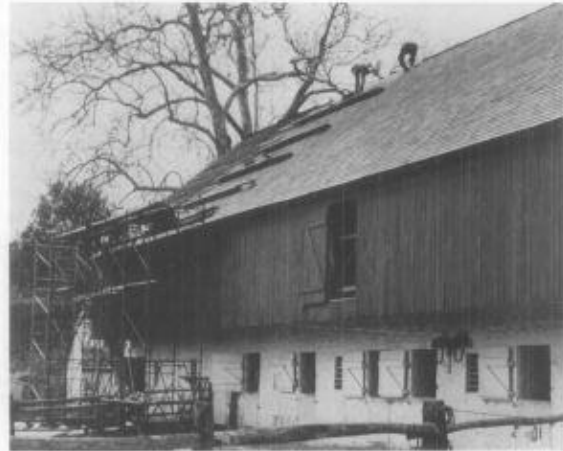
11. The replacement sawn red cedar shingles matched the deteriorated shingles exactly for this barn re-roofing. The old shingles, seen to the far left, were removed as the new shingles were installed. Even the horizontal coursing matched because the exposure length for both old and new shingles was the same. Photo: Williamsport Preservation Training Center.

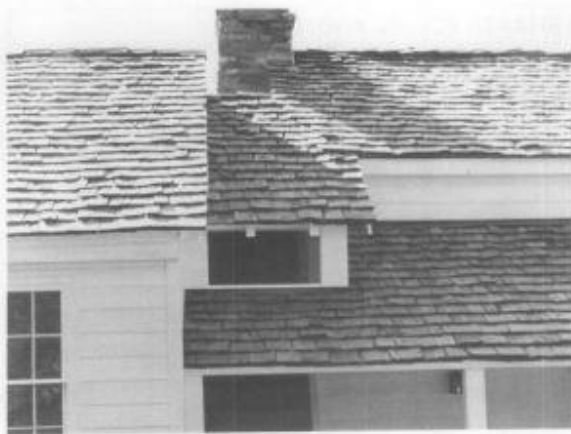
12. Inappropriately selected and installed wooden shingles can drastically alter the historic character of a building. This tavern historically was roofed with handsplit and dressed shingles of a relatively smooth appearance. In this case, a commercially available shake was used to effect a "rustic" appearance. Photo: National Park Service.

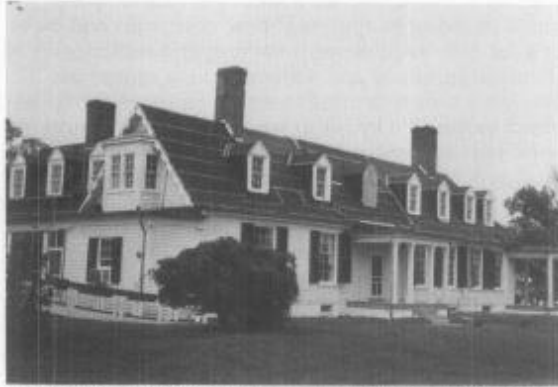
A. The later non-historic shingles were removed from Appomattox Manor (circa 1840 with later additions) and roofing paper was installed for temporary protection during the re-shingling.

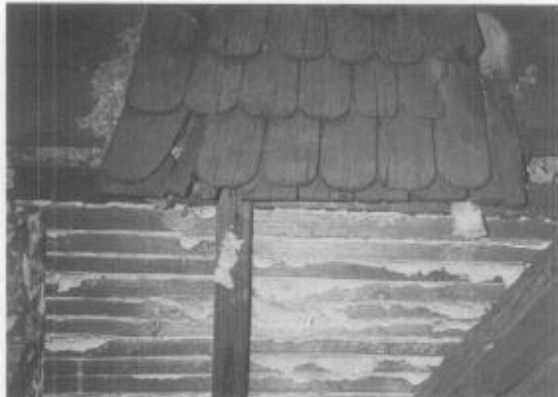
B. These weathered historic 19th-century handsplit and dressed shingles were found in place under a later altered roof. Note the straight butt eave shingles under the curved butts of the historic dormer shingles.

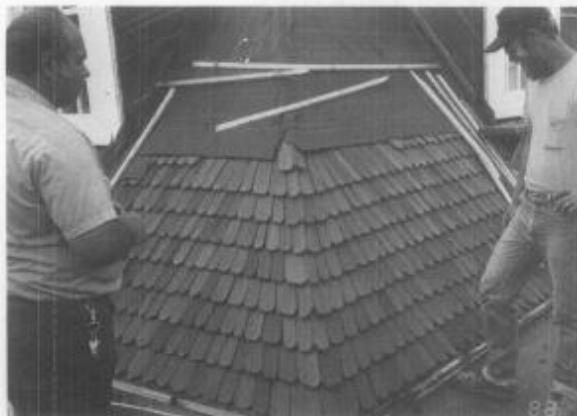
D. The fanned hips (seen here), swept valleys, and projecting ridge combs were installed as part of the re-roofing project. Special features, when documented, should be reproduced when re-shingling historic roofs.

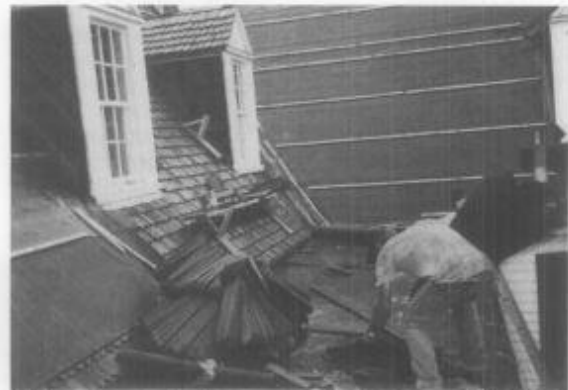
C. The replacement shingles (see specifications above), matched the historic shingles and were of such high quality that little hand dressing was needed at the site. The building paper, a temporary protection, was removed as the shingles were installed on the sheathing boards.

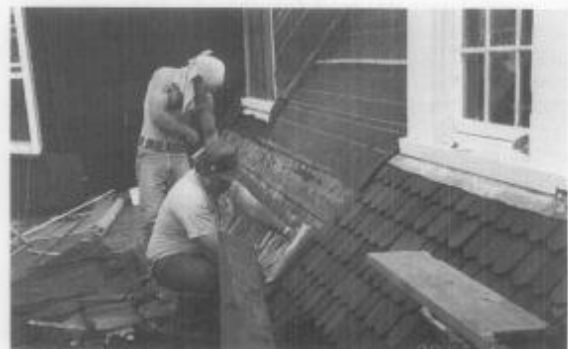
E. In order to achieve a "Class B" fire-rating, the shingles were dipped in fire-retardant chemicals and allowed to dry prior to installation. Iron oxide was added to this chemical dip to stain the shingles to match the historic red color. These coatings will need periodic reapplication.

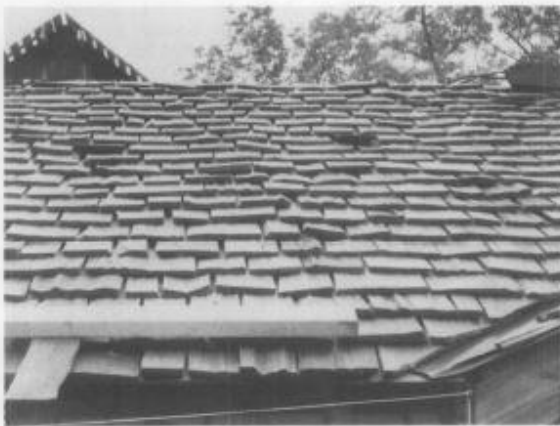
15. These commercially available roofing products with rustic split faces are not appropriate for historic preservation projects. In addition to the inaccurate appearance, the irregular surfaces and often wide spaces between shingles will allow wind-driven moisture to penetrate up and under them. The excessively wide boards will tend to cup, curl and crack. Moss, lichens and debris will have a tendency to collect on these irregular surfaces, further deteriorating the roofing. Photo: Sharon C. Park.

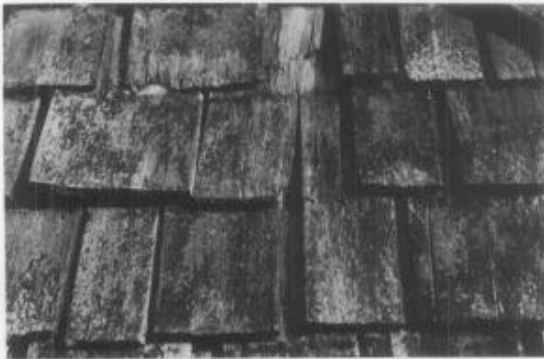
16. Routine maintenance is necessary to extend the life of the roof. On this roof, the shingles have not seriously eroded, but the presence of lichens and moss is becoming evident and there are a few cracked and missing shingles. The moss spores should be removed, missing shingles replaced, and small pieces of metal flashing slipped under cracked shingles to keep moisture from penetrating. Photo: Williamsport Preservation Training Center.

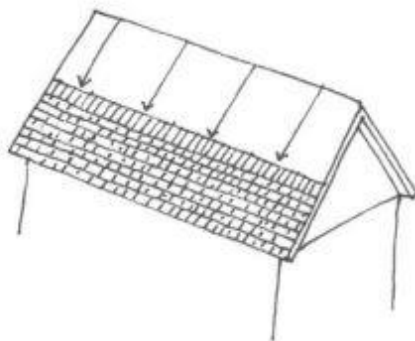
Measure from ridge to check alignment of shingles. Strike a line with chalk.

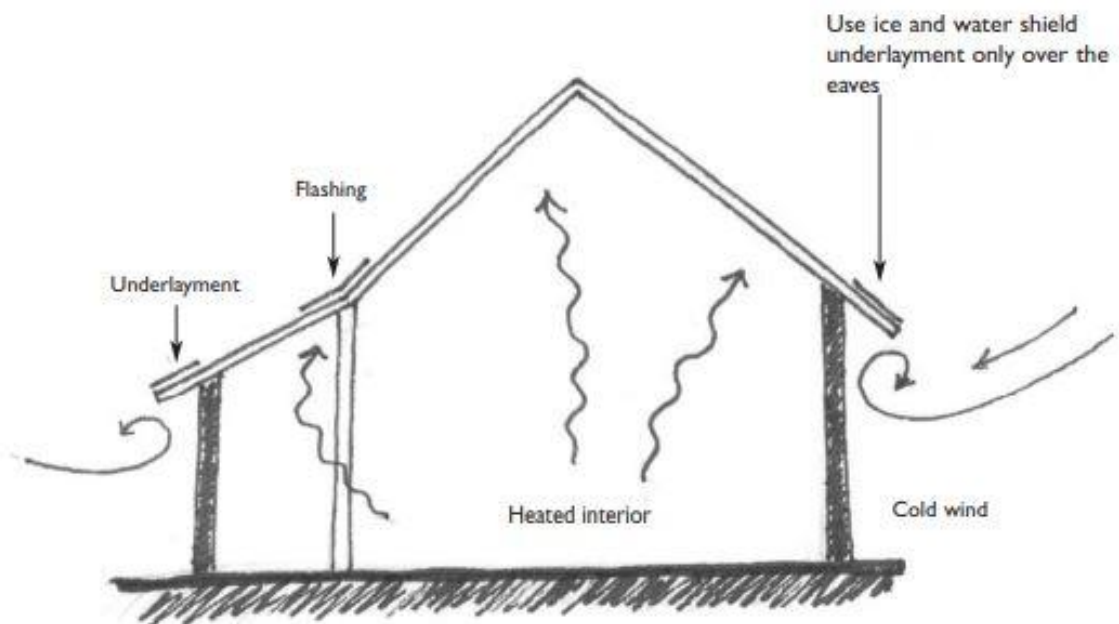
Incorrect way of stapling or nailing. Staples placed vertically and adjacent to each other may split the wood. Staples and nails exposed to weather will rust and form streaks.

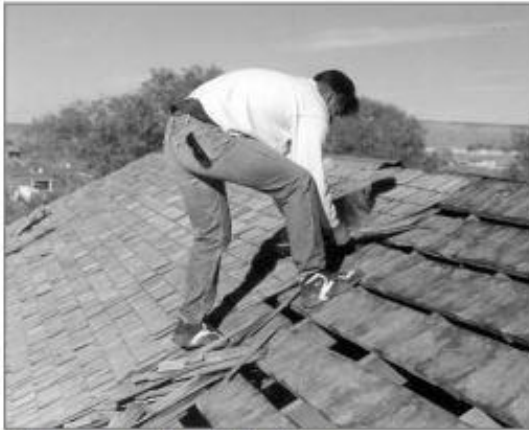
1. Remove existing shingles if any.

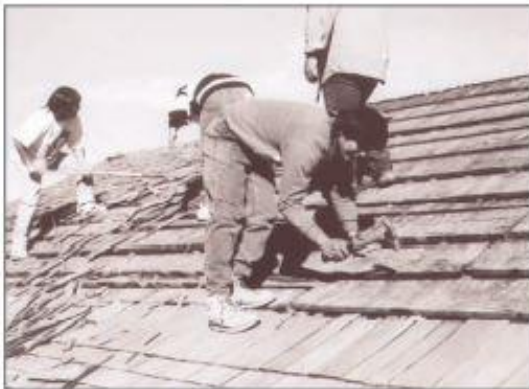
3. Drive in or pull out existing nails and repair or replace damaged purlins.
