**US Army Corps  
of Engineers®**  
Engineer Research and  
Development Center

## **José María Gil Adobe**

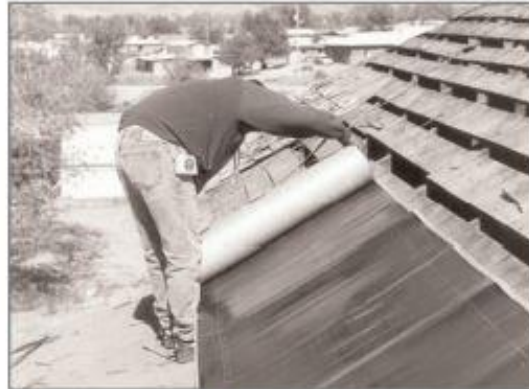
4. Ice and water shield should be installed on all overhangs. Roll out shield, cut to a workable length, and cut to fit at the hip if a hip exists.

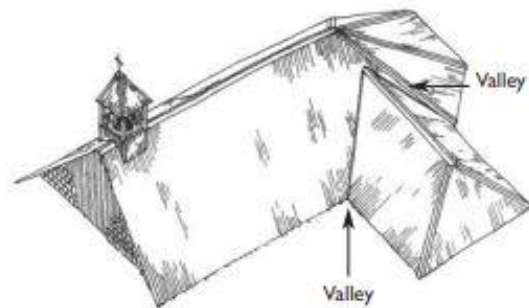
6. When the roof structure contains valleys, place galvanized, stainless steel or copper sheet metal flashing in the valley. Cut to length. Nail flashing in place.

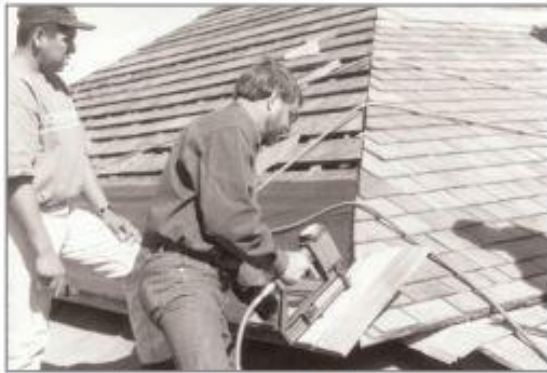
7. After shield and flashing installation has begun, determine the eave overhang and nail a guide shingle at one end. Leave a three inch overhang.

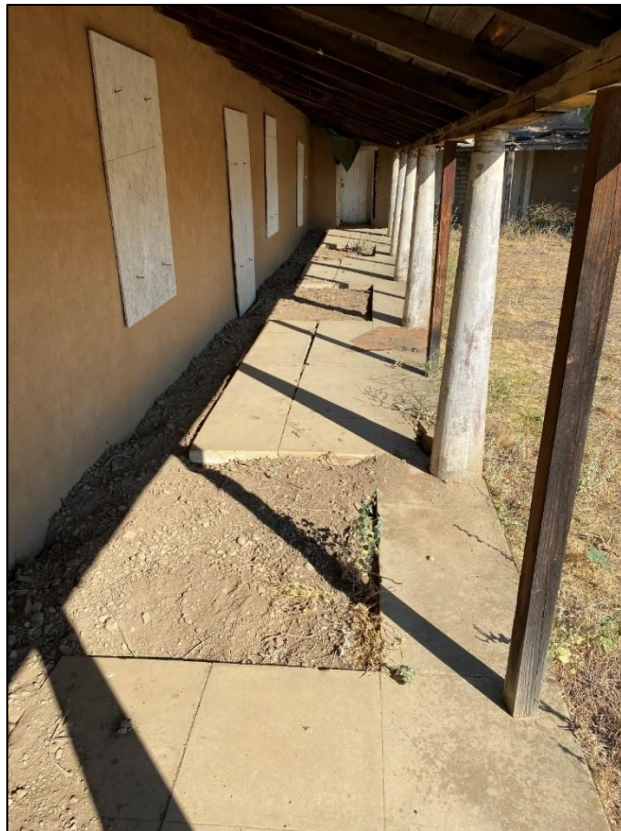
Figure 133. Removed concrete pavers on the northeast side of the José María Gil Adobe, 2021. (ERDC-CERL.)

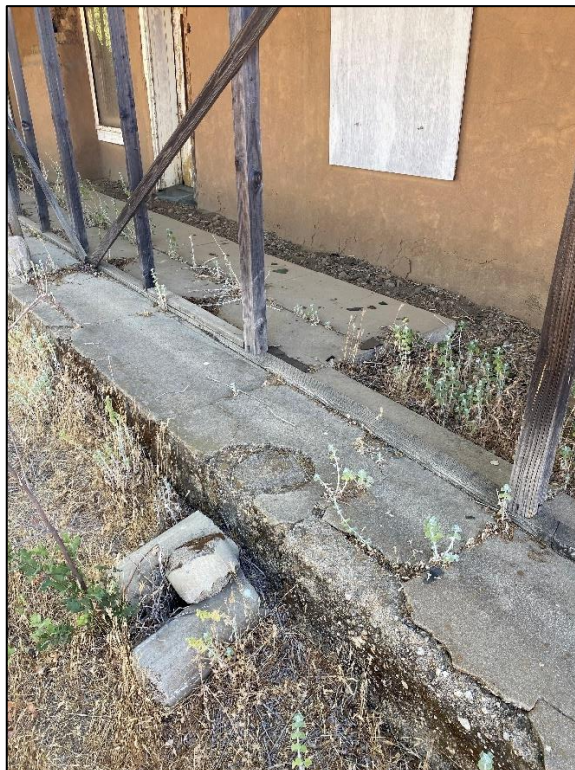
Figure 135. Spalling and cracking of concrete on the south side of the porch floor of the José María Gil Adobe, 2021. (ERDC-CERL.)

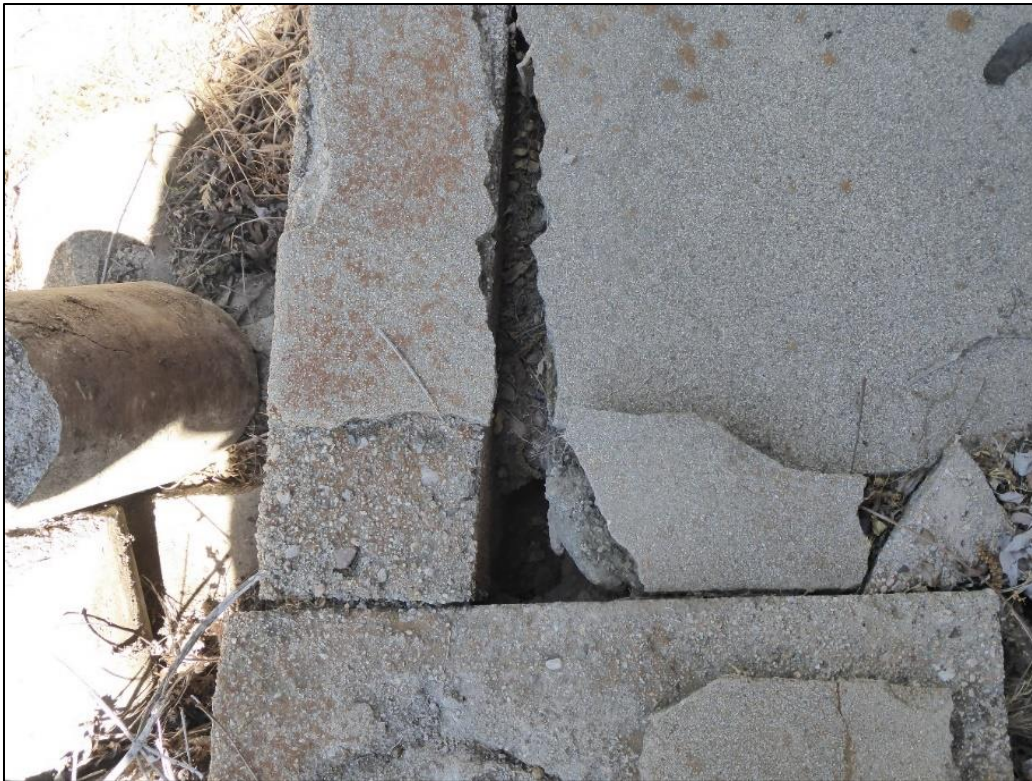
The José María Gil Adobe has concrete columns that support the veranda roof on all but the northwest side of the building (Figure 136). The intact columns are topped with wooden disks, possibly for leveling purposes of the roof. Many columns have cracked and failed, exposing metal reinforcements (Figure 137). Some columns have completely separated from their square concrete bases (Figure 138), while some have completely tipped over (Figure 139).

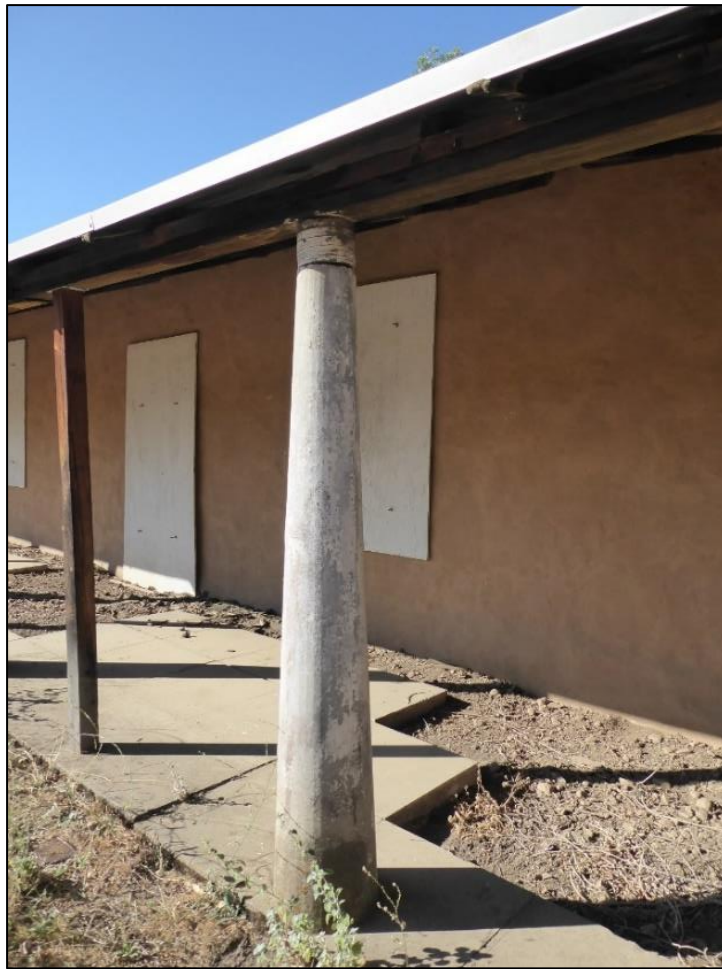
Figure 137. Crumbled concrete column showing metal reinforcement, on the southwest side of the José María Gil Adobe, 2021. (ERDC-CERL.)

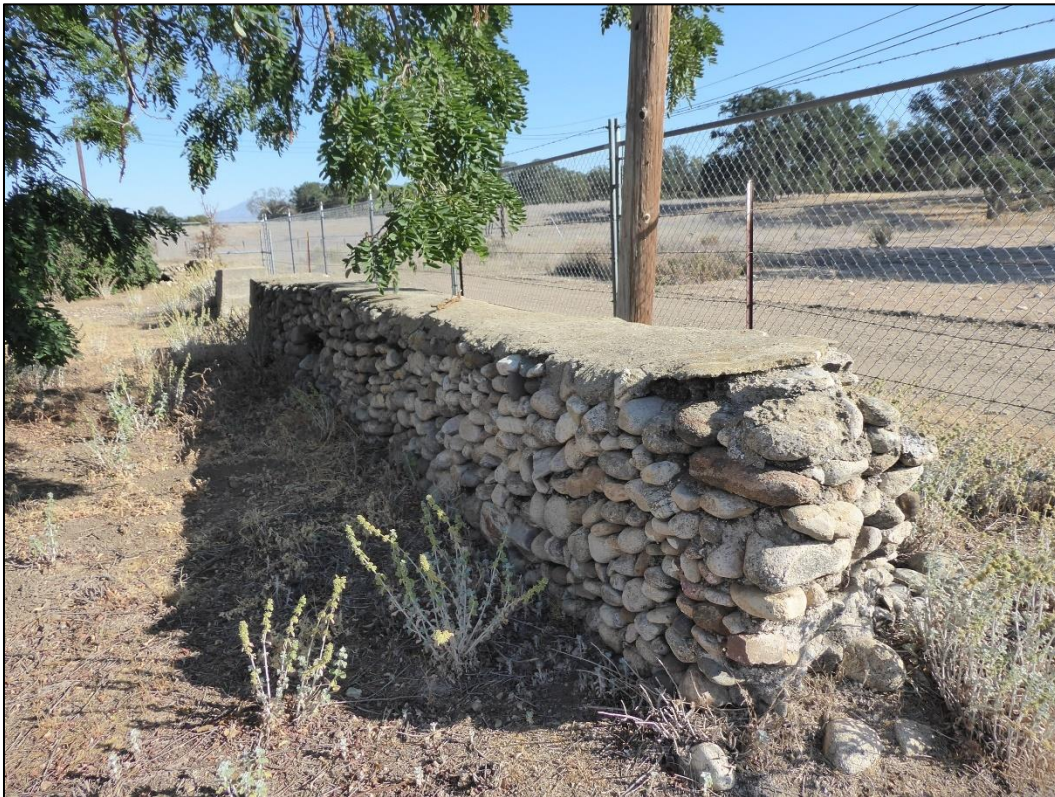
Figure 146. Cobblestone wall on the northmost corner of the site of the José María Gil Adobe, 2021. (ERDC-CERL.)

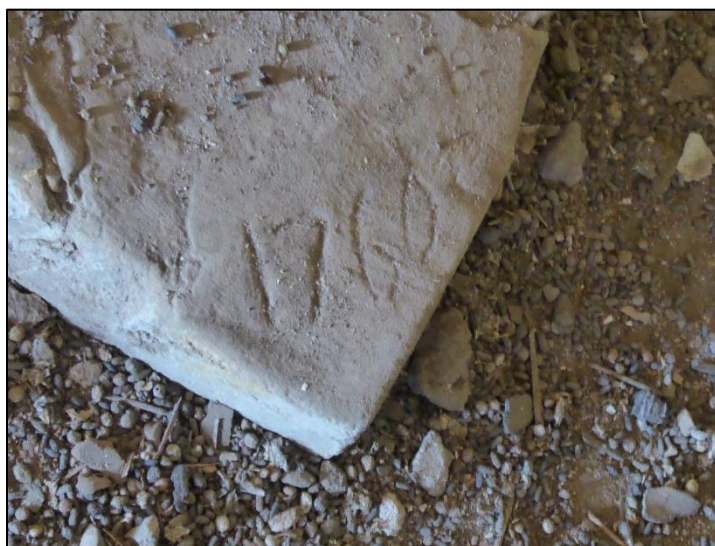
### 8.3 Treatment measures

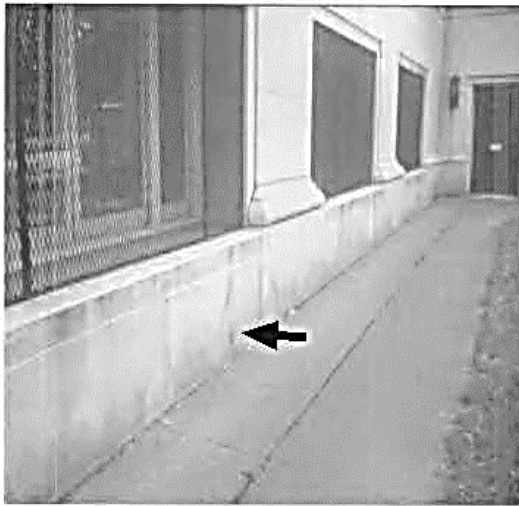
Figure 2. Biological growth as shown on this marble foundation can usually be removed using a low-pressure water wash, possibly with a non-ionic detergent added to it, and scrubbing with a natural or synthetic bristle brush.

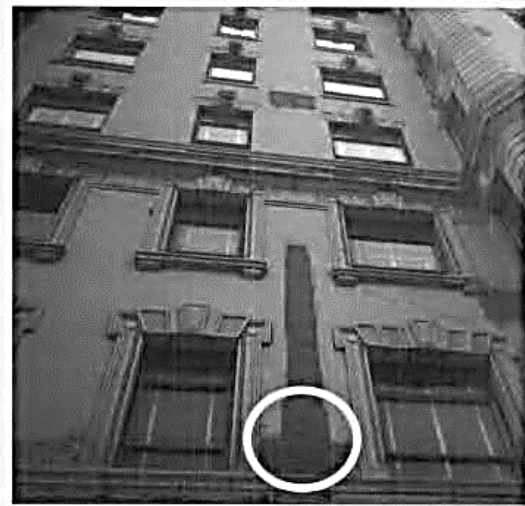
Figure 3. This small test area has revealed a red brick patch that does not match the original beige brick. This may explain why the building was painted, and may suggest to the owner that it may be preferable to keep it painted.

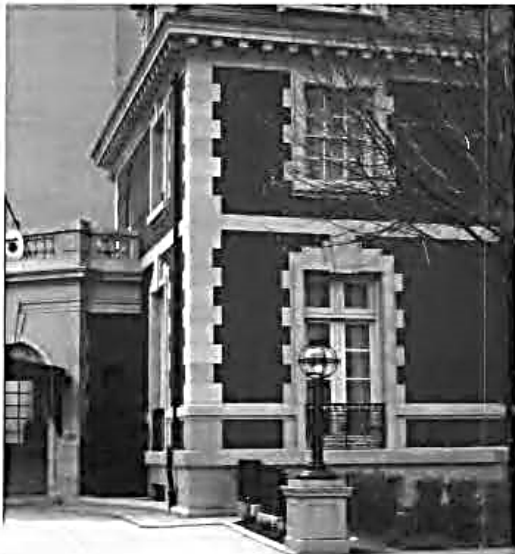
Figure 4. The foundation of this brick building is limestone, but the decorative trim above is architectural terra cotta intended to simulate stone.

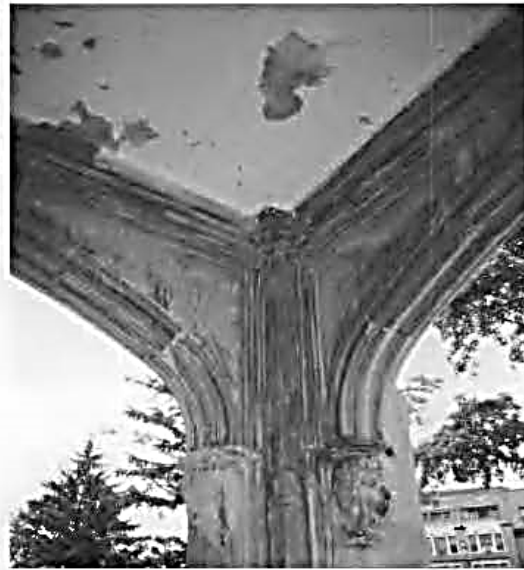
Figure 5. Repeated water washing did not remove the staining inside this limestone porte cochere. Upon closer examination, it was determined to be a water-repellent coating that had been applied many years earlier. An alkaline cleaner may be effective in removing it.

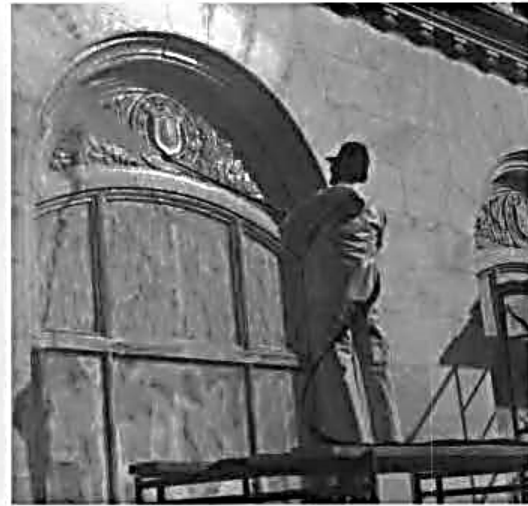
Figure 7. Glazed architectural terra cotta often may be cleaned successfully with a low-pressure water wash and hand scrubbing supplemented, if necessary, with a non-ionic detergent. Photo: National Park Service Files.

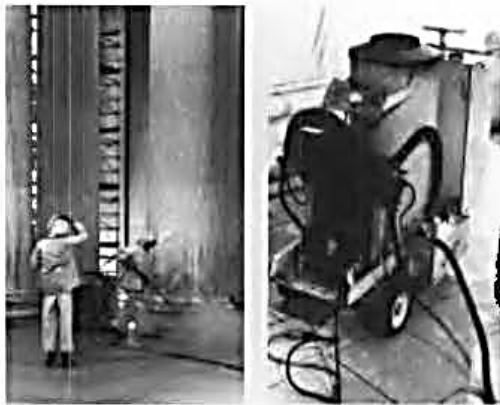
Figure 8. (Left) Low-pressure (under 100 psi) steam cleaning (hot-pressurized water washing), is part of the regular maintenance program at the Jefferson Memorial, Washington, D.C. The white marble interior of this open structure is subject to constant soiling by birds, insects and visitors. (Right) This portable steam cleaner enables prompt cleanup when necessary. Photos: National Park Service Files.

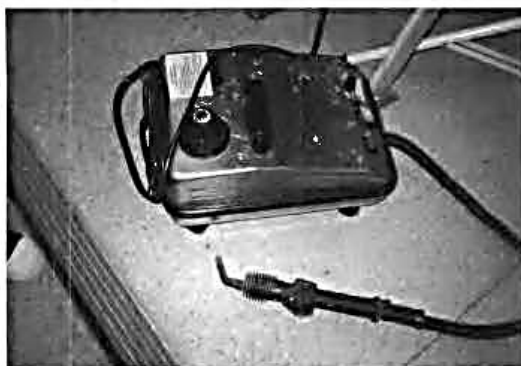
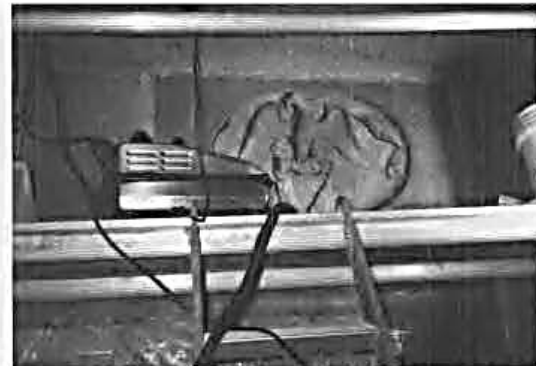
Figure 9. (Left) This small steam cleaner—the size of a vacuum cleaner—offers a very controlled and gentle means of cleaning limited, or hard-to-reach areas or carved stone details. (Right) It is particularly useful for interiors where it is important to keep moisture to a minimum, such as inside the Washington Monument, Washington, D.C., where it was used to clean the commemorative stones. Photos: Audrey T. Tepper.

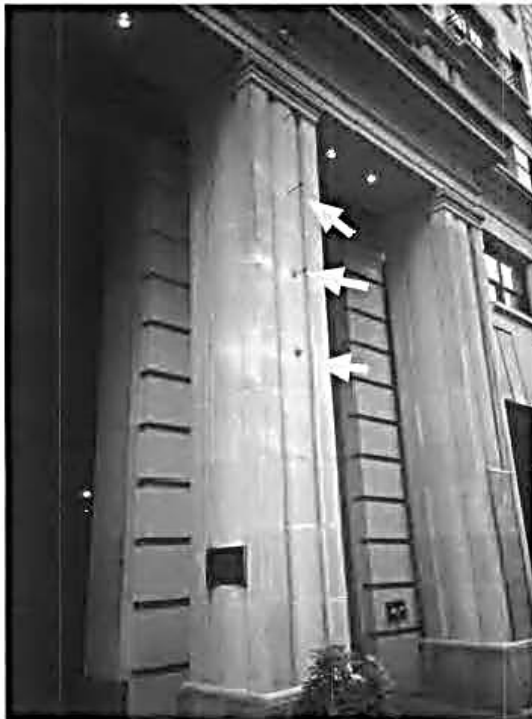
Figure 10. High-pressure water washing too close to the surface has abraded and, consequently, marred the limestone on this early-20th century building.

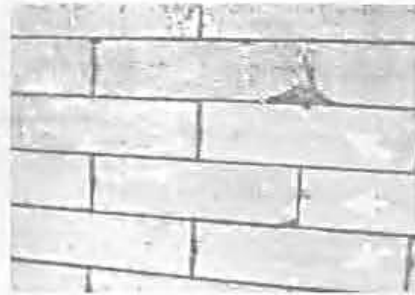
Figure 11. Rinsing with high-pressure water following chemical cleaning has left a horizontal line of abrasion across the bricks on this late-19th century row house.

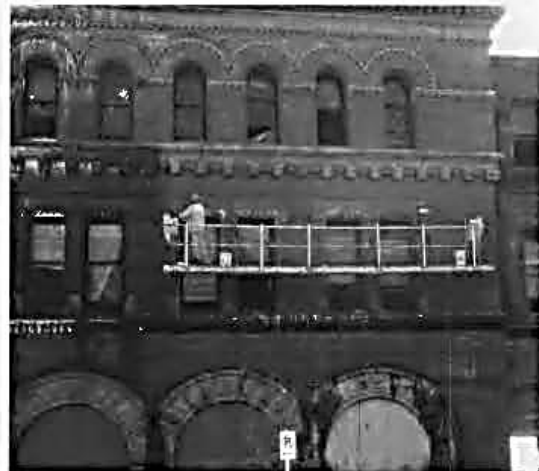
Figure 12. A mild acidic cleaning agent is being used to clean this heavily soiled brick and granite building. Additional applications of the cleaner and hand-scrubbing, and even poulticing, may be necessary to remove the dark stains on the granite arches below. Photo: Sharon C. Park, FAIA.

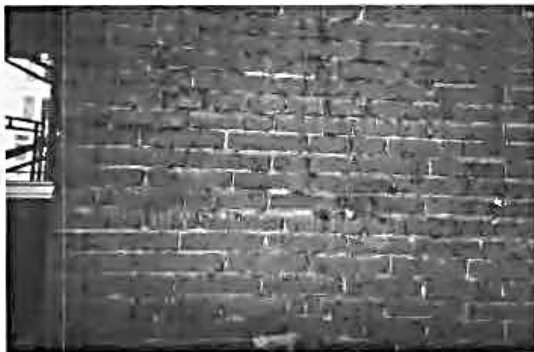
Figure 13. Sometimes it may be preferable to paint over a thick asphaltic coating rather than try to remove it, because it can be difficult to remove completely. However, in this case, many layers of asphaltic coating were removed through multiple applications of a heavy duty chemical cleaner. Each application of the cleaner was left to dwell following the manufacturer's recommendations, and then rinsed thoroughly. (As much as possible of the asphalt was first removed with wooden scrapers.) Although not all the asphalt was removed, this was determined to be an acceptable level of cleanliness for the project.

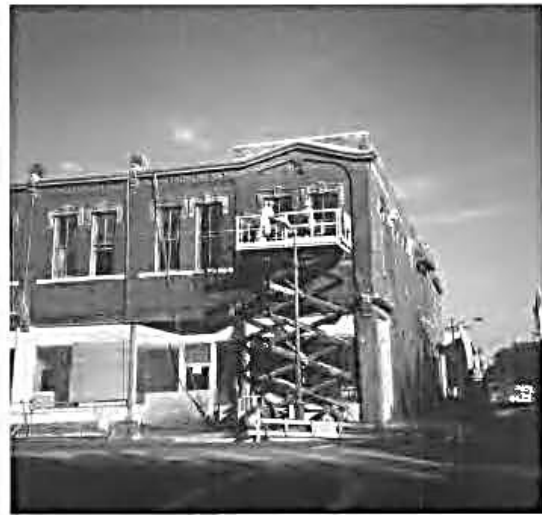
Figure 14. Chemical removal of paint from this brick building has revealed that the cornice and window hoods are metal rather than masonry.

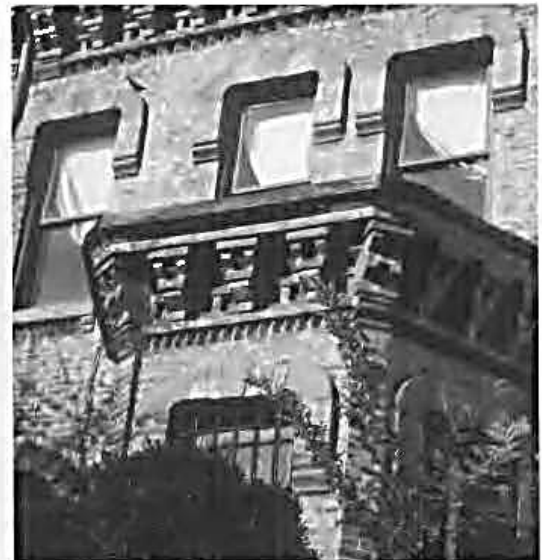
Figure 15. The whitish deposits left on the brick by a chemical paint remover may have resulted from inadequate rinsing or from the chemical being left on the surface too long and may be impossible to remove.

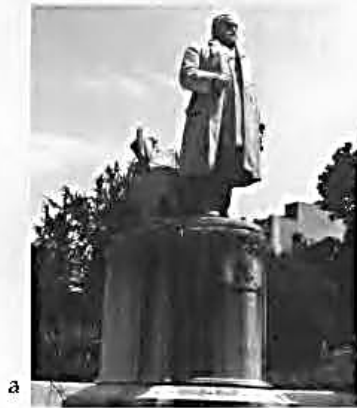
### Poulticing to Remove Stains and Graffiti

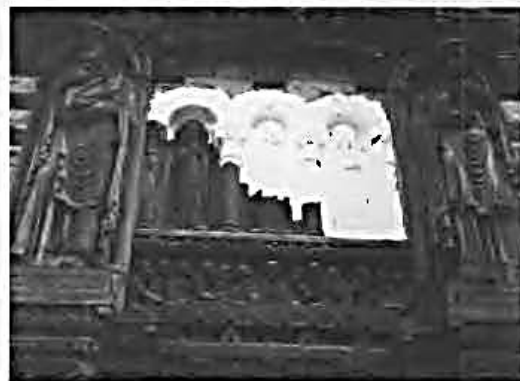
Figure 17. A poultice is being used to remove salts from the brownstone statuary on the facade of this late-19th century stone church. Photo: National Park Service Files.

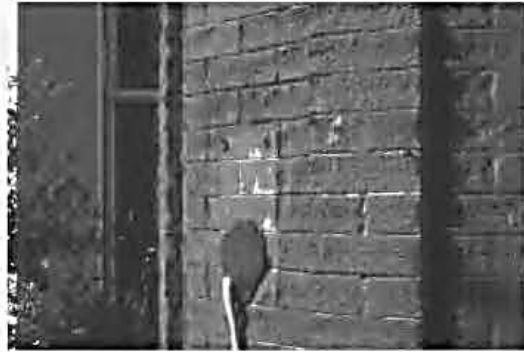
Figure 19. A comparison of undamaged bricks surrounding the electrical conduit with the rest of the brick facade emphasizes the severity of the erosion caused by sandblasting.

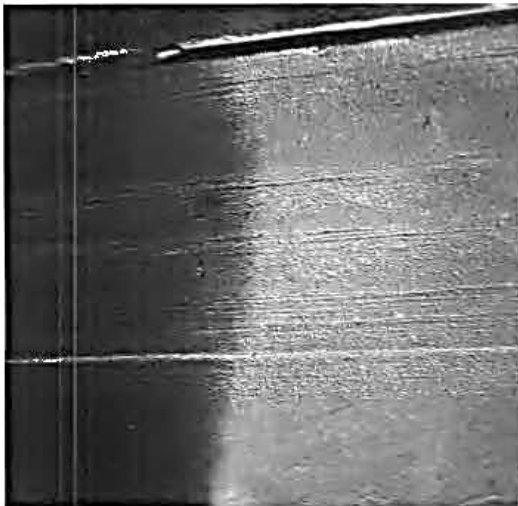
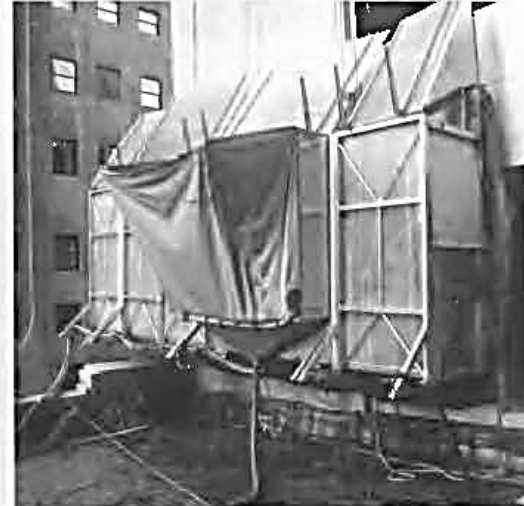
Figure 20. (Left) A comparison of the limestone surface of a 1920s office building before and after "cleaning" with a proprietary abrasive process using fine glass powder clearly shows the effectiveness of this method. But this is an abrasive technique and it has "cleaned" by removing part of the masonry surface with the dirt. Because it is abrasive, it is generally not recommended for large-scale cleaning of historic masonry, although it may be suitable to use in certain, very limited cases under controlled circumstances. (Right) A vacuum chamber where the used glass powder is collected for environmentally safe disposal is a unique feature of this particular process. The specially-trained operators in the chamber wear protective clothing, masks and breathing equipment. Photos: Tom Keohan.

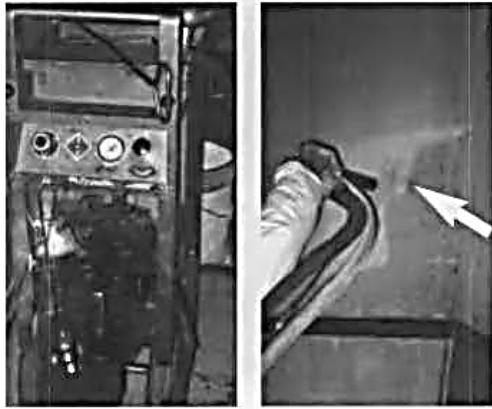
Figure 21. Low-pressure blasting with ice pellets or ice crystals (left) is an abrasive cleaning method that is sometimes recommended for use on interior masonry because it does not involve large amounts of water. However, like other abrasive materials, ice crystals "clean" by removing a portion of the masonry surface with the dirt, and may not remove some stains that have penetrated into the masonry without causing further abrasion (right). Photos: Audrey T. Tepper.

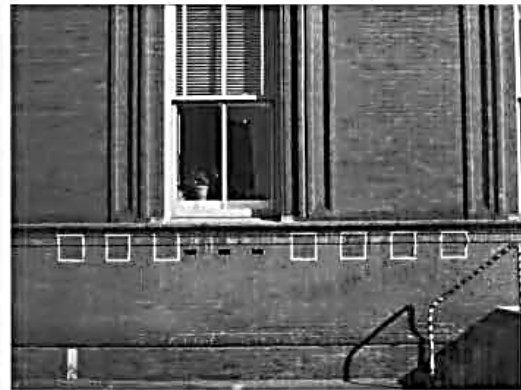
Figure 22. Cleaning test areas may be quite small at first and gradually increase in size as testing determines the "gentlest means possible".  
Photo: Frances Gale.

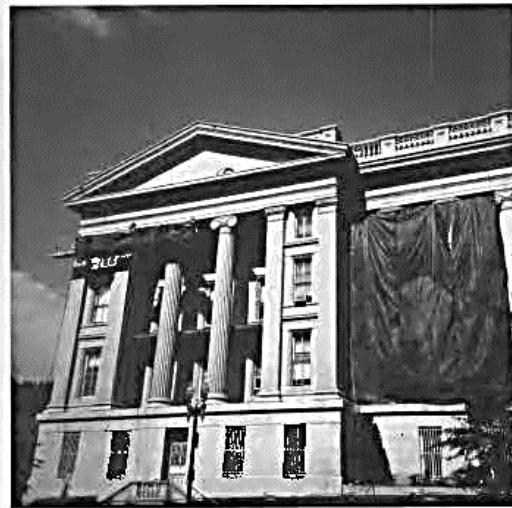
Figure 23. A tarpaulin protects and shields pedestrians from potentially harmful spray while chemical cleaning is underway on the granite exterior of the U.S. Treasury Building, Washington, D.C.

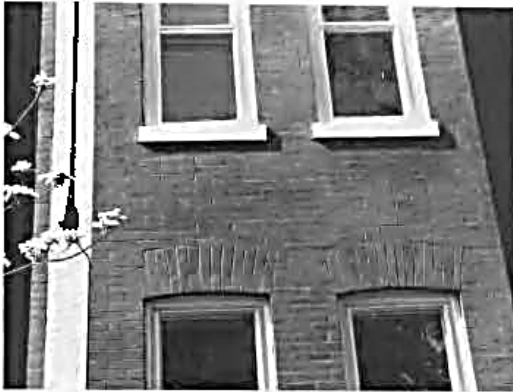
Figure 24. Although the application of a water-repellent coating was probably not needed on either of these buildings, the coating on the brick building (above), is not visible and has not changed the character of the brick. But the coating on the brick column (below), has a high gloss that is incompatible with the historic character of the masonry.

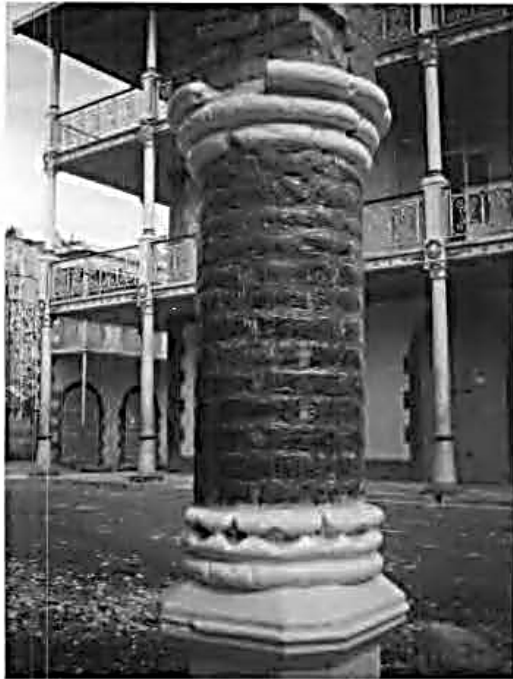
beneath the surface as subflorescence. Subflorescence eventually may cause the surface of the masonry to spall, particularly if a water-repellent coating has been applied which tends to reduce the flow of moisture out from the subsurface of the masonry. Although many of the newer water-repellent products are more breathable than their predecessors, they can be especially damaging if applied to masonry that contains salts, because they limit the flow of moisture through masonry.

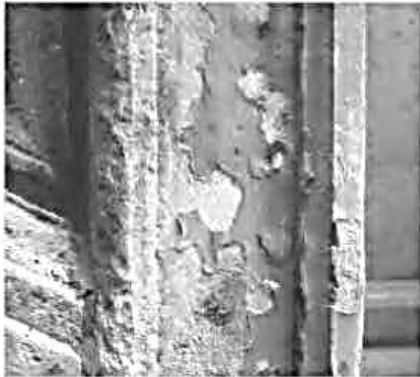
Figure 25. The clear coating applied to this limestone molding has failed and is taking off some of the stone surface as it peels. Photo: Frances Gale.

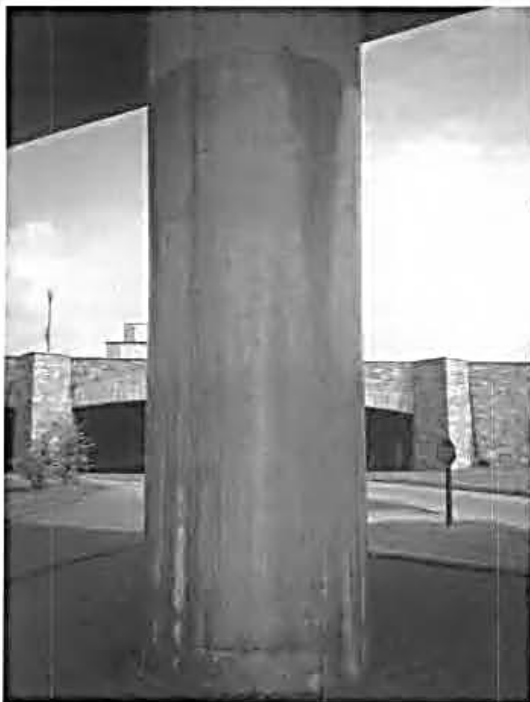
Figure 26. The anti-graffiti or barrier coating on this column is very shiny and would not be appropriate to use on a historic masonry building. The coating has discolored as it has aged and whitish streaks reveal areas of bare concrete where the coating was incompletely applied.

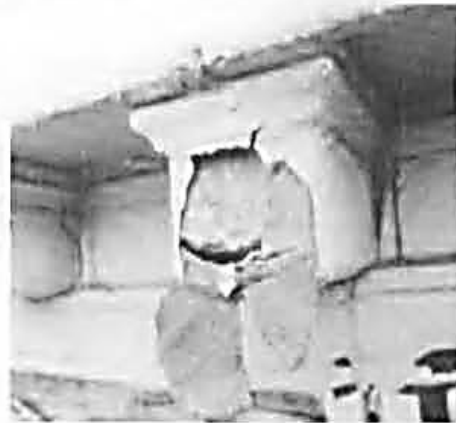
Figure 27. Instead of correcting the roof drainage problems, an elastomeric coating was applied to the already saturated limestone cornice. An elastomeric coating holds moisture in the masonry because it does not "breathe" and does not allow liquid moisture to escape. If the water pressure builds up sufficiently it can cause the coating to break and pop off as shown in this example, often pulling pieces of the masonry with it. Photo: National Park Service Files.

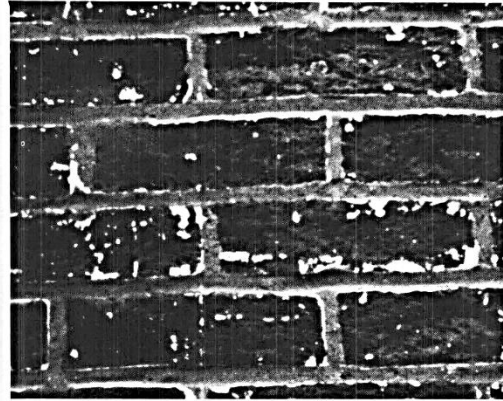
**Abrading the Surface without Removing the Paint.** Even though the entire outer surface layer of the brick has been sandblasted off, spots of paint still cling to the masonry. Sandblasting or other similarly abrasive methods are not always a successful means of removing paint.

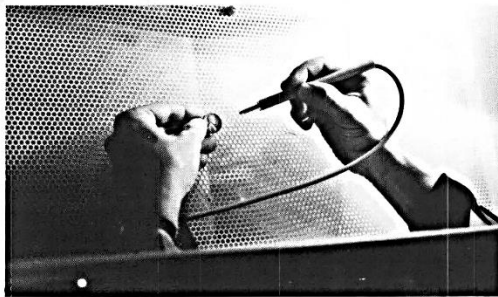
**Micro-Abrasive Cleaning.** This small, pencil-sized micro-abrasive unit is used by some museum conservators to clean small objects. This particular micro-abrasive unit is operated within the confines of a box (approximately 2 cubic feet of space), but a similar and slightly larger unit may be used for cleaning larger pieces of sculpture, or areas of architectural detailing on a building. Even a pressure cleaning unit this small is capable of eroding a surface, and must be carefully controlled.

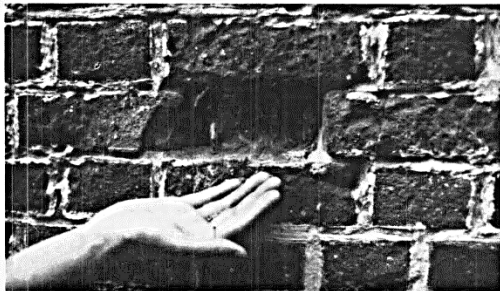
**Spalling Brick.** This soft, early 19th-century brick was sandblasted in the 1960s; consequently, severe spalling has resulted. Some bricks have almost totally disintegrated, and will eventually have to be replaced. (Robert S. Gamble)

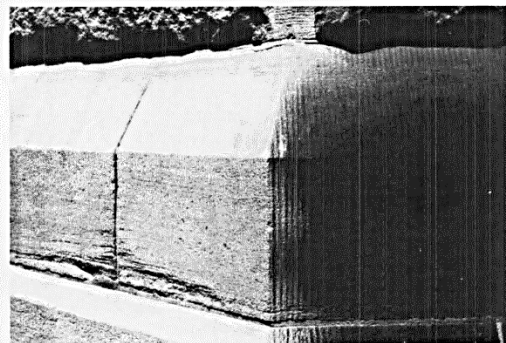
**Abrasive Cleaning of Tooled Granite.** Even this carefully controlled "wet grit" blasting has erased vertical tooling marks in the cut granite blocks on the left. Not only has the tooling been destroyed, but the damaged stone surface is now more susceptible to accelerated weathering.

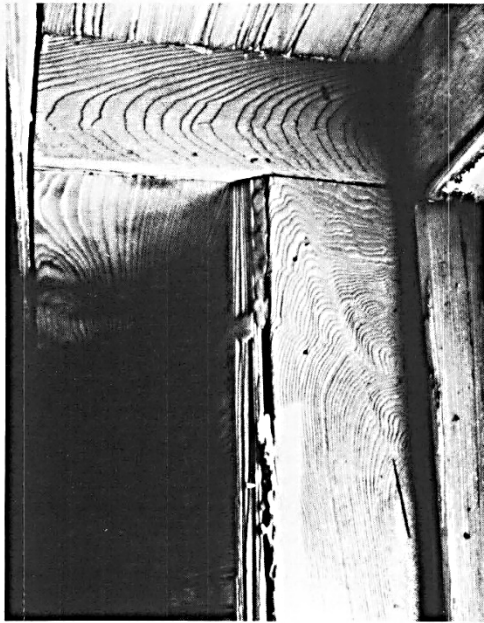
**Abrasive Cleaning of Wood.** This wooden windowsill, molding and paneling have been sandblasted to remove layers of paint in the rehabilitation of this commercial building. Not only is some paint still embedded in cracks and crevices of the woodwork, but more importantly, grit blasting has actually eroded the summer wood, in effect raising the grain, and resulting in a rough surface.

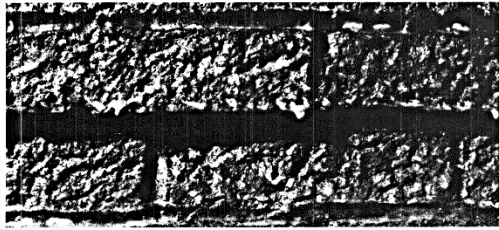
**Hazards of Sandblasting and Surface Coating.** In order to "protect" this heavily sandblasted brick, a clear surface coating or sealer was applied. Because the air temperature was too cold at the time of application, the sealer failed to dry properly, dripping in places, and giving the brick surface a cloudy appearance.

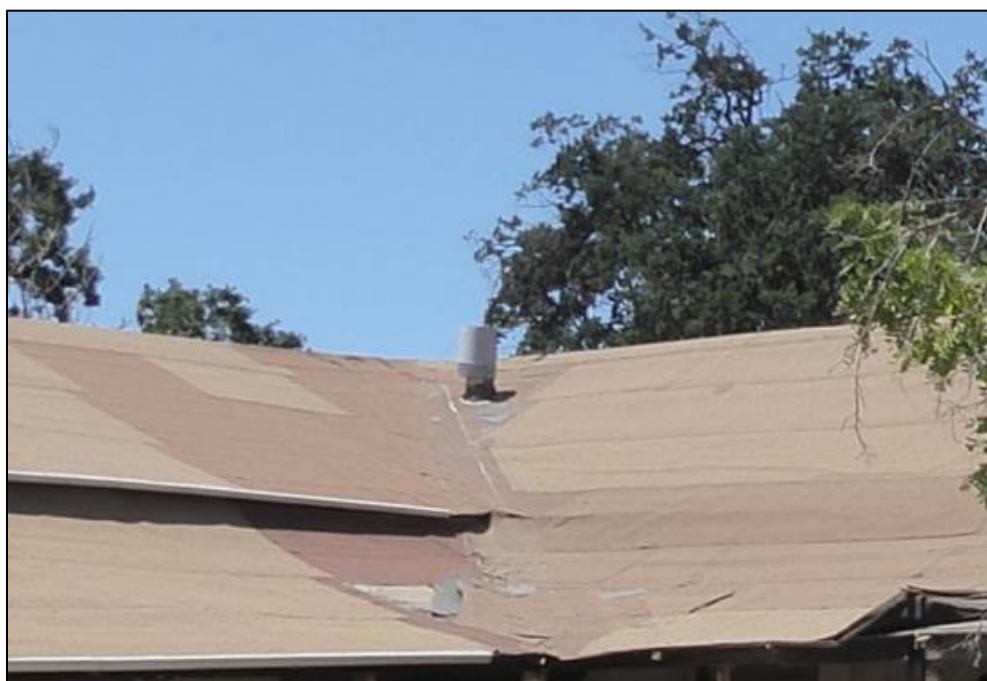
Figure 161. Rusted square nails on an exterior support frame of the José María Gil Adobe, 2021. (ERDC-CERL.)

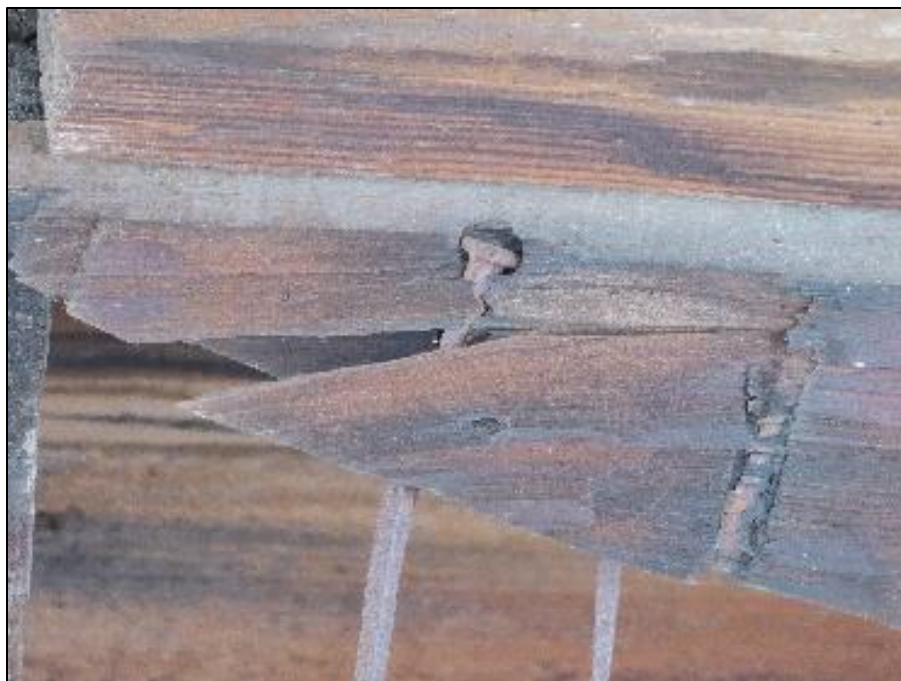
Figure 162. Metal doorknob that remains on an exterior door on the north wing of the José María Gil Adobe, 2021. (ERDC-CERL.)

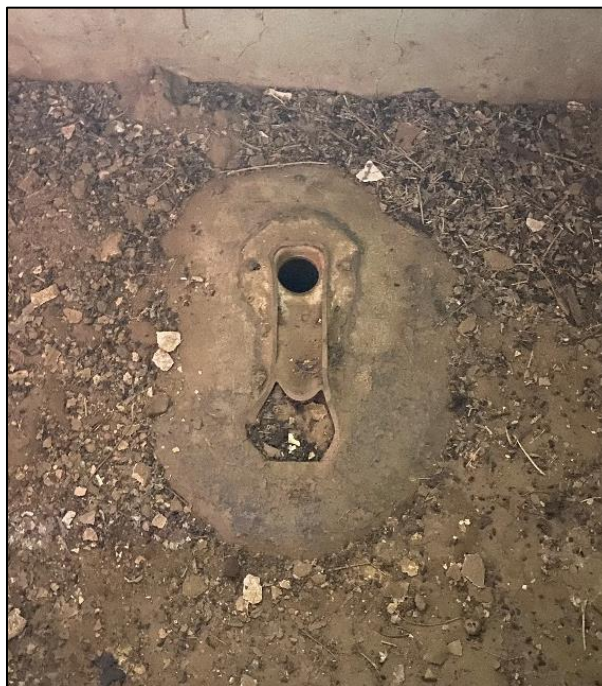
Metal doorknobs remain on the doors or in various locations inside the building. A doorknob was found lying on the stone fireplace in the south wing of the José María Gil Adobe (Figure 172). Interior doors have metal hinges that remain (Figure 173). These hinges are quite ornate and could date back to the Hearst ownership or before. Another small metal feature is a metal key socket that remains (Figure 174). Resting on the hearth of the stone fireplace is a metal firewood rack (Figure 175).

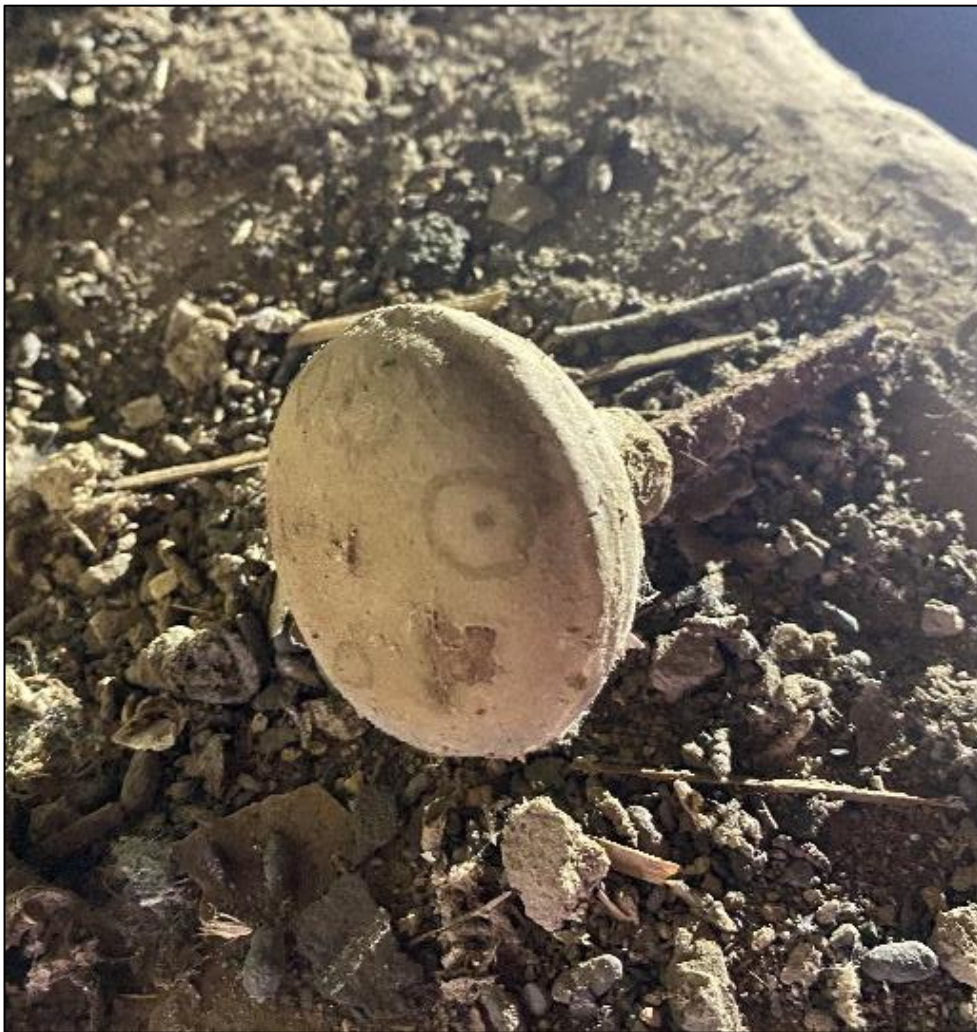
Figure 173. Stylistic metal door hinges that remain on interior doors of the José María Gil Adobe, 2021. (ERDC-CERL.)

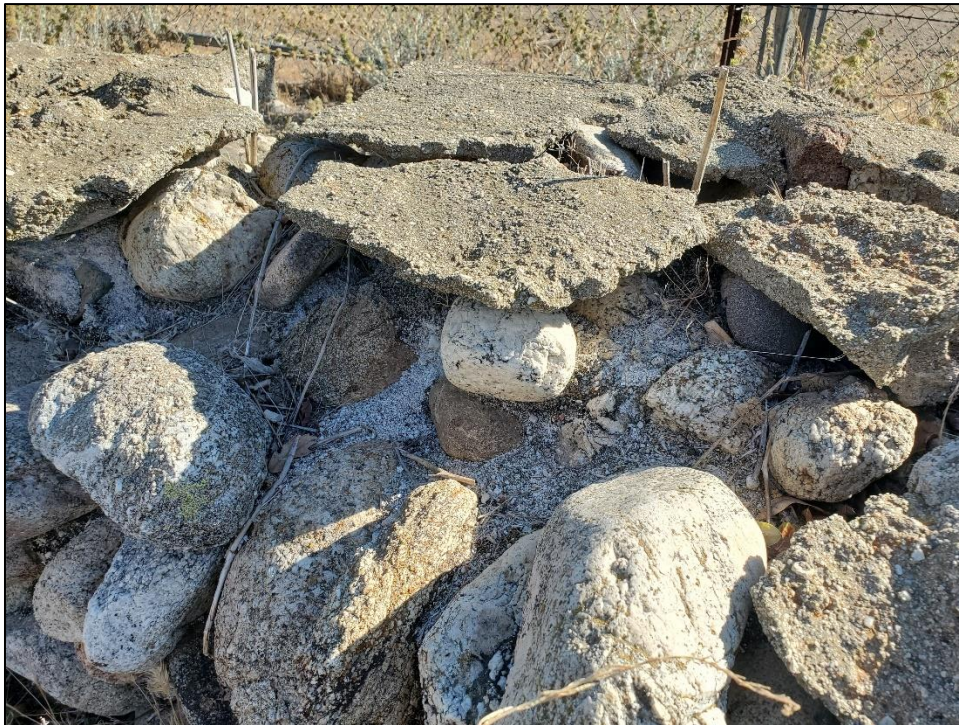
Figure 184. Inner mortar within stone wall (sample 2).

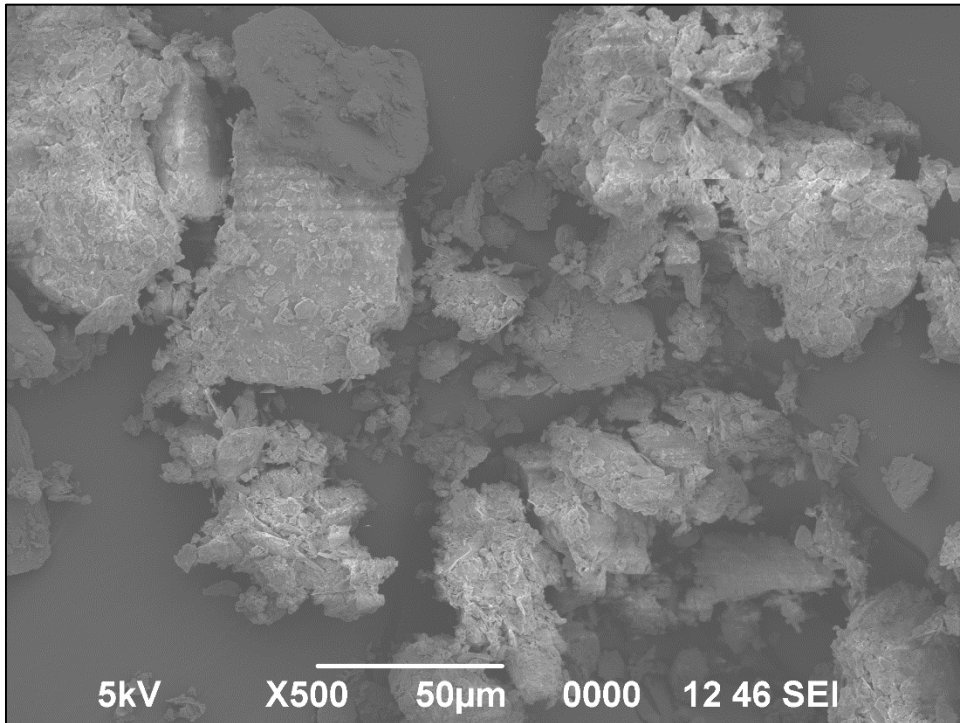
### 10.3.1 Samples 4, 5, 11, and 12 (interior plasters and fillings)

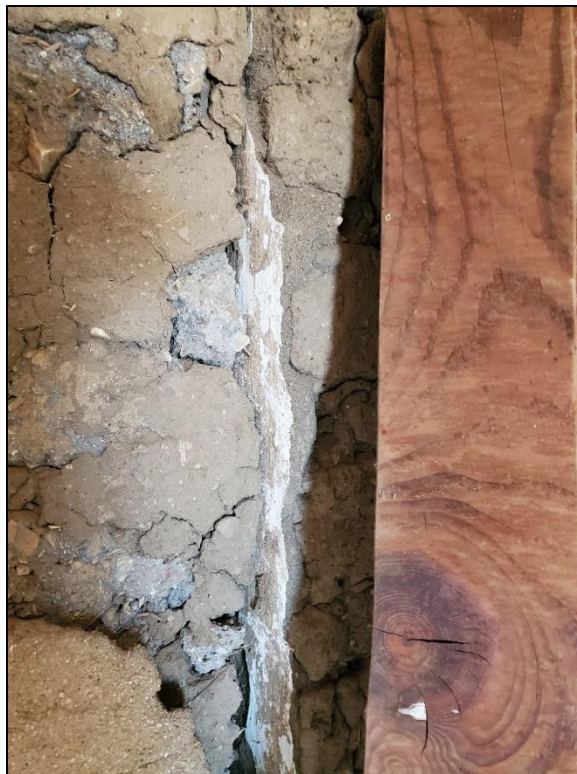
### 10.3.2 Samples 6, 7, and 8 (interior coatings)

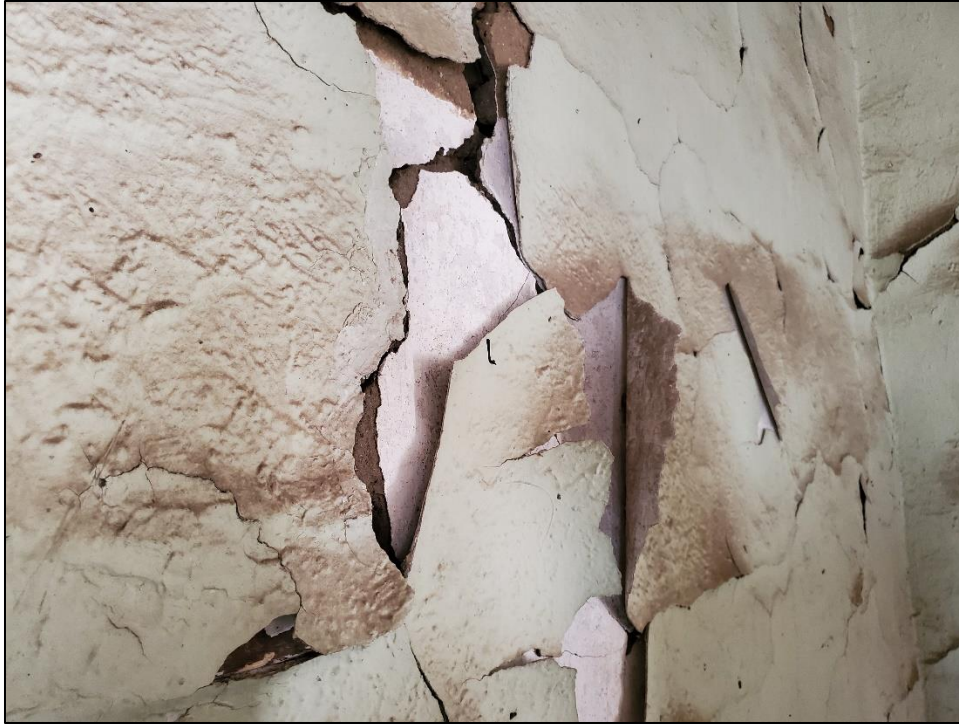
#### 10.4 Outbuilding analysis

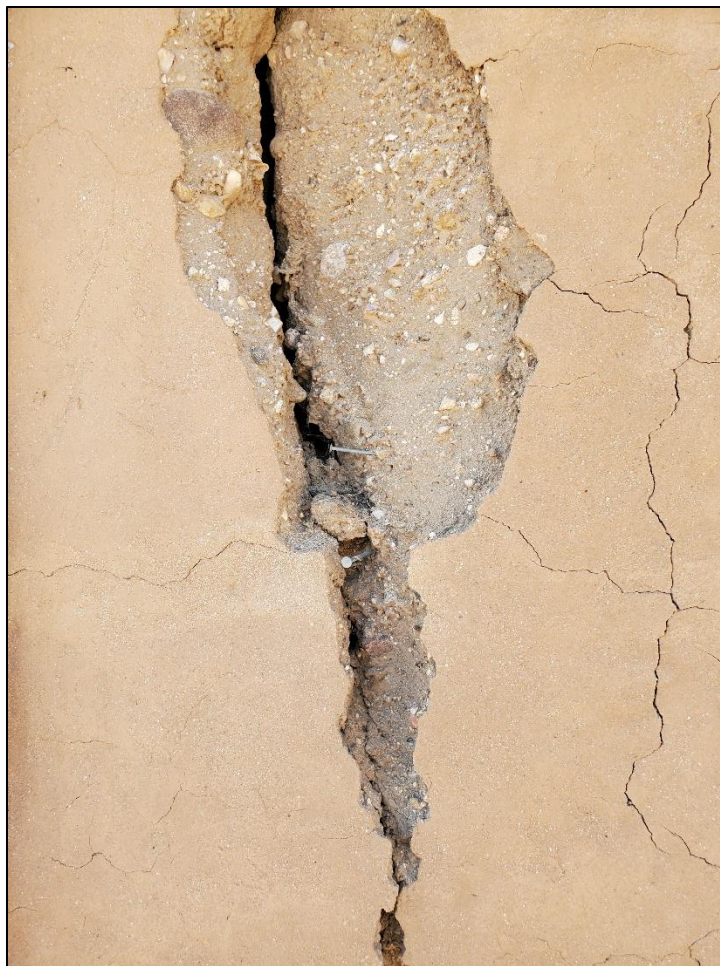
## 10.5 Conclusions and recommendations
