José María Gil Adobe

Historic Context, Maintenance Issues, Measured Drawings,
and Adaptive Reuse

October 2023

Final Report

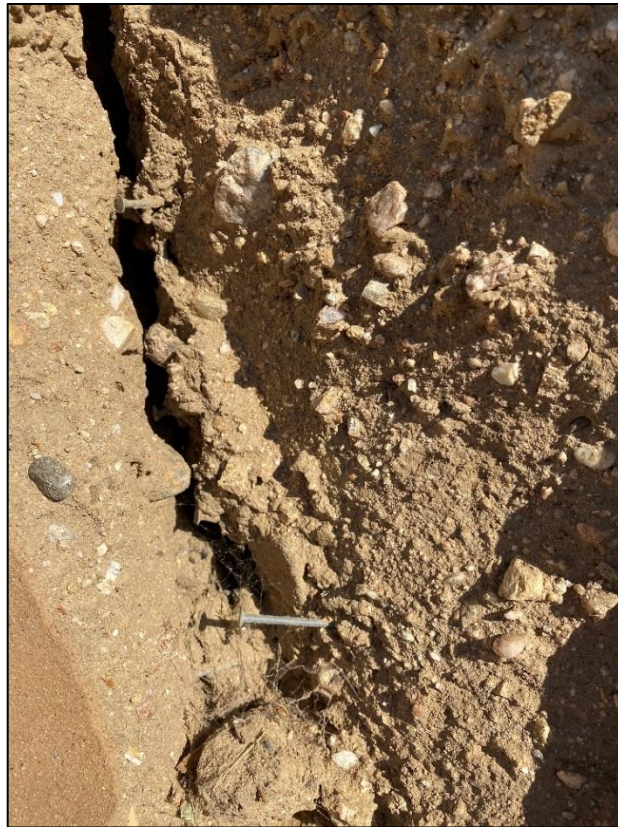
The rammed earth material seen in Figure 43 has been exposed due to a large crack on the southeast side of the cold storage building. The crack was most likely caused by a past earthquake and can be fully seen in Figure 48. The remainder of the rammed earth structure is coated in a plaster that was added during the same time period and of the same kind as the José María Gil Adobe (Figure 44).

Figure 43. Rammed earth material exposed in crack on the southeast side of the cold storage building, 2021. (ERDC-CERL.)

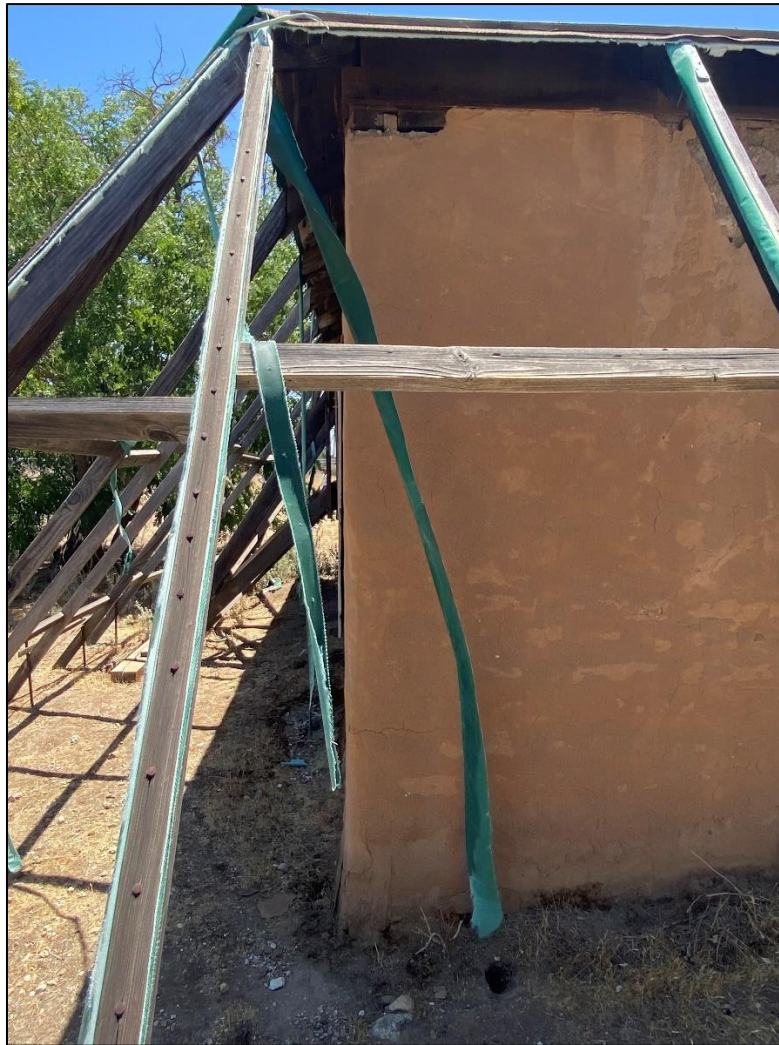
Figure 61. Uneven surface and flare of adobe wall at the base on the north corner of the José María Gil Adobe, 2021. (ERDC-CERL.)

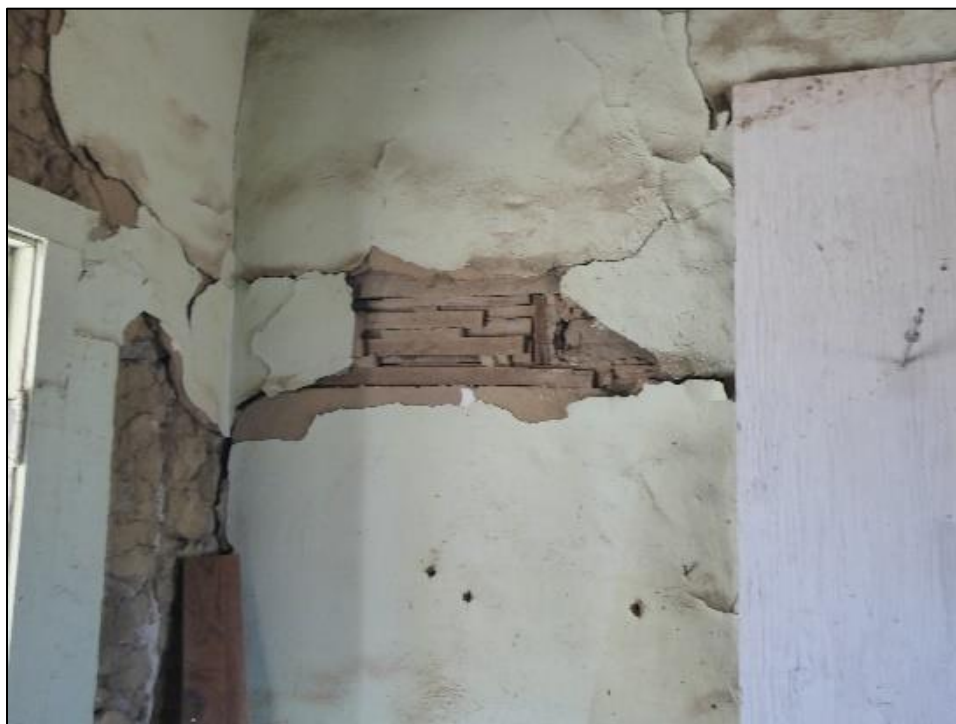
Figure 90. Cracked plaster and paint exposing wooden elements in the south wing of the José María Gil Adobe, 2021. (ERDC-CERL.)

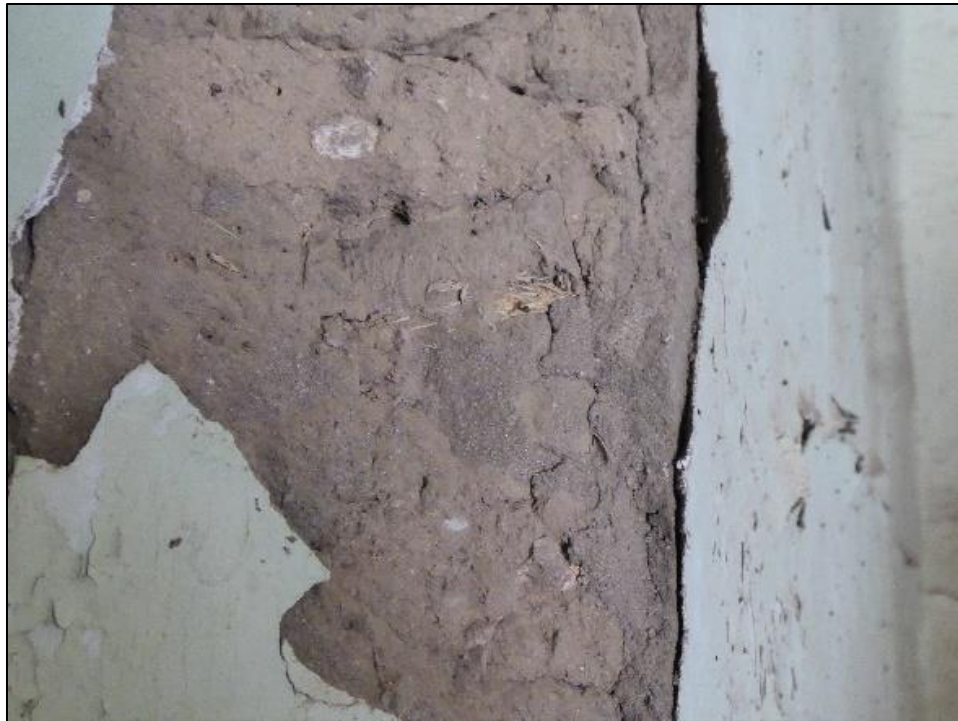
Figure 91. Intact plaster with peeling paint in the south wing of the José María Gil Adobe, 2021. (ERDC-CERL.)

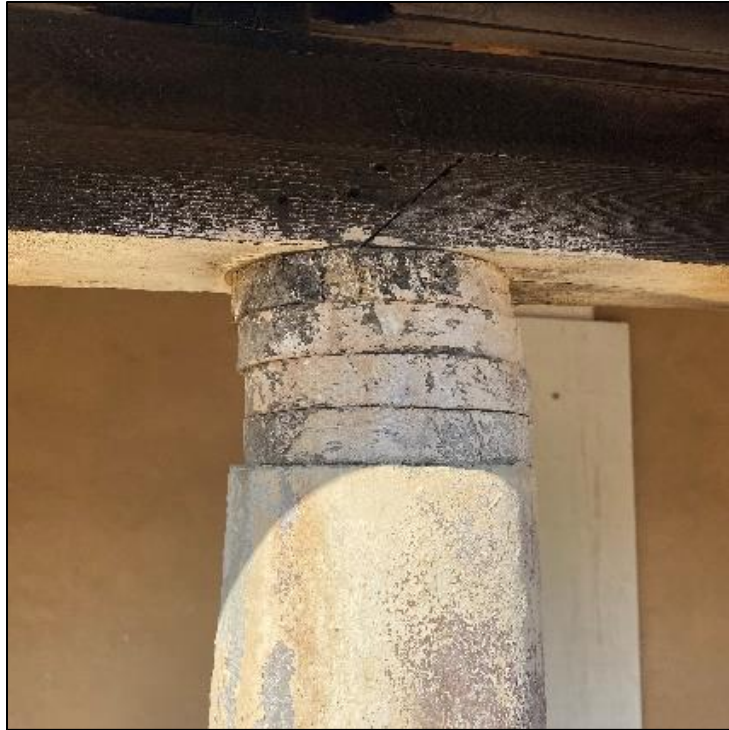
Figure 105. Wooden disks on top of the concrete columns supporting the veranda roof, possibly for leveling purposes, on the José María Gil Adobe, 2021. (ERDC-CERL.)

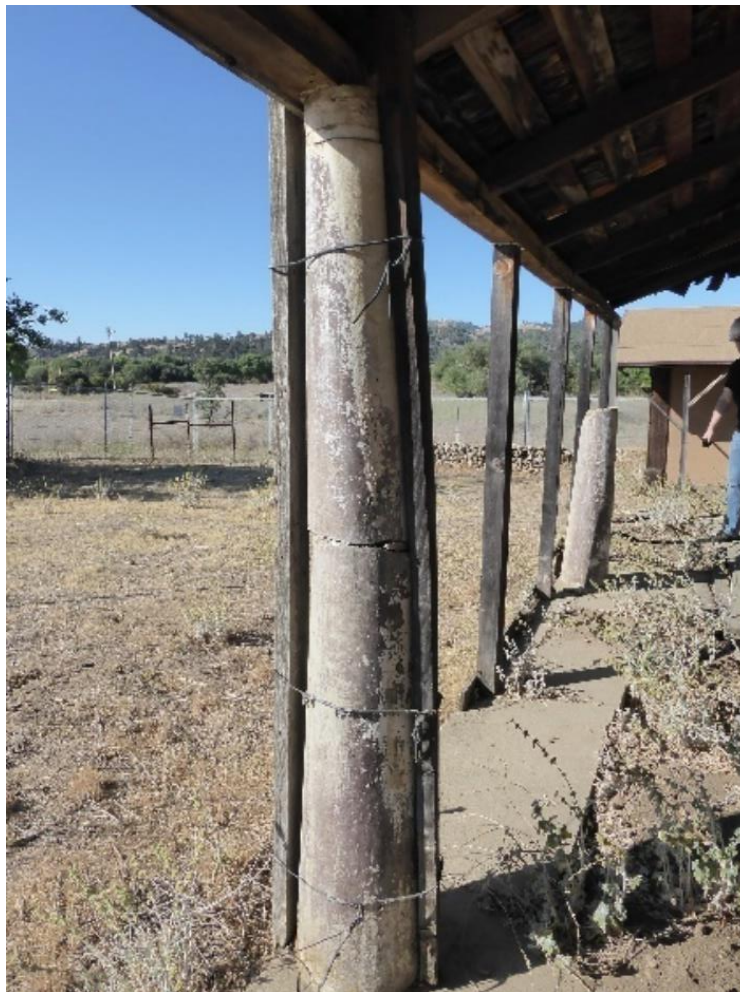
The US Army purchased the José María Gil Adobe in September of 1940 and since then has tried to keep the adobe standing by using insufficient and temporary methods. Wooden, buttress-like support braces were added on the north side of the building to prevent the walls from collapsing outward, contributing to load support in the lateral direction (Figure 104). The concrete columns on the northeast side of the building (there are crumbling columns on the south side) have been increased in height by wooden disks, most likely for leveling purposes (Figure 105). Some columns have failed and are now supported with wooden braces (Figure 106).

Figure 106. Two wooden 2 × 4 in. boards supporting a concrete column that is cracked in multiple places, 2021. (ERDC-CERL.)

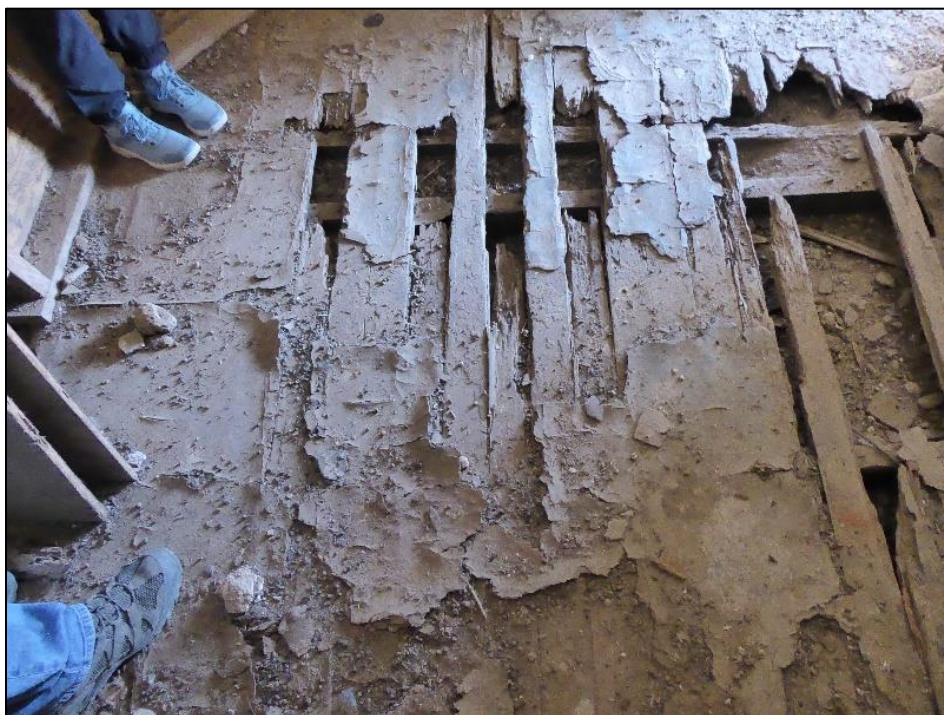
The floor of the José María Gil Adobe is wood strip flooring in some rooms and dirt in others. The wooden floors are in “POOR” condition. The majority of the floorboards are rotten due to their age and exposure to the elements due to roof leaks and wildlife. The floor is missing boards in some areas due to breakage (Figure 112, Figure 113, and Figure 114).

Figure 113. Wood strip flooring with breakthrough areas in a central location of a floor in the José María Gil Adobe, 2021. (ERDC-CERL.)

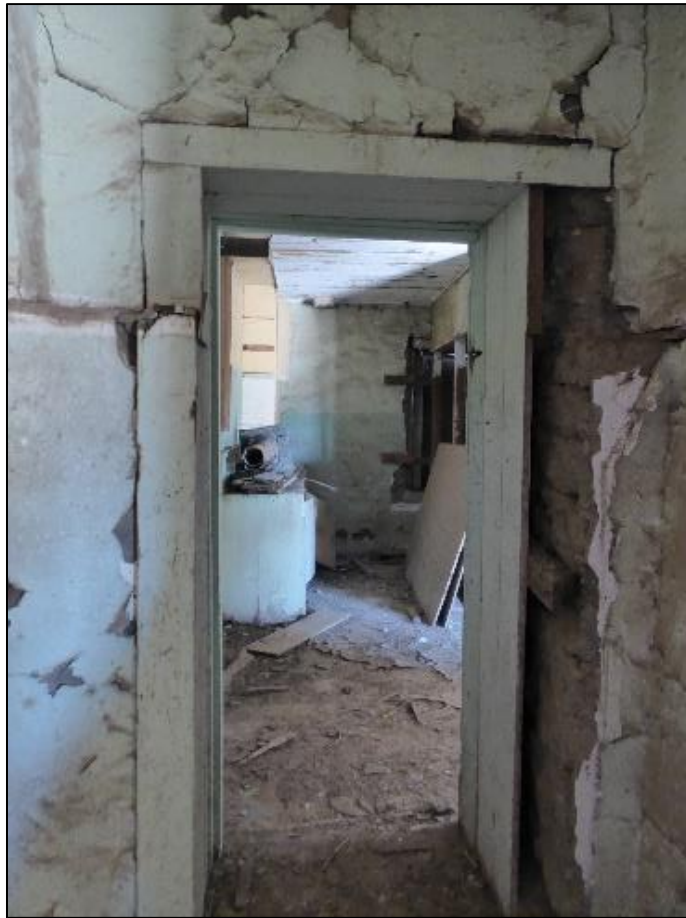
Figure 119. Interior wooden door trim with a missing board on the *right side* in the José María Gil Adobe, 2021. (ERDC-CERL.)

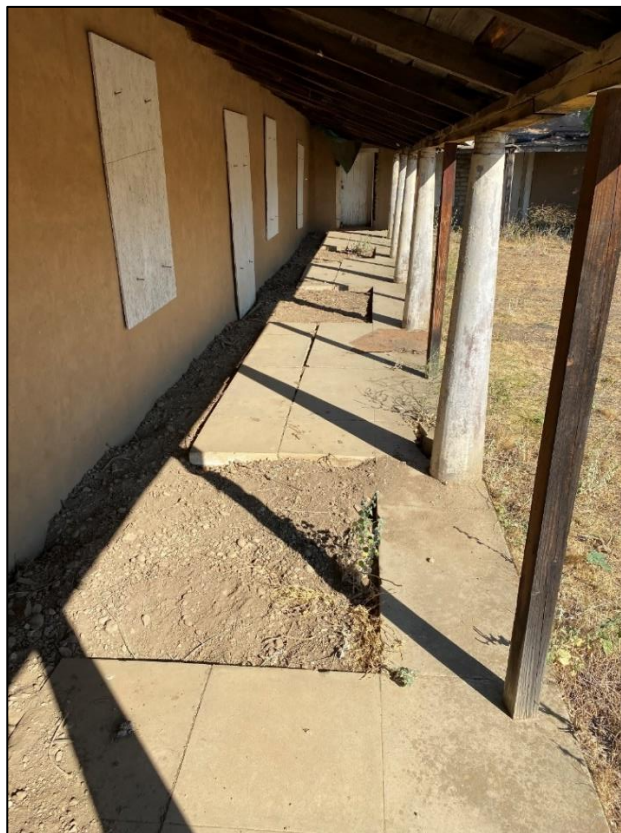
Figure 133. Removed concrete pavers on the northeast side of the José María Gil Adobe, 2021. (ERDC-CERL.)
