Review of Regressive Channel Erosion and Grade Control Options on the Rio Coca, Ecuador

by Chris Haring, Tom Darby, David May, and Paul Boyd

PURPOSE: The US Army Corps of Engineers (USACE) is assisting the Ecuadorian state-run Corporación Eléctrica del Ecuador (CELEC) in addressing a water resource issue involving regressive channel erosion on the Rio Coca. Reconnaissance of the site was completed the week of 21 February 2022; parts of the river system were viewed to determine if improvements could be made to the current grade control structure (GCS) mitigation plan for reducing channel erosion and stabilizing the river system downstream of the Coca Coda Sinclair (CCS) Dam.

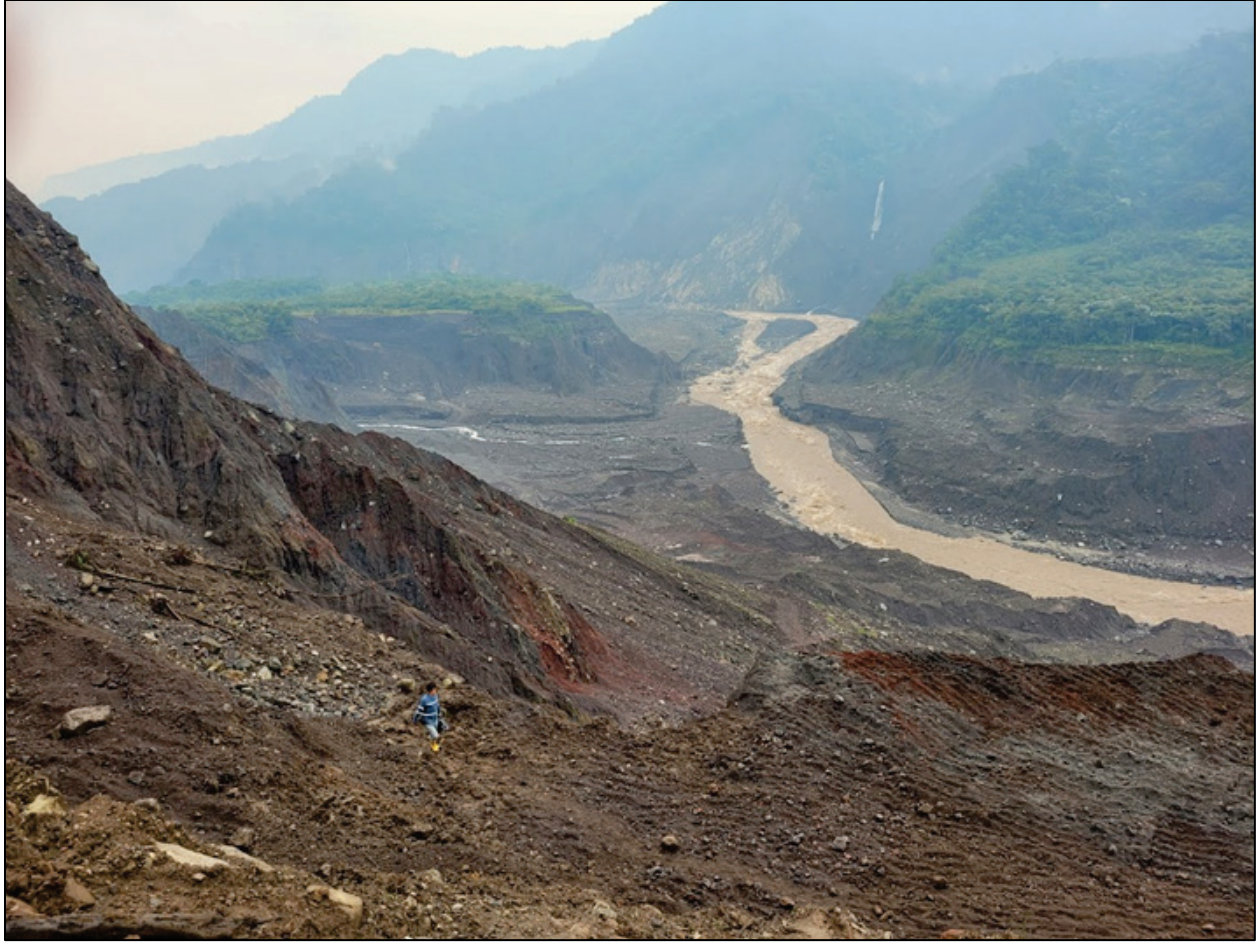
Figure 2. Regressive erosion on the Rio Coca at an overlook on C. Teniente Hugo Ortiz, approximately 500 m northwest of San Luis, Ecuador.

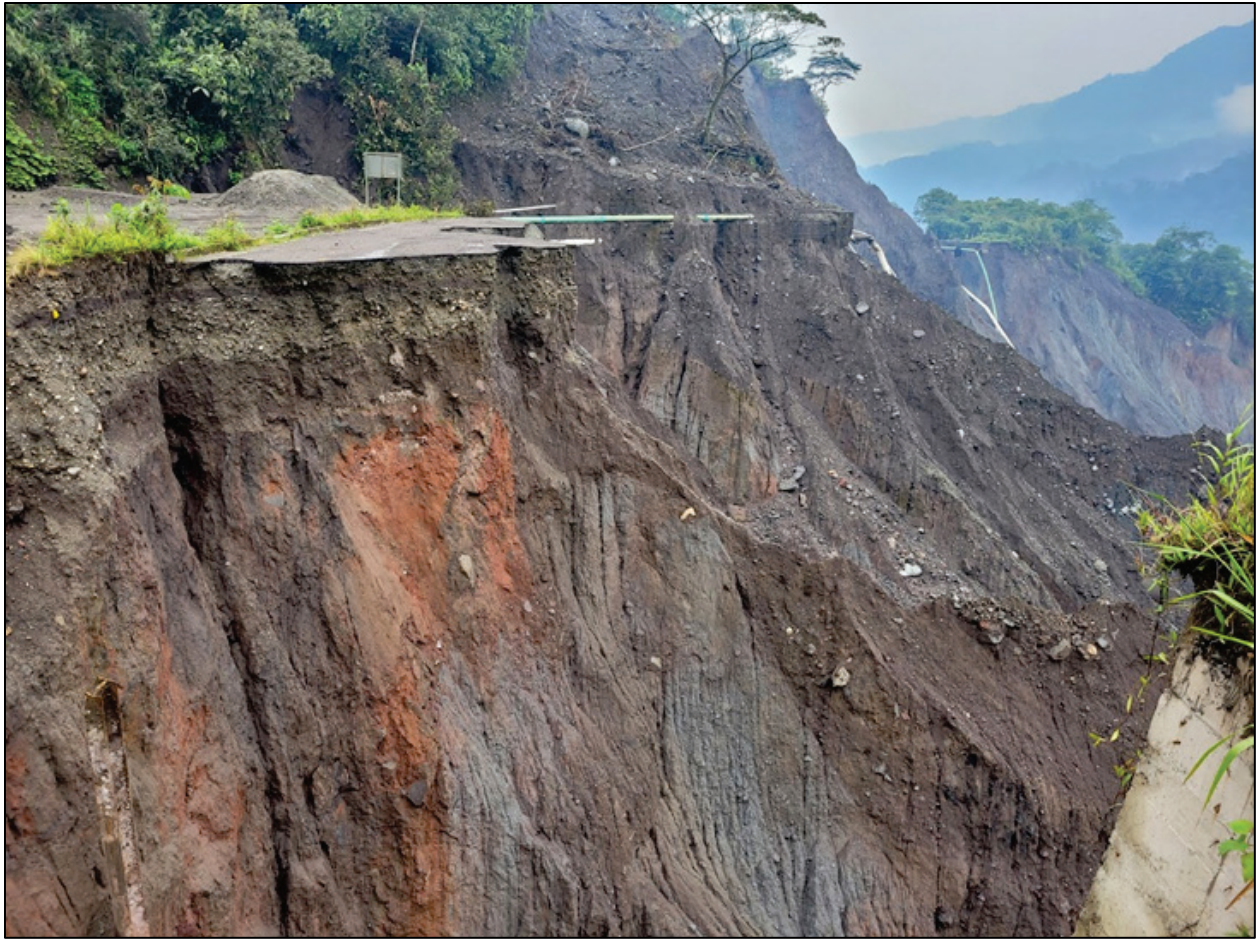
Figure 3. Regressive erosion on the Rio Coca at a tributary bridge on C. Teniente Hugo Ortiz, approximately 550 m northwest of San Luis, Ecuador.

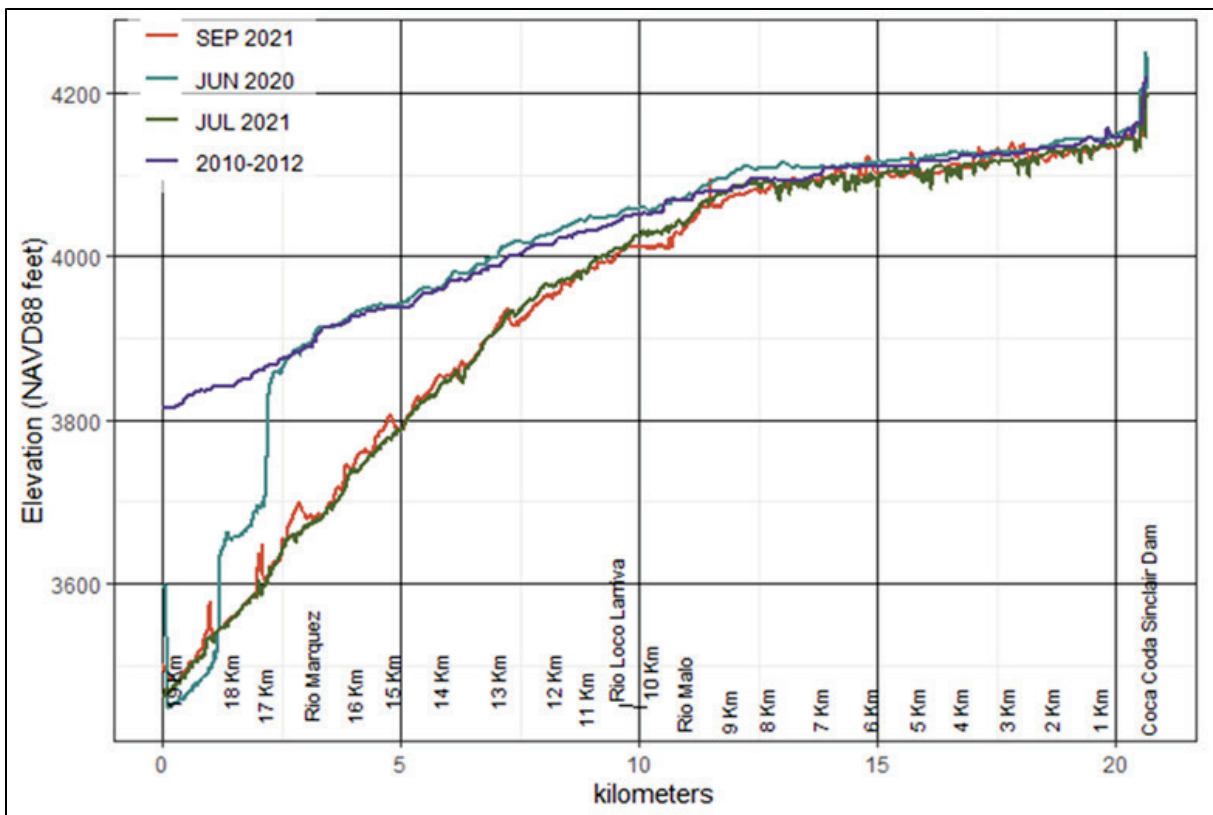
The Rio Coca's longitudinal profile has changed drastically since the waterfall-failure event in February of 2020 (Figure 5 and Figure 6). Figure 5 illustrates the Rio Coca cross-section locations. To further assess the spatial and temporal changes to the channel and valley profile (Figure 6), FluvialGeomorph (FG; Haring et al. 2020; Haring and Biedenharn 2021) was used to plot lidar provided by CELEC. The purple profile illustrates the with-waterfall slope prior to the failure event in early February 2020. The red profile shows the effects of the regressive erosion, with the baselevel lowering by more than 114.3 m (375 ft) at San Rafael and by approximately 3.1–4.6 m (i.e., 10–15 ft) upstream, close to the mouth of the Rio Malo.

Figure 6. Plots of multiple Rio Coca longitudinal profiles based on lidar. (The oldest profile is *purple*, and the newest profile is *red*.)

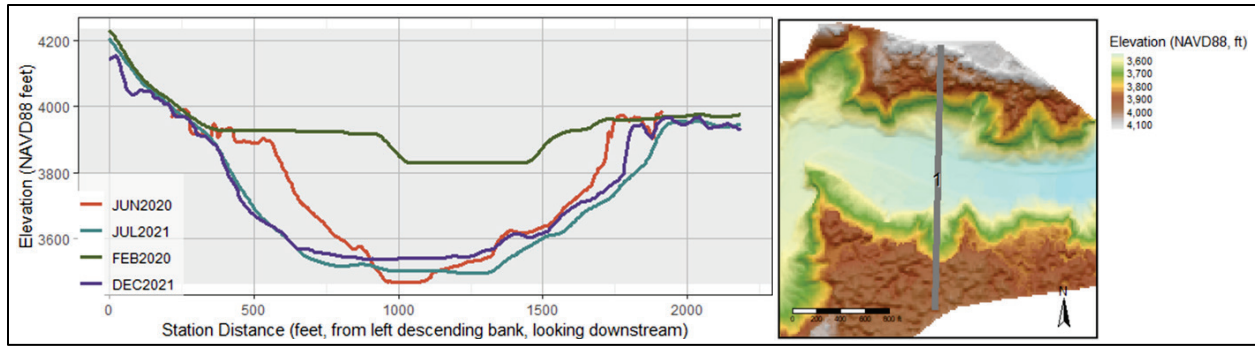
Spatial and temporal changes to cross-sectional channel locations provide detailed information on geomorphic channel adjustments. Figure 7 through Figure 10 illustrate channel deepening and widening, which increase from the downstream cross-section (XS) 1 to the upstream XS 90. The FG analysis matches well with general field observations that identified wholesale valley widening and deepening (XS 1) upstream of the failed waterfall. The regressive erosion decreased in the San Luis area (XS 60) because large bed material is present, resulting in less channel deepening and widening upstream (XS 60 and 75) at the mouth of the Rio Malo.

Figure 7. Rio Coca lidar for cross-section (XS) 1, illustrating temporal and spatial channel degradation at the San Rafael Waterfall.

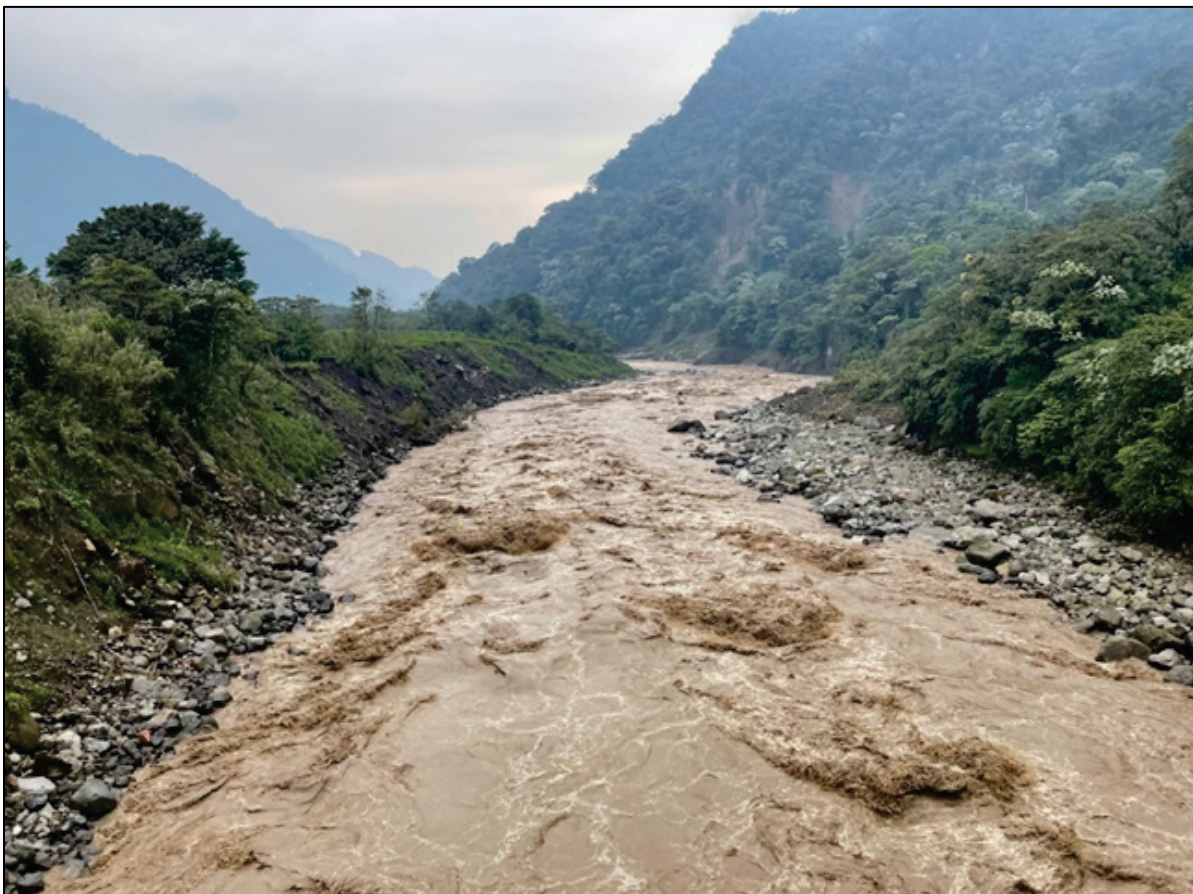
Figure 12. Rio Coca; downstream channel at kilometer marker (Km) 7.8 (Walking Bridge).

of avalanche deposits (between Km 12 and Km 19), fluvio-lake character deposits (between Km 0+0 and Km 12), and deposits of gap volcanic underlying the deposits of avalanche to the fluvio-lacustrine (between Km 5.6 and 16.8; CELEC 2021). Figure 11 illustrates the general geological profile. There have been some additional updates to the geologic mapping, especially in the area upstream and downstream of the Rio Malo tributary confluence (approximate stations Km 7–12). The newer mapping and field observations monitoring the progress of the regressive erosion front have located important resistive materials present in the form of surface outcrops acting as hard points. The main hard point locations are at Km 7.8 (Walking Bridge), 12 (San Luis Bridge knick zone) and 14 (downstream of San Luis). All three hard points are located where the Rio Coca encounters the right valley wall. The hard points are areas where consistent fluvial erosion has weathered valley wall materials (i.e., bedrock) from the adjacent and underlying strata and provided larger, concentrated, erosion-resistant bed materials (Figure 12).

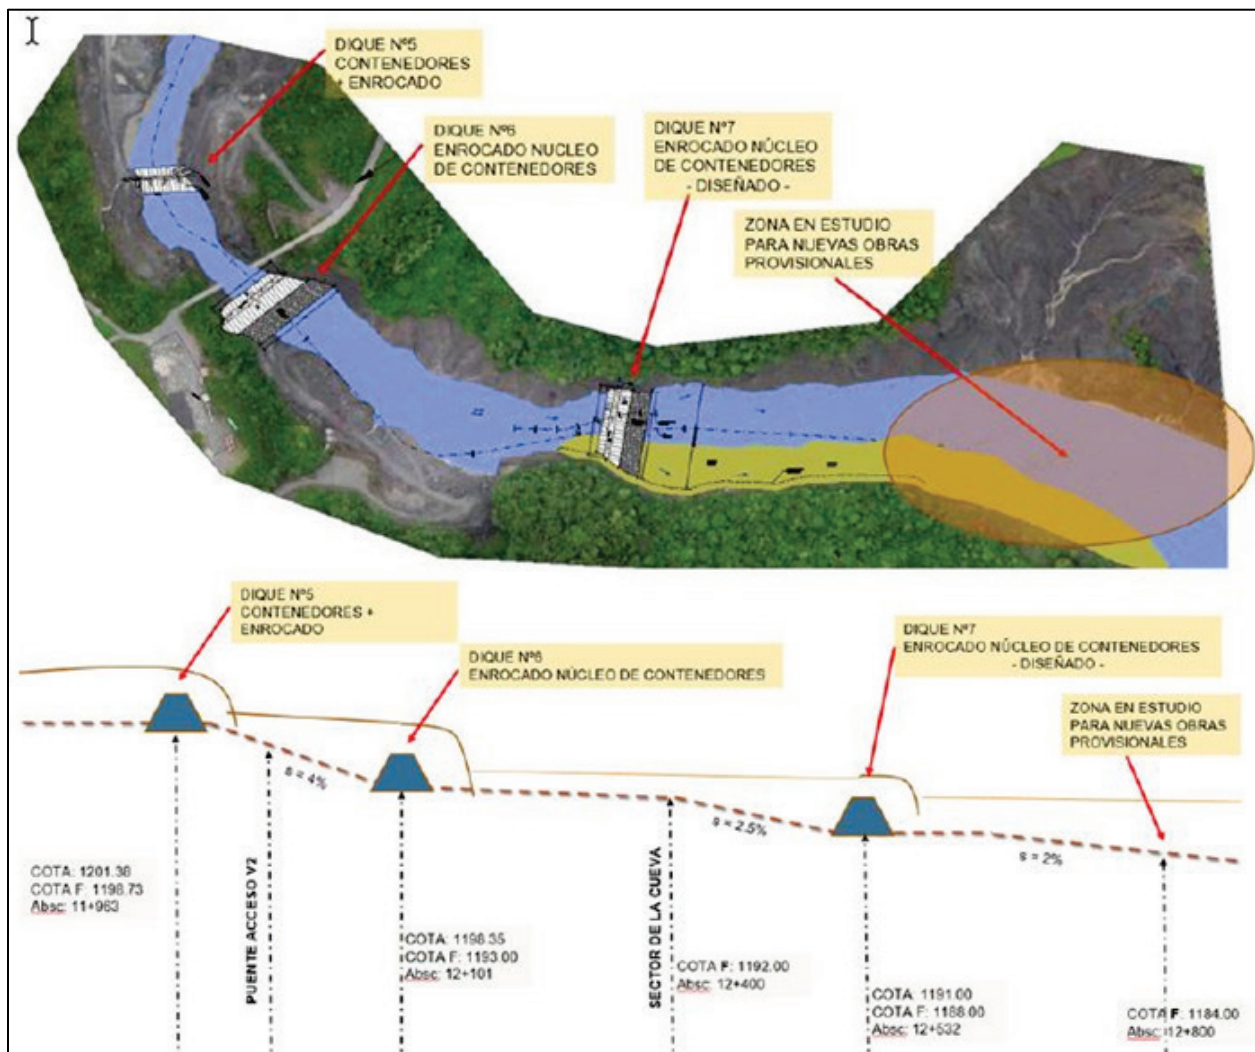
Figure 13. Rio Coca Km 12 location illustrating the existing GCS plan. Image reproduced with permission from CELEC (2021).

Two check dam structures (CDSs; Figure 13) were constructed in the pinch-point location (i.e., San Luis) to protect from extension of the knickpoint upstream and to protect an existing bridge. Both structures were compromised during a March 2021 flow event of $1600 \text{ m}^3/\text{s}$. The structures were constructed with a solid core and concrete-filled metal containers and were shaped upstream and downstream with large local channel materials. The materials used for construction had a median size of 1.2 m (Pedro Barrera, pers. comm., February 2022). Highly concentrated flow velocities in the pinch-point river section undoubtedly compromised the structure. A structure with a rigid core is typically able to adjust to minor winnowing of materials. However, loss of the structure may occur when excessive foundation scour occurs and the solid core cannot freely adjust; movement of the CDS may occur. The CDS is one form of GCS that is designed with a solid core and uses available onsite materials. There are many other types of GCSs that incorporate similar materials, such as well-graded riprap. The sizing of riprap depends on accurately measuring and predicting channel velocities and shear stresses so that materials can be sized appropriately. The advantage of large and well-graded riprap is that it has launching and rellocking capabilities once the structure or revetment encounters the anticipated velocities and resulting scour. The construction of the CDSs was limited by the requirement to use only locally available rock (i.e., 1.2 m in size) and the limited gradation that was present; these likely caused the structures to be compromised. Flanking of the structure on either bank line, especially in a pinch-point-incised channel location, is also a concern because water depth and channel shear stress increase. These locations were not observed during the site visit.

It is not known why the two CDSs were compromised, but some enhancements to the designs will increase the likelihood of success. The extreme shear stress and velocities in the pinch-point likely produced sufficient energy to compromise the structures in some way, whether it was flanking, material removal movement (approximately 1–1.2 m sizing) around the solid core, or a combination of both. Possible enhancements to the structure designs are provided in the next section.

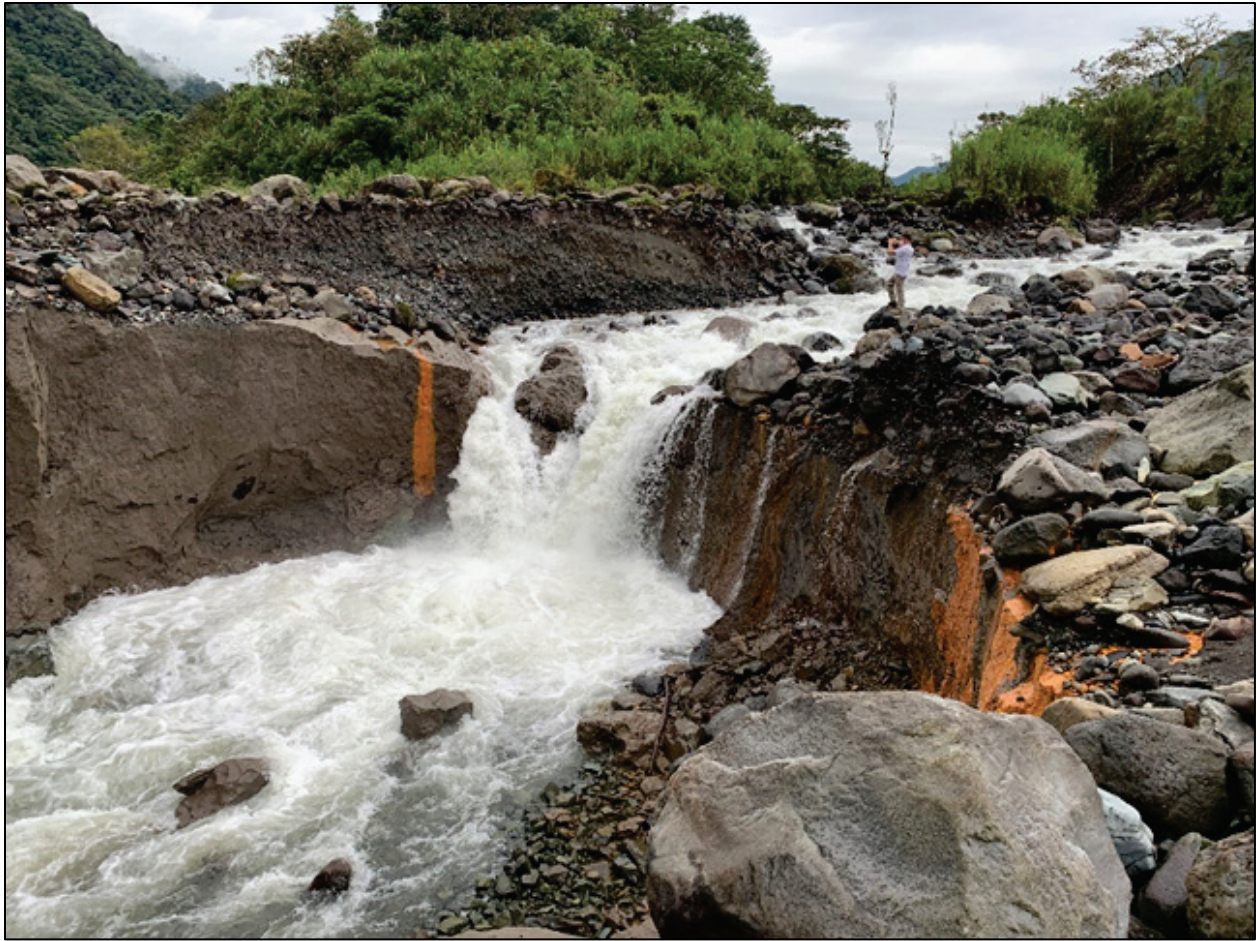
Figure 14. Channel degradation and instability progressing from the Rio Coca upstream into the tributary Rio Malo.

9. Investigate and assess stabilization measures applicable to all Rio Malo tributary channels. Regressive erosion will continue in tributaries and further contribute to sediment delivery to the downstream Rio Coca reaches, especially the downstream CCS Dam outflow structure (Km 15).

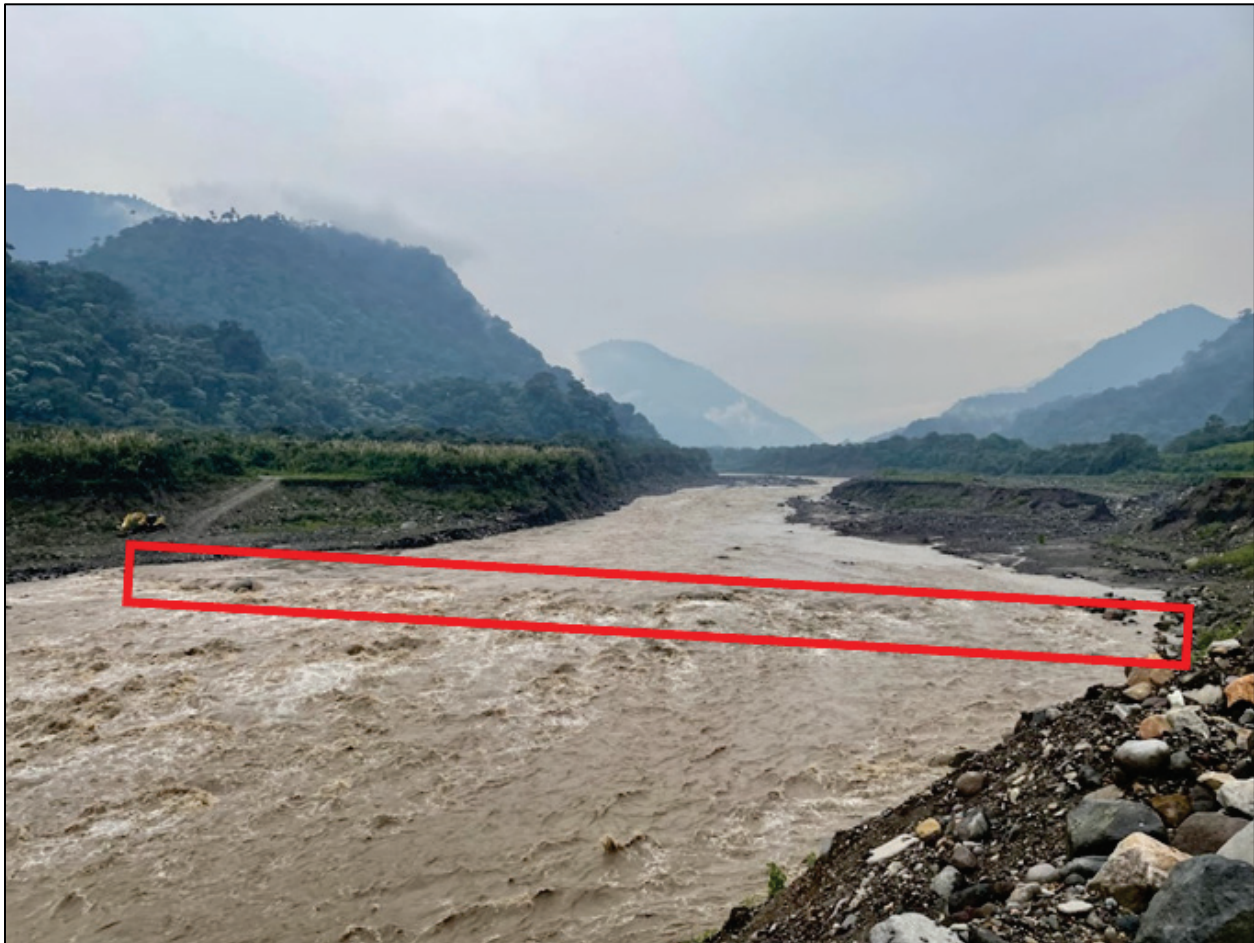
A third CDS (Figure 15) was constructed upstream of the pinch-point at approximate station 9+550 (upstream of La Loma Camp). This structure was viewed during the site visit on 22 February 2022 and appeared to be functioning well (Figure 16). From design information, it appears that the structure was installed as a linear structure perpendicular to flow and did not have a solid core (CELEC 2021). The structure will be tested with the upcoming rainy season (Spring/Summer 2022).

Figure 16. Rio Coca CDS in foreground of photo (looking upstream, structure location in *red*).

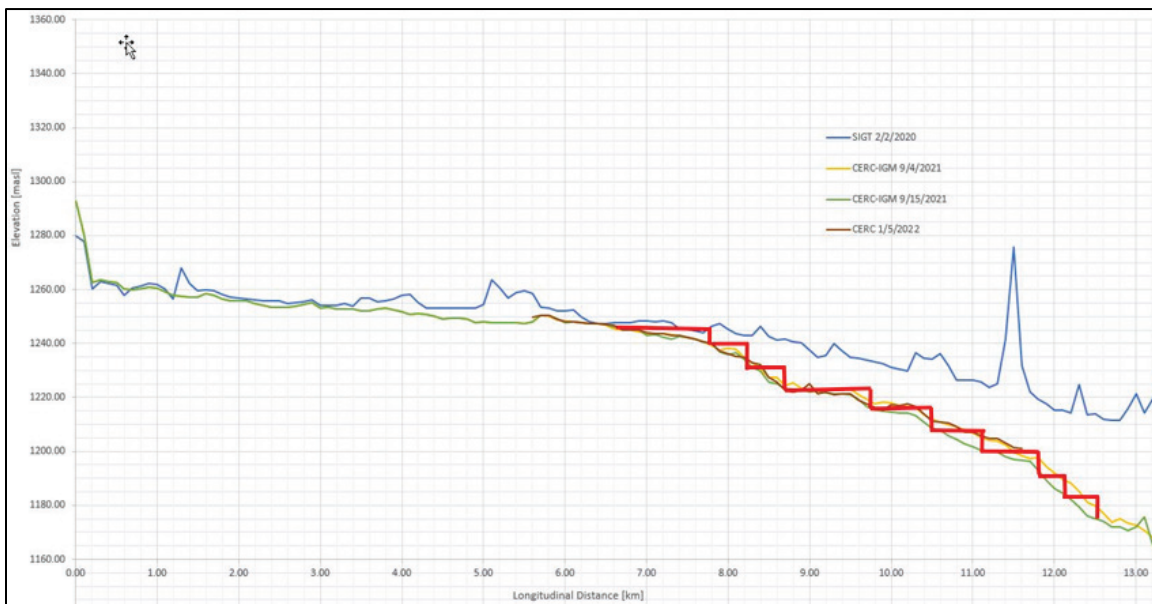
Figure 17. Longitudinal channel profiles based on separate lidar collection dates (2/2/2020 is *blue*, 9/4/2021 is *yellow*, 9/15/2021 is *green*, and 1/5/2022 is *brown*). Potential Rio Coca stabilization grade control plan (Km 7.8–12.5).

1. A system-wide approach to grade control would start downstream of the existing knick zone at San Luis and work upstream to stabilize the channel slope (Figure 17). Based on the existing lidar profile surface, there is the potential to construct nine GCSs, ranging from 5 to 10 m in height, to stabilize the channel from Km 7.8 to 12.5. This would likely be extended downstream to the previous San Rafael Waterfall location if access to the river corridor can be established. A road is currently being constructed downstream of San Luis and could be used to provide access for construction of a series of structures below the existing knick zone. This would provide additional protection from continued degradation migrating from the downstream reaches. The exact height, width, and location of structures need to be field verified.

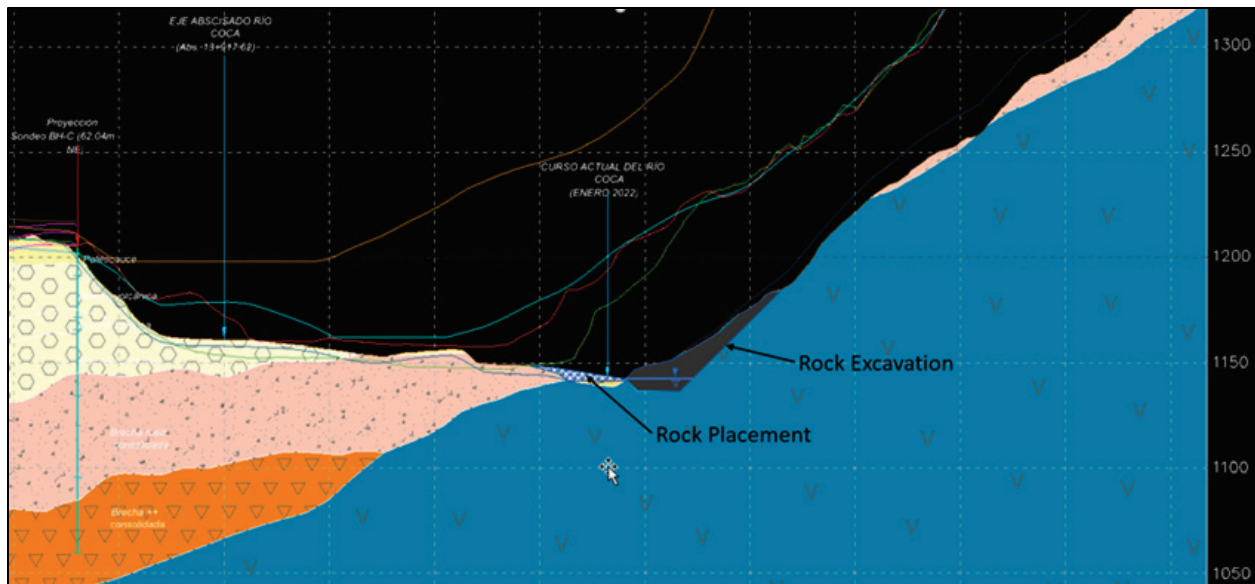
Figure 18. Rock excavation and placement to prevent further downcutting; example is at Km 14. Image adapted from CELEC (2021).

2. The hard-point locations at Km 7 (Walking Bridge), 12 (San Luis Bridge knick zone), and 14 (downstream of San Luis) should be used to continue the system-wide approach to stabilizing the Rio Coca. After the February 2022 trip, discussions at USACE (Figure 18) centered on possibly blasting and using local bedrock sources to stabilize the channel in these locations. This could possibly be extended to other locations where the harder bedrock materials are present.
