## Low Sill Control Structure

Physical Modeling Investigation of Riprap Stability Downstream of End Sill

May 2024

Final Report

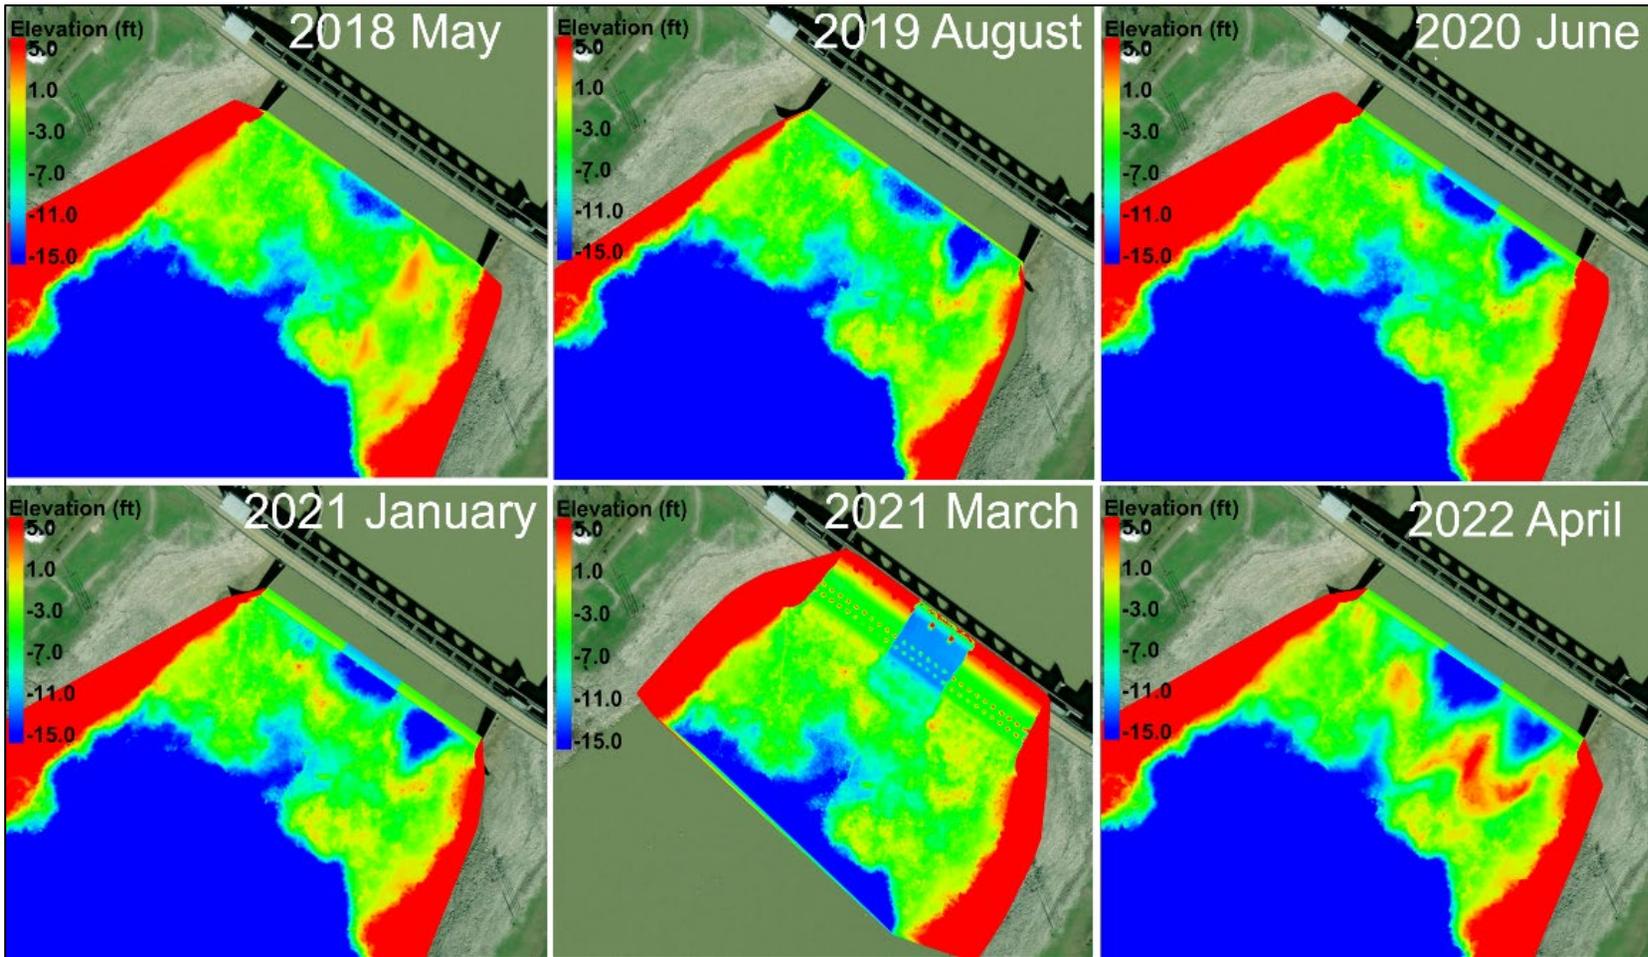
Figure 2. Bathymetric surveys downstream of the end sill of the Old River Low Sill Control Structure (LSCS) from May of 2018 to April of 2022.

In 2019–2020, scour holes were found developing downstream of the end sill of the structure. The scour downstream of Gate Bay 10 was especially severe and it was feared that this scour could potentially lead to undermining of the structure (Gate Bays are numbered 1–11 going from northwest to southeast). Repairs to the scoured areas were made by MVN in March of 2021 in which they deployed R-5000 (W50 of 2,200 lb) stone downstream of the structure with an approximate blanket thickness of 9 ft.\* The survey conducted in April of 2022 indicated that the riprap placed in March 2021 had been removed and deposited just downstream of the scoured areas. The resulting scour looked very similar to the scour that had been seen in 2019–2020. The scour progression and rock placement and movement can all be seen in Figure 2 (areas in orange or red are southwest of scour holes). For reference, gate numbering can be seen in the 2018 May survey.

In reviewing Figure 2, it is obvious that in May 2018 the only potential scoured area was downstream of Gate Bays 5 to 7. By August 2019 the channel downstream of Gate Bays 8 to 10 had scoured significantly and the channel bed scour downstream of Gate Bays 5 to 7 had enlarged slightly. By June 2020 these two scour areas deepened and enlarged but after that remained relatively unchanged until January 2021. The stone used to produce the bed configuration in March 2021 was designed based on a velocity of 17.5 ft/s and classified as R-5000 ( $W_{50}$  of 2,200 lb) by

MVN. The stone used in the 2021 repair was based on a lower velocity than the recommended stone size in 1976. Therefore, the scour that occurred between March 2021 and April 2022 was similar to the past performances of various sized stone used over the years downstream of the end sill.

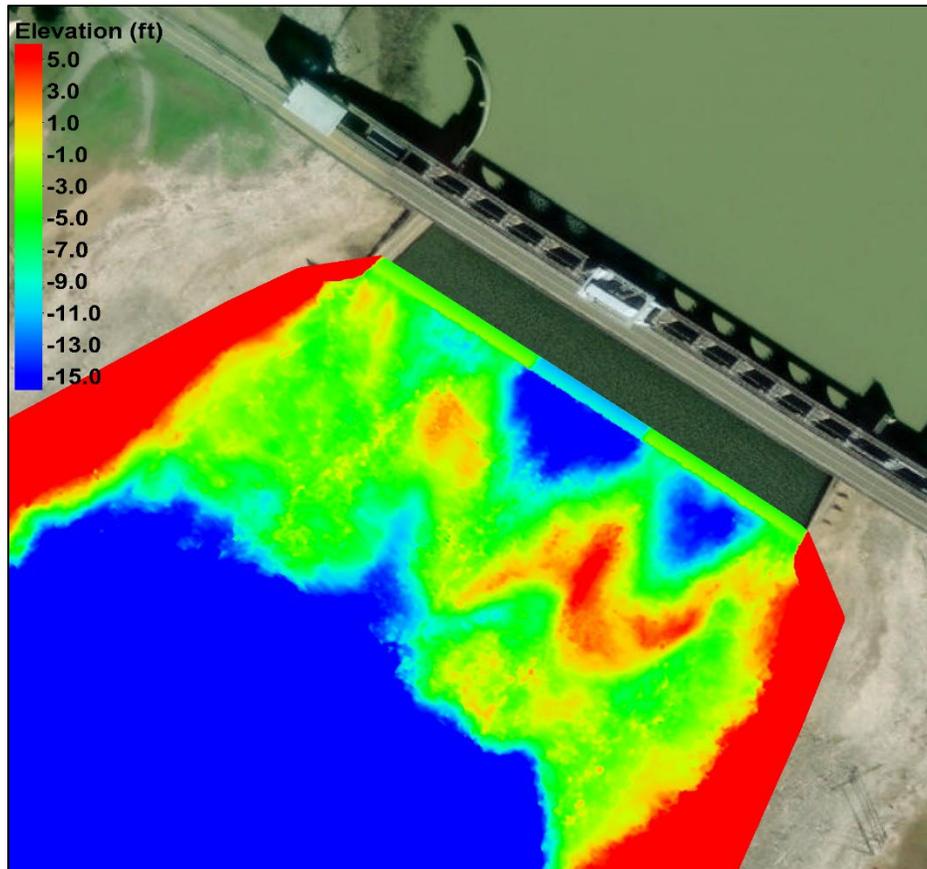
Figure 11. April 2022 prototype lidar survey.

Comparing the model ending survey to the April 2022 survey (Figure 11) indicates that the scour downstream of Gate Bays 1 to 4 is very similar to what occurred in the prototype. The scour downstream of Gate Bays 5 to 7 was like the prototype, although the scoured area was not as large or as deep as in the prototype; however, as in the prototype, of the three scoured areas this was the largest. The scour and stone deposition downstream of Gate Bays 8 to 11 was a reasonable representation of the prototype tendencies. The pre minus posttest lidar comparison is in Figure 13 and the post test bed can be seen in Figure 14.

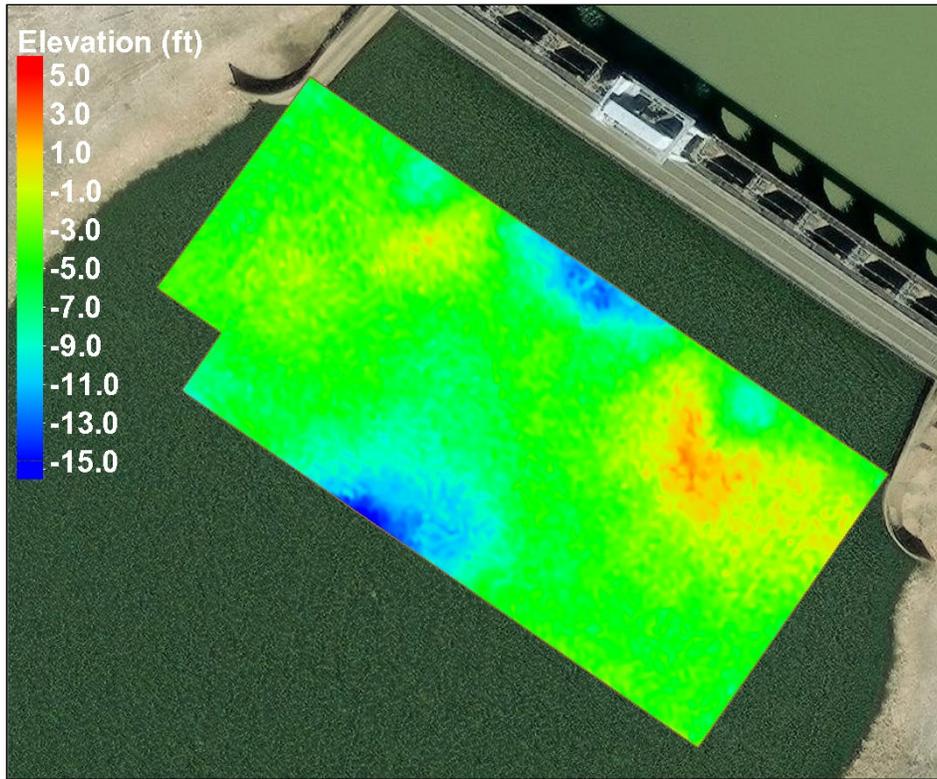
Figure 12. Posttest lidar from the verification gradation stone test.

The bed configuration at the end of the test is shown in Figure 12. Comparing the model ending survey to the Pretest conditions (Figure 9) indicated that the areas downstream of Gate Bays 1 to 4, 5 to 7, and 8 to 11 scoured during the testing. Downstream of Gate Bays 1 to 4 approximately 6 ft to 7 ft of scour occurred. Downstream of Gate Bays 5 to 7 the existing scour area increased in size and deepened approximately 3 ft to 4 ft.

Downstream of Gate Bays 8 to 11 about 10 ft of stone was scoured and some of that material was deposited directly downstream.

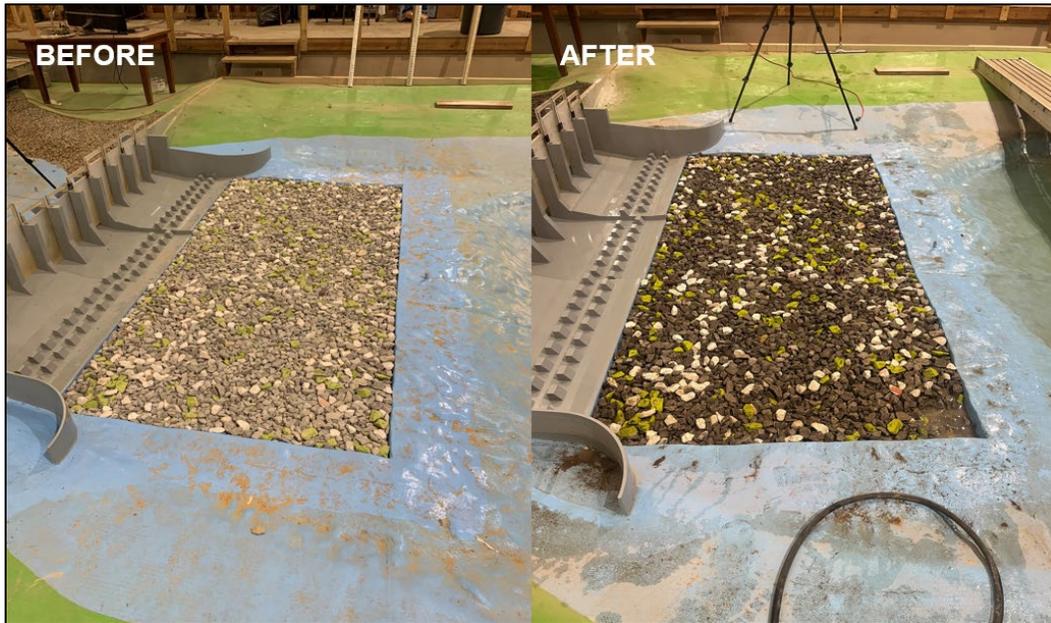
Figure 17. Photograph of Gradation A test area before and after testing.

All tests were conducted using the stepped hydrograph shown in Figure 4. During the testing there was no major movement in the areas of concern as seen in Figure 17 indicating that Gradation A was stable for the flow conditions tested. The pretest lidar results are shown in Figure 18.

The before and after photographs in Figure 17 and the pre- and posttest lidar plots in Figure 18 and Figure 19 respectively indicate that there was no scour of the Gradation A stone downstream of the low Gate Bays 5 to 7 or the high Gate Bay 10 as has occurred previously in the prototype (see Figure 2). Figure 20 shows the difference plot from pre minus posttest lidar surveys which also shows no scour from the model test. The *red* and *blue* “dots” that are seen in Figure 20 are from slight movement of the rocks sliding and rolling during testing. Therefore, Gradation A stone would be suitable for stabilizing the areas of scour. However, since the Gradation A stone was relatively large, it was decided to test a smaller size stone compared to Gradation A, but larger than the R-5000 gradation previously installed in the prototype.

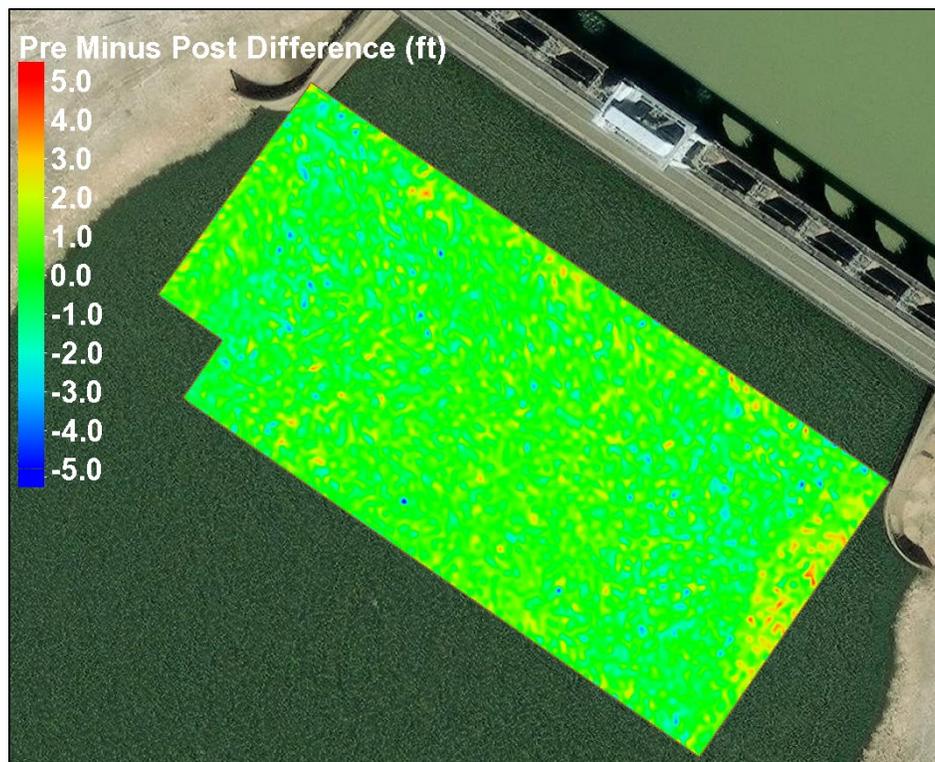
Figure 25. Difference lidar plot of pretest minus posttest bathymetry from the Gradation B test.

As was the case for the Verification and Gradation A tests, all tests were conducted using the stepped hydrograph shown in Figure 4. During the Gradation B tests there was no major movement in the areas of concern. Figure 22 shows photographs of the test area before and after the experiment and it is obvious that no movement took place during the testing. The pretest and posttest lidar results are shown in Figure 23 and Figure 24, respectively. Comparing the two figures indicates that Gradation B was stable for the flow conditions tested (Figure 25).

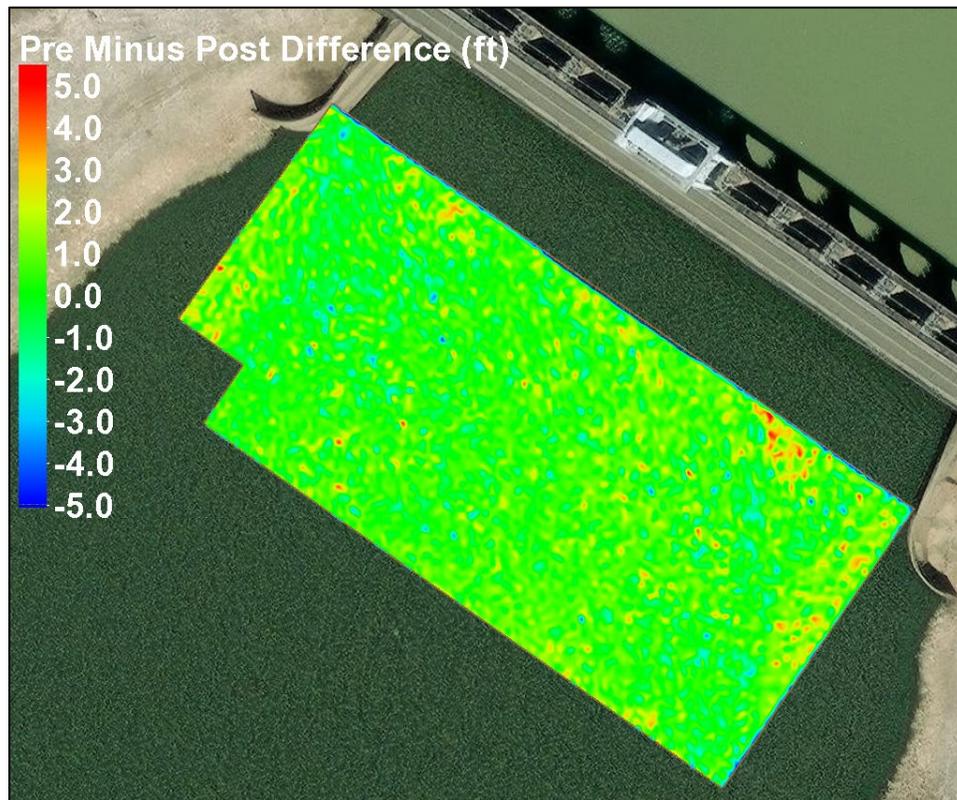
Figure 26. Difference lidar plot of pretest minus posttest bathymetry from the Gradation B tailwater drop test.

(Figure 23) and the bed configuration at the end of the tailwater drawdown test. The differences between those two surveys are presented in Figure 26. While there appears to be some movement of stone approximately downstream of the areas aligned with Gate Bays 2 and 10, that movement is very localized with there does not appear to be any systematic movement of stone throughout the basin. It should be noted relative to the data shown in Figure 26 that red areas are indicative of bed scour since the figure is a plot of the difference of the initial bed configuration (pretest) and the posttest tailwater lowering.

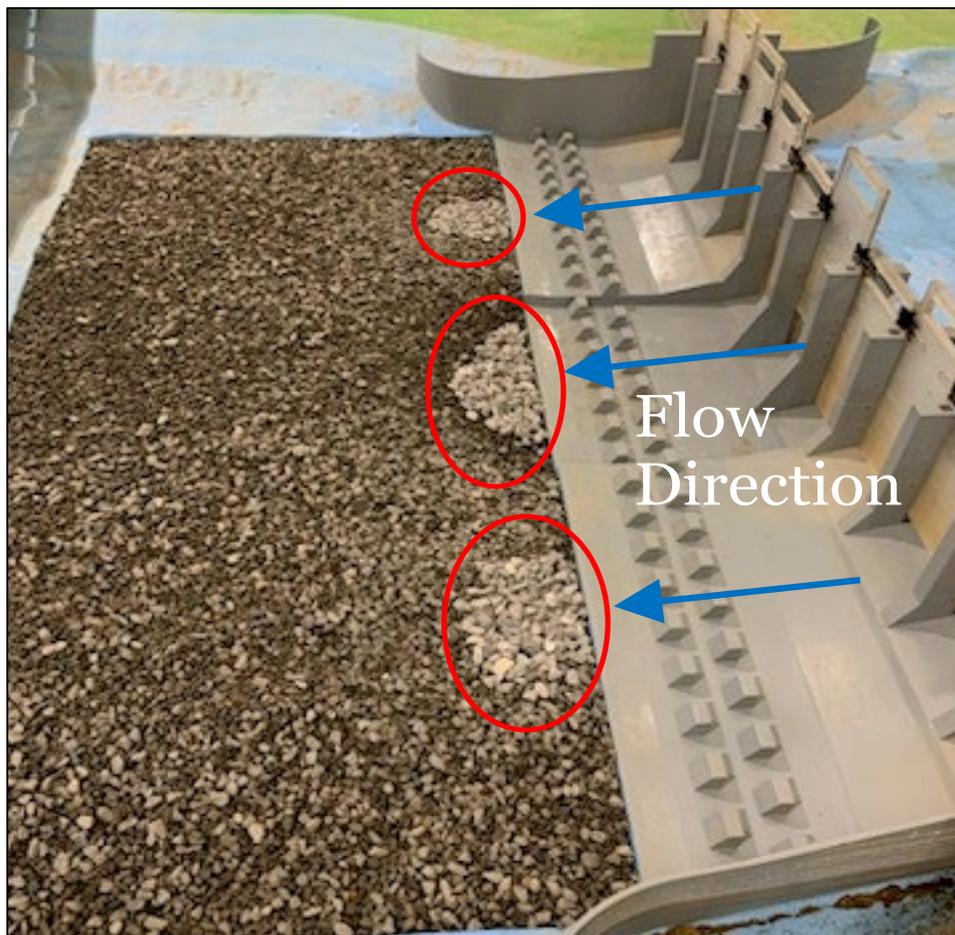
Figure 27. Scour holes filled with Gradation B stone.

At the request of MVN, a test was conducted to determine the effects of installing Gradation B stone in the three scoured areas downstream of the end sill in the Verification Gradation stone test (Figure 12). Such a test would be indicative to the situation MVN had relative to the existing scour in the prototype (Figure 11). It should be noted that most of the stone downstream of the end sill was the modelled R-5000 stone from the verification test. Figure 27 shows the bed configuration at the end of the

Verification Gradation test with the three scour holes filled with Gradation B stone (the light-colored stone immediately downstream of the LSCS end sill looking to the north; circled in red) and Figure 28 shows the pretest lidar survey.

Based on the results of the tests conducted during this study, it is recommended that a stone sized similar to Gradation B stone be used for future repairs of scoured areas downstream of the LSCS end sill. This recommendation is supported by the results of the Gradation B tests, the tailwater lowering tests on the Gradation B stone, and the Riprap Repair Test. In these three tests the Gradation B stone remained stable and indicated no tendency to be scoured.

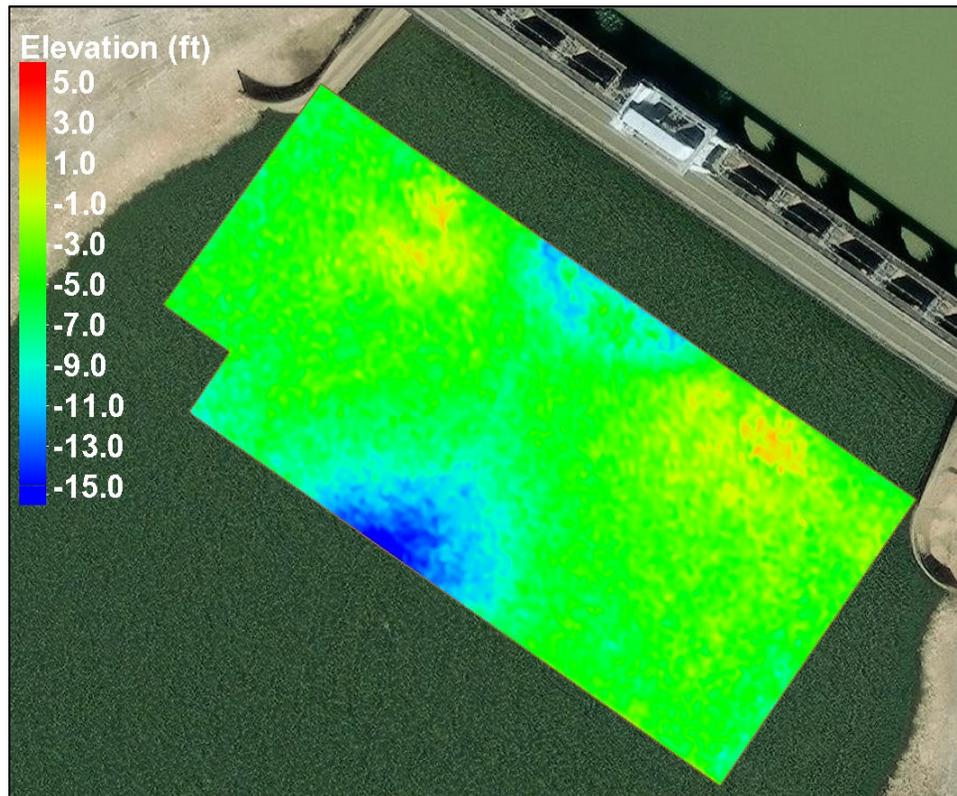
Figure 28. Pretest lidar from the Riprap Repair Test.

A comparison of the Postverification Test lidar survey shown in Figure 12 above and the Pre-Riprap Repair Test shown in Figure 28 with the three scour holes filled with Gradation Stone B shows that the scour hole downstream of Gate Bays 1 to 4 was filled about 6 ft or 7 ft with the area raised from elevation  $-6$  ft to elevation  $0$  ft. The scour hole downstream of gate bays 5 to 7 was filled about 10 ft with Stone B with the area raised from elevation  $-15$  ft to elevation  $-5$  ft. Downstream of Gate Bays 8 to 11 the scour hole at the end of the Verification Test was filled by about 6 ft with the area raised from elevation  $-5$  ft to elevation  $+1$  ft.

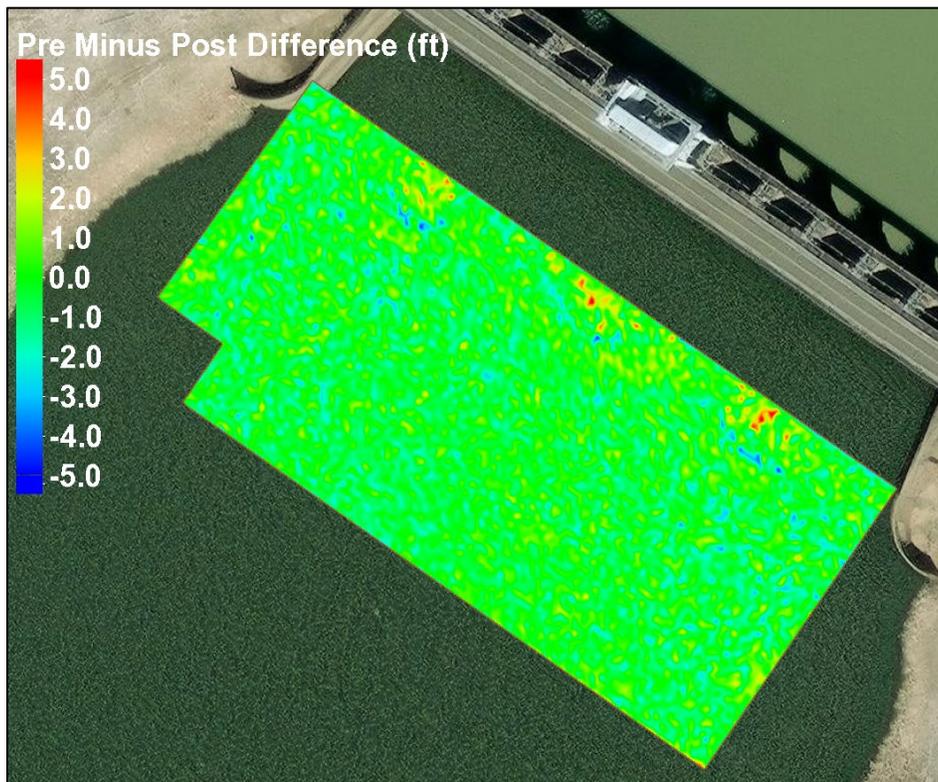
Figure 30. Difference lidar plot of pretest minus posttest bathymetry from the Riprap Repair Test.

Comparing the difference of the lidar surveys by subtracting the posttest survey from the pretest survey indicates very minor or virtually insignificant differences between the two surveys. A plot of the differences is presented in Figure 30. The few differences that are indicated on the figure are due to slight rock movement and lidar data measuring the top of a stone on one survey and the side of the stone on the other survey.
