SS V. A. FOGG; SINKING IN THE GULF OF
MEXICO ON 1 FEBRUARY 1972 WITH LOSS
OF LIFE

Coast Guard
Washington, D. C.

13 September 1974

1. Report No. USCG/NTSB-MAR-74-8		2. Government Accession No.		3. Recipient's Catalog No.	
4. Title and Subtitle Marine Casualty Report -- SS V.A. FOGG Gulf of Mexico 1 February 1972				5. Report Date September 13, 1974

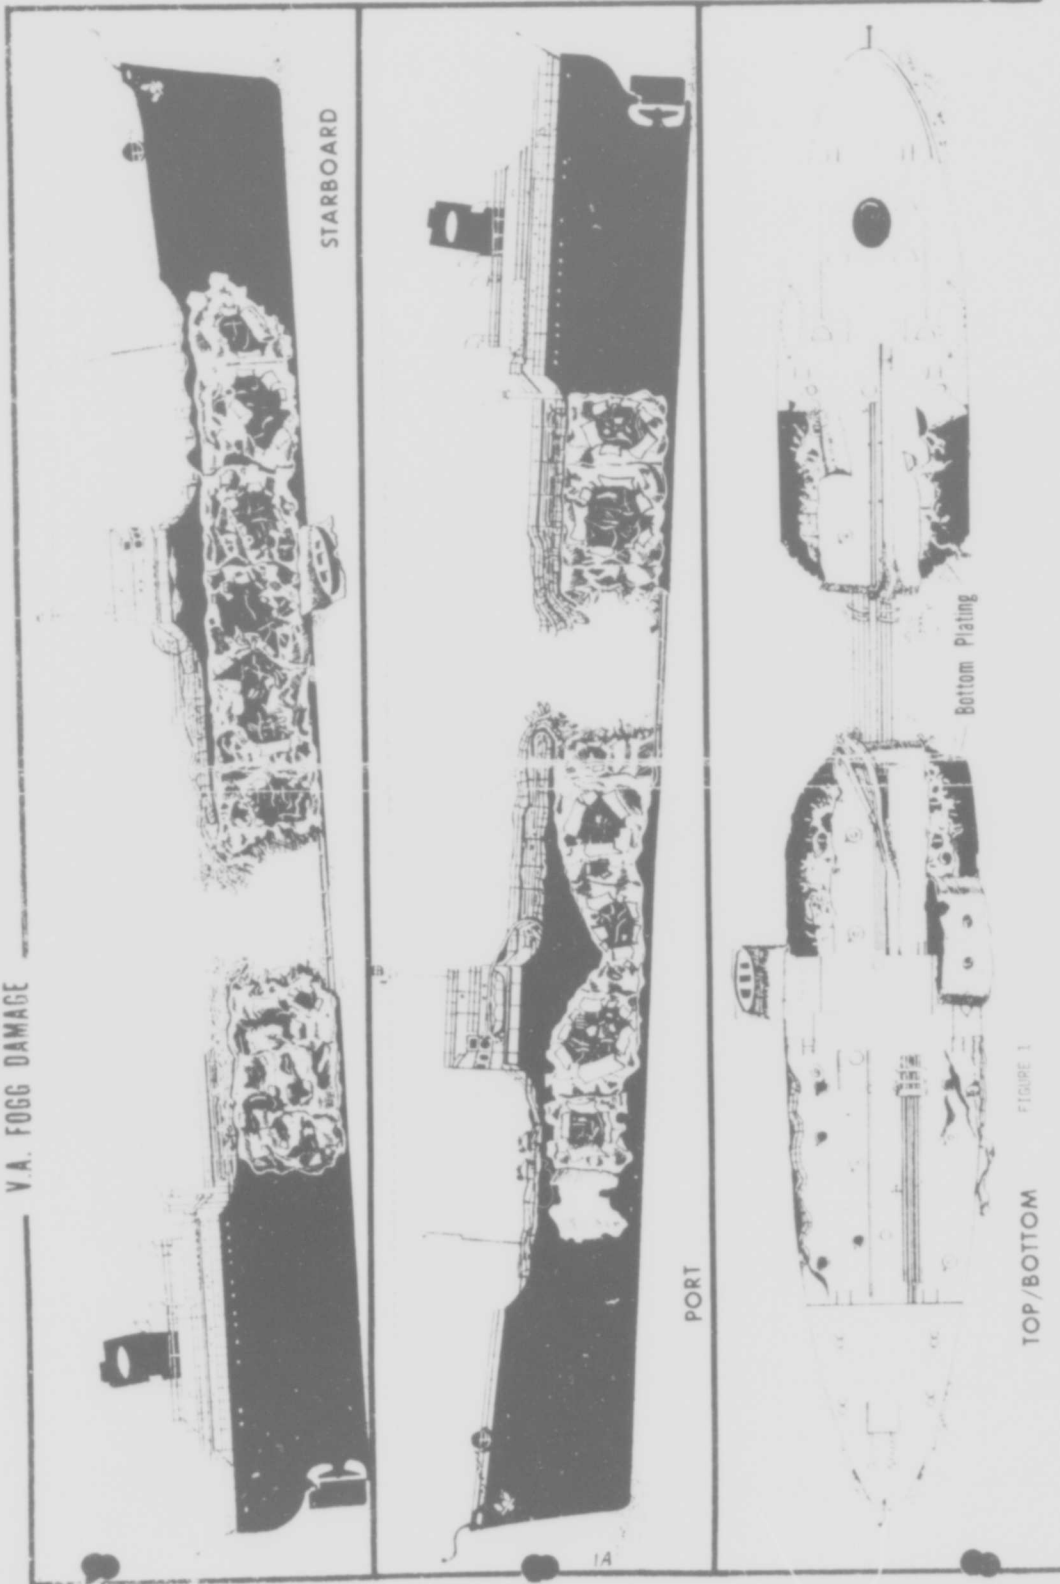
V.A. FOGG DAMAGE

Only by viewing the vessel or the exhibits to this report can a true appreciation of the extent of vessel damage be gathered. To help the reader appreciate the gross damage an artist's interpretation is attached. This interpretation does not claim complete accuracy but is illustrative of the massive damage sustained by the vessel. Attached for reference purposes is a photograph of the vessel taken prior to the casualty.
