ENTANGLEMENT OF THE SUBMERSIBLE  
JOHNSON SEA LINK WITH SUBMERGED WRECK-  
AGE OFF KEY WEST, FLORIDA ON OR ABOUT  
17 JUNE 1973 WITH LOSS OF LIFE

1. Report No. USCG/NTSB-MAR-75-2	2. Government Accession No.	3. Recipient's Catalog No.	
4. Title and Subtitle Marine Casualty Report - Submersible JOHNSON SEA LINK Entanglement off Key West, Florida, 17 June 1973		5. Report Date January 15, 1975

Submersible JOHNSON SEA LINK  
Straits of Florida  
17 June 1973

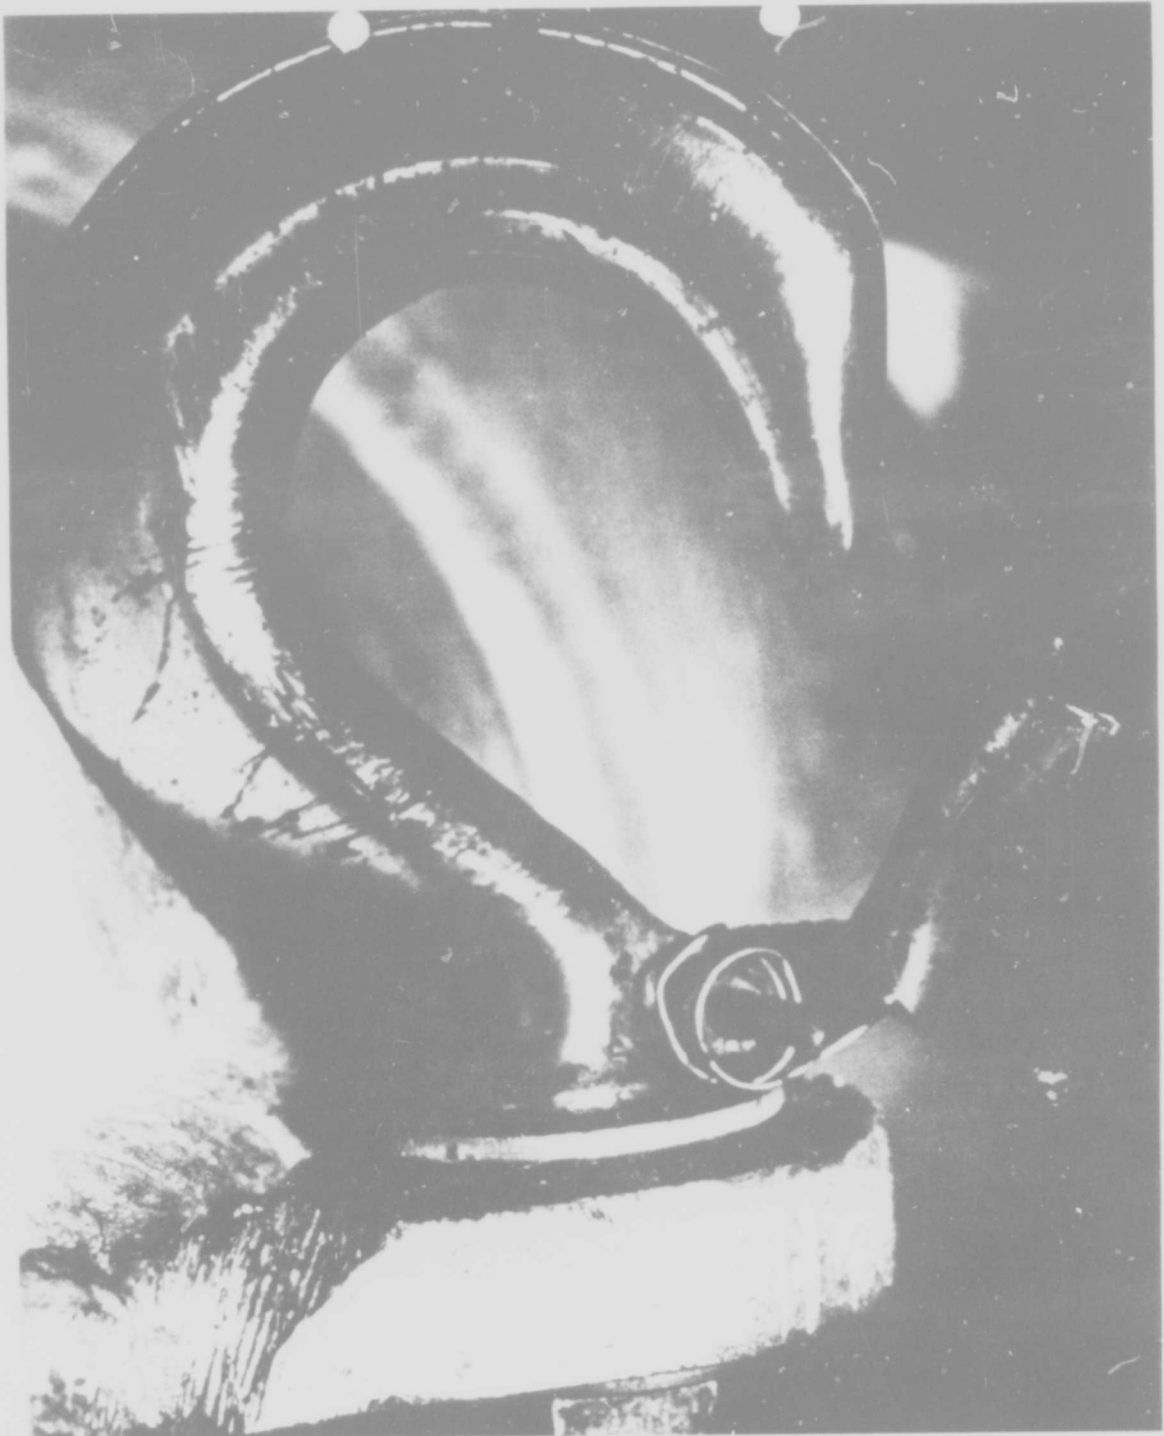
Figure 1 - Starboard Spring Loaded, Moused Hook

The National Transportation Safety Board determines that the probable cause of the accident was the fouling of the starboard spring-loaded moused hook and other appendages on the submersible with a cable attached to the aftermost flagpole of the scuttled destroyer.

Before the JOHNSON SEA LINK submerged on June 17, the hooks were not known to be damaged. A survey of the submersible after the casualty showed that the starboard hook had been damaged by a cable and that the mousing device had failed. (See Figure 1.) The mousing device could have failed when the submersible was raised from the bottom by the grapnel operated on board the A. B. WOOD II. The force exerted during this maneuver would have caused the cable to break free from the hook. Since there was evidence of damage inflicted by a cable at other points on the submersible, it could not be determined if the initial source of fouling was the snagging of the cable by the hook.

23. The SEA DIVER, with the SEA LINK still on board, arrived in its home port of Fort Pierce, Florida on 28 June. During the course of a hull examination subsequent to 28 June certain sections of the SEA LINK displayed evidence of cable scraping. In the general area of where Dr. Meek observed the cable to pass up over the stern of the SEA LINK were a number of structural members that contained scratches and serrations inconsistent with the remainder of its surface. For example, the forward edge of the propellor shroud on the starboard fixed propulsion motor contained deep scratches resembling file marks. Above these abrasions were similar scratches on the plastic cover of a pneumatic valve. Immediately above this plastic cover is an aluminum pad that is welded to a support member of the starboard surface buoyancy tank. Bolted through a hole in this pad is a steel hook which is used to restrain guide lines during retrieval of the submersible but is not used as a lifting hook. The hook is approximately one and a half (1½) inches in diameter and five (5) inches long with a two (2) inch opening. The opening faces downward and is guarded by a spring-loaded mousing device. Both the pad and the hook displayed evidence of chafing by a hard object capable of producing a serrated effect. In addition to the scoring of the hook the spring-loaded mousing device was wrenched from its normally closed position.

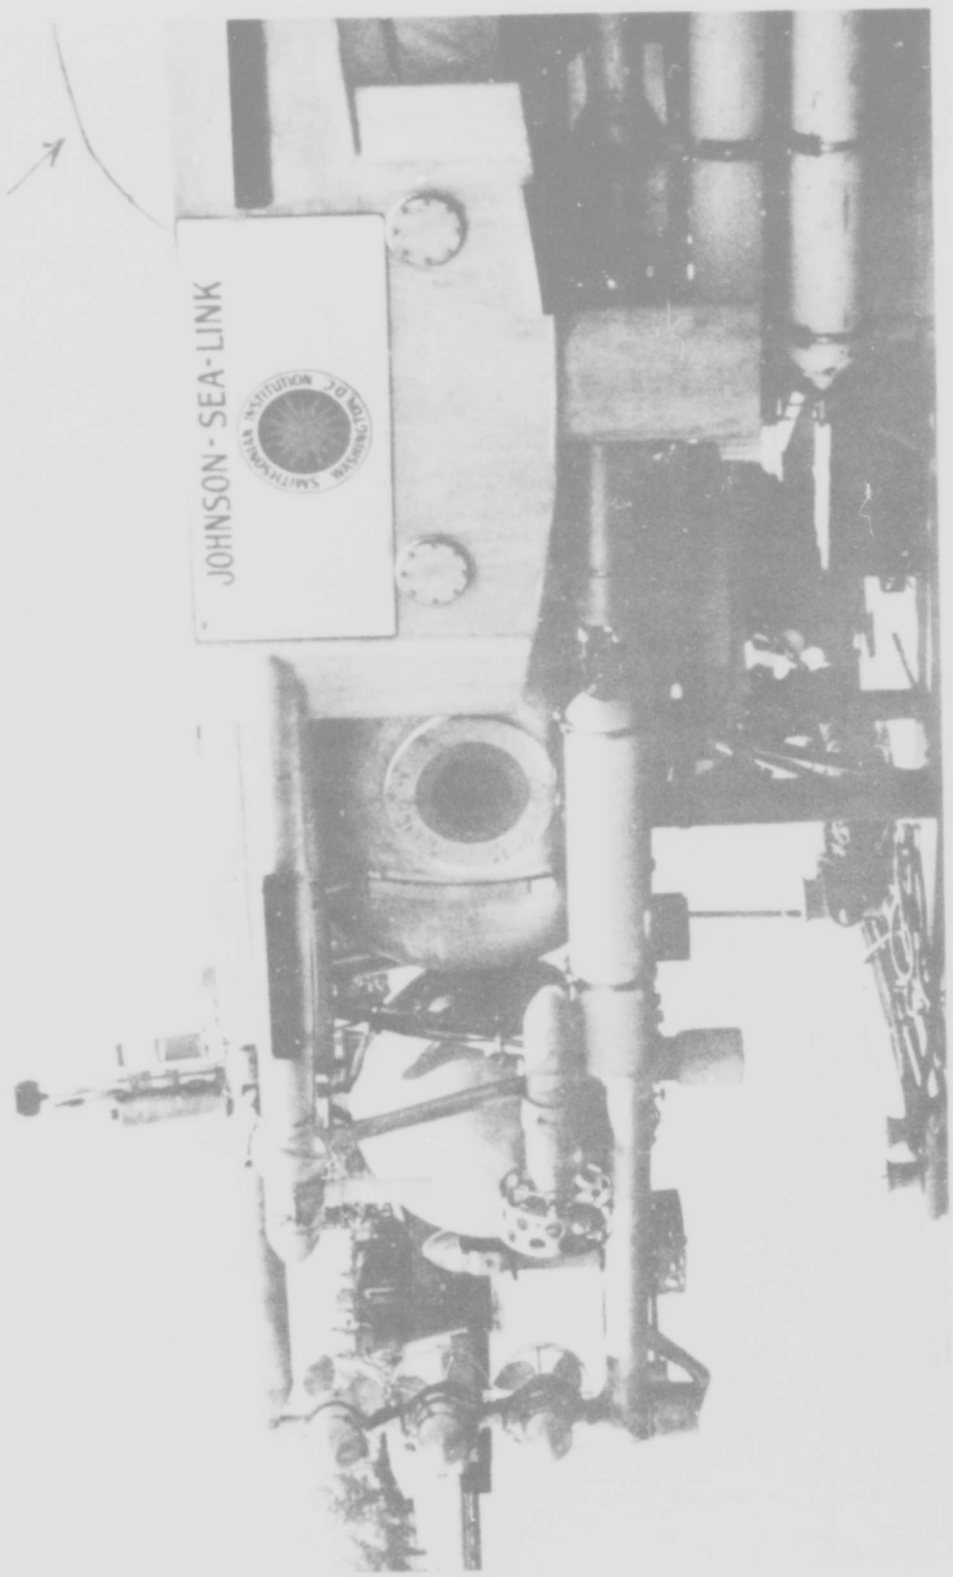
c. The submersible, as a complete unit, defies comparison with any conventional ship or boat shape. Its modular construction lacks the symmetry or "fairing" normally found in both surface and subsurface vessels. This submersible can best be described as an ill defined network consisting of an aluminum framework to which various shapes, containers and appendages have been attached according to their functional value rather than a concern for symmetry. (Photograph appended)
