Aberdeen Proving Ground  
Maryland

One T113 hull composed of aluminum armor and one T117 hull fabricated with rolled homogeneous steel armor were subjected to ballistic tests consisting of resistance to penetration by high-explosive shell fragments, ballistic shock tests of the welded joints, resistance to penetration of the virgin armor with small-arms fire, and resistance-to-splash tests from impacting small-arms fire around the various door and hatch openings. Satisfactory comparisons between the T113 and T117 vehicle hulls were obtained for the test conditions outlined above. It is recommended that consideration be given to increasing the armor thickness of the T113 hull within allowable weight limitations in order to provide a level of protection more nearly equal to that afforded by the T117 hull against high-explosive shell fragments and small-arms fire.

MEMORANDUM REPORT

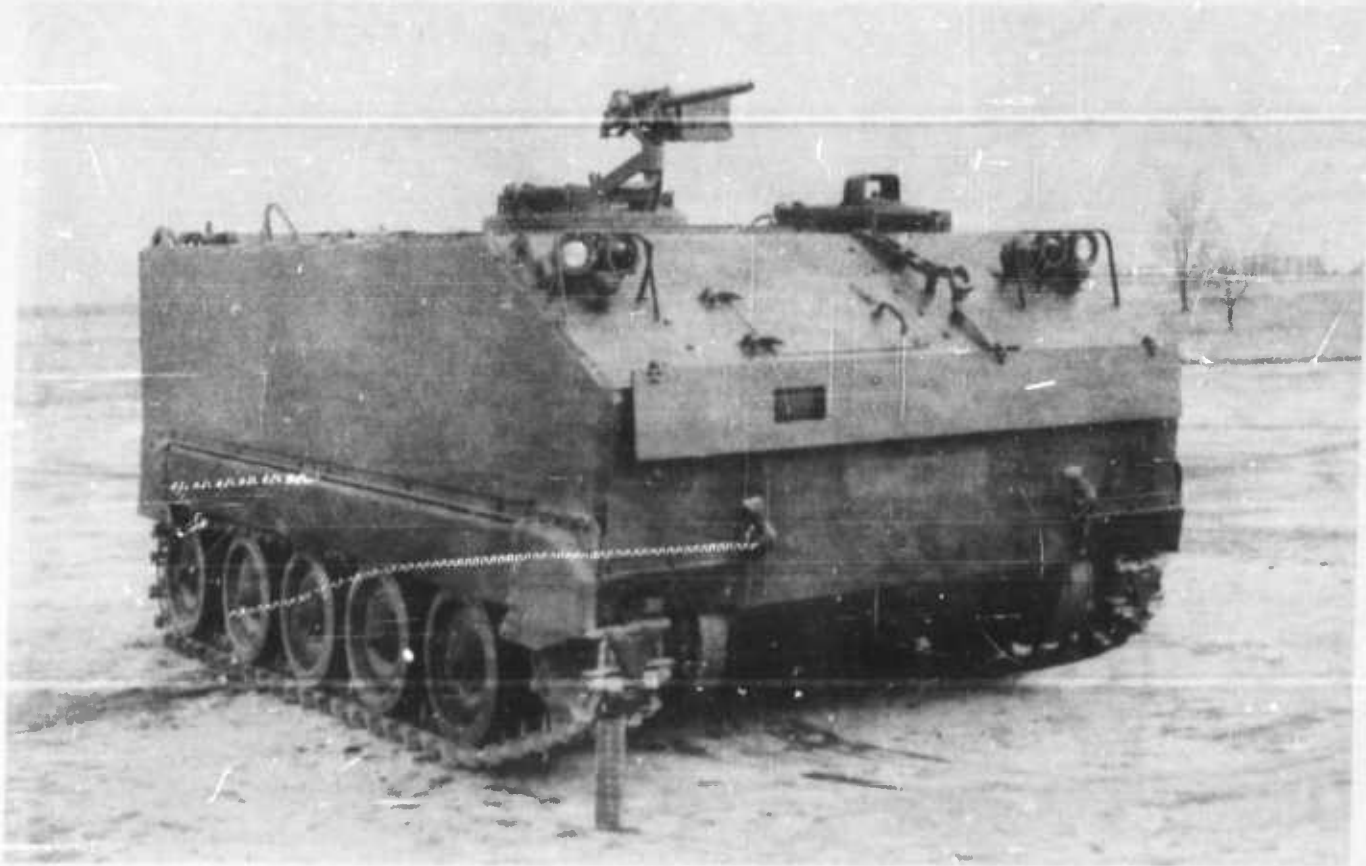
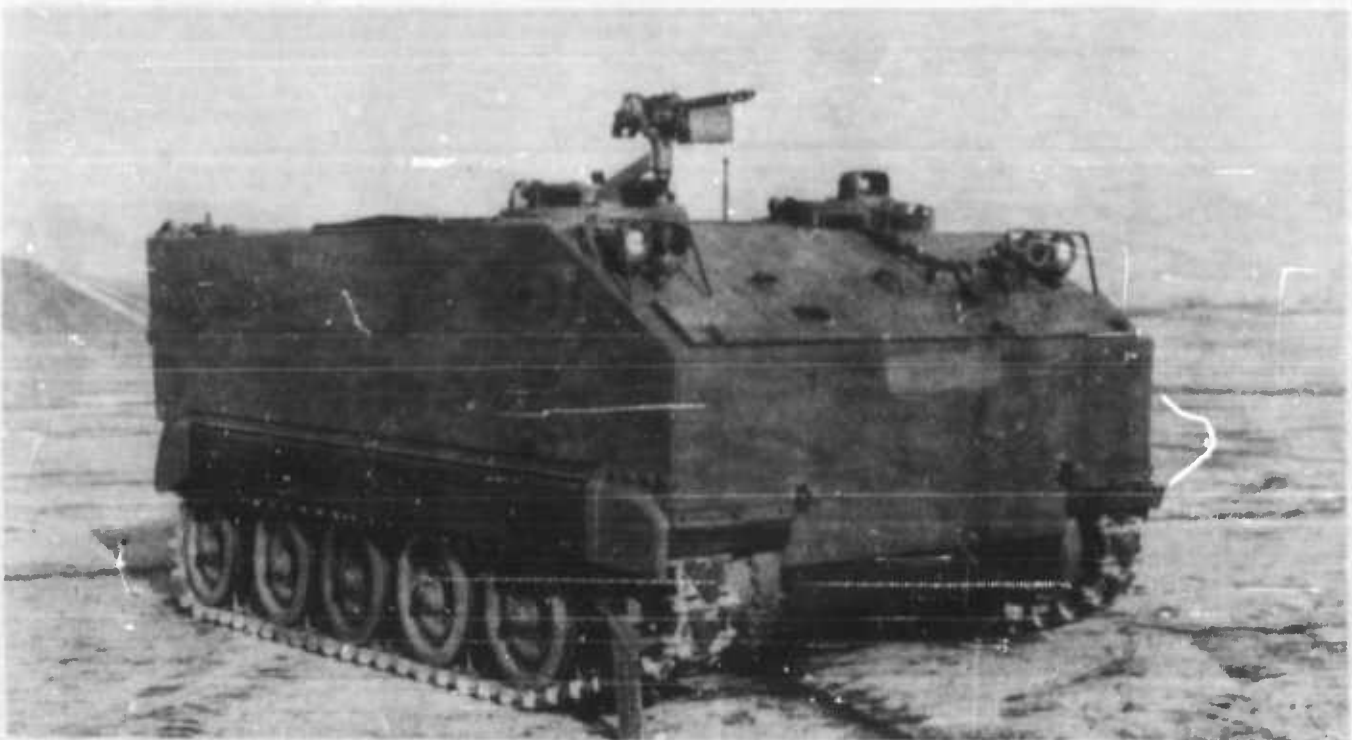
Figure 1: Three-quarter Right Front Views of T113 (TOP) and T117 (BOTTOM) Universal Carriers.

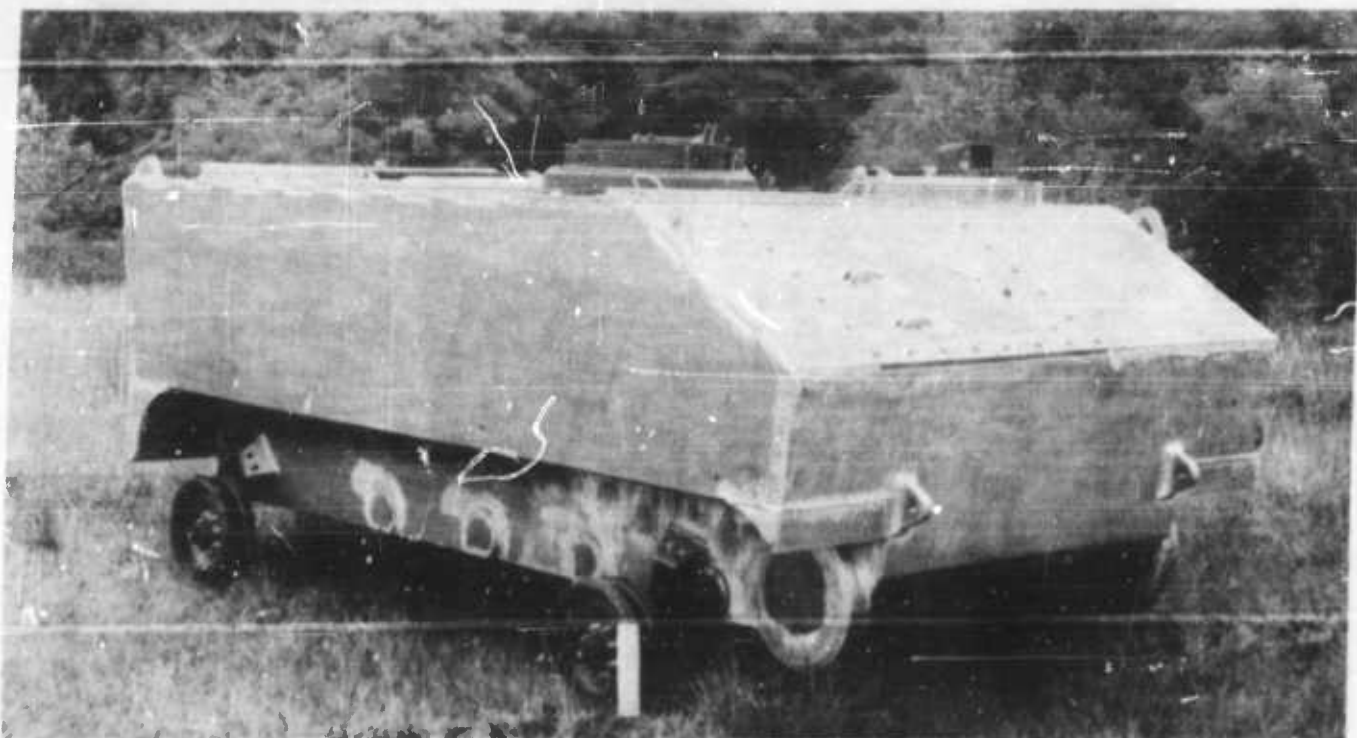
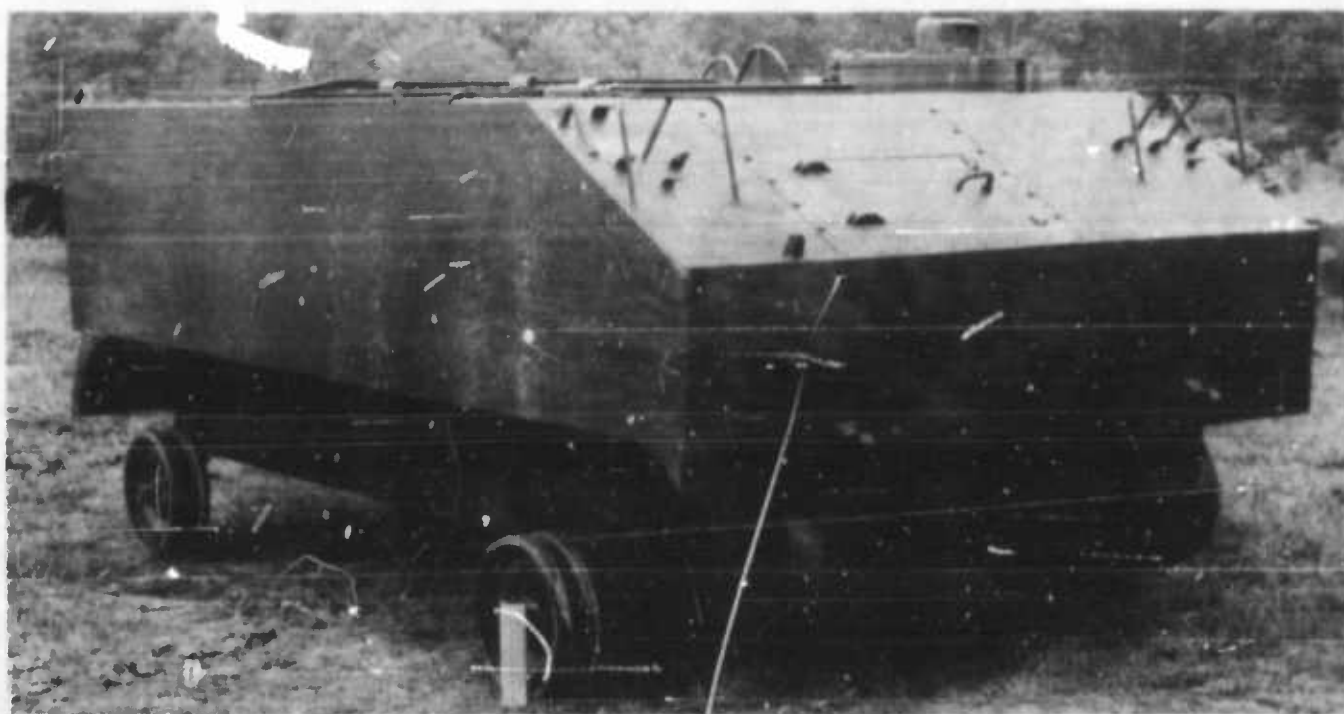
Figure 2: General Views of T113 Hull (TOP) and T117 Hull (BOTTOM) as Submitted for Test.

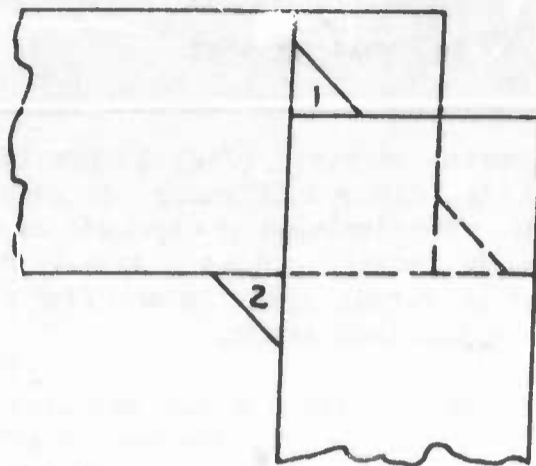
*Fig 3*

The T113 was designed with two different types of welded joints employed between the upper hull side plate and the upper glacis plate and hull roof plate. An interlocking or "dove tail" incomplete-weld-penetration joint was used on the right side of the hull (Fig. 3). In a joint of this type each plate of the joint is alternately recessed or notched to a predetermined distance so that when the two plates are brought together and joined by a continuous weld pass a true interlocking design is achieved.

Figure 3: Cross Sectional View of a Typical Interlocking Joint.

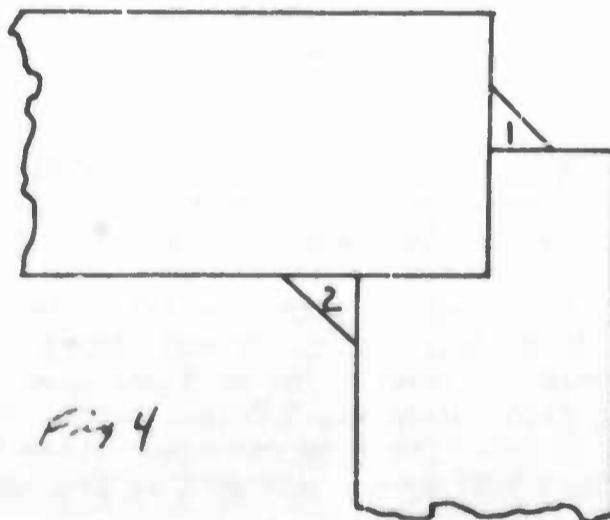
*Fig 4*

On the left side of the hull a rebated-type incomplete-weld-penetration joint was used.

Figure 4: Cross Sectional View of a Typical Rebated Joint.

A comparison of the three types of welded joints presented for test in these two hulls shows very little difference in performance. The rebated-type joint on the left side of the T113 hull offered the lowest resistance to shock-producing impacts. An average weld-area crack of 11-7/8 inches occurred in the rebated-type weld joint between the upper hull side plate and main roof plate. At the rebated-type joint between the upper hull side plate and upper glacis plate an average weld-area crack of 12 inches occurred. On the right side of the T113 incorporating the interlocking type joints, an average weld area crack of 7-5/8 inches occurred at the junction of the roof plate and upper hull side plate with the interlocks tested in the shear condition. In this same area with the interlocks tested in the compression

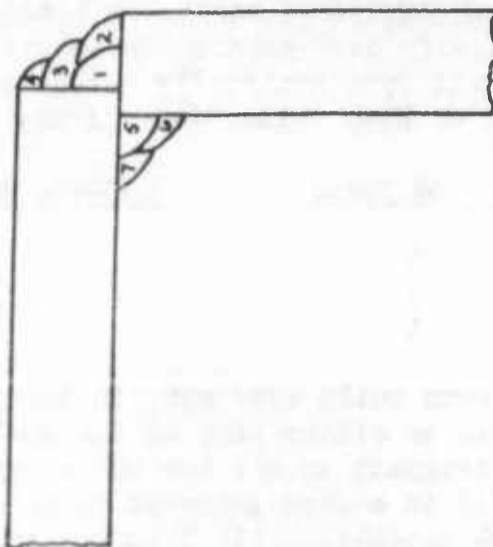
The T117 vehicle was fabricated from a rolled homogeneous steel armor of a modified hardness. The main armor of this hull was of 1/2-inch thickness except for a 5/8-inch-thick vertical front nose plate, a 3/16-inch-thick main floor plate and a 3/8-inch-thick lower hull side plate. This hull was designed with all conventional incomplete-weld-penetration joints (Fig. 5).

Figure 5: Cross Sectional View of Conventional Incomplete-Weld-Penetration Joint.
