WT-1631 W)/21 / 1 OPERATION HARDTACK-PROJECT 37

DAMAGE 10 EXISTING EPG STRUCTURES (U)

W.J. Flathau, Project Officer and R.A. Cameron,

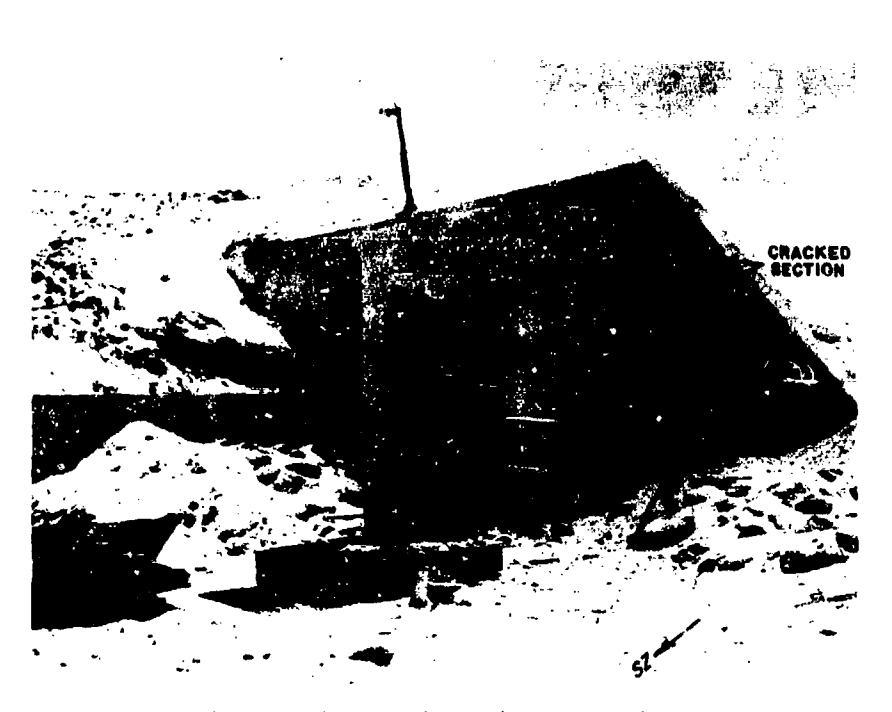
Figure 4.5 Post-Yellowwood, (Item 18) station complex, close-up of entrance and cracked wing wall. Pressure levels: Koa, 42 psi; Yellowwood, 11.5 psi; and Tobacco, 1.9 psi.

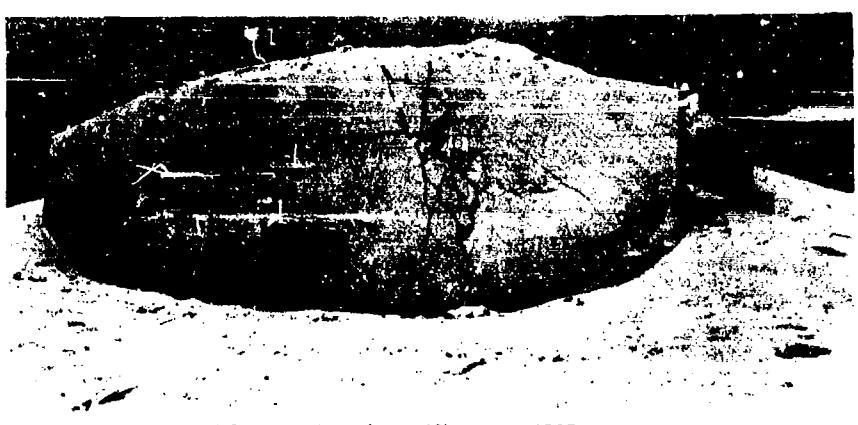
Figure 4.9 Post-Koa, (Item 19) Station 1525, filte-on view. Pressure level: Koa, 42 psi; 350 cal/cm².

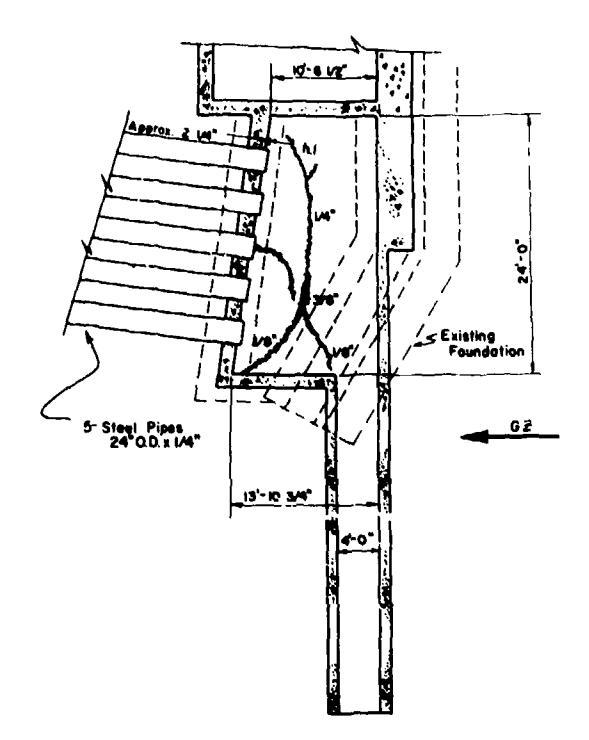
The plain-concrete floor of this station was badly cracked and the five 24-inch pipes entering this station were forced inward about $2\frac{1}{4}$ inches (Figure 4.18). The crack pattern (shown in Figure 4.19) indicates that the existing foundation underneath part of the floor gave additional support to that portion.

Figure 4.19 Post-Koa, (Item 20) Station 1311, crack pattern in floor. Prossure level: Koa, 42 psi.

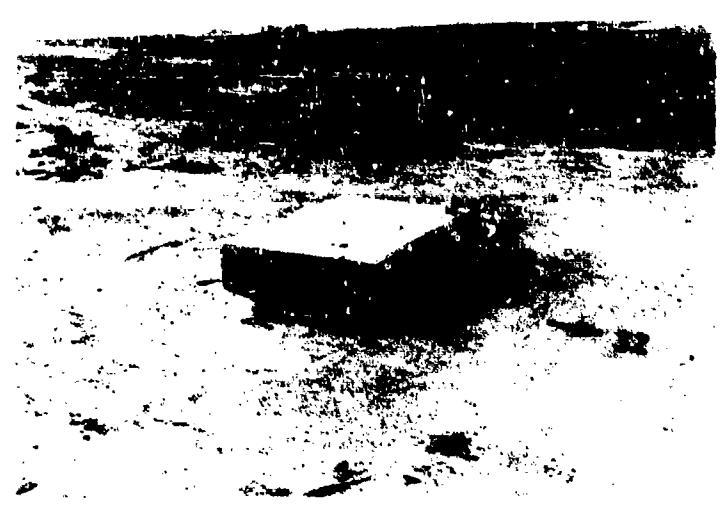
Figure 4.33 Post-Walnut, (Item 25) Station 1312, erosion adjacent to foundation. Pressure level: Walnut, 33 psi; Elder, 58 psi; 450 cal/cm².

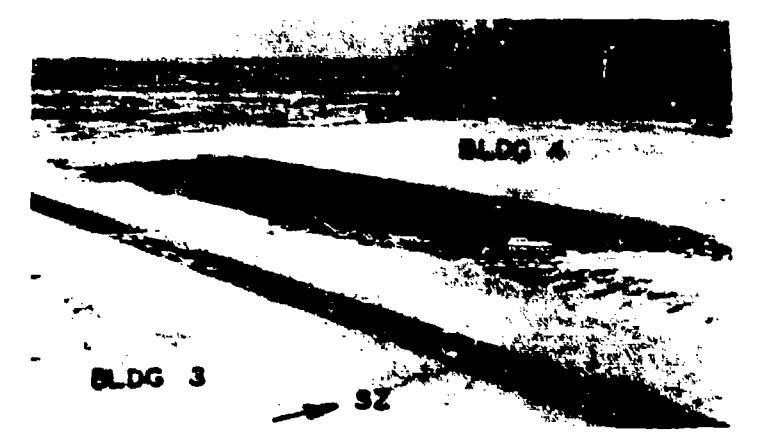
Figure 4.6% Post-Elder, (Item 26) Station 3.1.1, outside view of punched-in roof section at north end of Building 4. Pressure level: Elder, 20 pst.

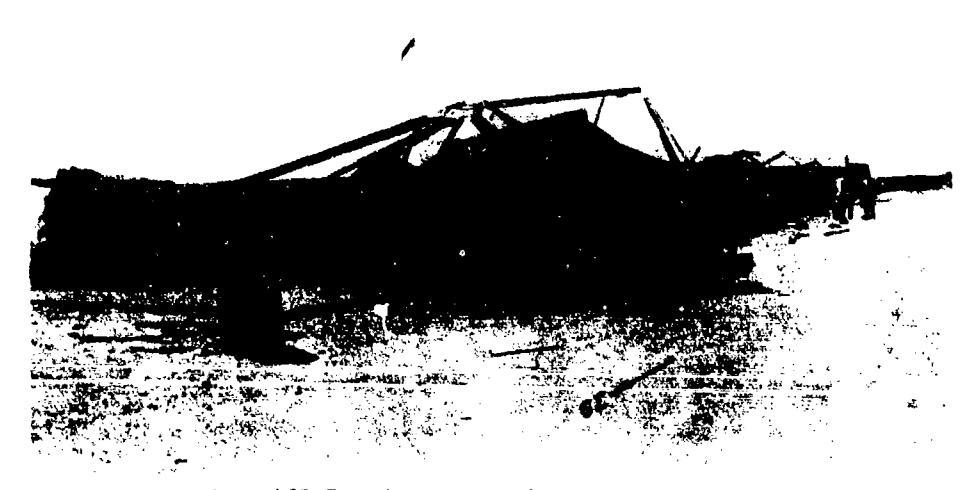
Timber Buildings and Tents. Light temporary timber buildings were severely damaged from the 1.5- to 2.0-psi air overpressure from Shot Cactus. The first two rows of

Figure 4.98 Post-Cactus, camp damage, tents. Pressure level: Cactus, 2.0 psi.

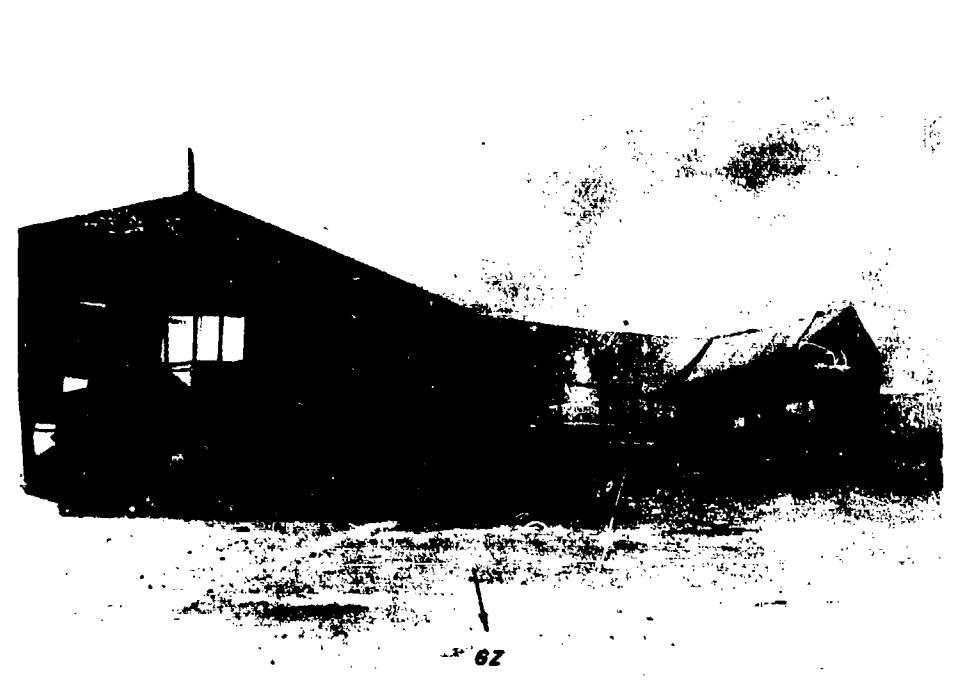
Figure 4.99 Post-Cactus, camp damage, light timber construction. Pressure level: Cactus, 1.5 psi.

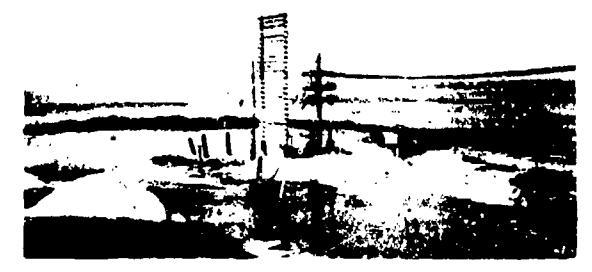
Figure D.5 Transformer station after wave action ceased and water subsided. Shot Oak, Site Elmer.
