BUREAU OF SHIPS GROUP

TECHNICAL INSPECTION REPORT

FAILURES OF MASTS, YARDARMS, BOOMS, AND RIGGING

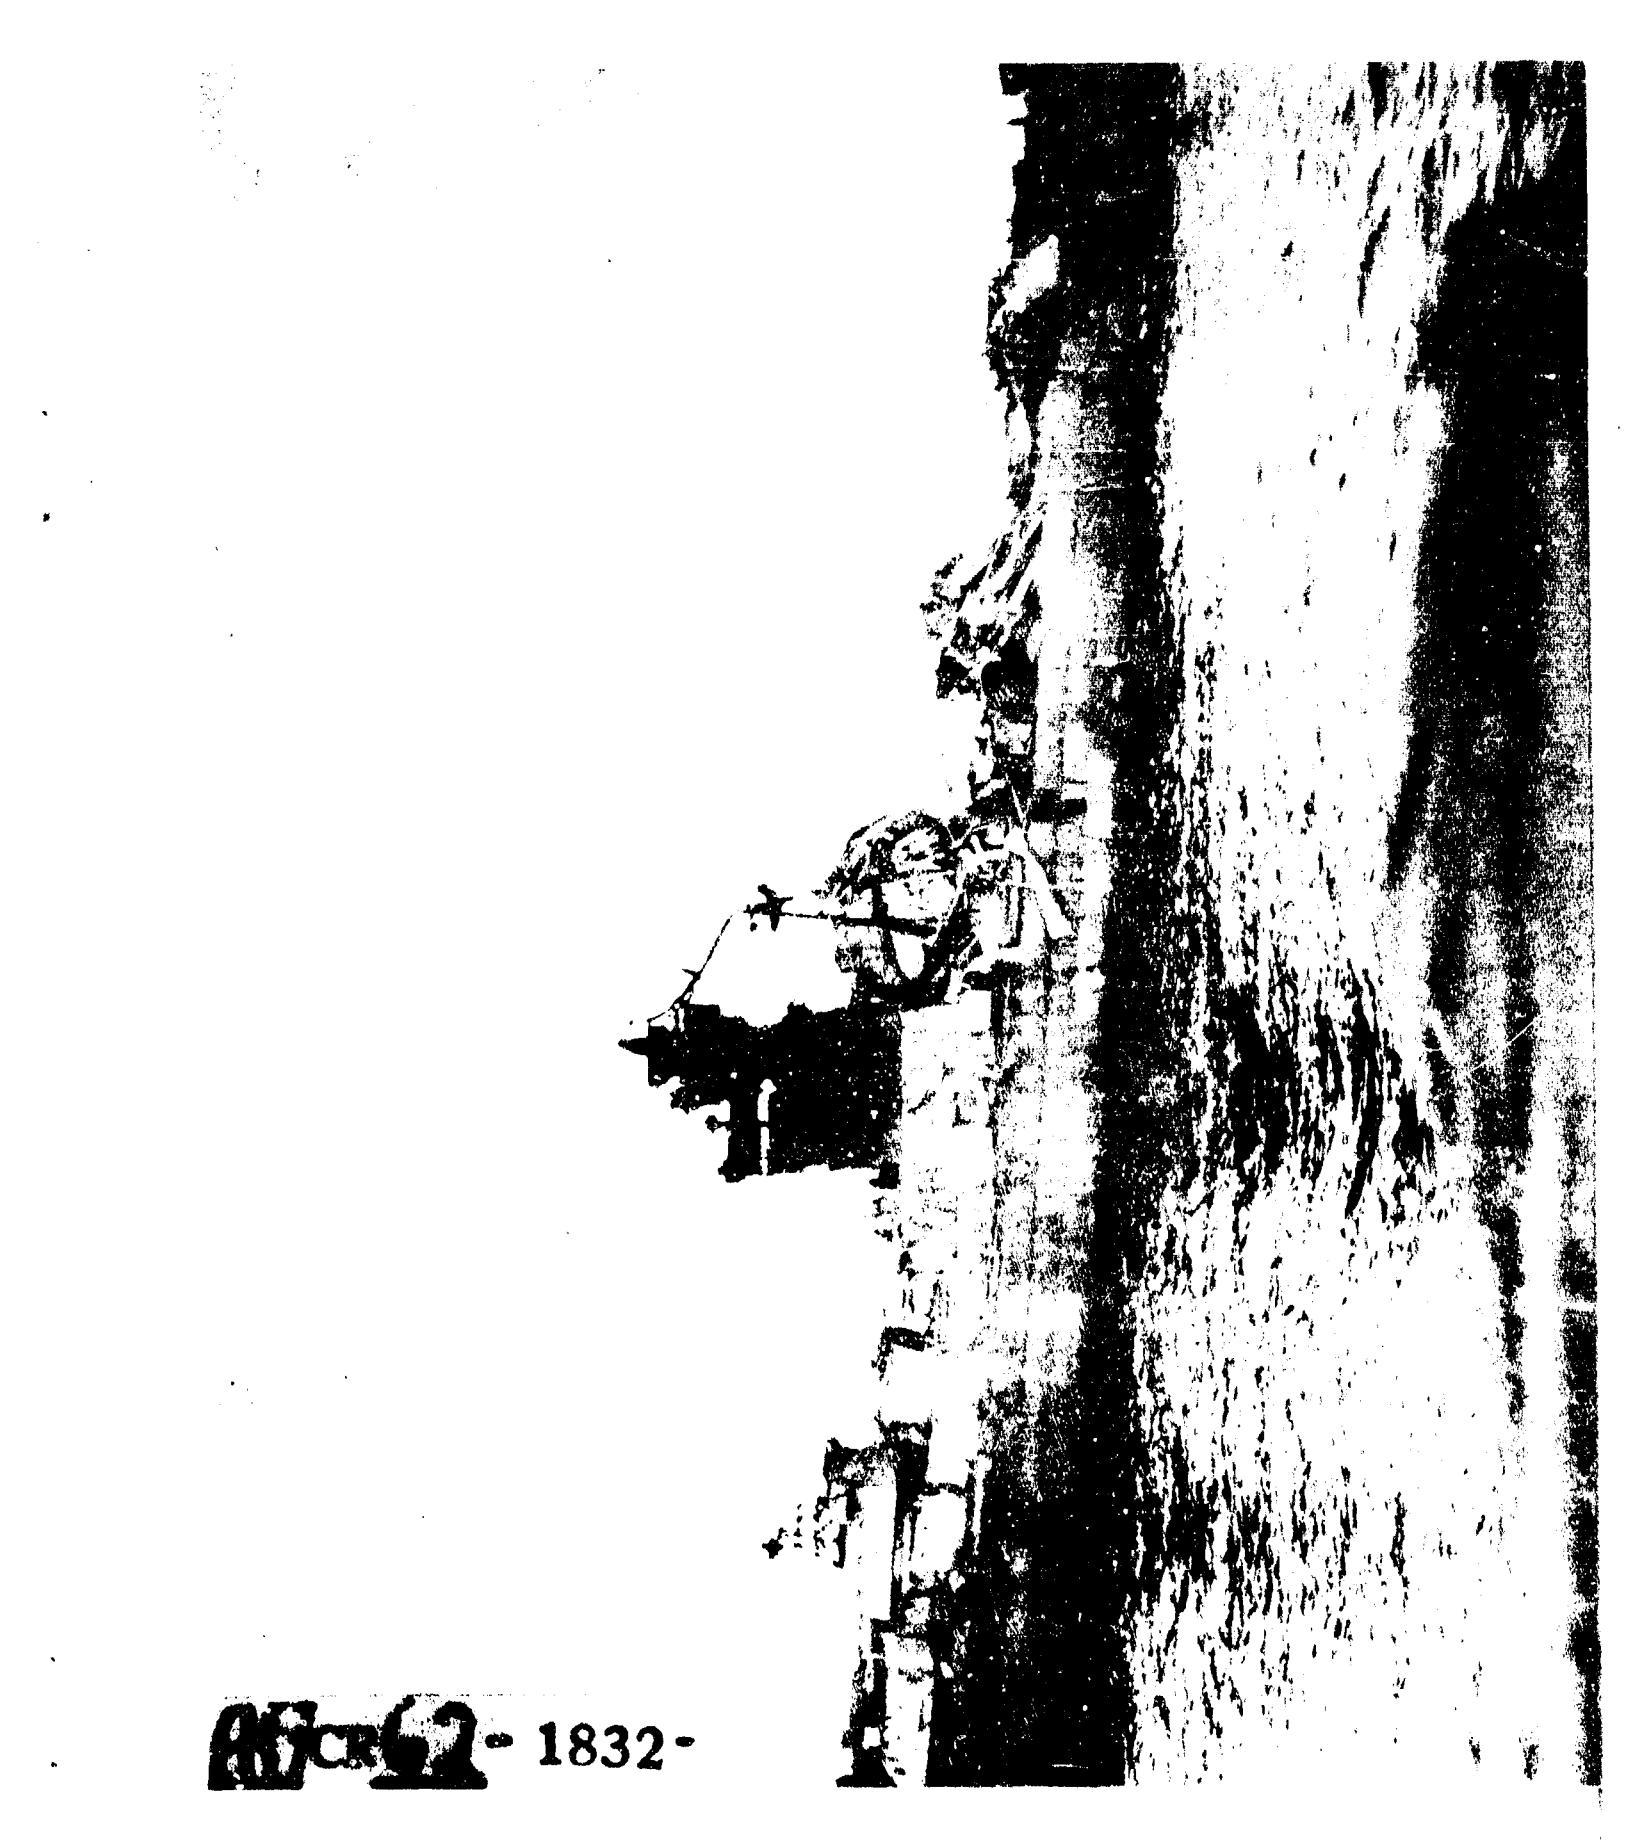
AA-CR-62-1832-4. SAKAWA (Ex-Jap Cruiser). View looking at port beam after Test A. Note that forward superstructure leans forward as does foremast and tripod. Note flattening of superstructure aft of forward tripod.

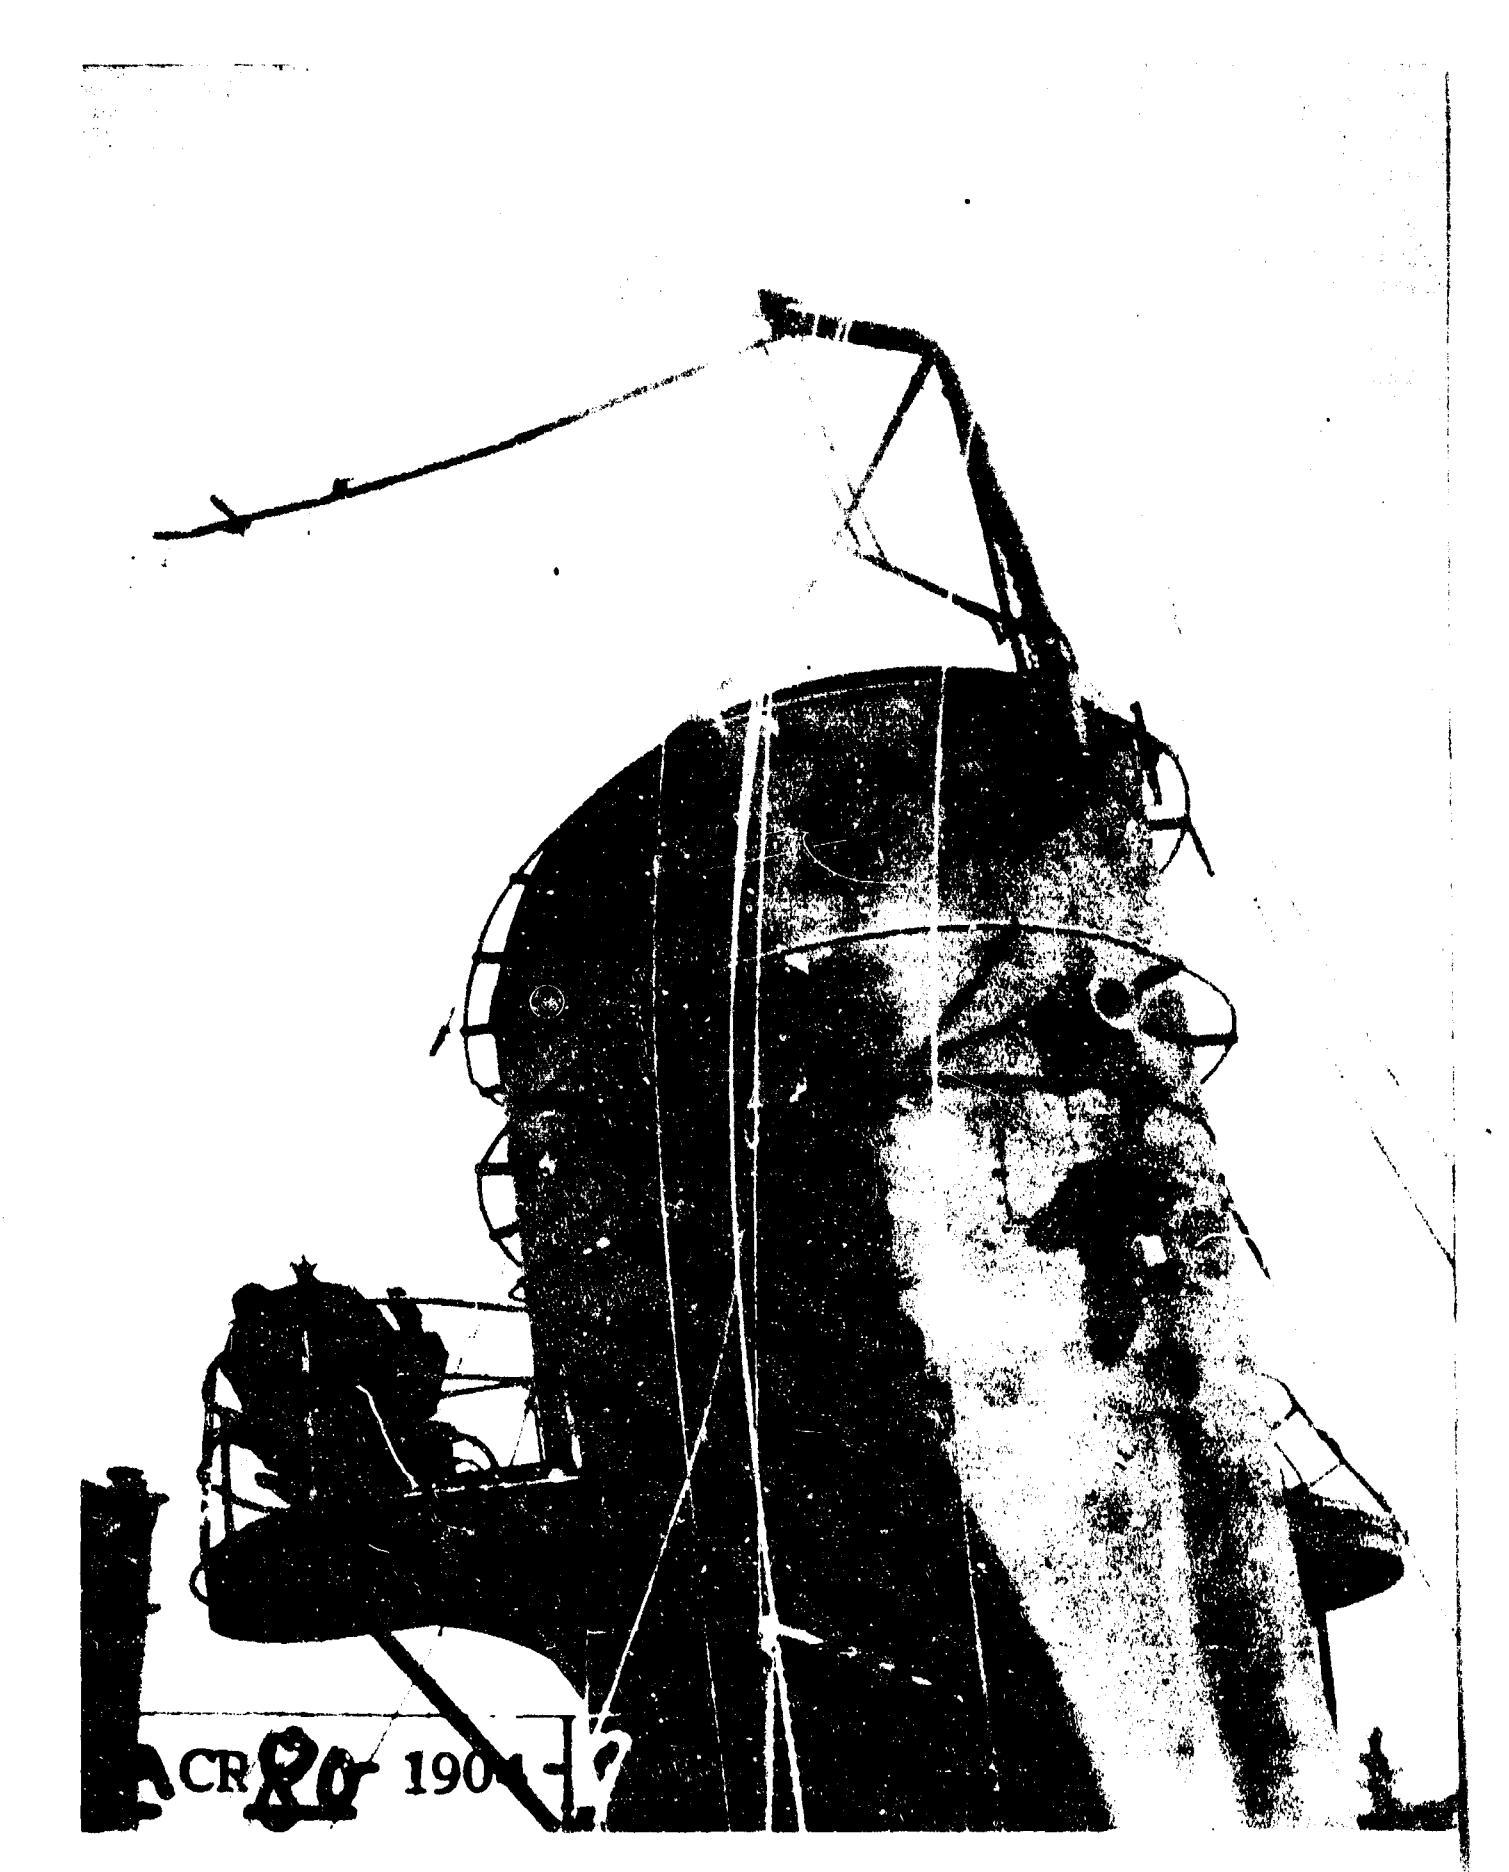
photos 1904-7, 2058-9, and 1922-8; pages 34, 35, and 36. Just above the braces, at mid-height, the mast bends sharply aft and slightly to starboard. The braces are sharply bowed. The port yardarm bends sharply at the mast and extends somewhat to starboard. The starboard yardarm is broken off about six inches from the mast.

AA-CR-80-1904-7. USS CRITTENDEN (APA77). Signal mast on forward smokestack. Looking aft and to port.

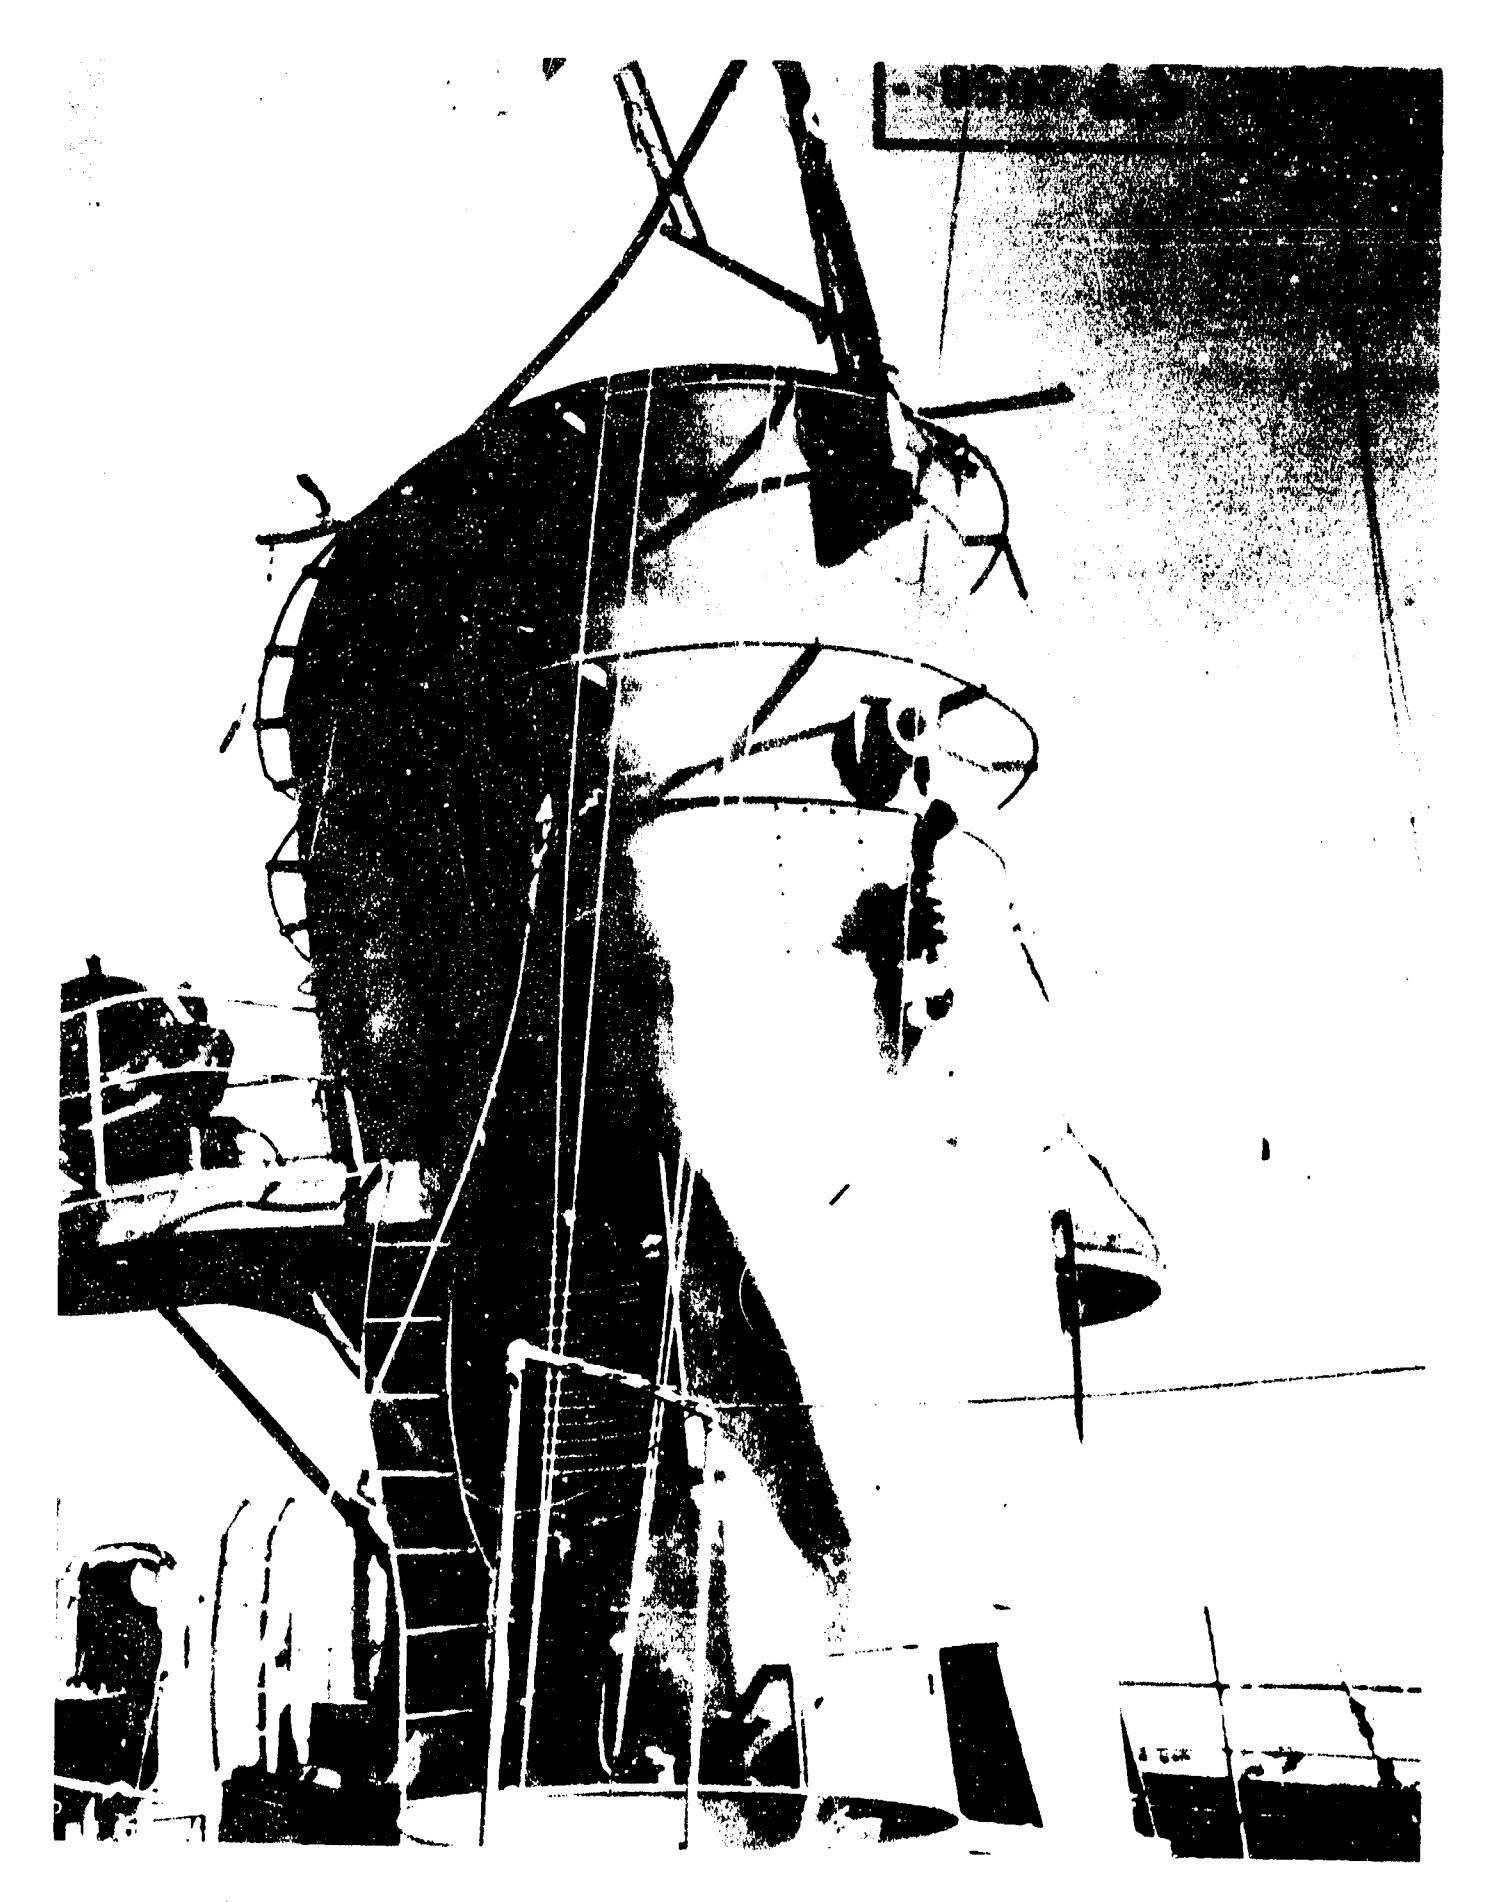
AA-CR-59-2058-9. USS CRITTENDEN (APA77). Forward smokestack showing lower portion of signal mast.

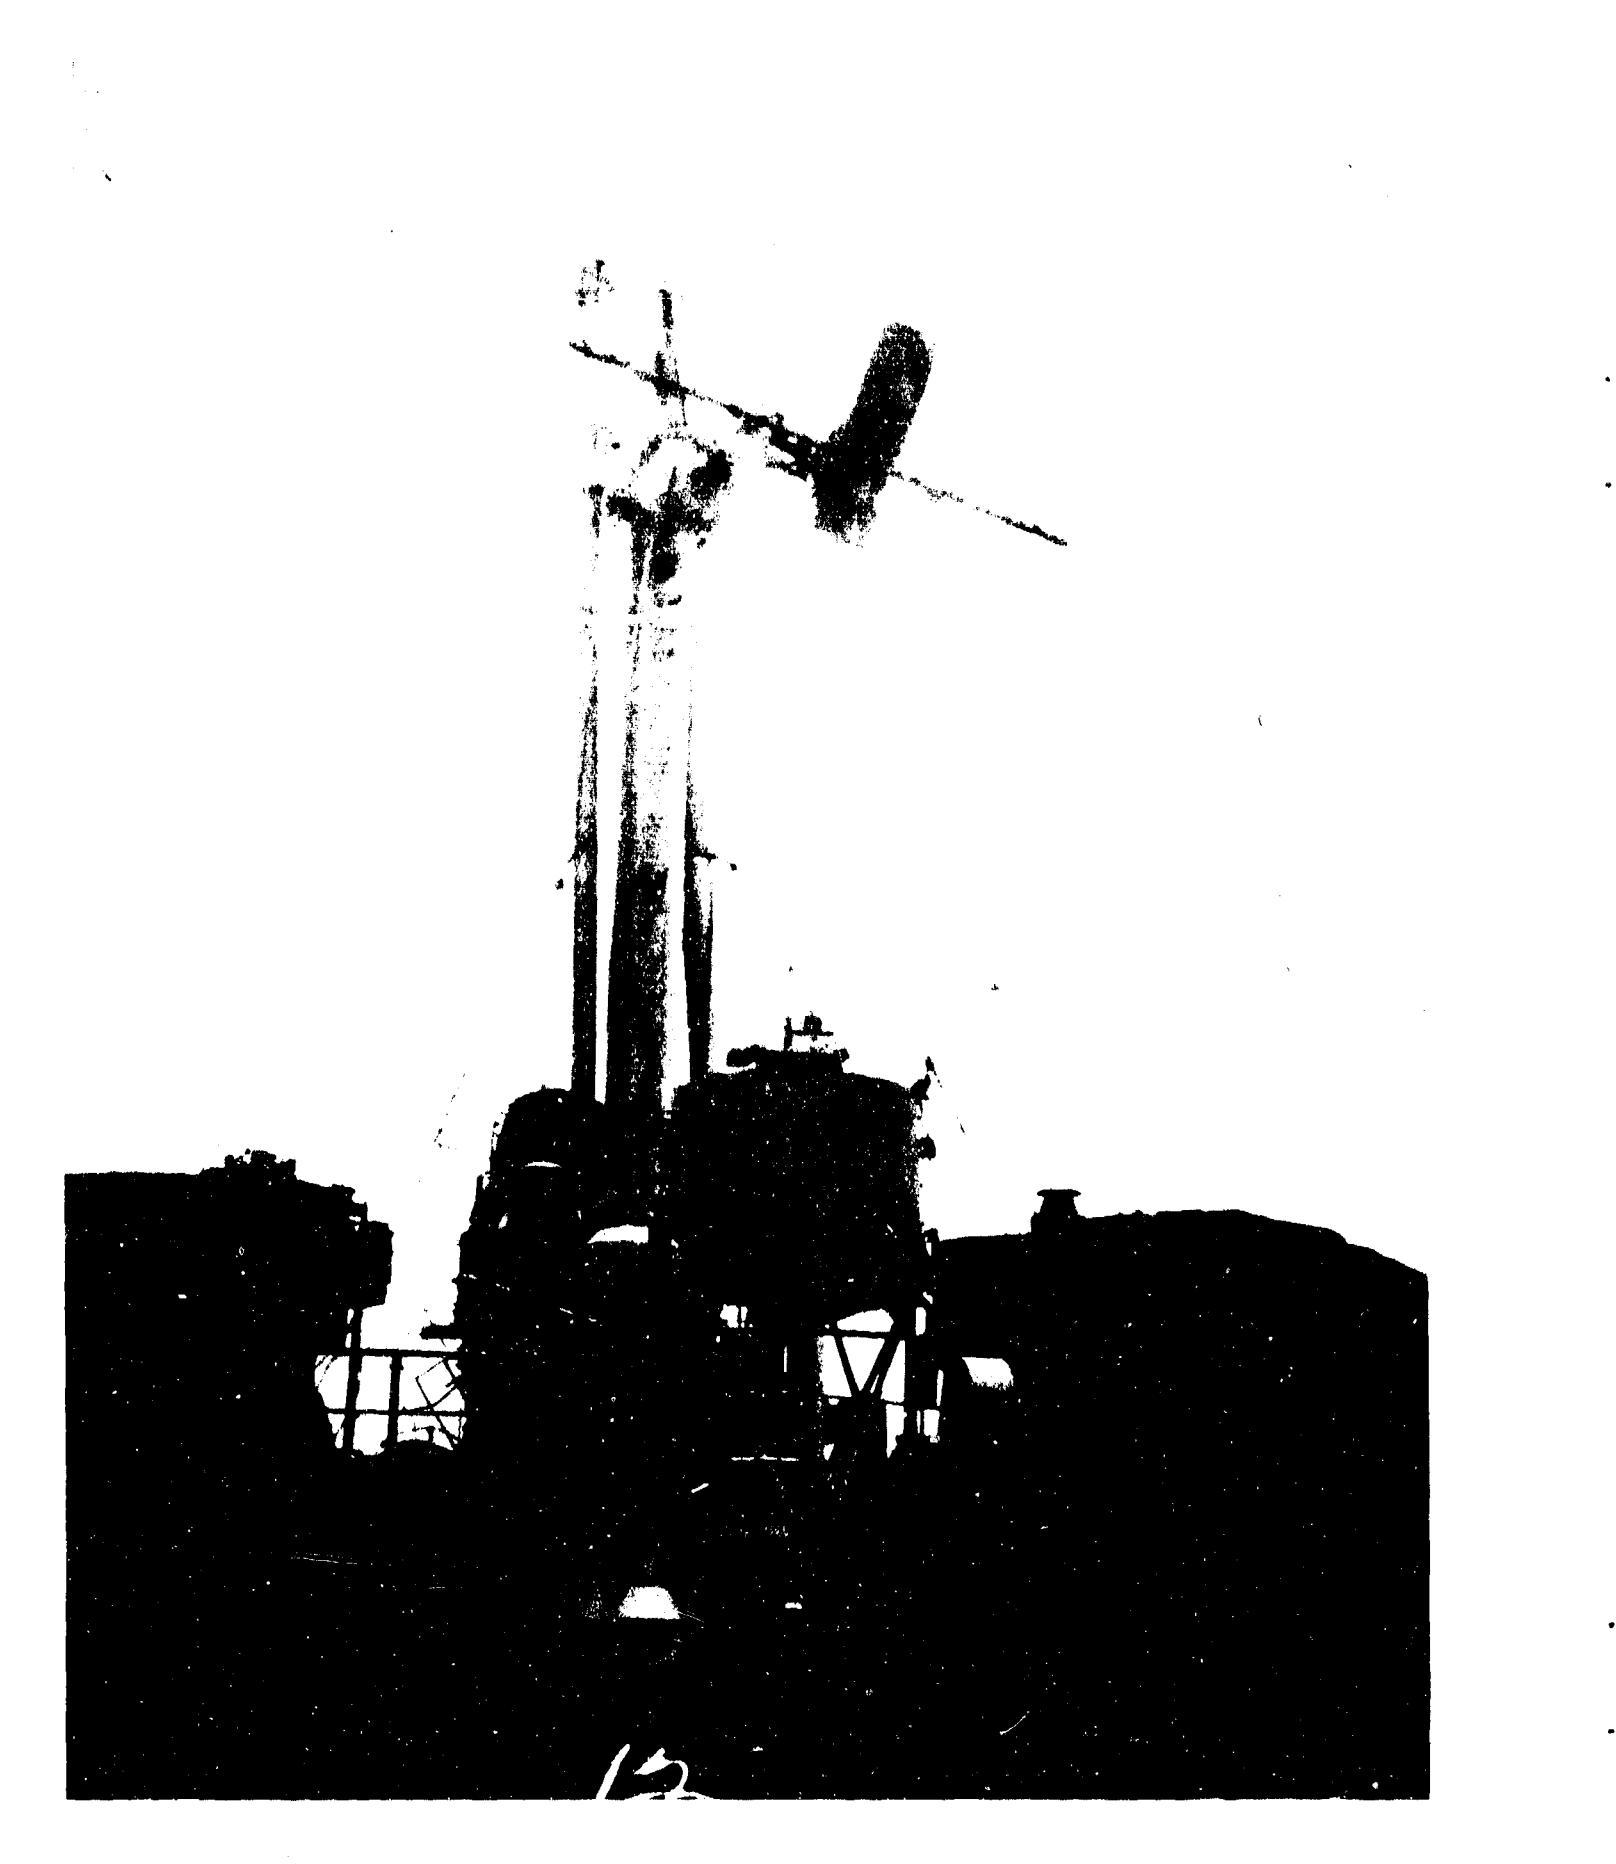
3. The maintopmast is bent about 110 degrees out of its normal vertical position and in the direction of the blast travel. See photos 227-49-116, 1906-9, 1906-12 and 1921-12; pages 26, 37, 38, and 39. The bend occurs just above the crosstree level and, as in the case of the foremast, the mast is fractured at the bend. The mainmast cargo booms, which were stowed in clamps along the mast, are useless due to their severe deformation. Photos 1922-2 and 1905-11; pages 40 and 41 show severe kinking of the starboard boom about 10 feet above the hinge pin. The port boom is bent in an easy curve.

AA-CR-82-1921-12. U.S.S. CRITTENDEN (APA-77). Mainmast. Looking forward from upper deck at stern.

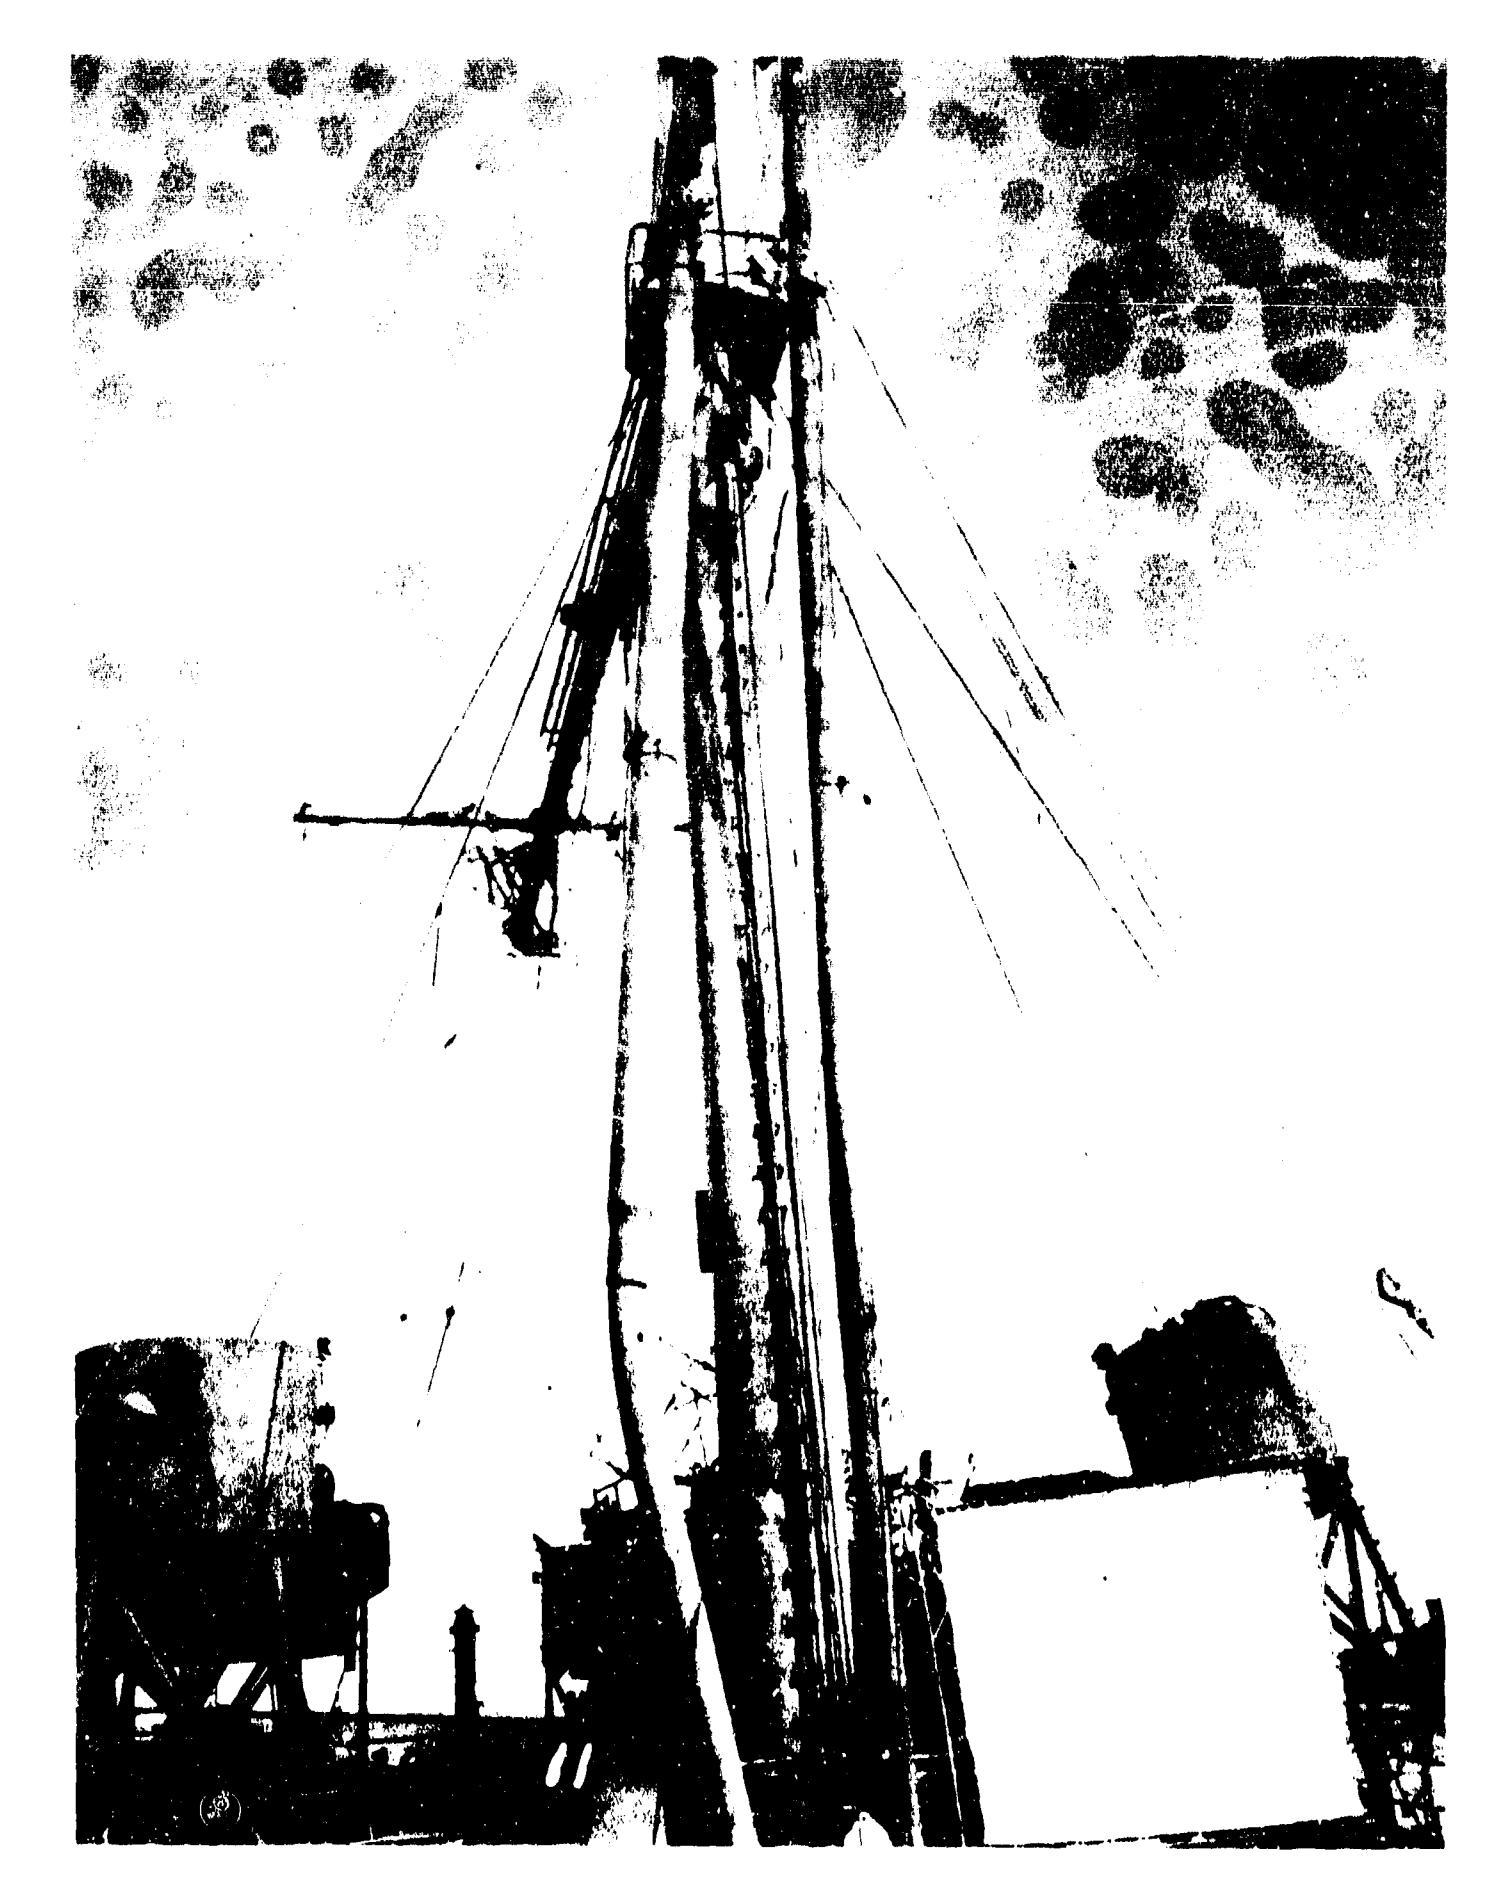
AA-CR-80-1905-11. USS CRITTENDEN (APA-77). Mainmast. Note bend and kink in starboard cargo boom.

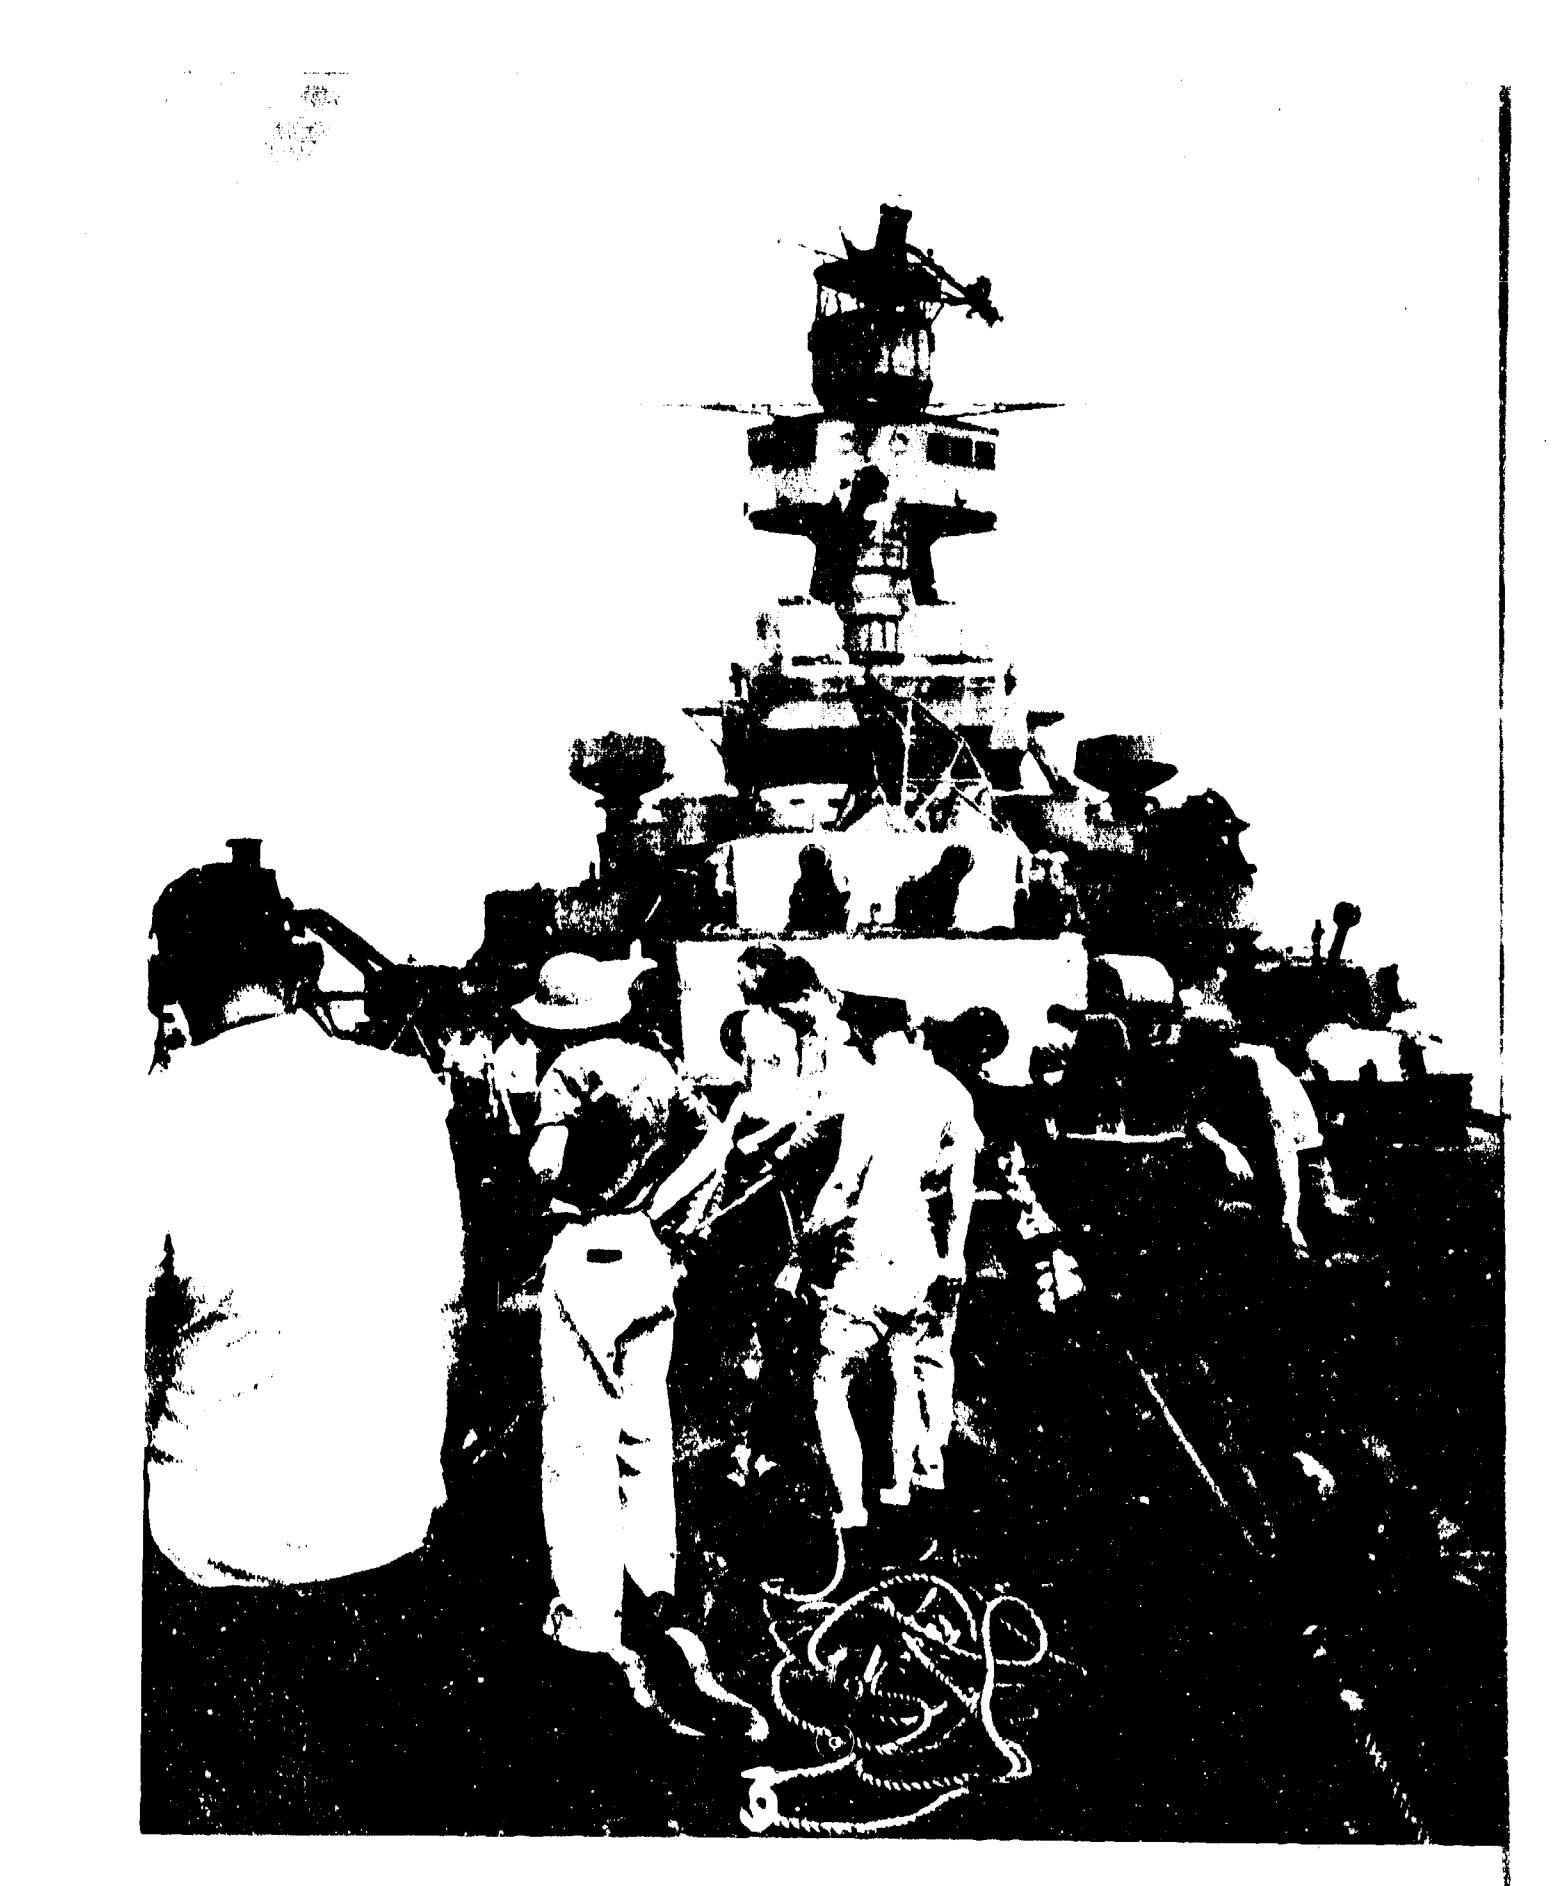
AA-CR-68-2091-3. USS ARKANSAS (BB33). View looking aft at forward superstructure showing SK radar mast and yardarms.

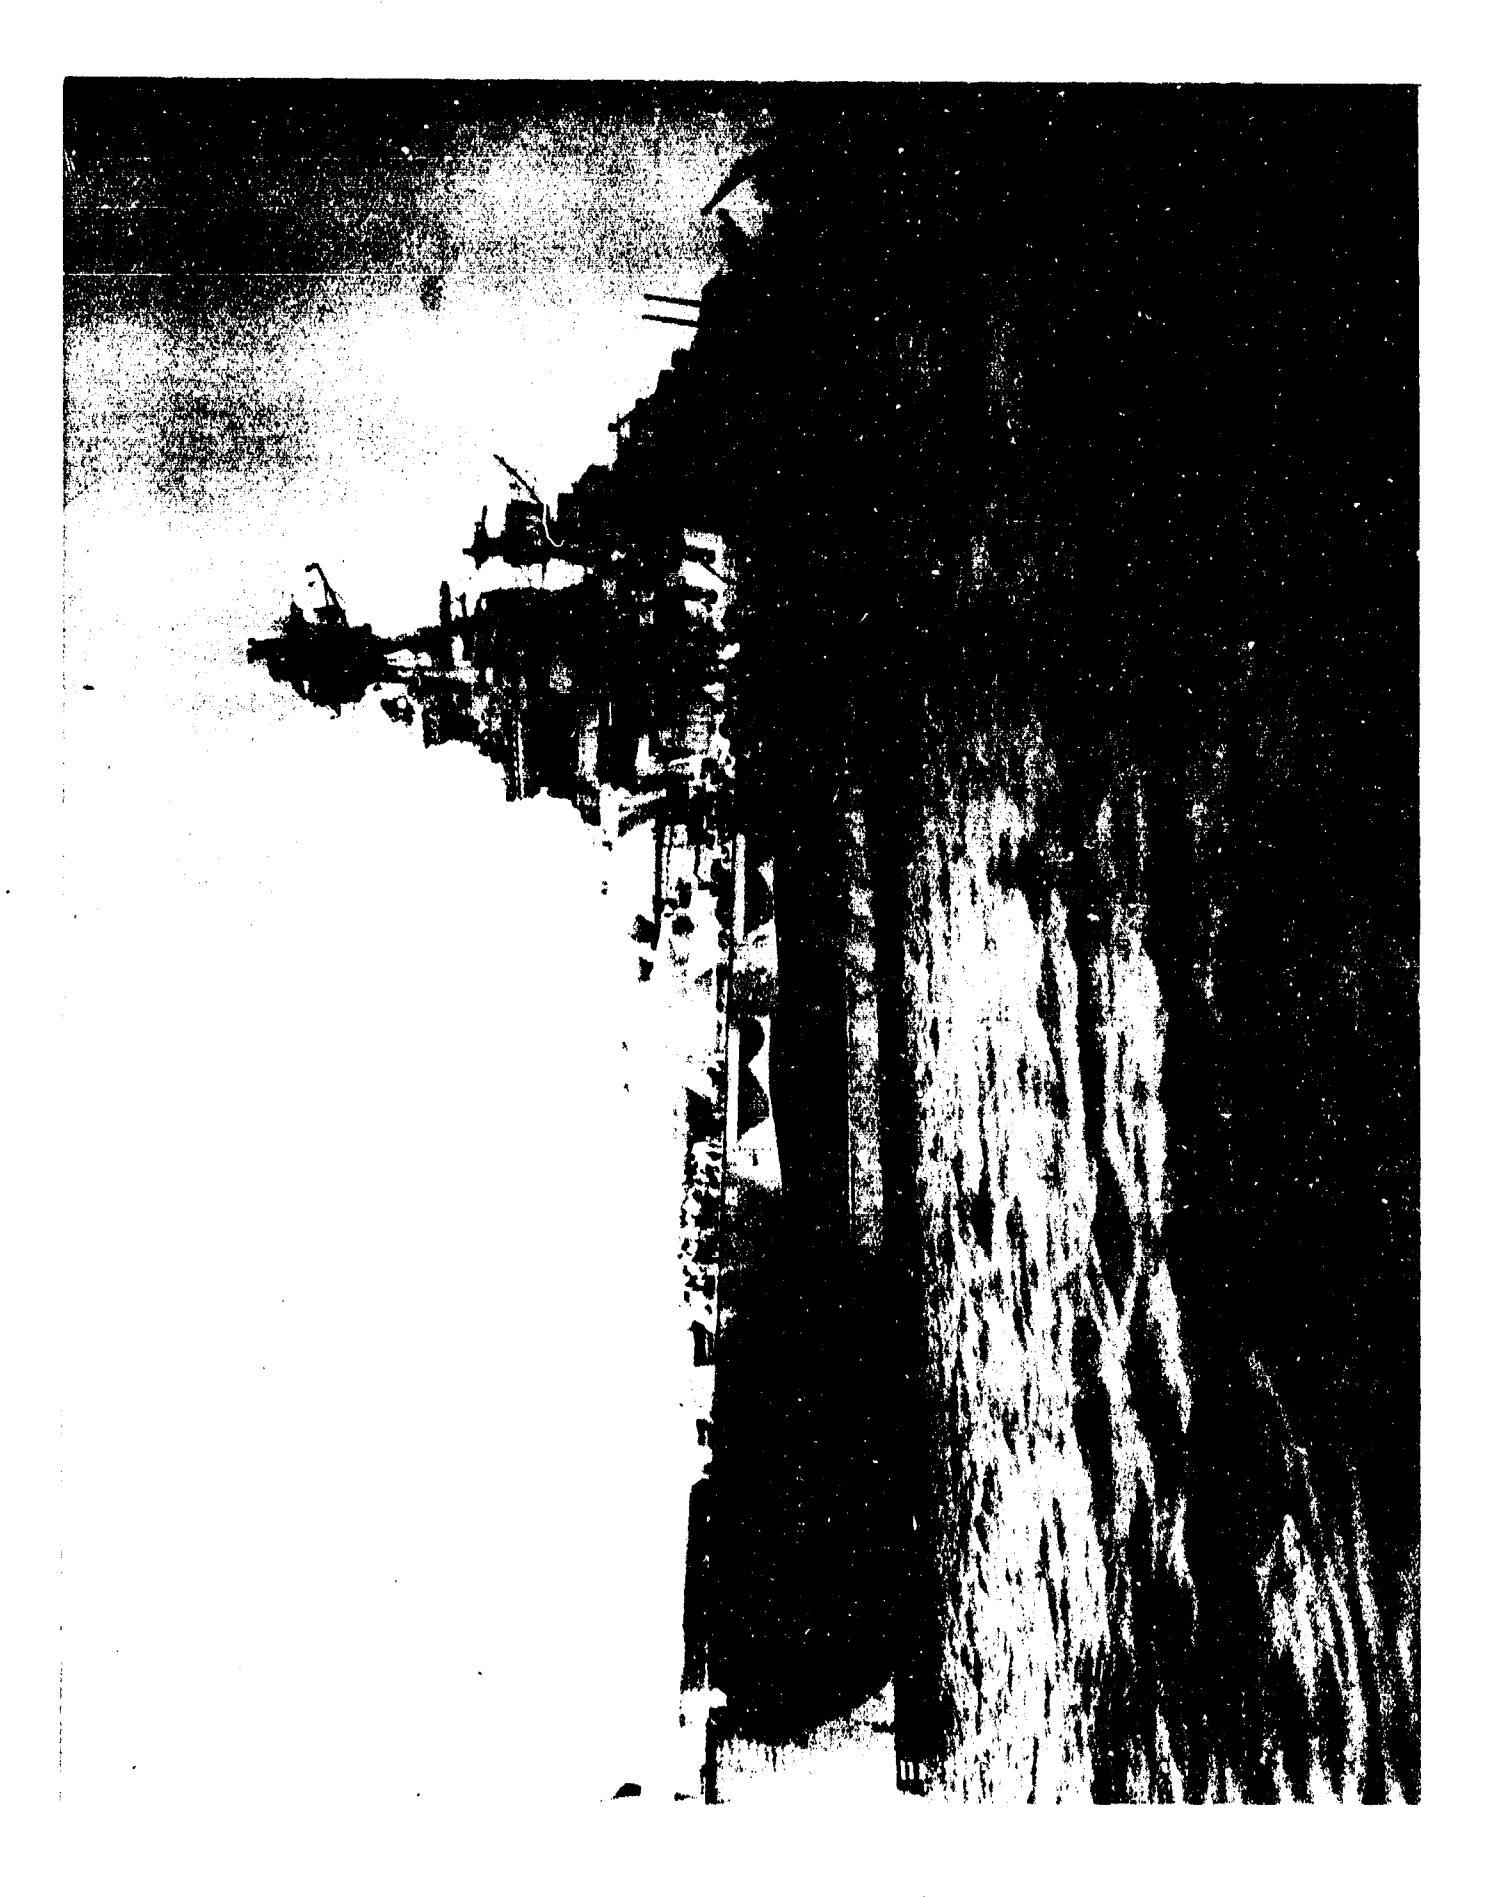
1. The forward tripod of the NEVADA was about 600 yards from the burst, which bore about 210 degrees relative. Photos 196-151-10, 15, 9; 227-91-75, 74 and 73; pages 90, 92, 94, 91, 93, and 95 are comparative views taken before and after Test A. The SG radar polemast is broken and lying on the radar platforms. The 15 inches diameter polemast supporting the radar platform is bent forward about 15 degrees and practically in the centerline plane of the ship. The after half of the pole has a slight but definite horizontal wrinkle, about 30 inches above the main battery control platform. The port signal yardarm is twisted and bent and the starboard yardarm broken off as the result of failure of the connections. See photo 1909-1, page 96 for general view of foremast and mainmast yardarms. Note the absence of starboard forward arm. The male bracket at the starboard after side of the foremast structure is intact. The female end of the yardarm spread as is clearly visible in photo 1900-3, page 97. Indications are that the connection bolt failed. At the forward connection, both the bracket and bolt remained intact but the male bracket pulled out of its fillet weld to the mast structure. The yardarm was blown forward and to starboard as shown in photo 1900-4, page 98.

AA-CR-227-91-75. USS NEVADA (BB36). View looking at port bow after Test A.
