BUREAU OF SHIPS GROUP

TECHNICAL INSPECTION REPORT

FAILURES OF MASTS, YARDARMS, BOOMS, AND RIGGING

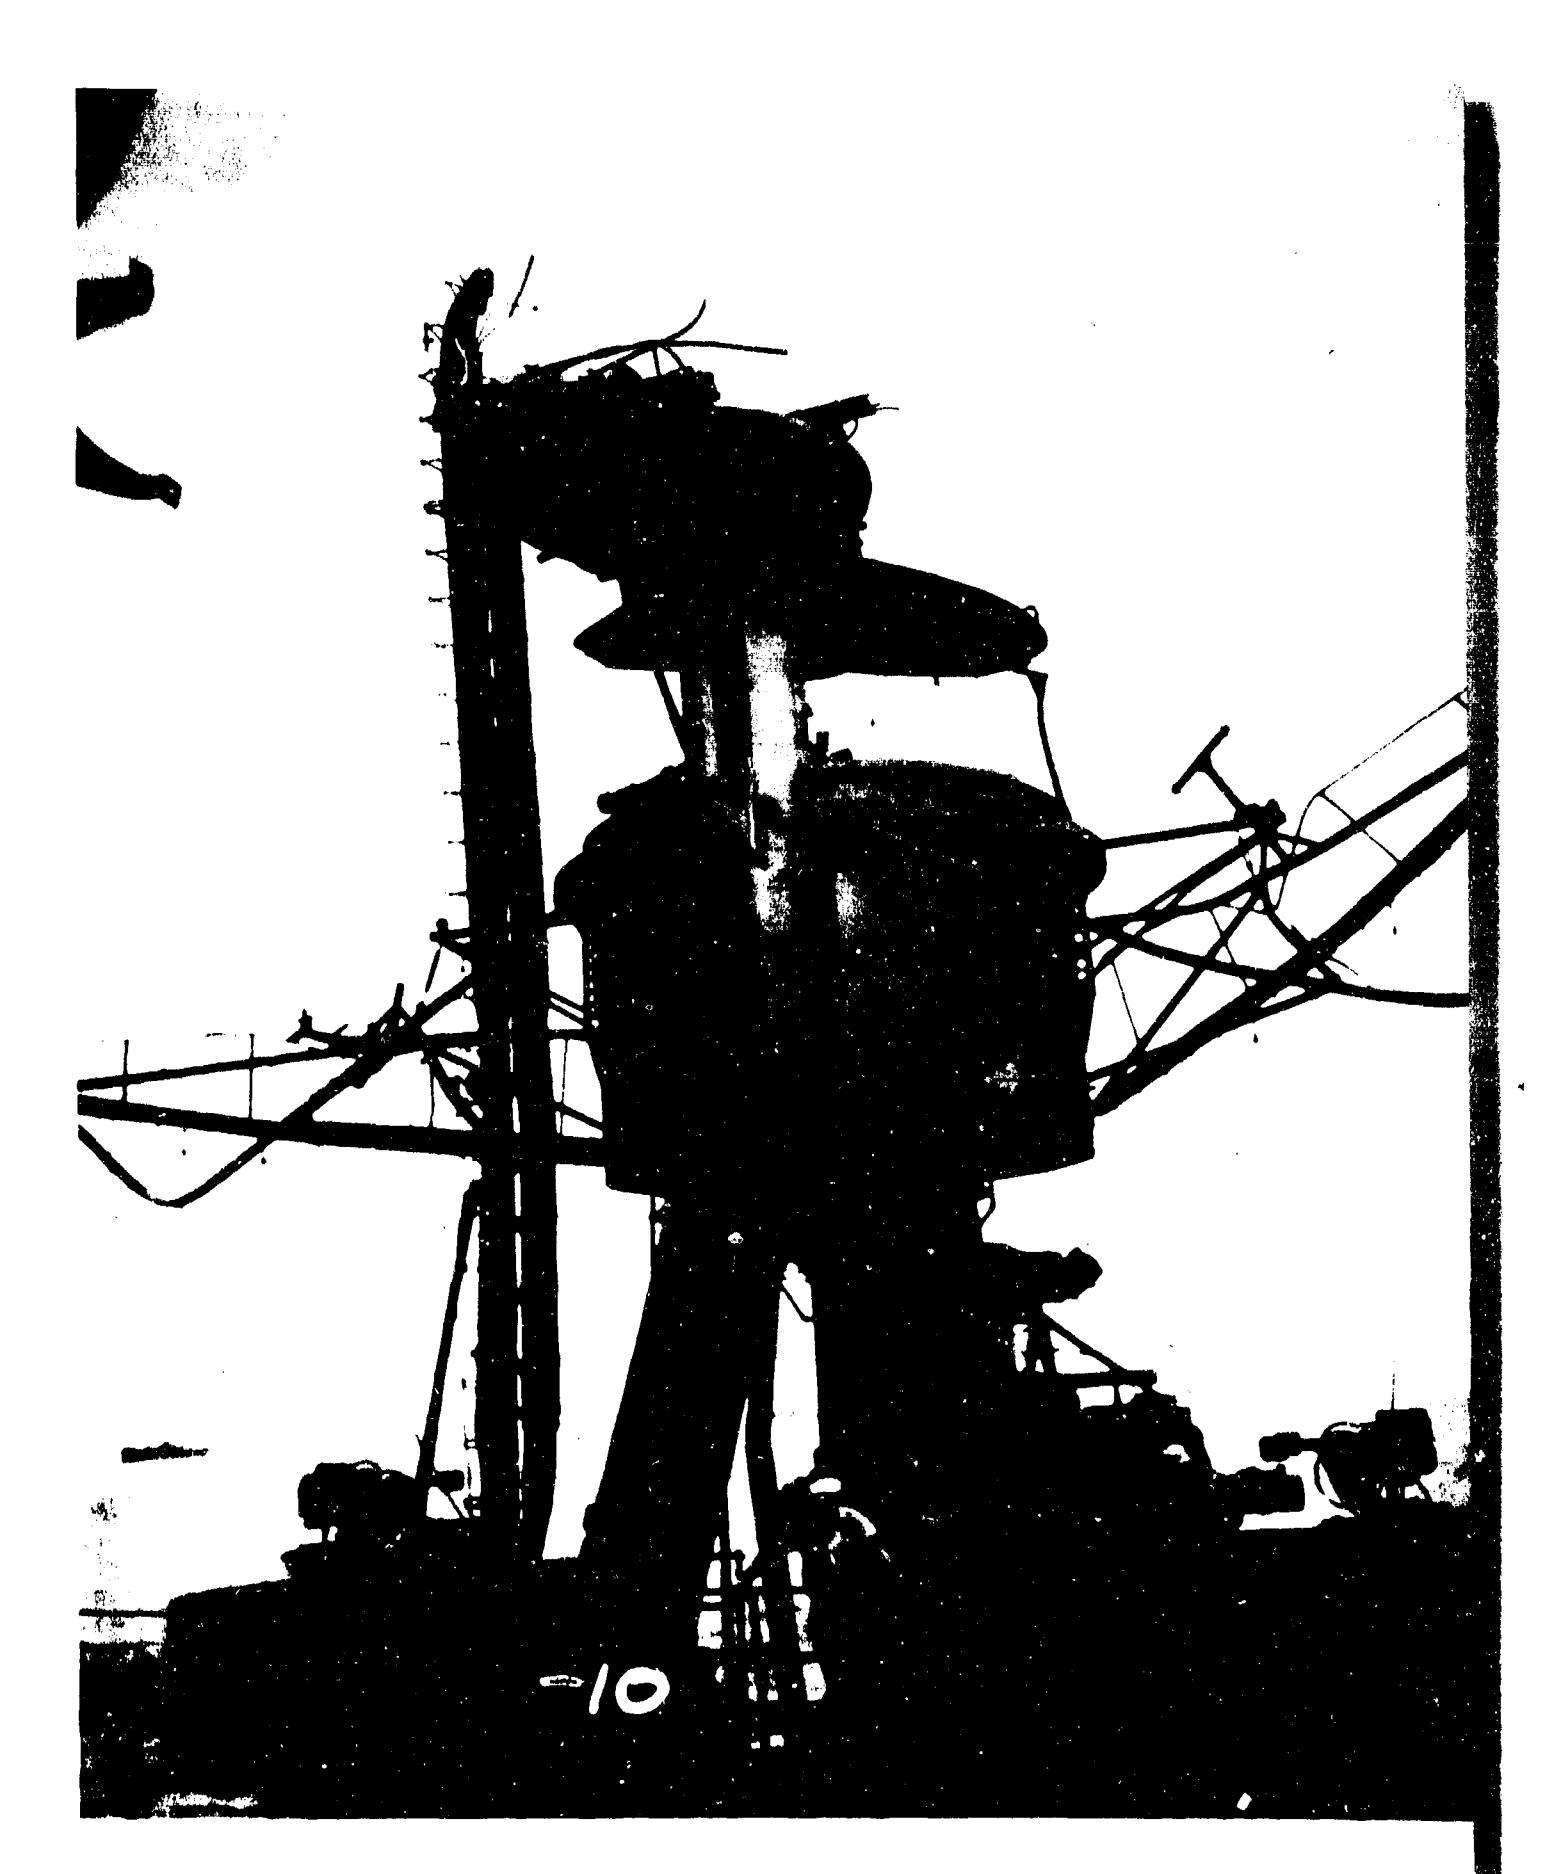
AA-CR-80-1897-10. USS NEVADA (BB36). After tripod, looking aft showing mainmast and yardarms. For close-up of end of mainmast pcle see 1900-7.

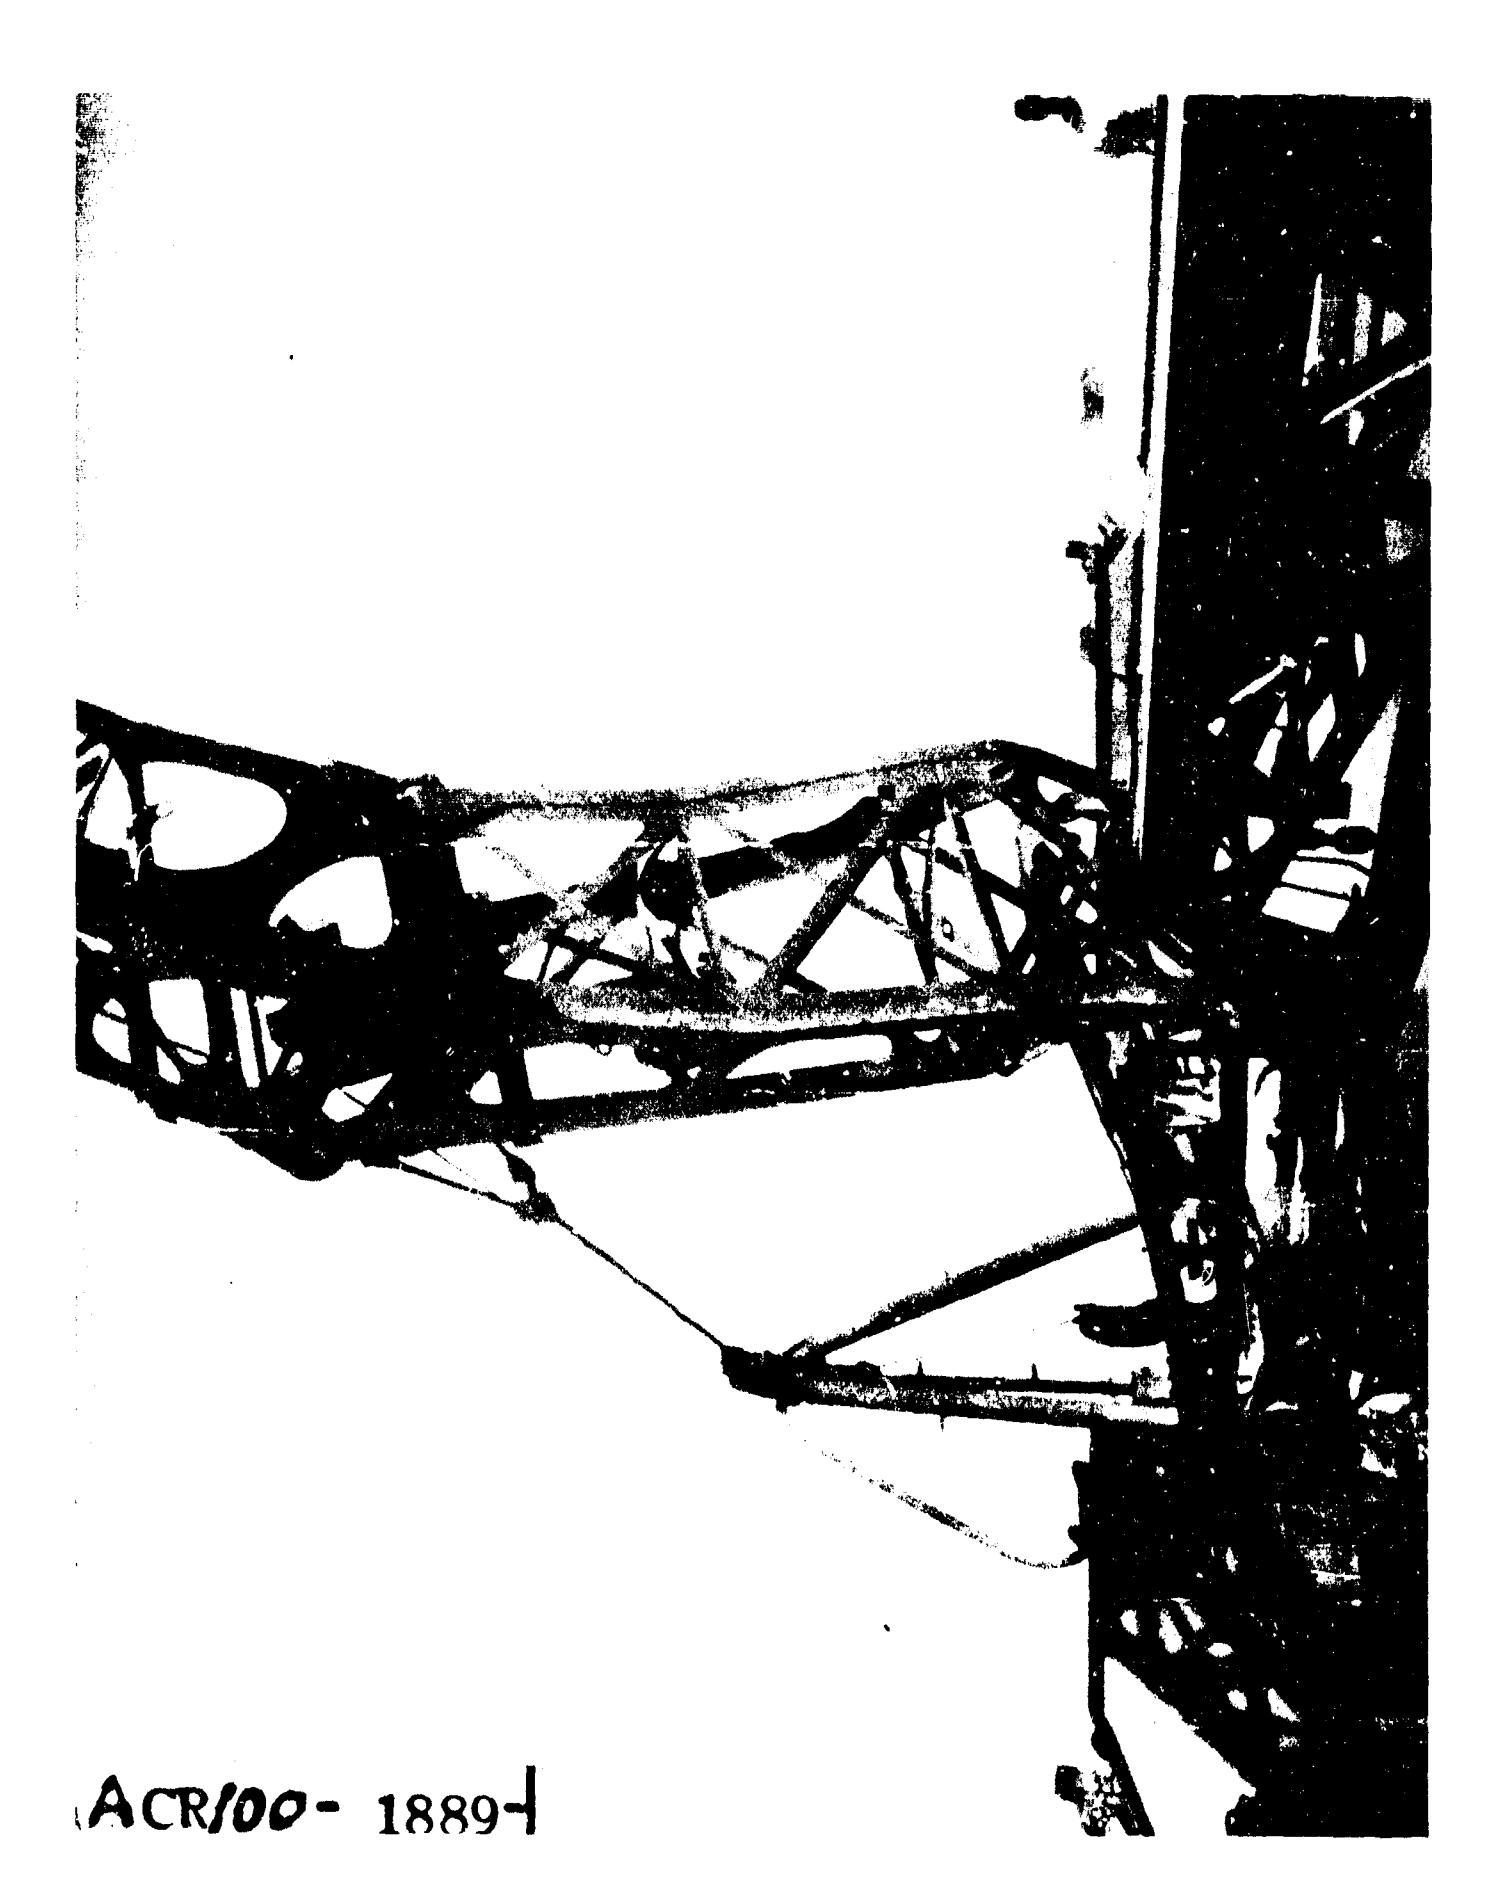
AA-CR-100-1889-10. USS NEVADA (BB36). Close-up of lower section of stern crane resting on catapult looking aft and to starboard.

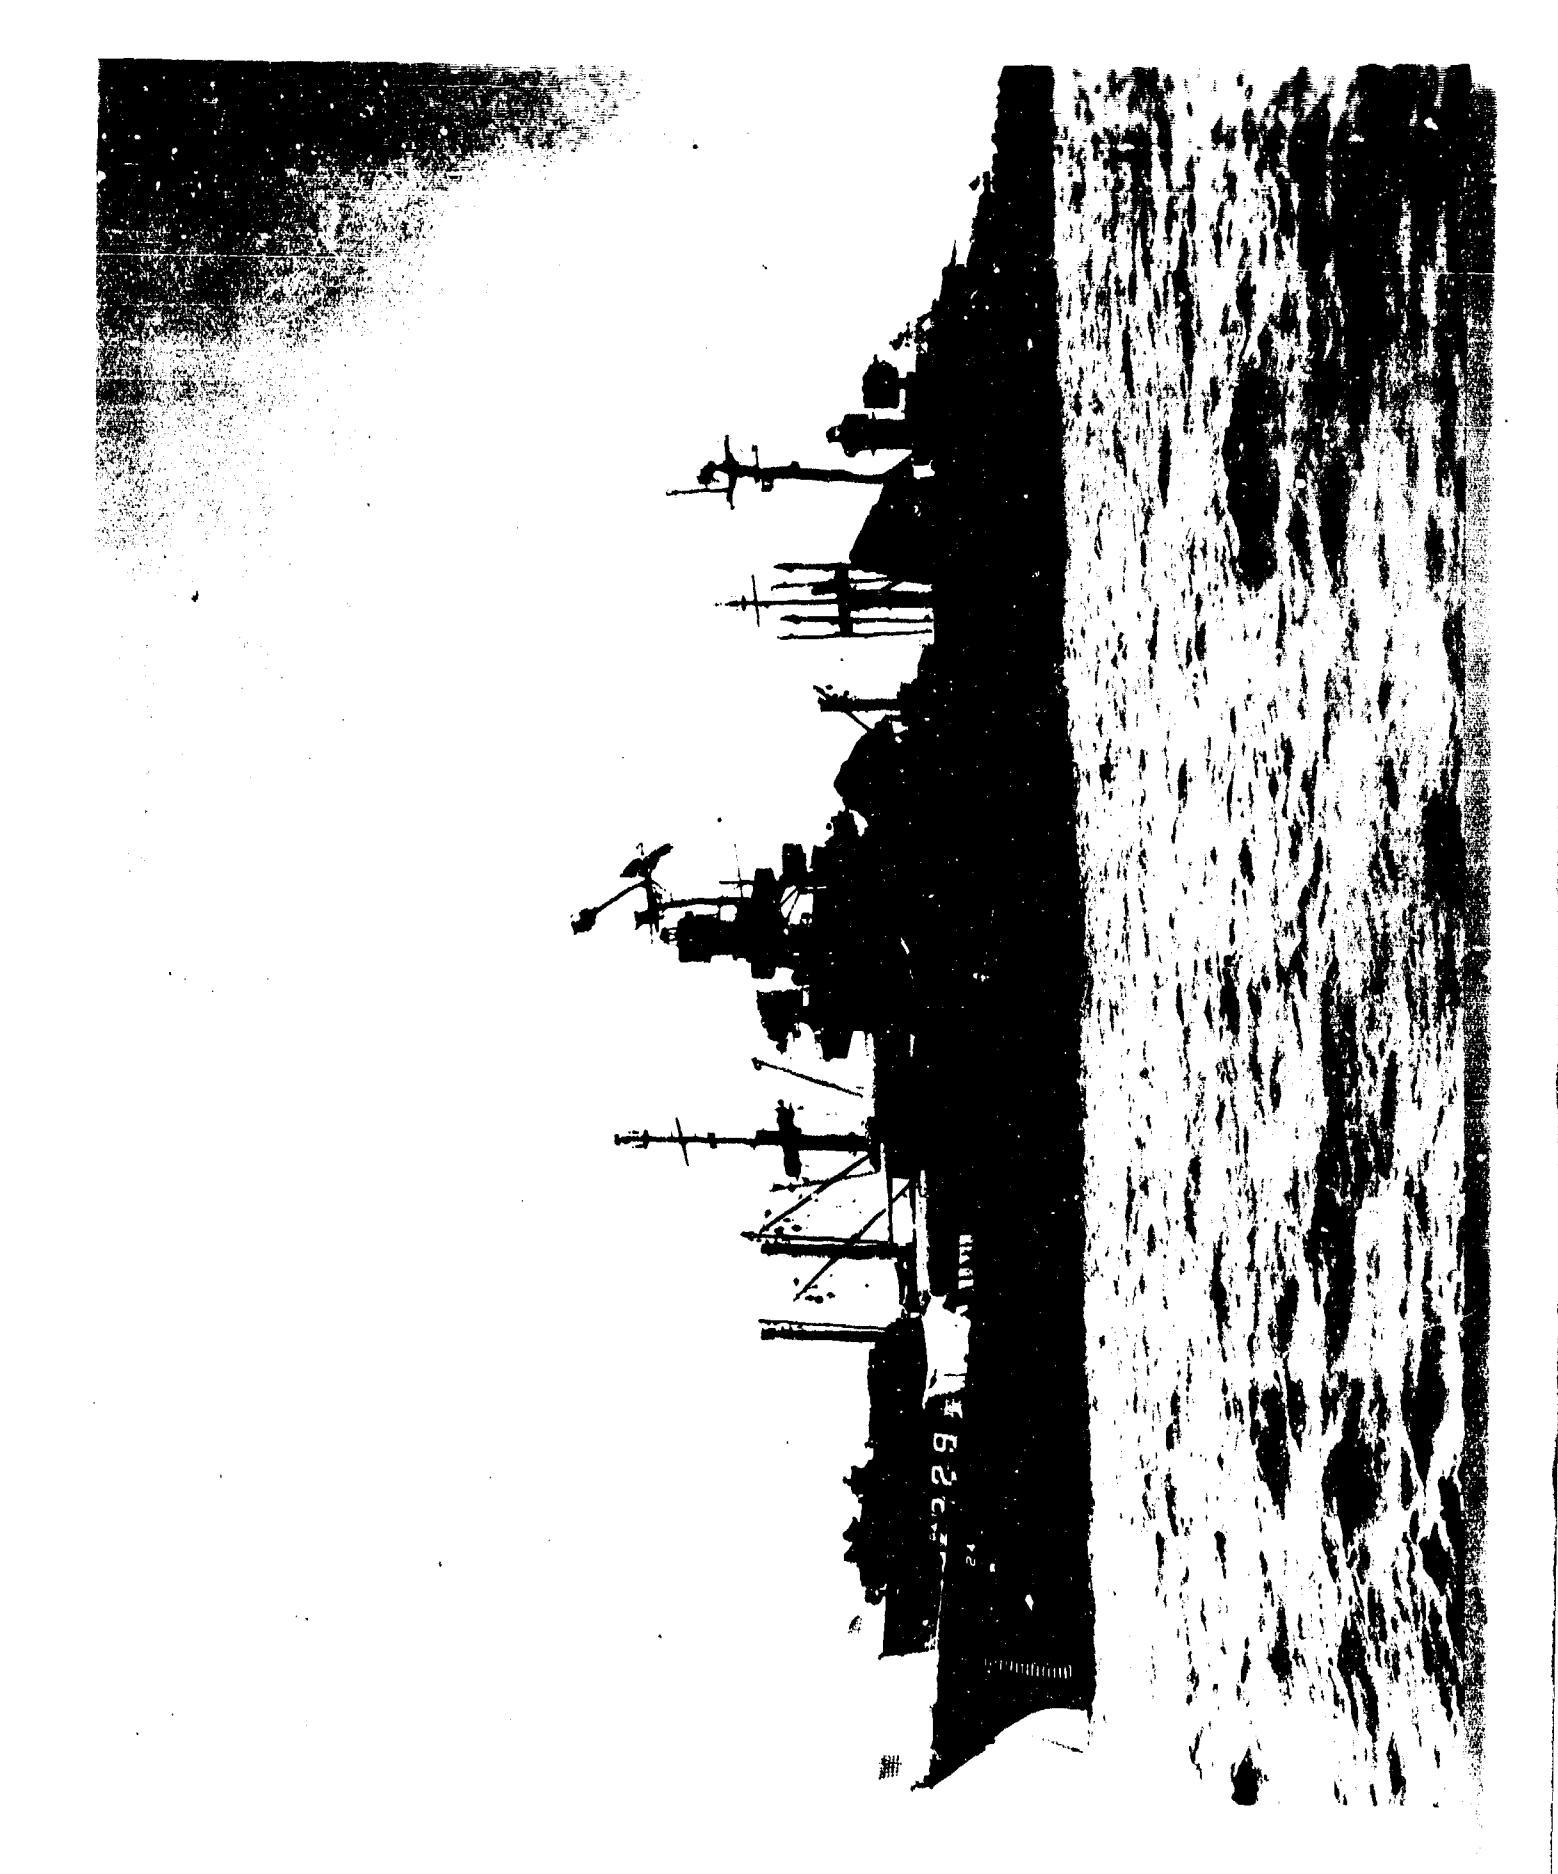
1. PENSACOLA took the blast from about 169 degrees relative. Photos 196-154-1, 227-93-45, 227-50-126 and 127; pages 126, 127, 128 and 129 are comparative views before and after Test A. SG radar pole mast is bent forward in a smooth curve such that a tangent to the curve at the top of pole would be at an angle of approximately 60 degrees with the vertical. The pole is bent about 100 degrees to port of the centerline plane. The port and starboard yardarms are angled slightly forward of the normal plane. There are no fractures in the pole or yardarms.

AA-CR-227-50-126. U.S.S. PENSACOLA (CA24). View looking at port bow after Test A.

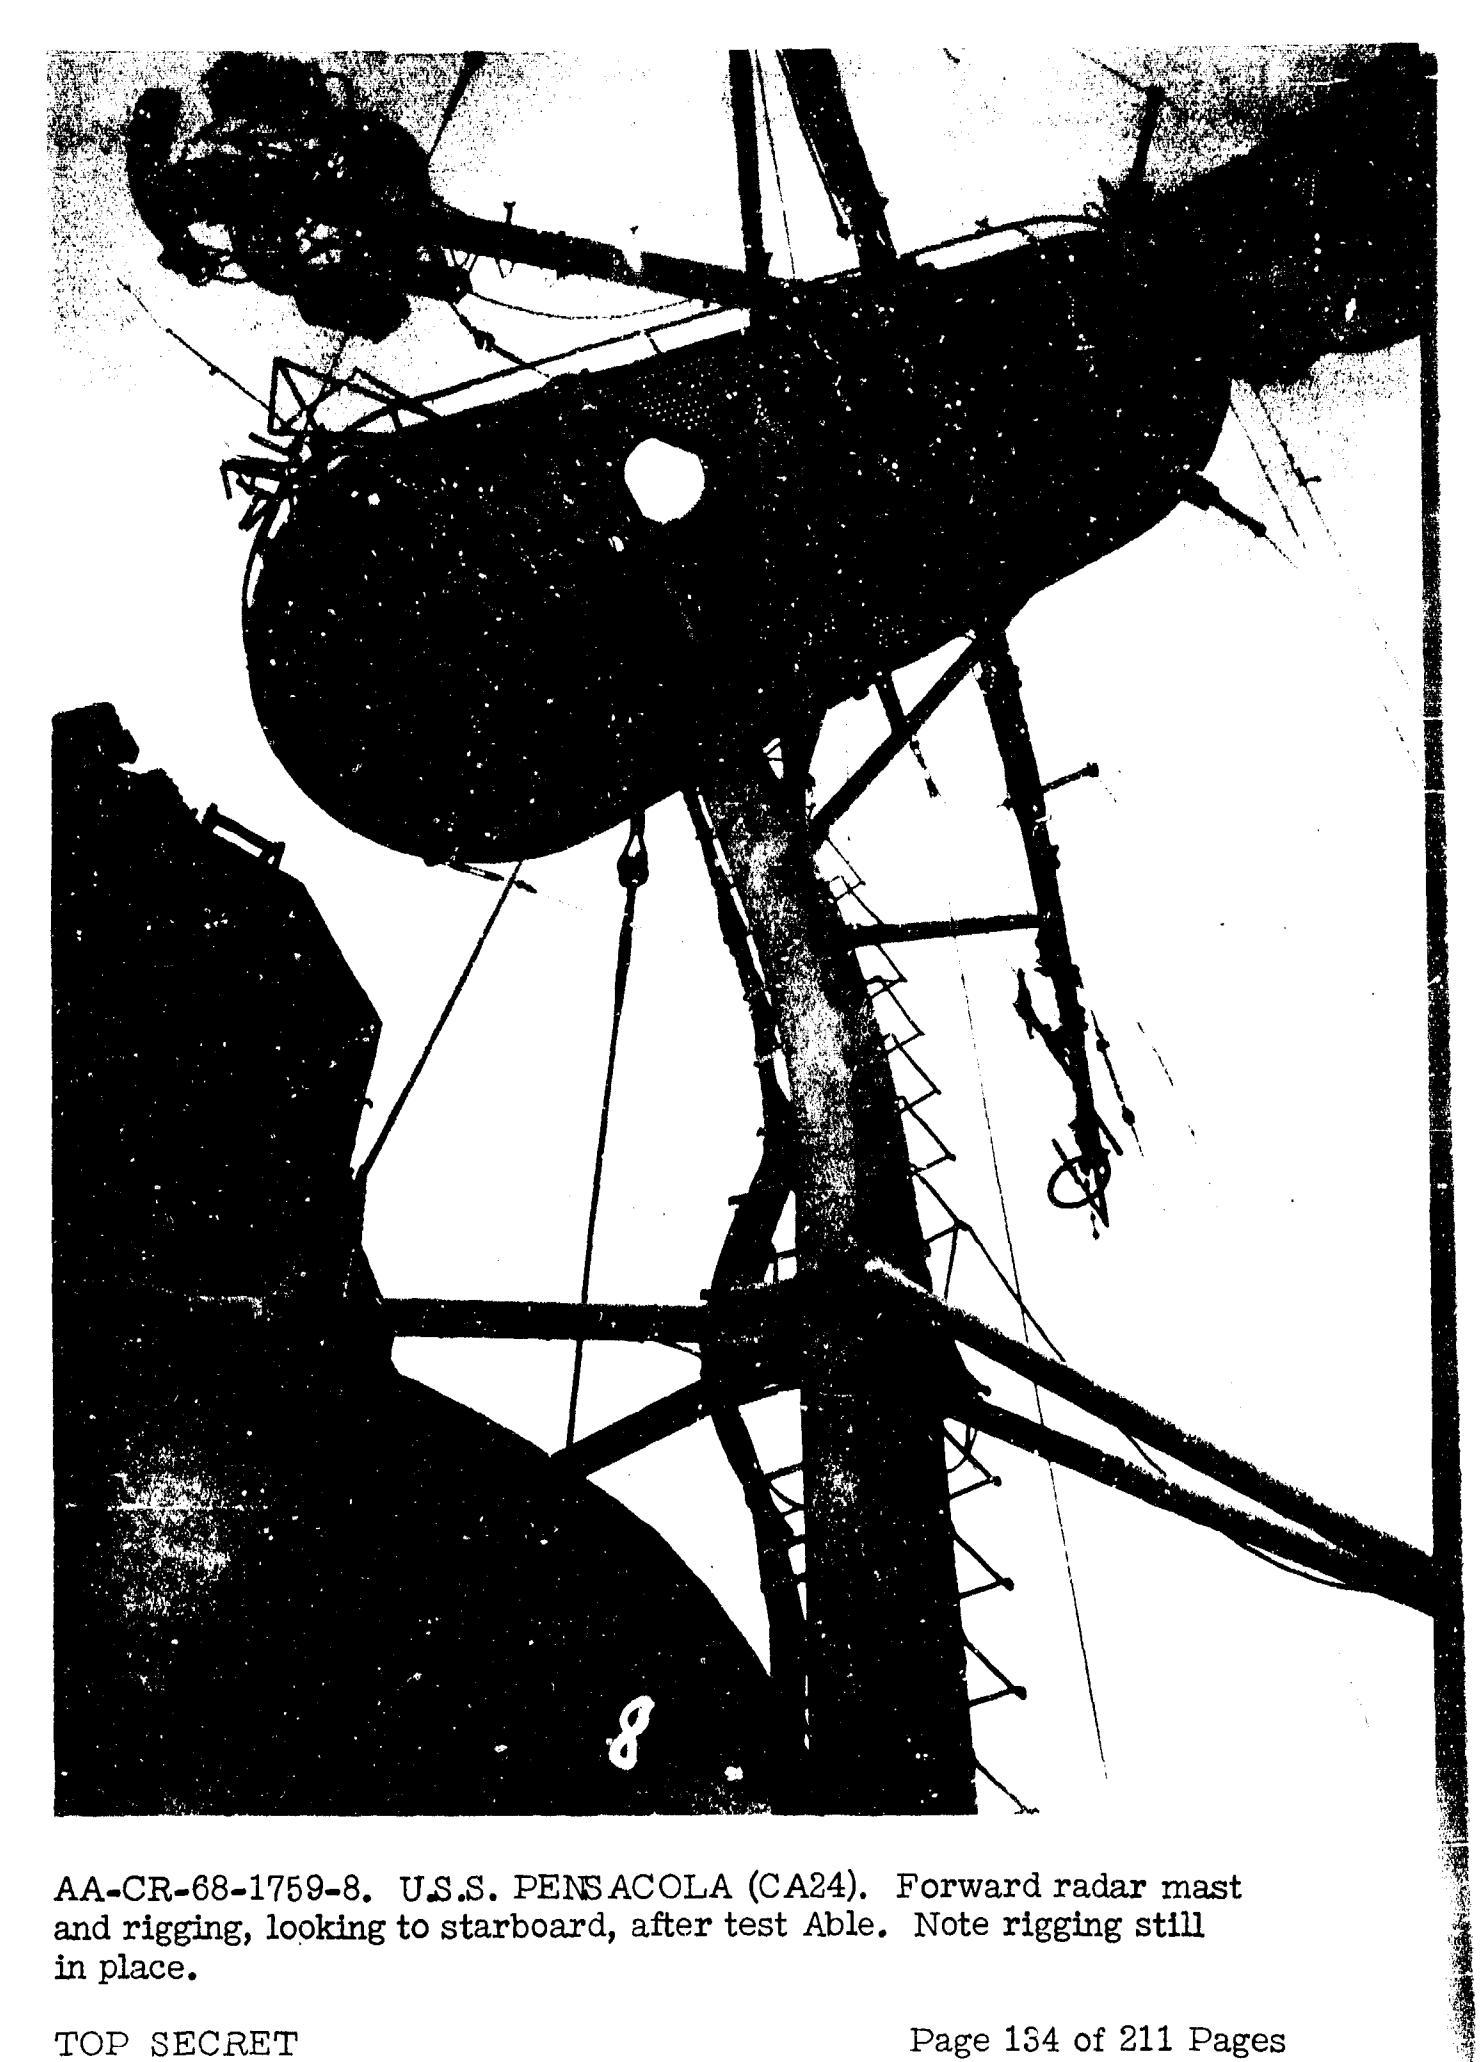
2. Photos 1757-1, 2; 1761-12; 157-8; and 1759-8 pages 130, 131, 132, 133 and 134 are views of the foremast. Photos 157-8 and 1759-8, pages 133 and 134 show that the pole which supports the radar platform is bent in a smooth curve starting about 12 feet above the fire control platform at a point just above the 4 inch pipe braces. There is no failure in these braces or in those between the pole and the radar platform. Failure of these poles is the result of bending under load without evidence of local weakness.

AA-CR-68-1759-8. U.S.S. PENSACOLA (CA24). Forward radar mast and rigging, looking to starboard, after test Able. Note rigging still in place.

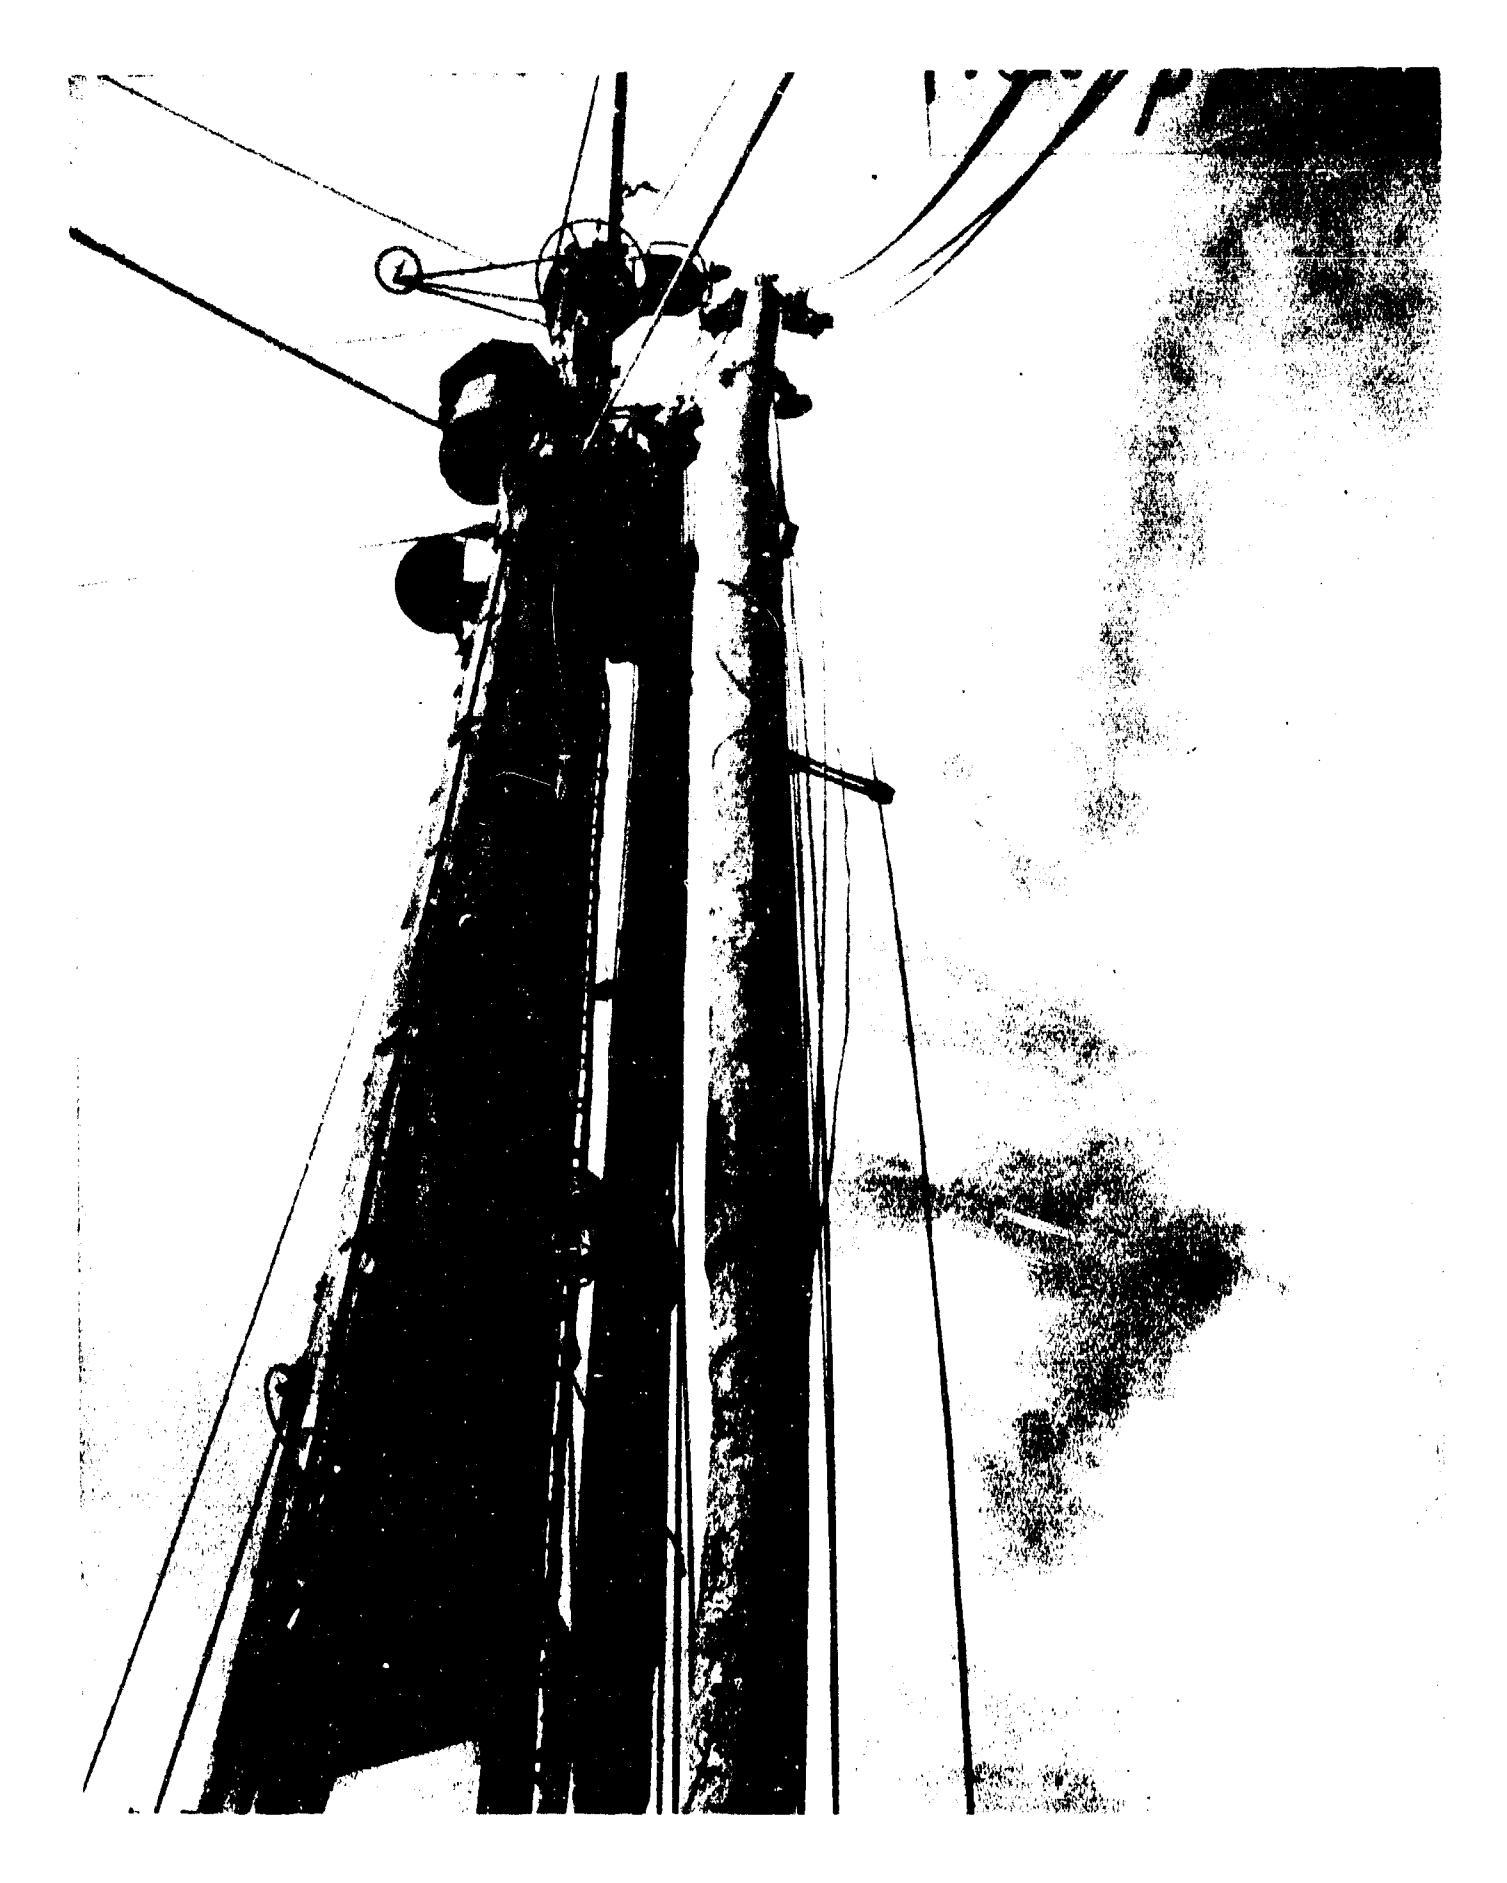
AA-CR-88-2104-6. U.S.S. DAWSON (APA79). Bends in port forward stack.

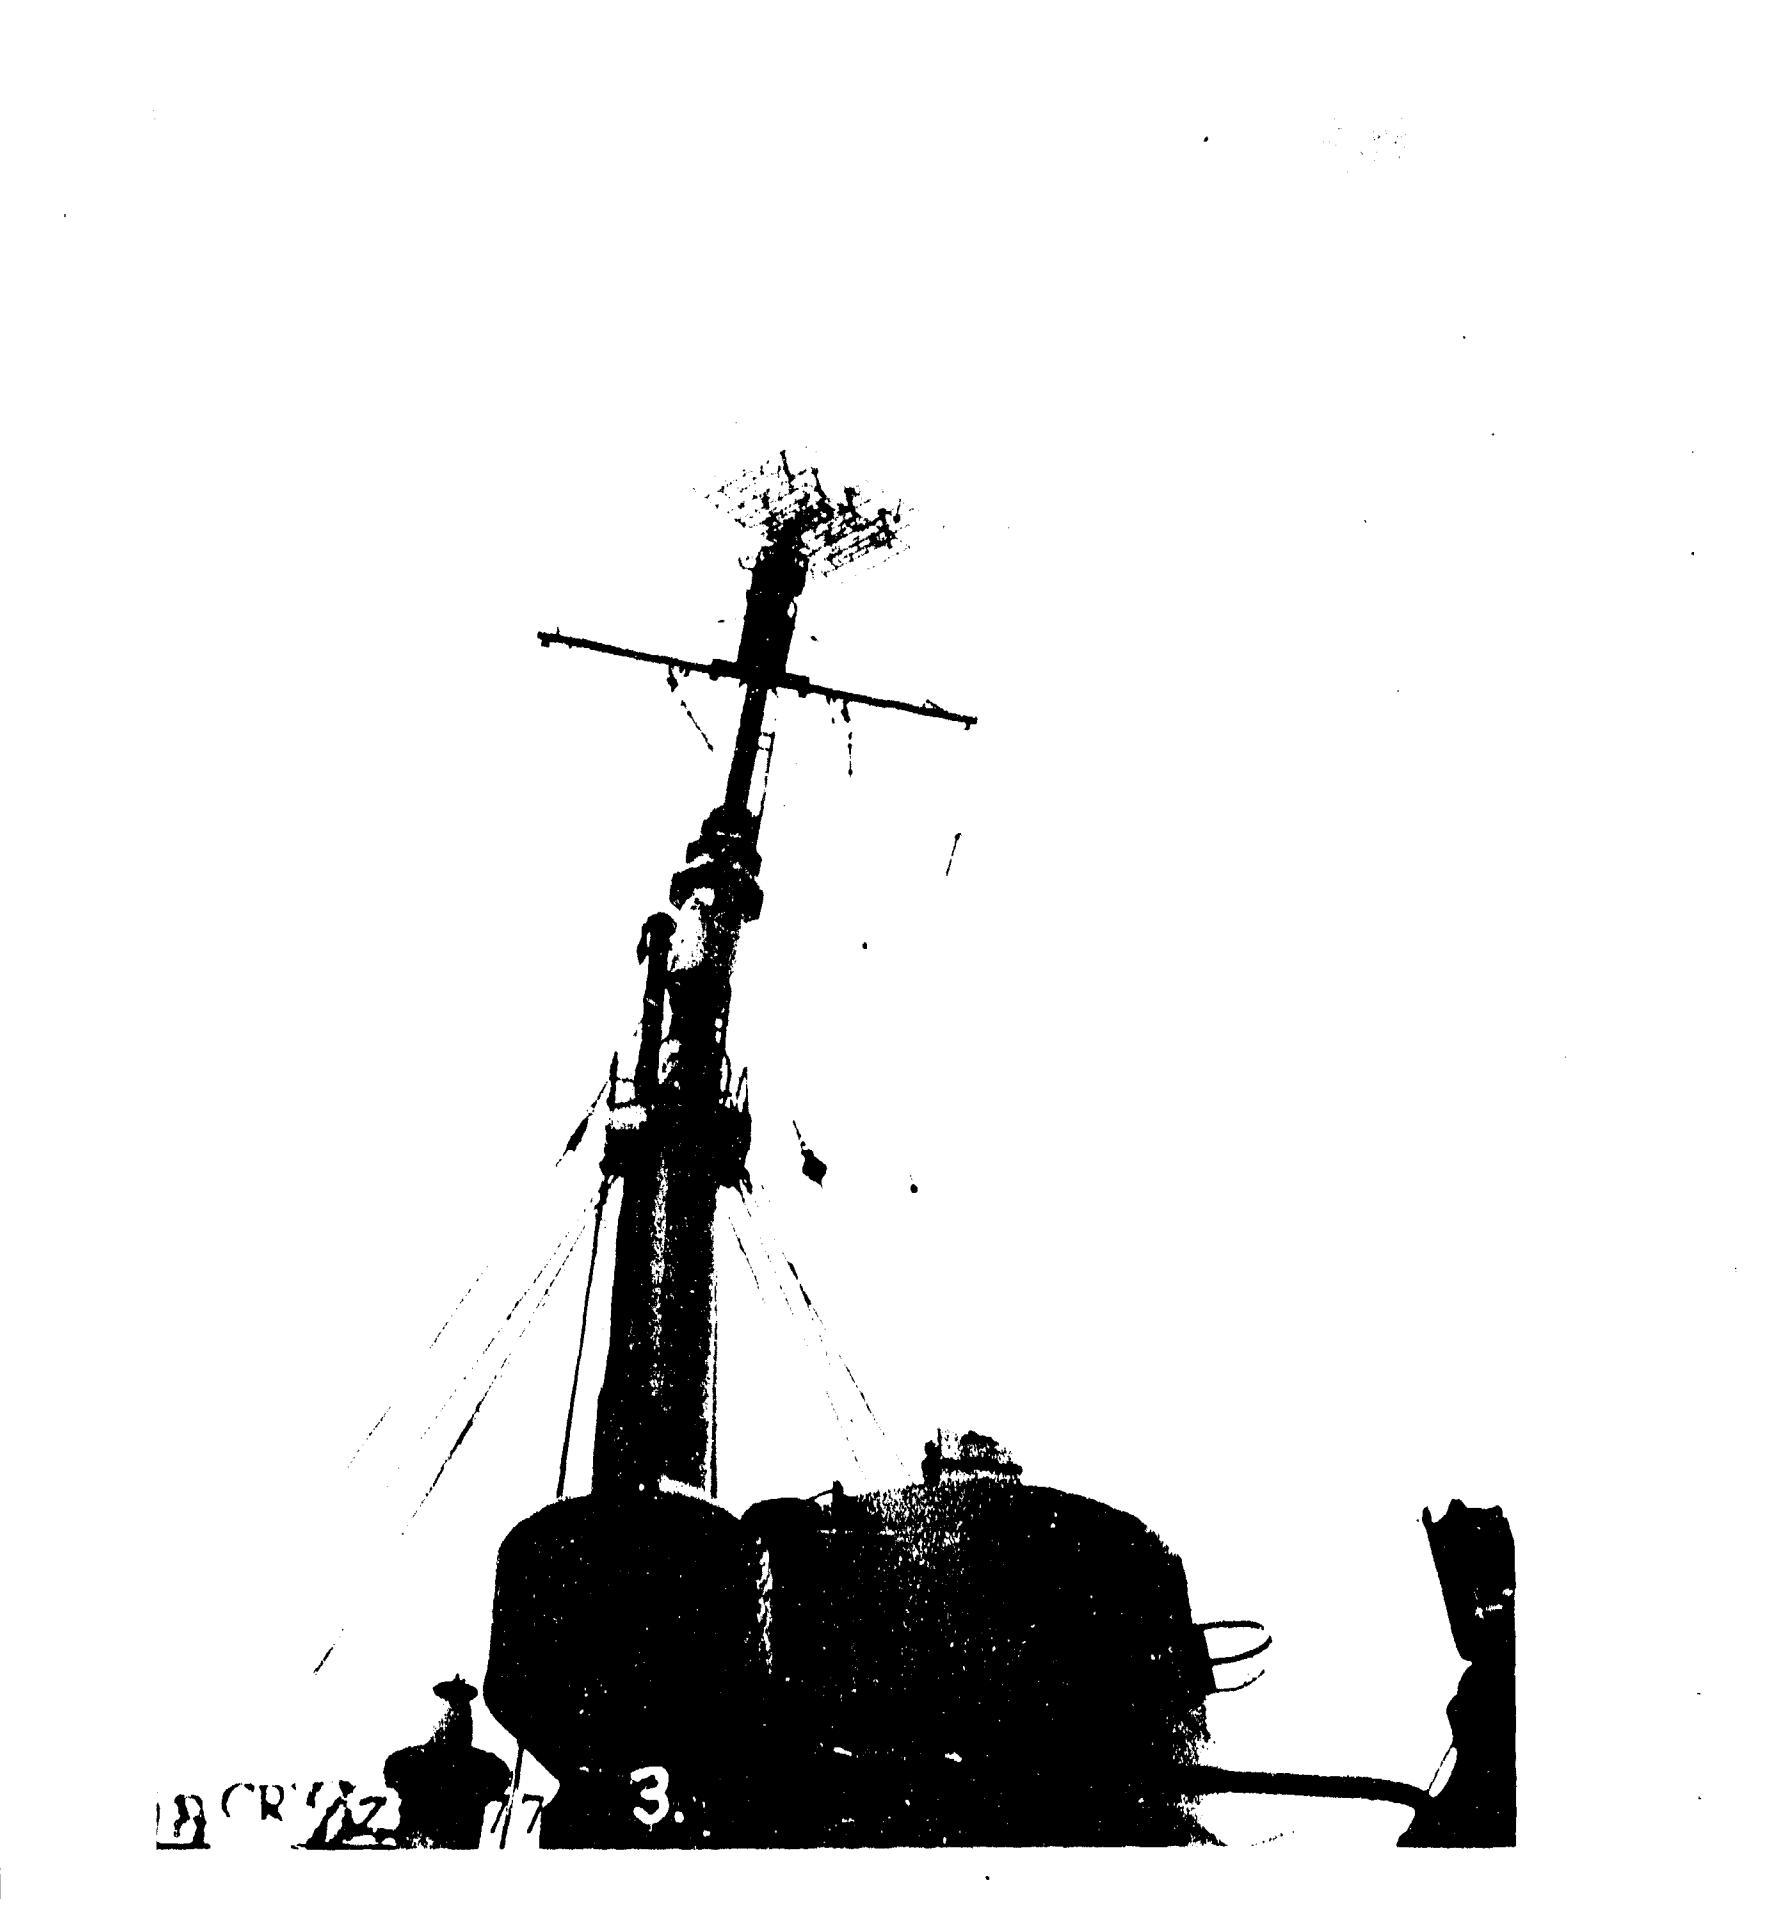
3. The lower section of the mainmast is intact. About one foot above the step in the mast the top section is bent about 30 degrees out of normal in the direction of travel of the blast. There is previous fracture at this point. See photos 1773-3 and 2103-1, pages 159 and 160.

AA-CR-92-1773-3. U.S.S. DAWSON (APA79). Main topmast, looking forward showing rigging still in place.

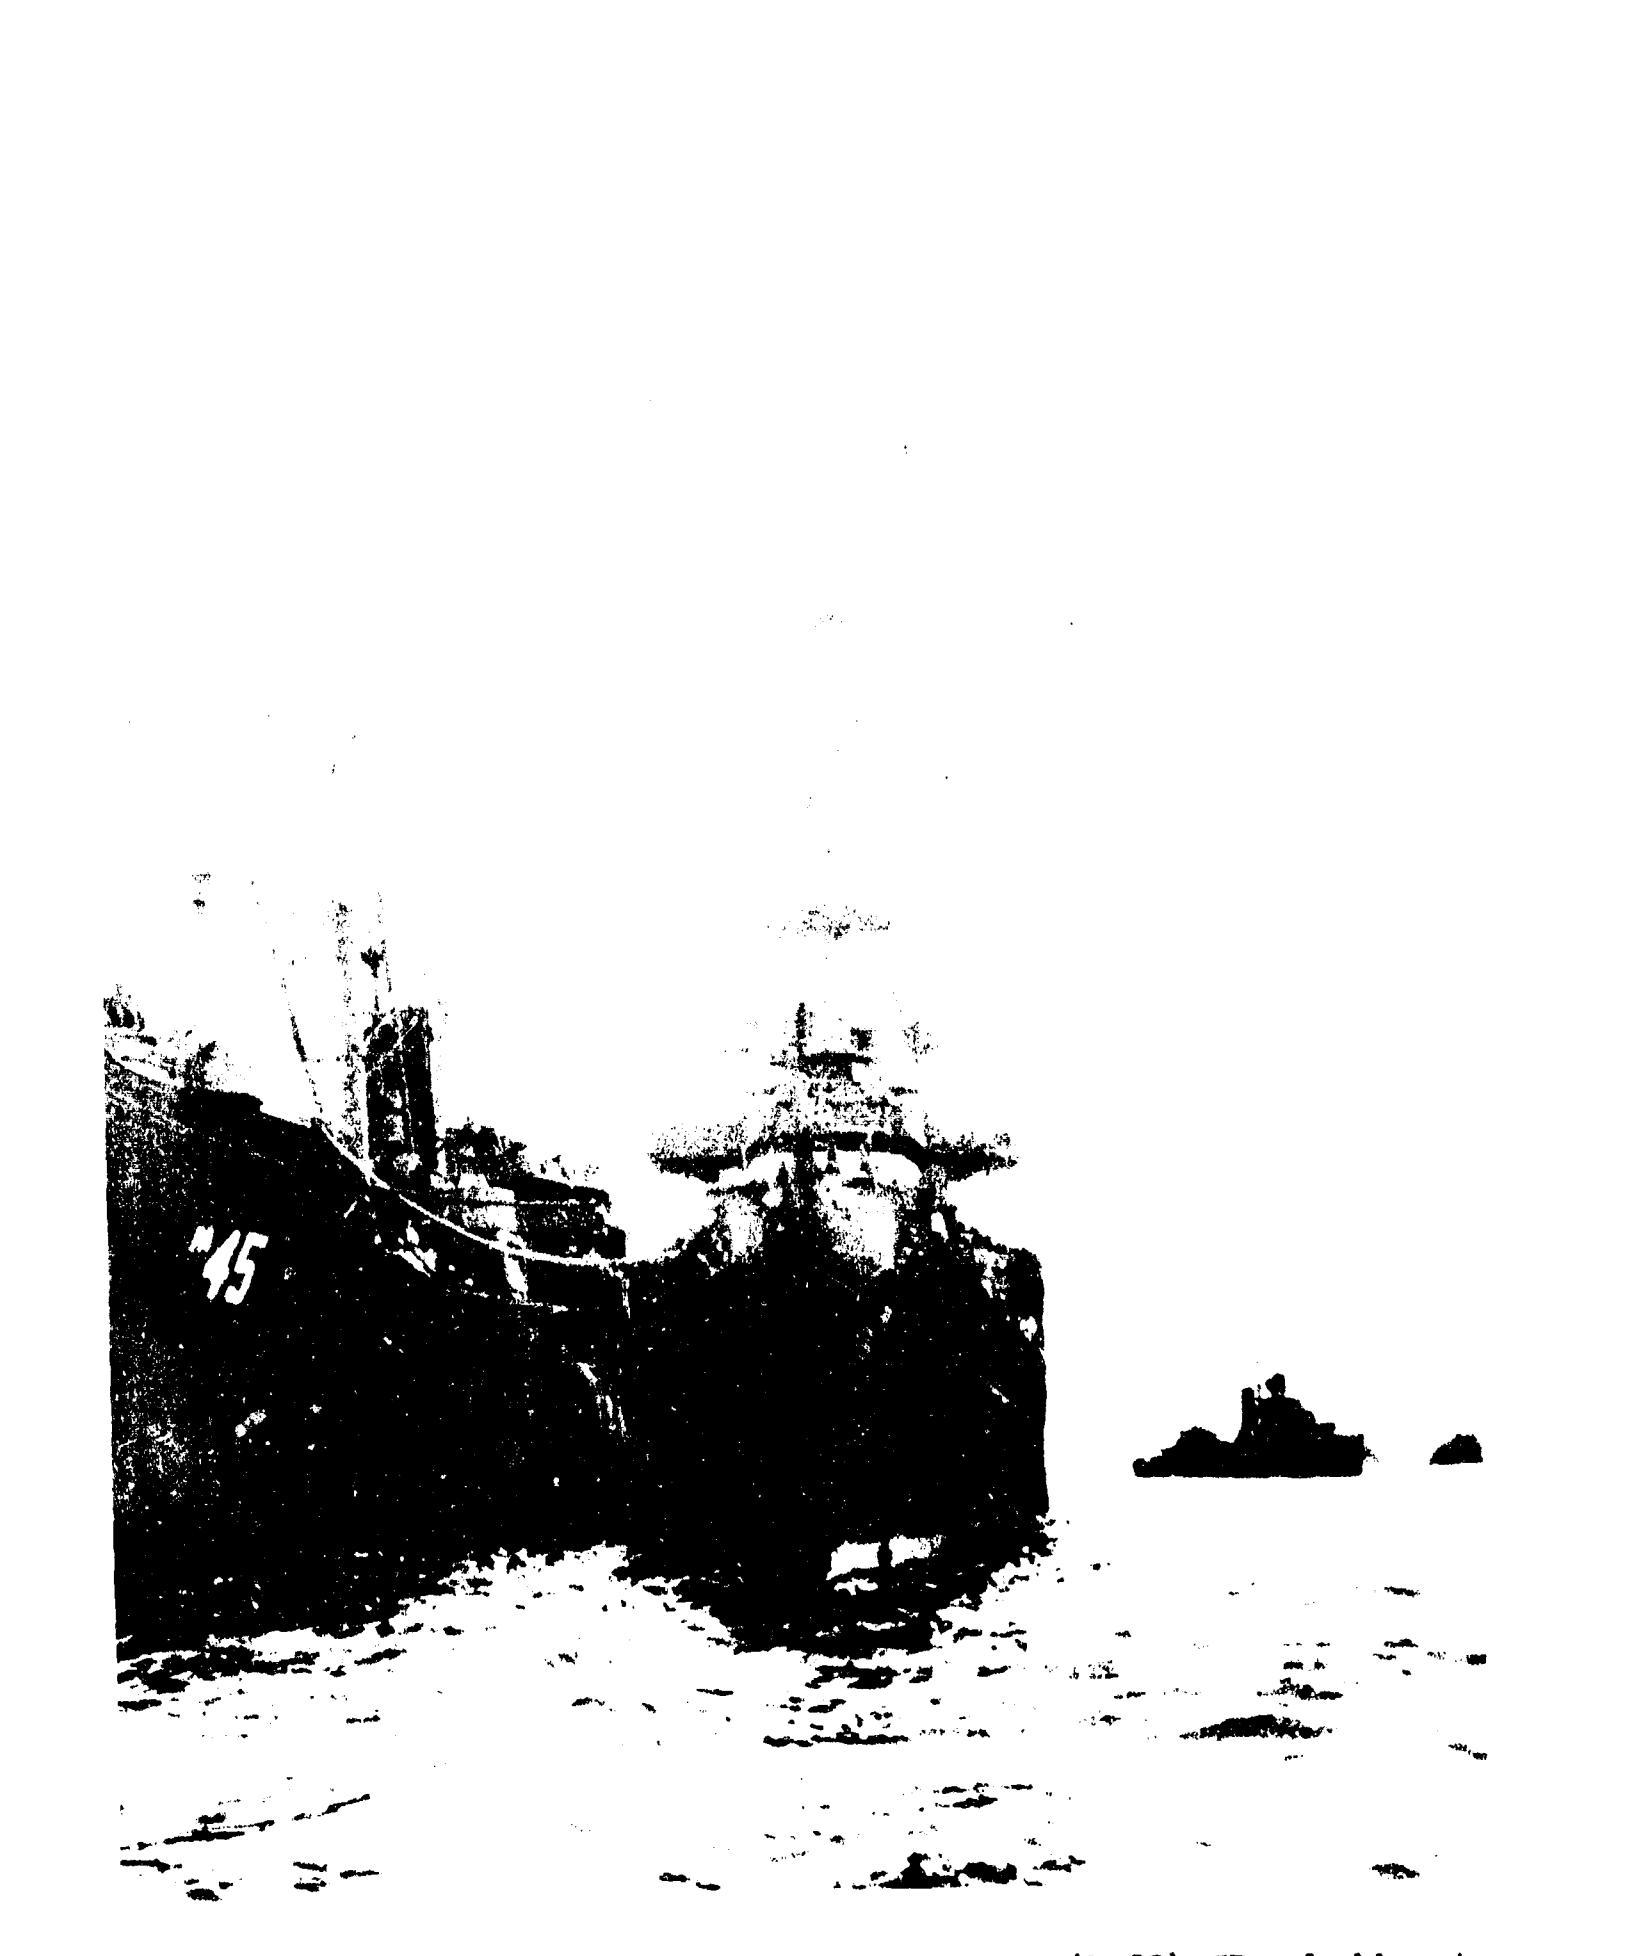
1. This ship was attacked from about 230 degrees relative. Photos 227-91-46, 47; 227-50-113, 116, 117; 196-159-10, 11, and 12; pages 168, 169, 166, 167, 165, 164, 162 and 163 are comparative views before and after Test A. The pole mast supporting the SG radar is bent in a smooth curve in the direction of blast travel. The condition of this polemast, the jackstaff and mainmast pole can be seen in photo 227-91-46, page 168. There is no discernible damage to any of the main tripod structures or their supports.

AA-CR-227-50-117. U.S.S. SALT LAKE CITY (CA25). View looking at bow after Test A.
