BUREAU OF SHIPS GROUP

TECHNICAL INSPECTION REPORT

FAILURES OF MASTS, YARDARMS, BOOMS, AND RIGGING

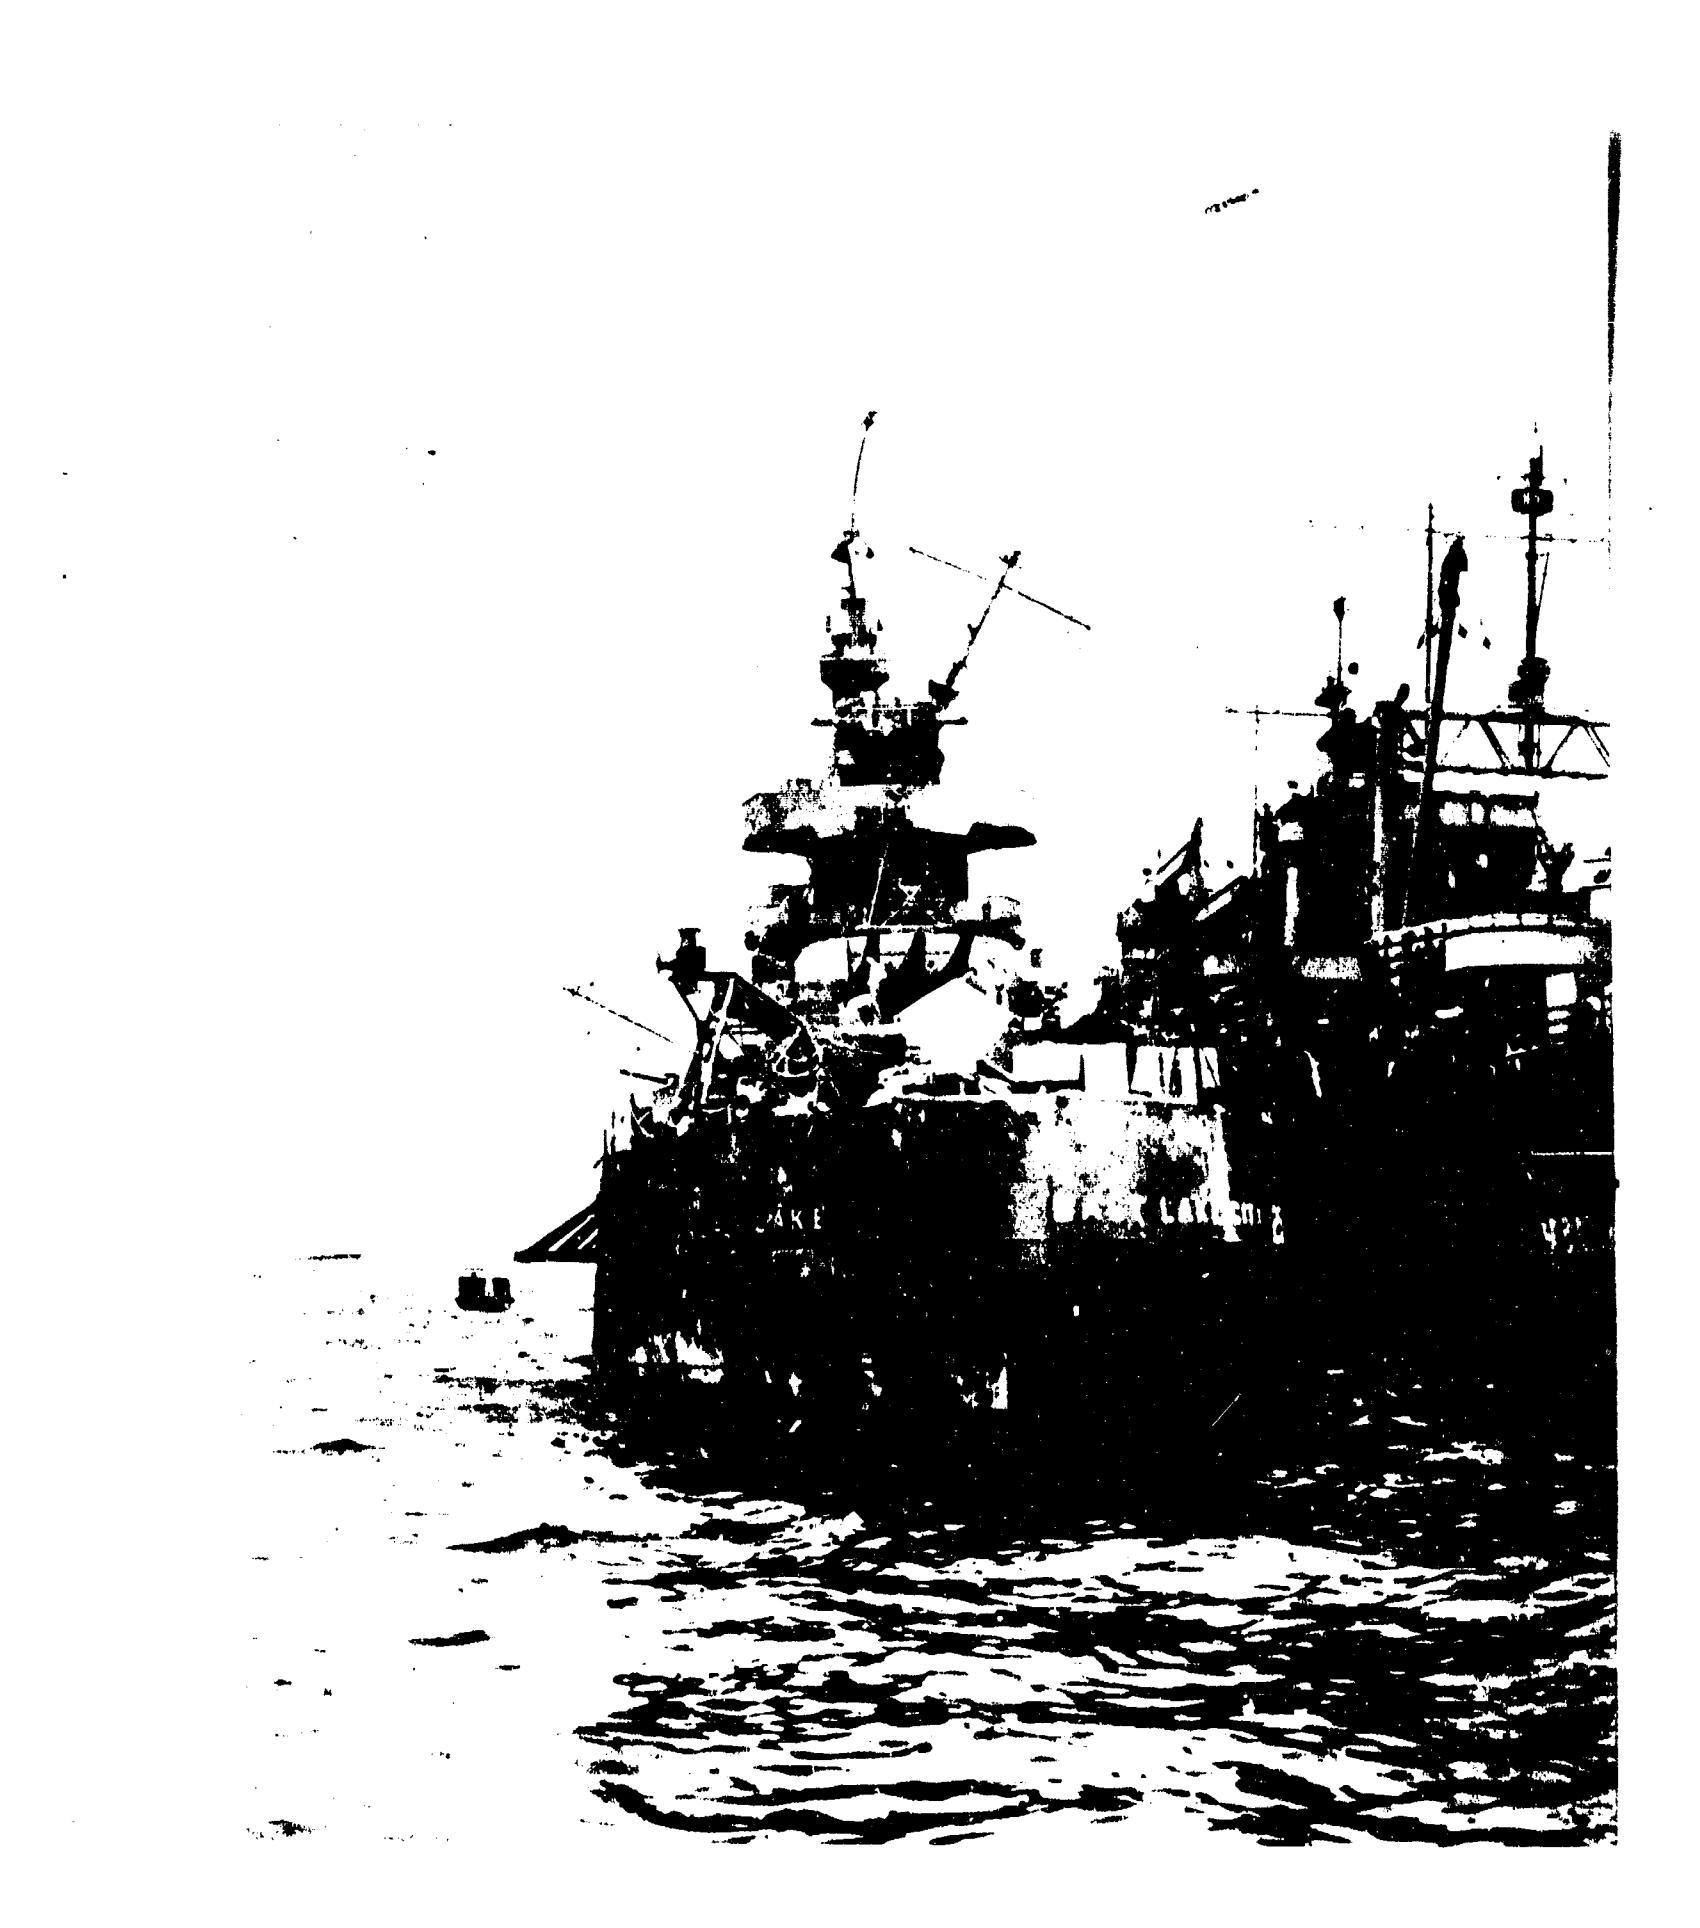
1. This ship was attacked from about 230 degrees relative. Photos 227-91-46, 47; 227-50-113, 116, 117; 196-159-10, 11, and 12; pages 168, 169, 166, 167, 165, 164, 162 and 163 are comparative views before and after Test A. The pole mast supporting the SG radar is bent in a smooth curve in the direction of blast travel. The condition of this polemast, the jackstaff and mainmast pole can be seen in photo 227-91-46, page 168. There is no discernible damage to any of the main tripod structures or their supports.

AA-CR-227-50-113. U.S.S. SALT LAKE CITY (CA25). View looking at stern after Test A.

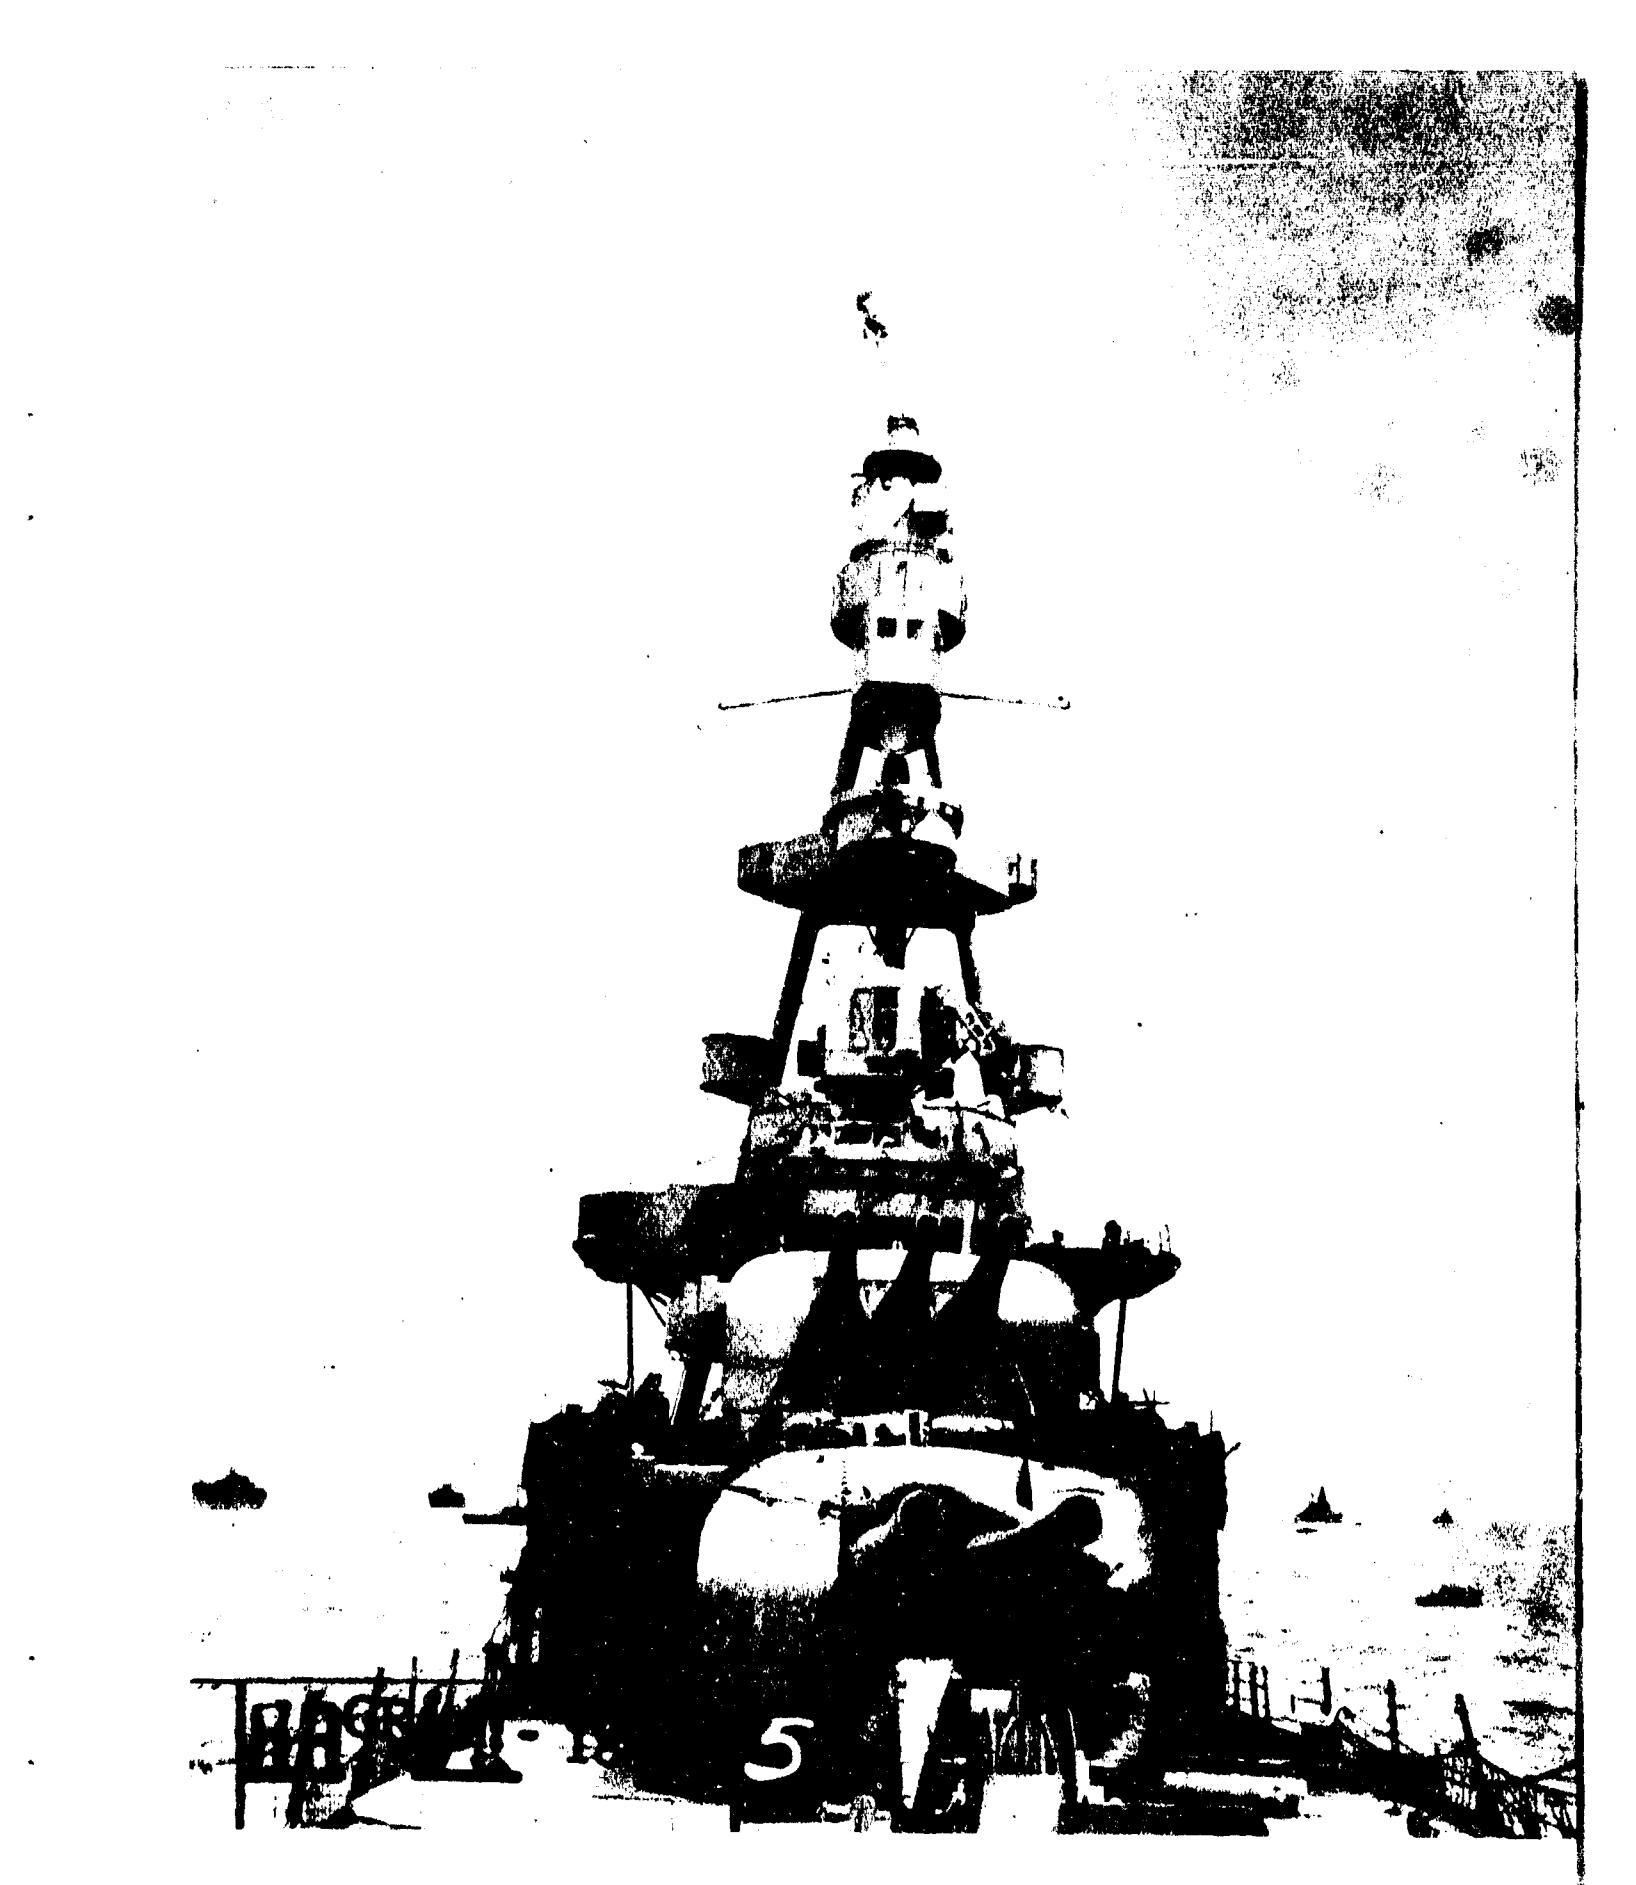
AA-CR-62-1861-5. U.S.S. SALT LAKE CITY (CA25). View looking at forward superstructure from bow. Note curve in "SG" radar polemast.

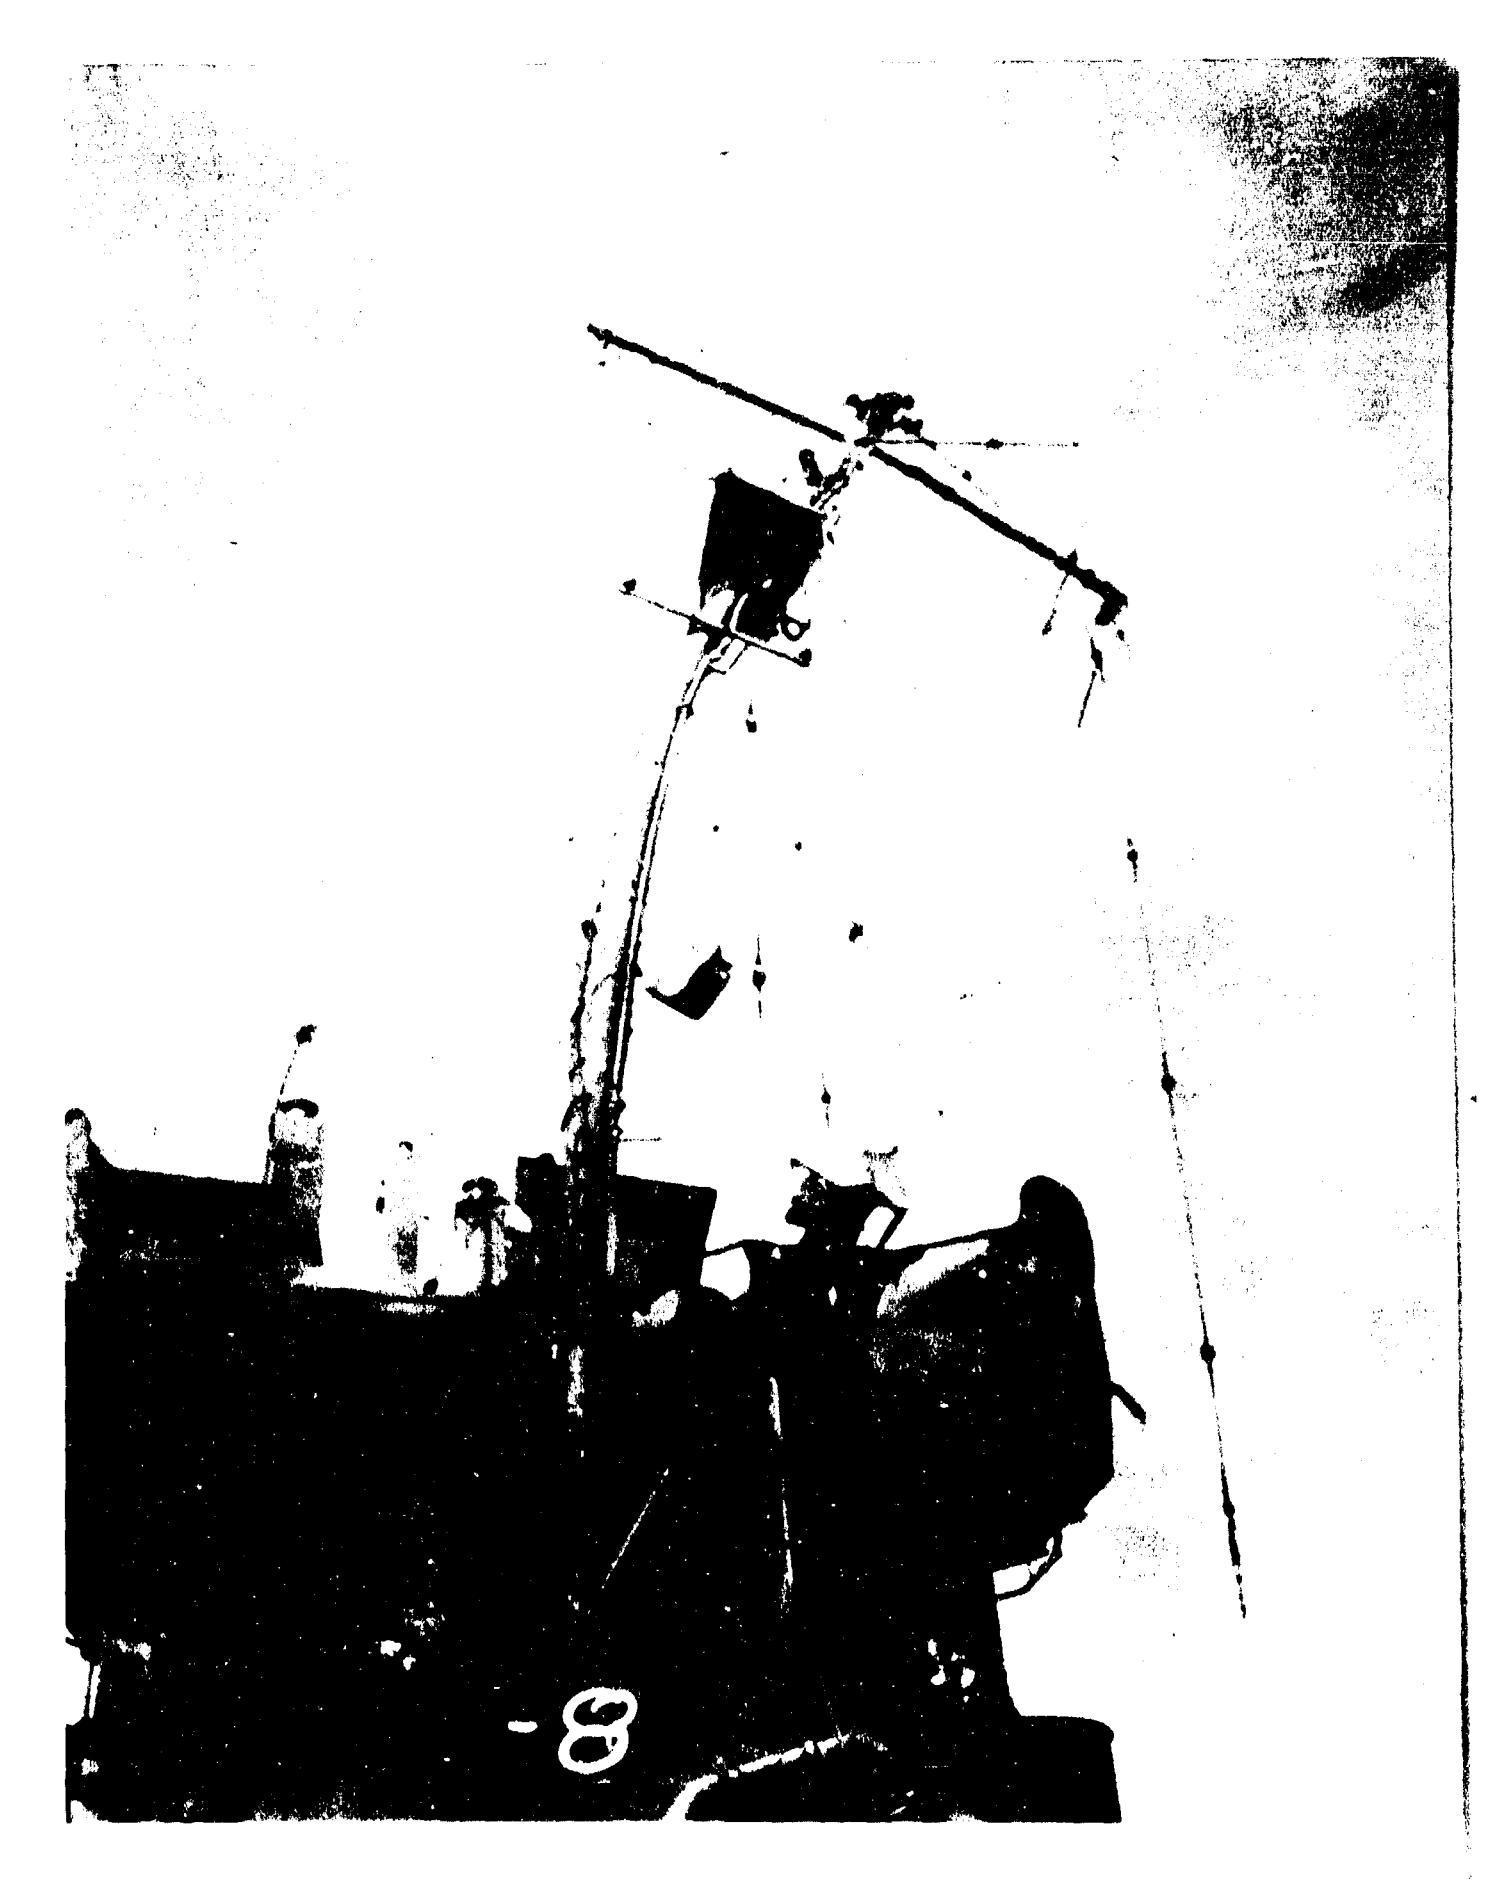
AA-CR-62-1868-8. U.S.S. SALT LAKE CITY (CA25). View looking forward at bulkhead 88 from frame 94 showing curve in mast and condition of rigging.

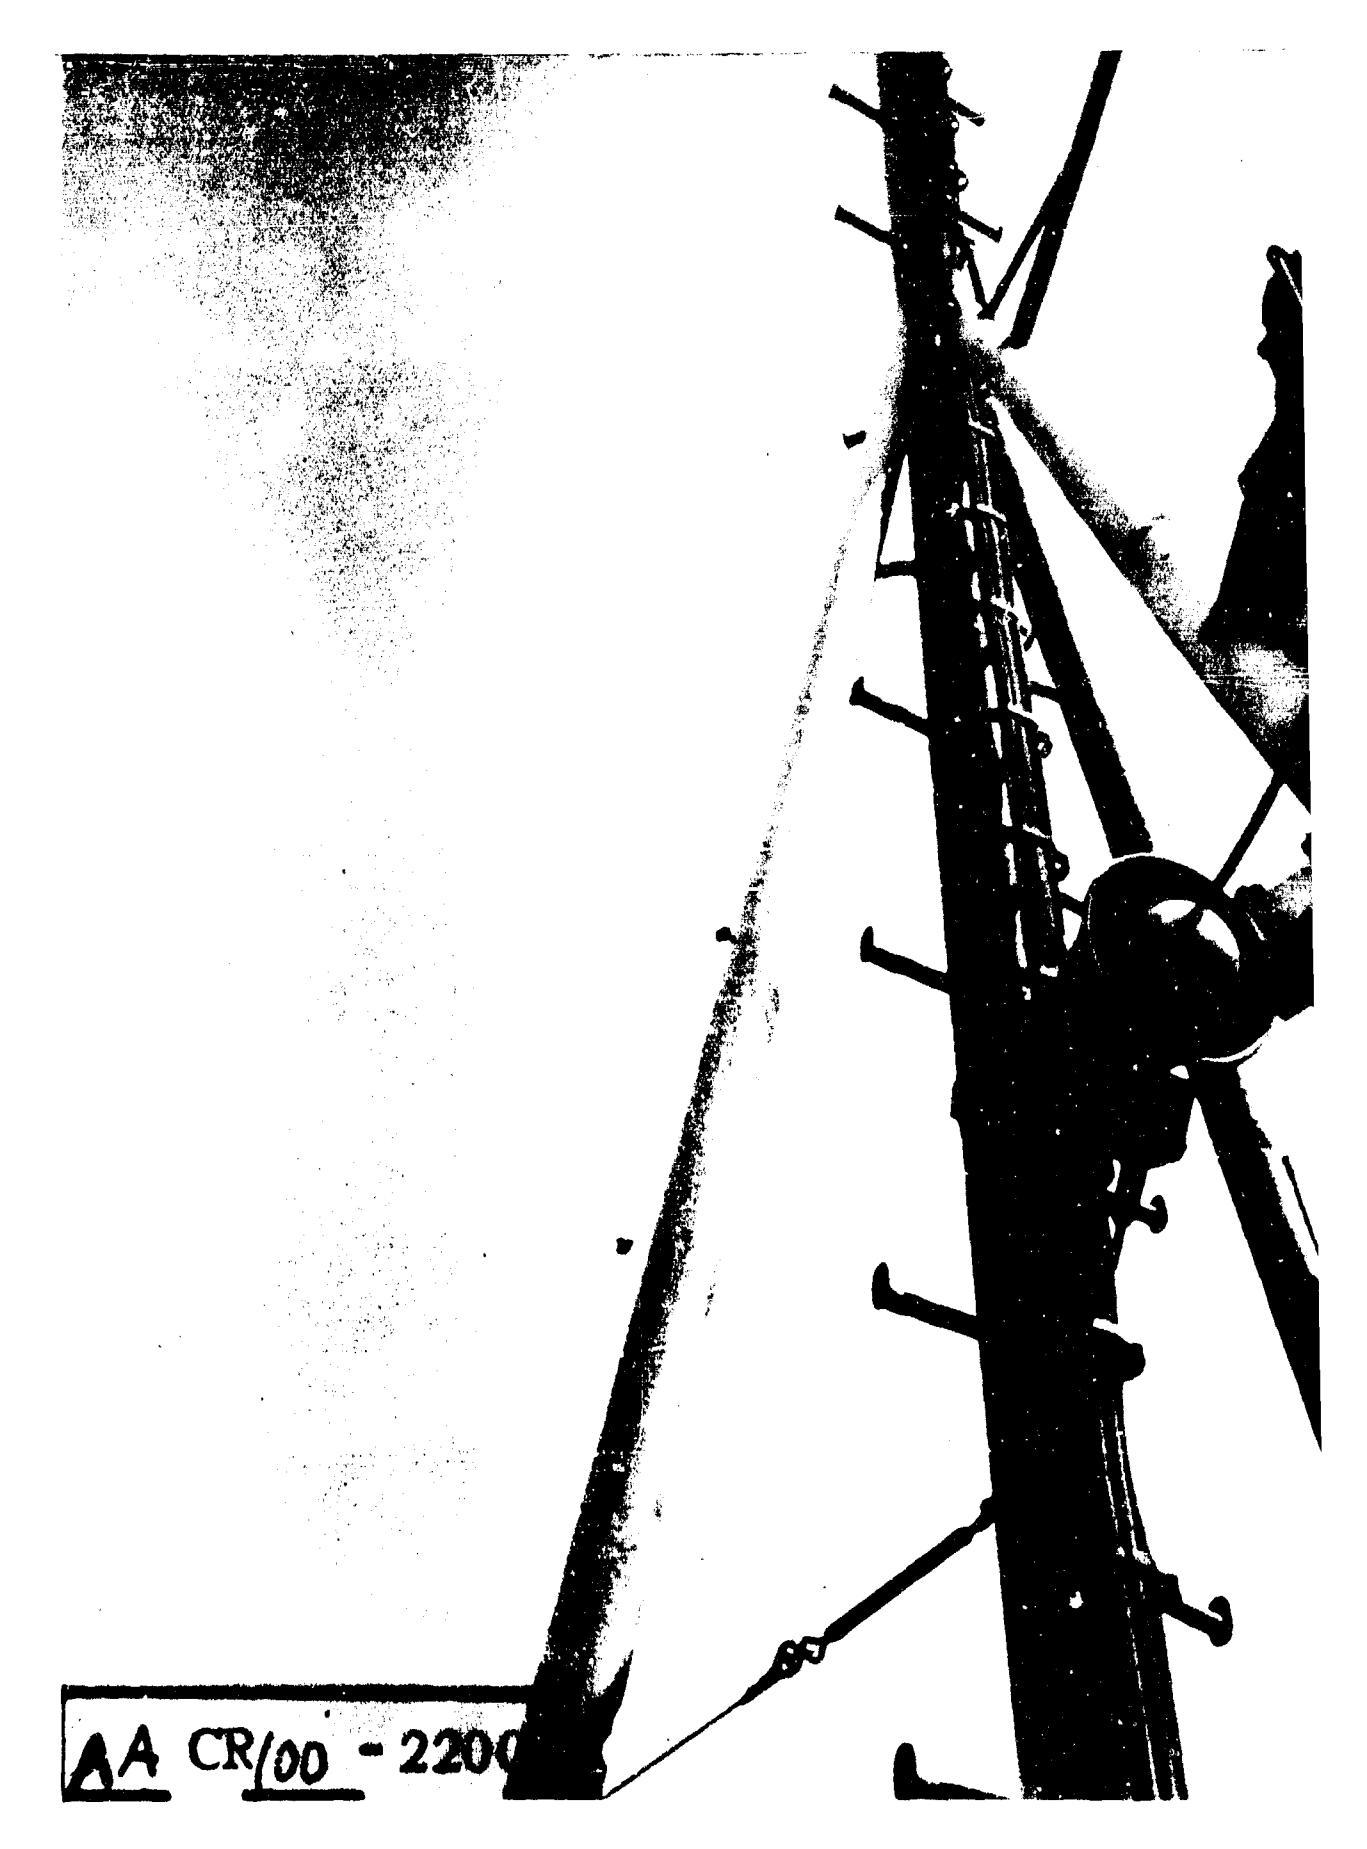
AA-CR-100-2200-8. U.S.S. RHIND (DD404). Mainmast and braces. Paint cracks are visible just above junction of braces.

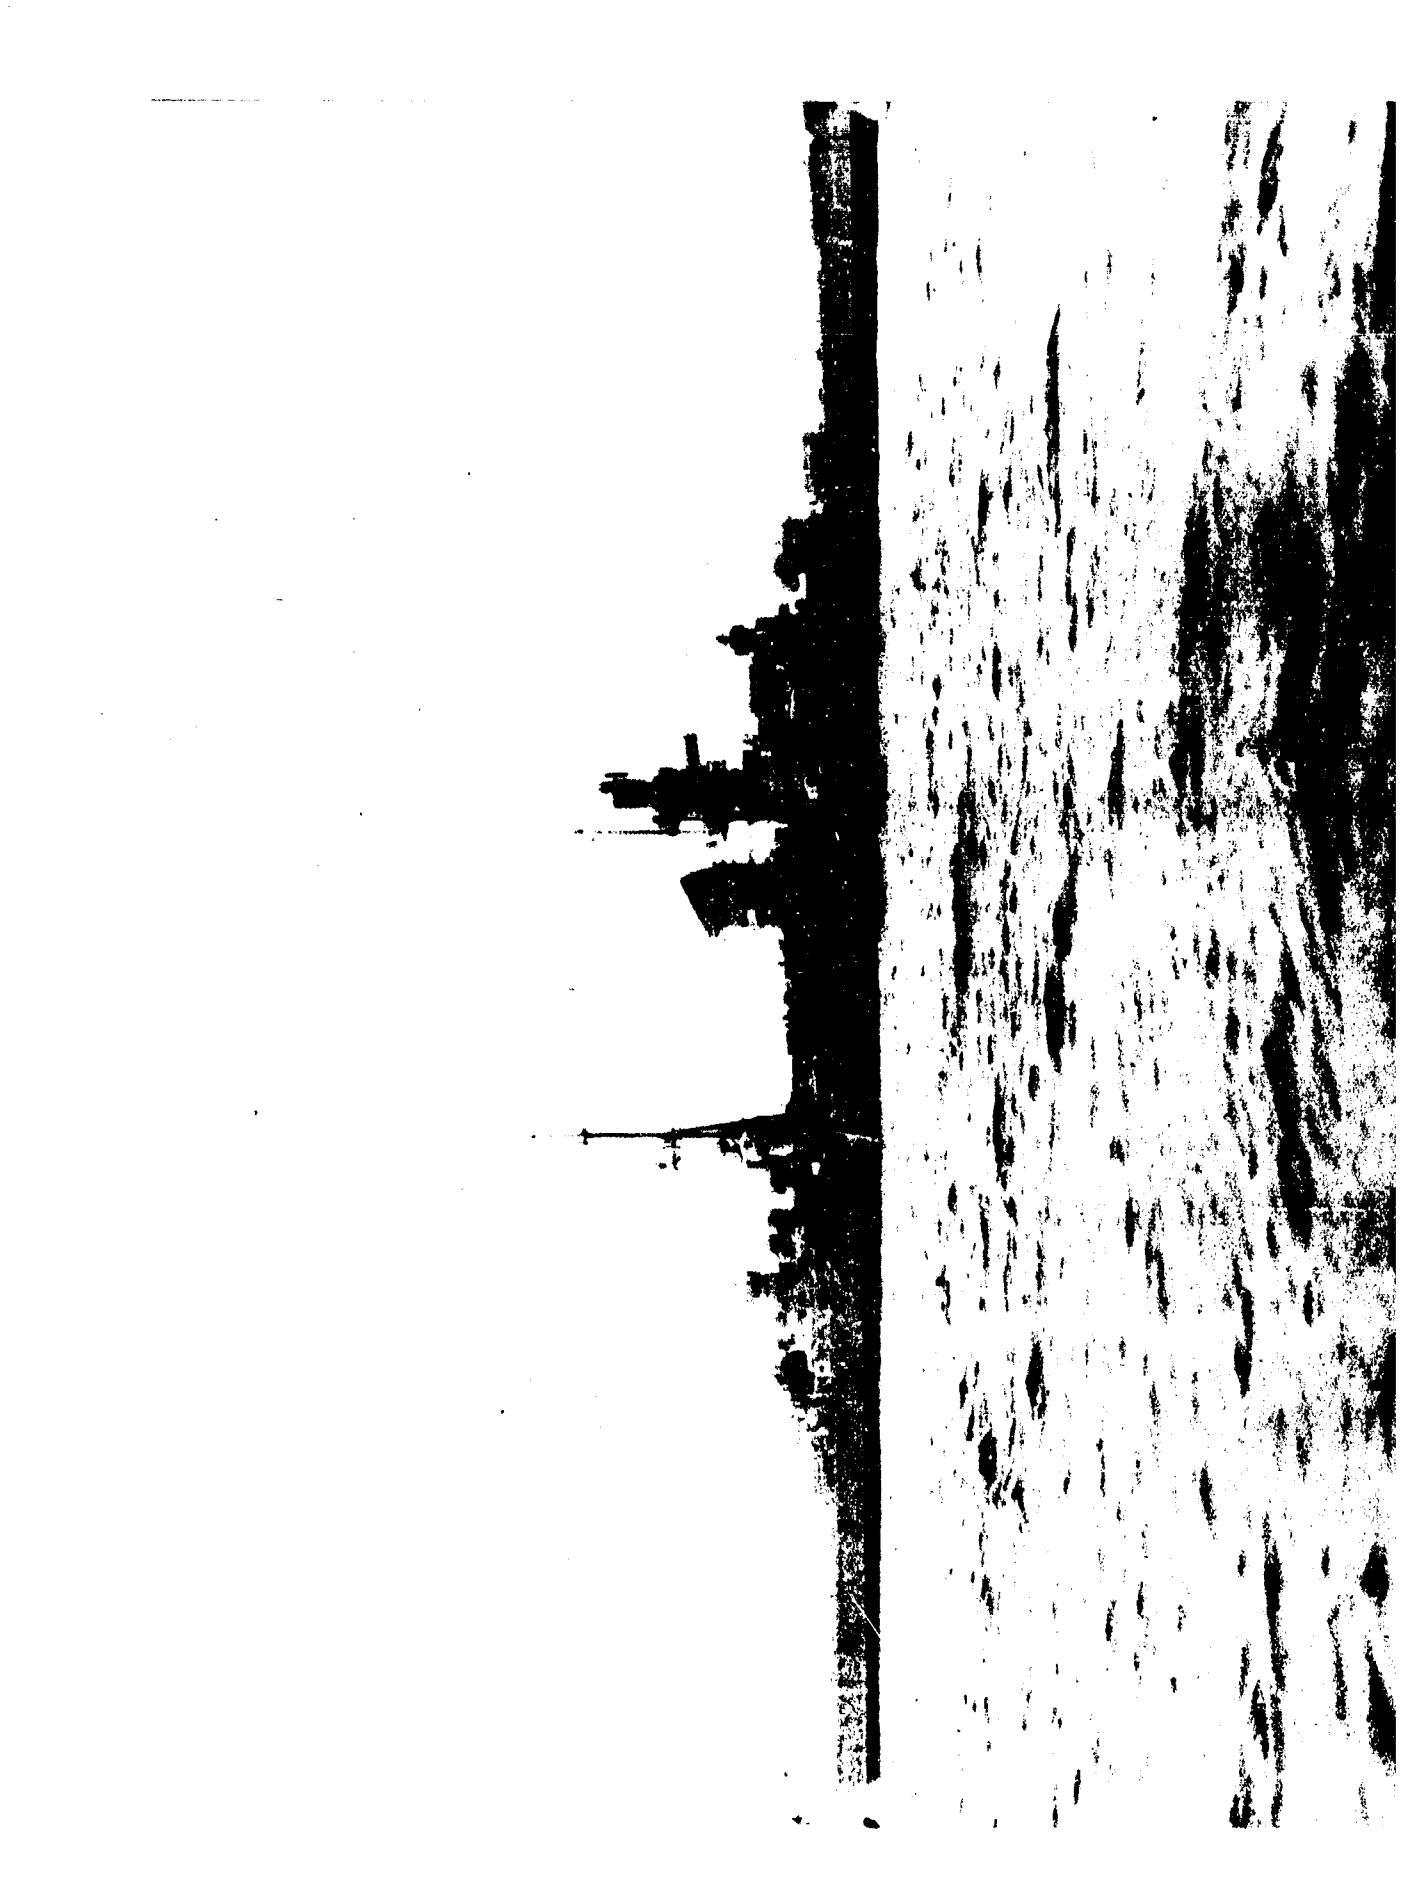
AA-CR-227-92-101. PRINZ EUGEN (IX300). View looking at starboard beam after Test Able. Note that main topmast has been broken off.
