ARMY CONCEPT TEAM IN VIETNAM APO San Francisco 96243

SEARCHLIGHT

REPORT EVALUATION BY DIRECTOR, JRATA

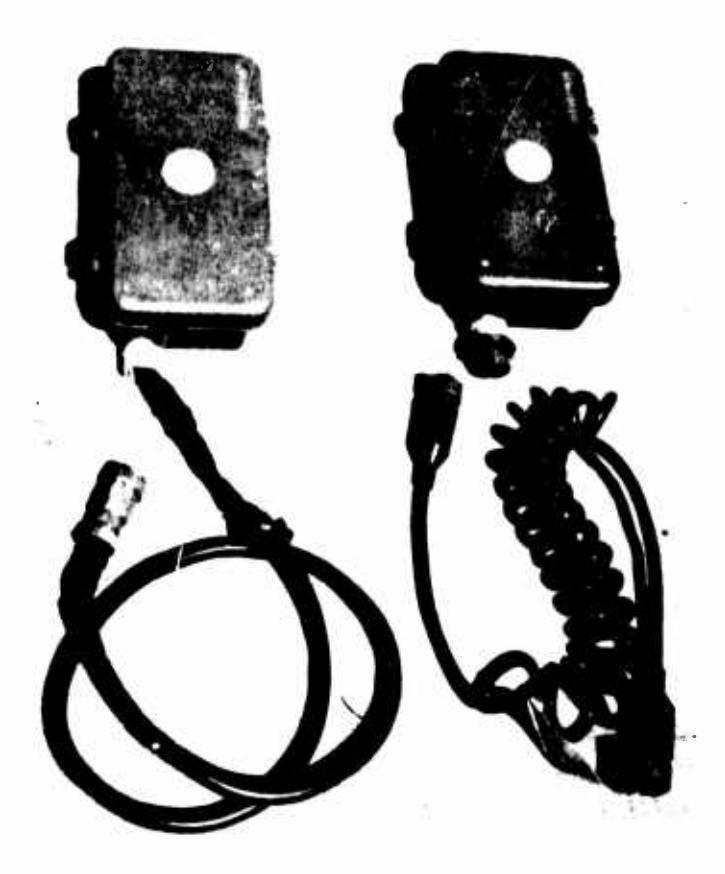
(U) FIGURE E-1. Control box cables (new bonded cable on right).
