RCA

SEVENTH QUARTERLY PROGRESS REPORT
ON
PRODUCTION ENGINEERING MEASURE
FOR
TUBE TYPE 7587

DURING PERIOD OF:
1 DECEMBER 1963 TO 29 FEBRUARY 1964
CONTRACT NO. DA36-039-SC-86732
ORDER NO. 19054-PP-62-81-81

TUBE TYPE 7587

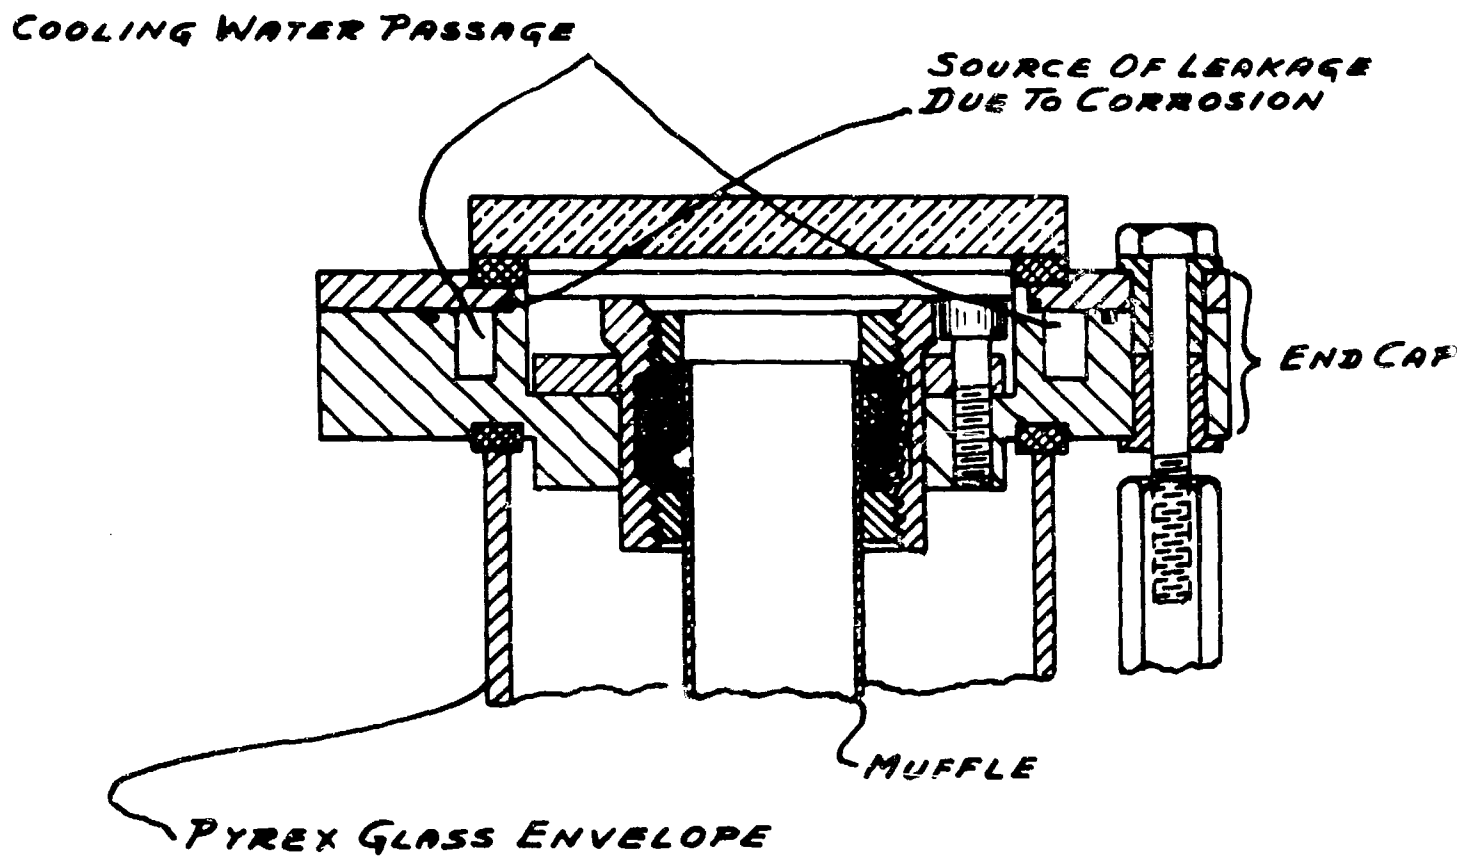
FIG. 1
**CROSS SECTIONAL VIEW OF A TYPICAL END CAP
FOR THE EXHAUST MACHINE**

The sixteen head exhaust machine continued in full production use except for a downtime period resulting from cooling water leaks and manifold porosity. During December, the unit experienced sudden, temporary pressure rises in the high vacuum system, which occurred sporadically and very infrequently. This condition caused the manifold vacuum to drop two to three orders of pressure for several seconds during operation, and had the outward appearance of a leak that suddenly occurred, and just as suddenly disappeared. One head was removed from the machine and inspection revealed considerable corrosion in the cooling water passages of the end caps. The end caps were removed, subjected to high internal water pressure, and over a period of 24 hours, minute droplets of water appeared on the inner wall. As shown in figure 1, the end caps are a two piece structure that is copper brazed together. This construction allows the inclusion of an integral water cooling passage. By cutting a section through an end cap, it was found that corrosion had progressed along the copper brazed interface until leakage occurred. All aspects of electrolytic corrosive action were studied, but none could account for such rapid progress. However, an analysis of the recirculating cooling system water revealed a high incidence of arsenic

compounds, which was further traced to disassociation of a rust inhibitor additive. As a result, the entire cooling system for the Nuvistor plant was drained, flushed, and refilled with pure glycol. All heads were removed from the machine, and the end caps were replaced with new units.

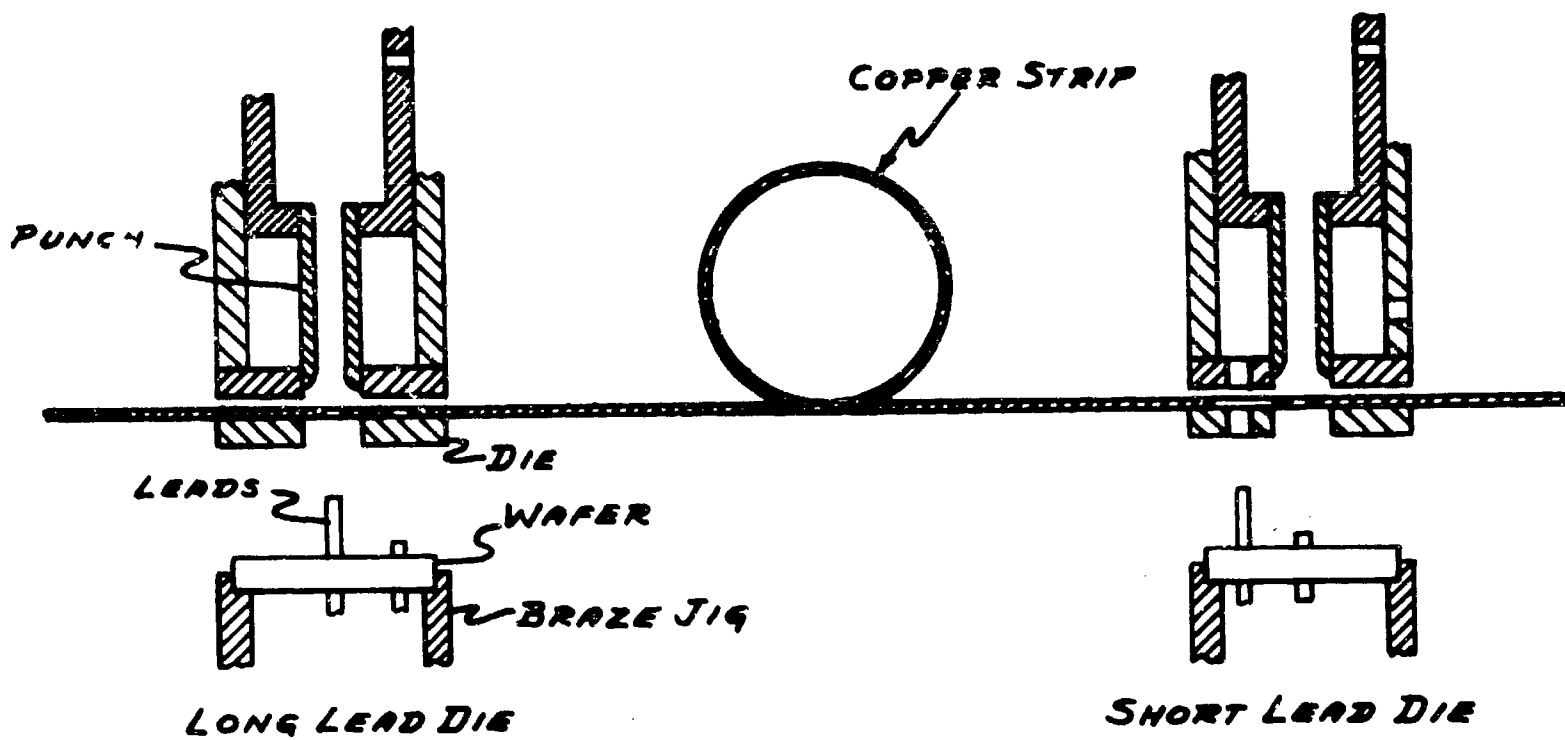
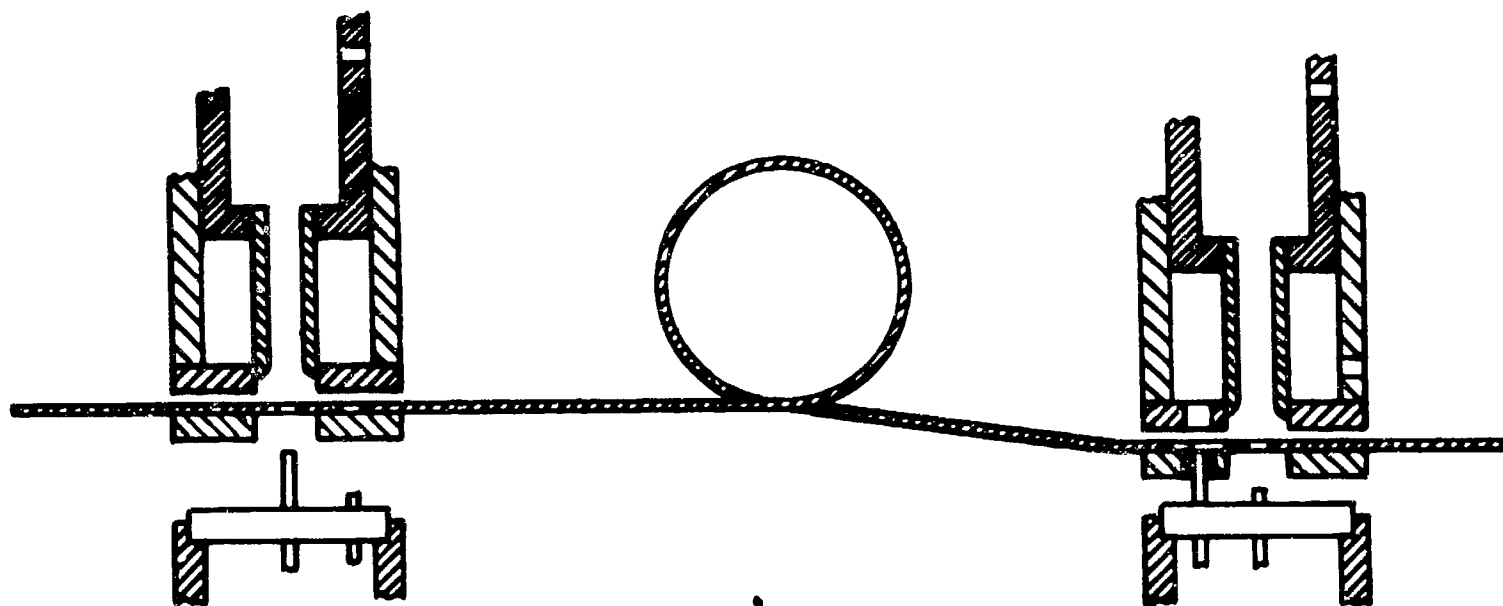
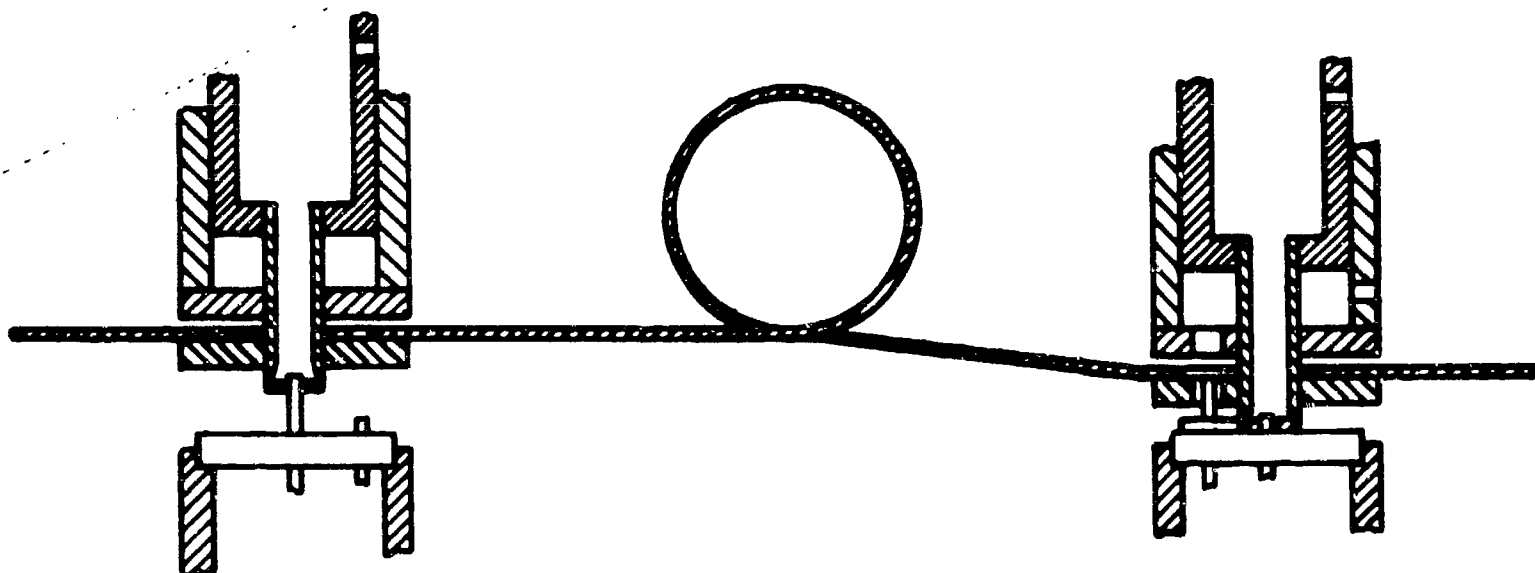
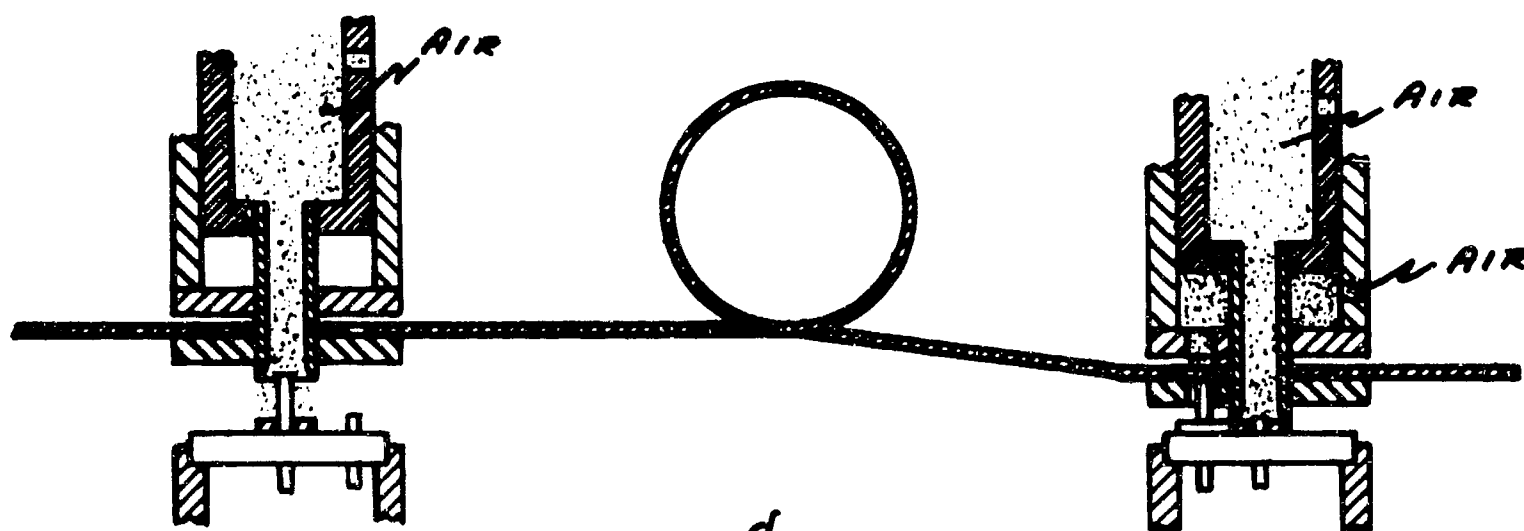
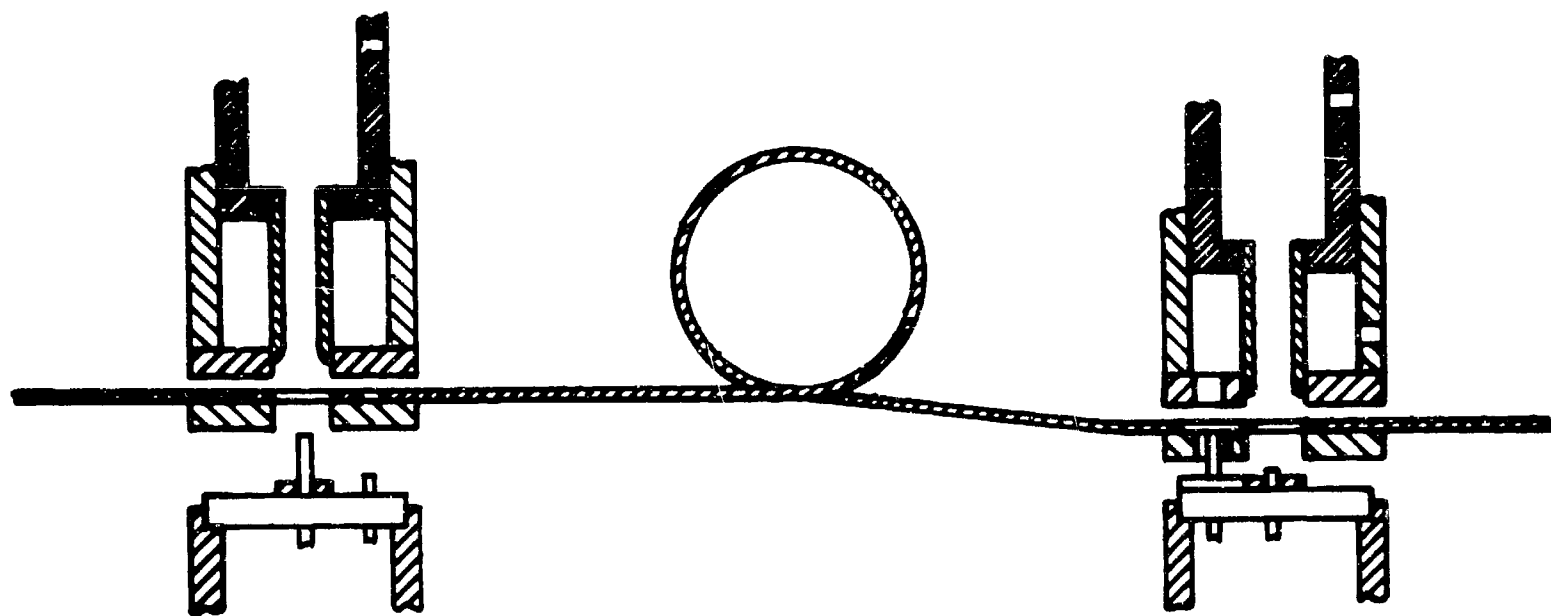
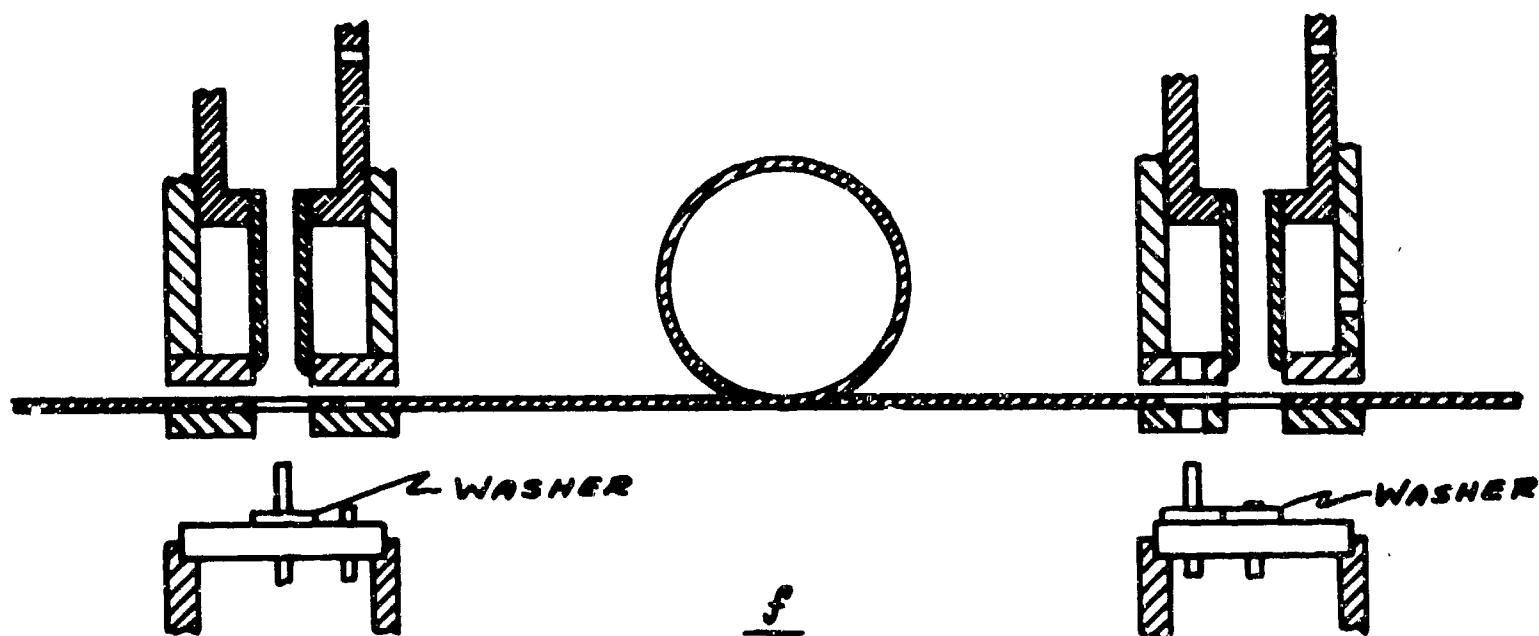
FIG. 2

inefficiency was tilted #1 grid flanges. The #1 grid flange is particularly susceptible to tilting in the tetrode because, on a relative basis, it has the least support. The #2 grid flange is located and held by the brazing jig, and the cathode support flange is so small that the leads exhibit a very slight moment arm. The #1 flange is not supported by any member other than the grid, and the leads can exert a tilting action by virtue of a considerable moment arm.

A second observation indicated that when tilting did occur, it was always in the second die head, and the flanges were always tilted down in the area of the stub leads. From this evidence, it appeared that the stub lead washers only were striking or pushing the leads down. Die alignment was rechecked and found to be excellent. After several more runs, it became apparent that the tilting shrinkage could be varied by changes in the air pressure used to strip the washers from the punches. As shown in figures 2, 3 and 4 two sources of air are injected into the second die head. The upper source is used to strip the washers from the ends of the punches. The lower source maintains a downward rush of air on the long lead clearance holes to prevent lifting of previously loaded washers, and leads during the upstroke of the punch ram.

On the basis that tilting shrinkage could be severely affected and varied by air pressure changes, the air supply for the second die head was replaced with two separate, regulated lines, one for punches and the other for the clearance holes. Both lines contain surge tanks to eliminate regulator resonance. At the end of the period, tests were in process to determine optimum air pressures, and the first data collected indicated that a vast improvement had been made.
