Hexcel Research
Reference: 6065

August 26, 1964

Subject: Contract No. DA-04-200-AMC-477 (A)
Development and Evaluation of a Lightweight Aluminum Honeycomb Case
Monthly Progress Report #7

REPORT OF PROGRESS
JULY 1964

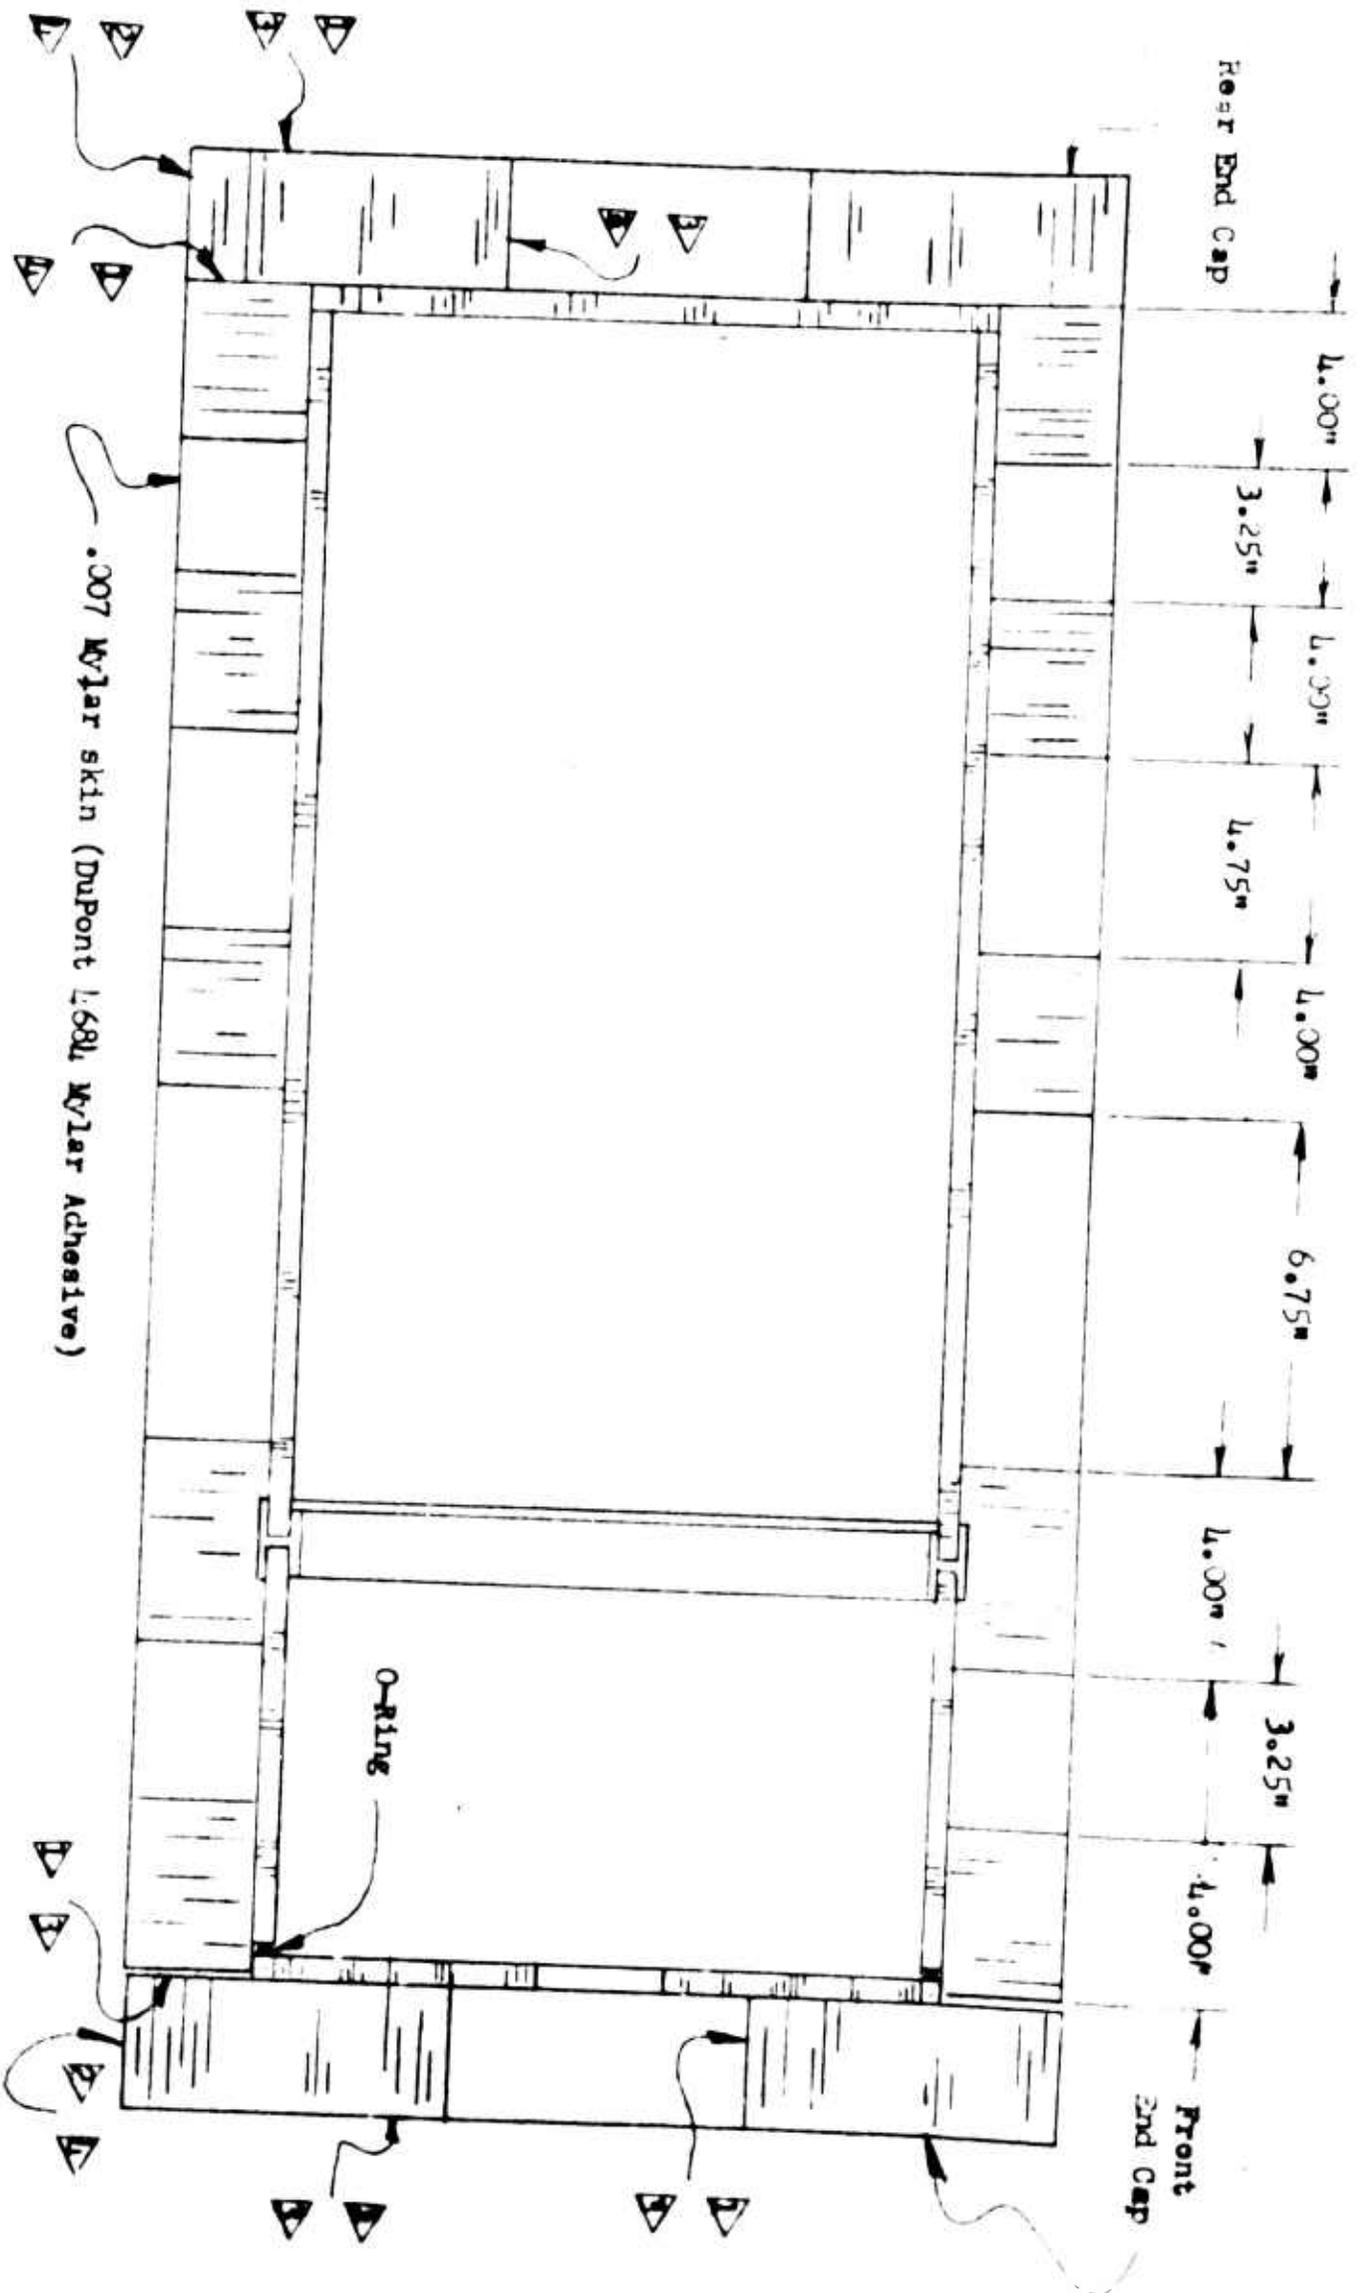
FIGURE 1

A diagram of Case HXL-6-477 is shown in Figure 1. The bond between the plastic faces and the energy absorption core of the end caps was very poor in that large areas remained unbonded after fabrication.

During the test, the front and rear end caps became partially filled with water. The energy absorption core filled with water to a level of from 7 to 11 inches from the rear end of the energy absorption cylinder (excluding the rear end cap).

The edges of the front end cap buckled inward $1/4$ " to $3/8$ " all around the circumference. The core was crushed inward (and pulled away from the skin) approximately one inch at two points on the

circumference. There was very little permanent deformation in the skin of the rear end cap or the cylinder other than a slight waviness.

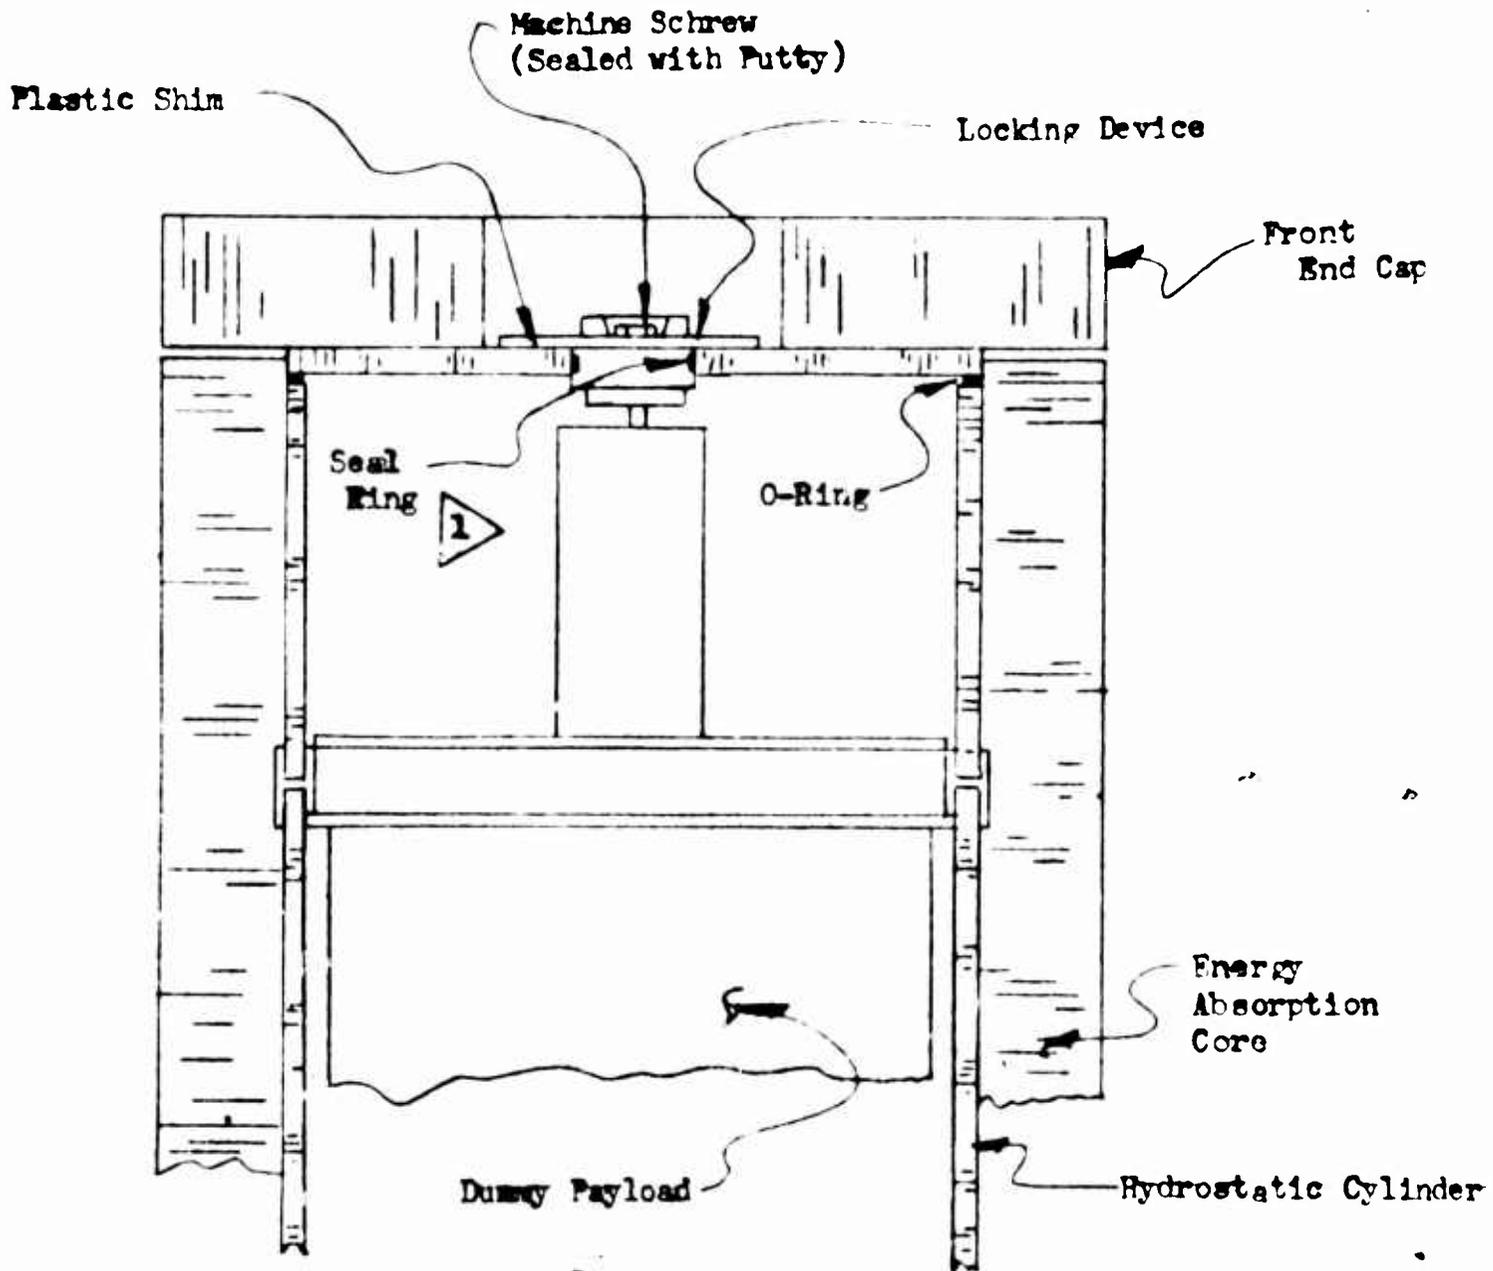
FIGURE 2

It was concluded that the primary source of the leakage into the hydrostatic cylinder occurred by way of the locking device seal ring.

No leakage into the inside of the hydrostatic cylinder occurred during this test. However, leakage past the seal ring occurred during the test on Case HXL-6-477. The probable cause of the different results of the two tests is that the plastic seal ring used during the test on Case HXL-6-477 appeared to be faulty and was replaced prior to the test on Case HXL-7-477.

HYDROSTATIC PRESSURE SEALING CASES HXL-6-477 AND HXL-7-477

The seal ring consists of a Plastic Ring of rectangular cross-section and a rubber back-up ring.

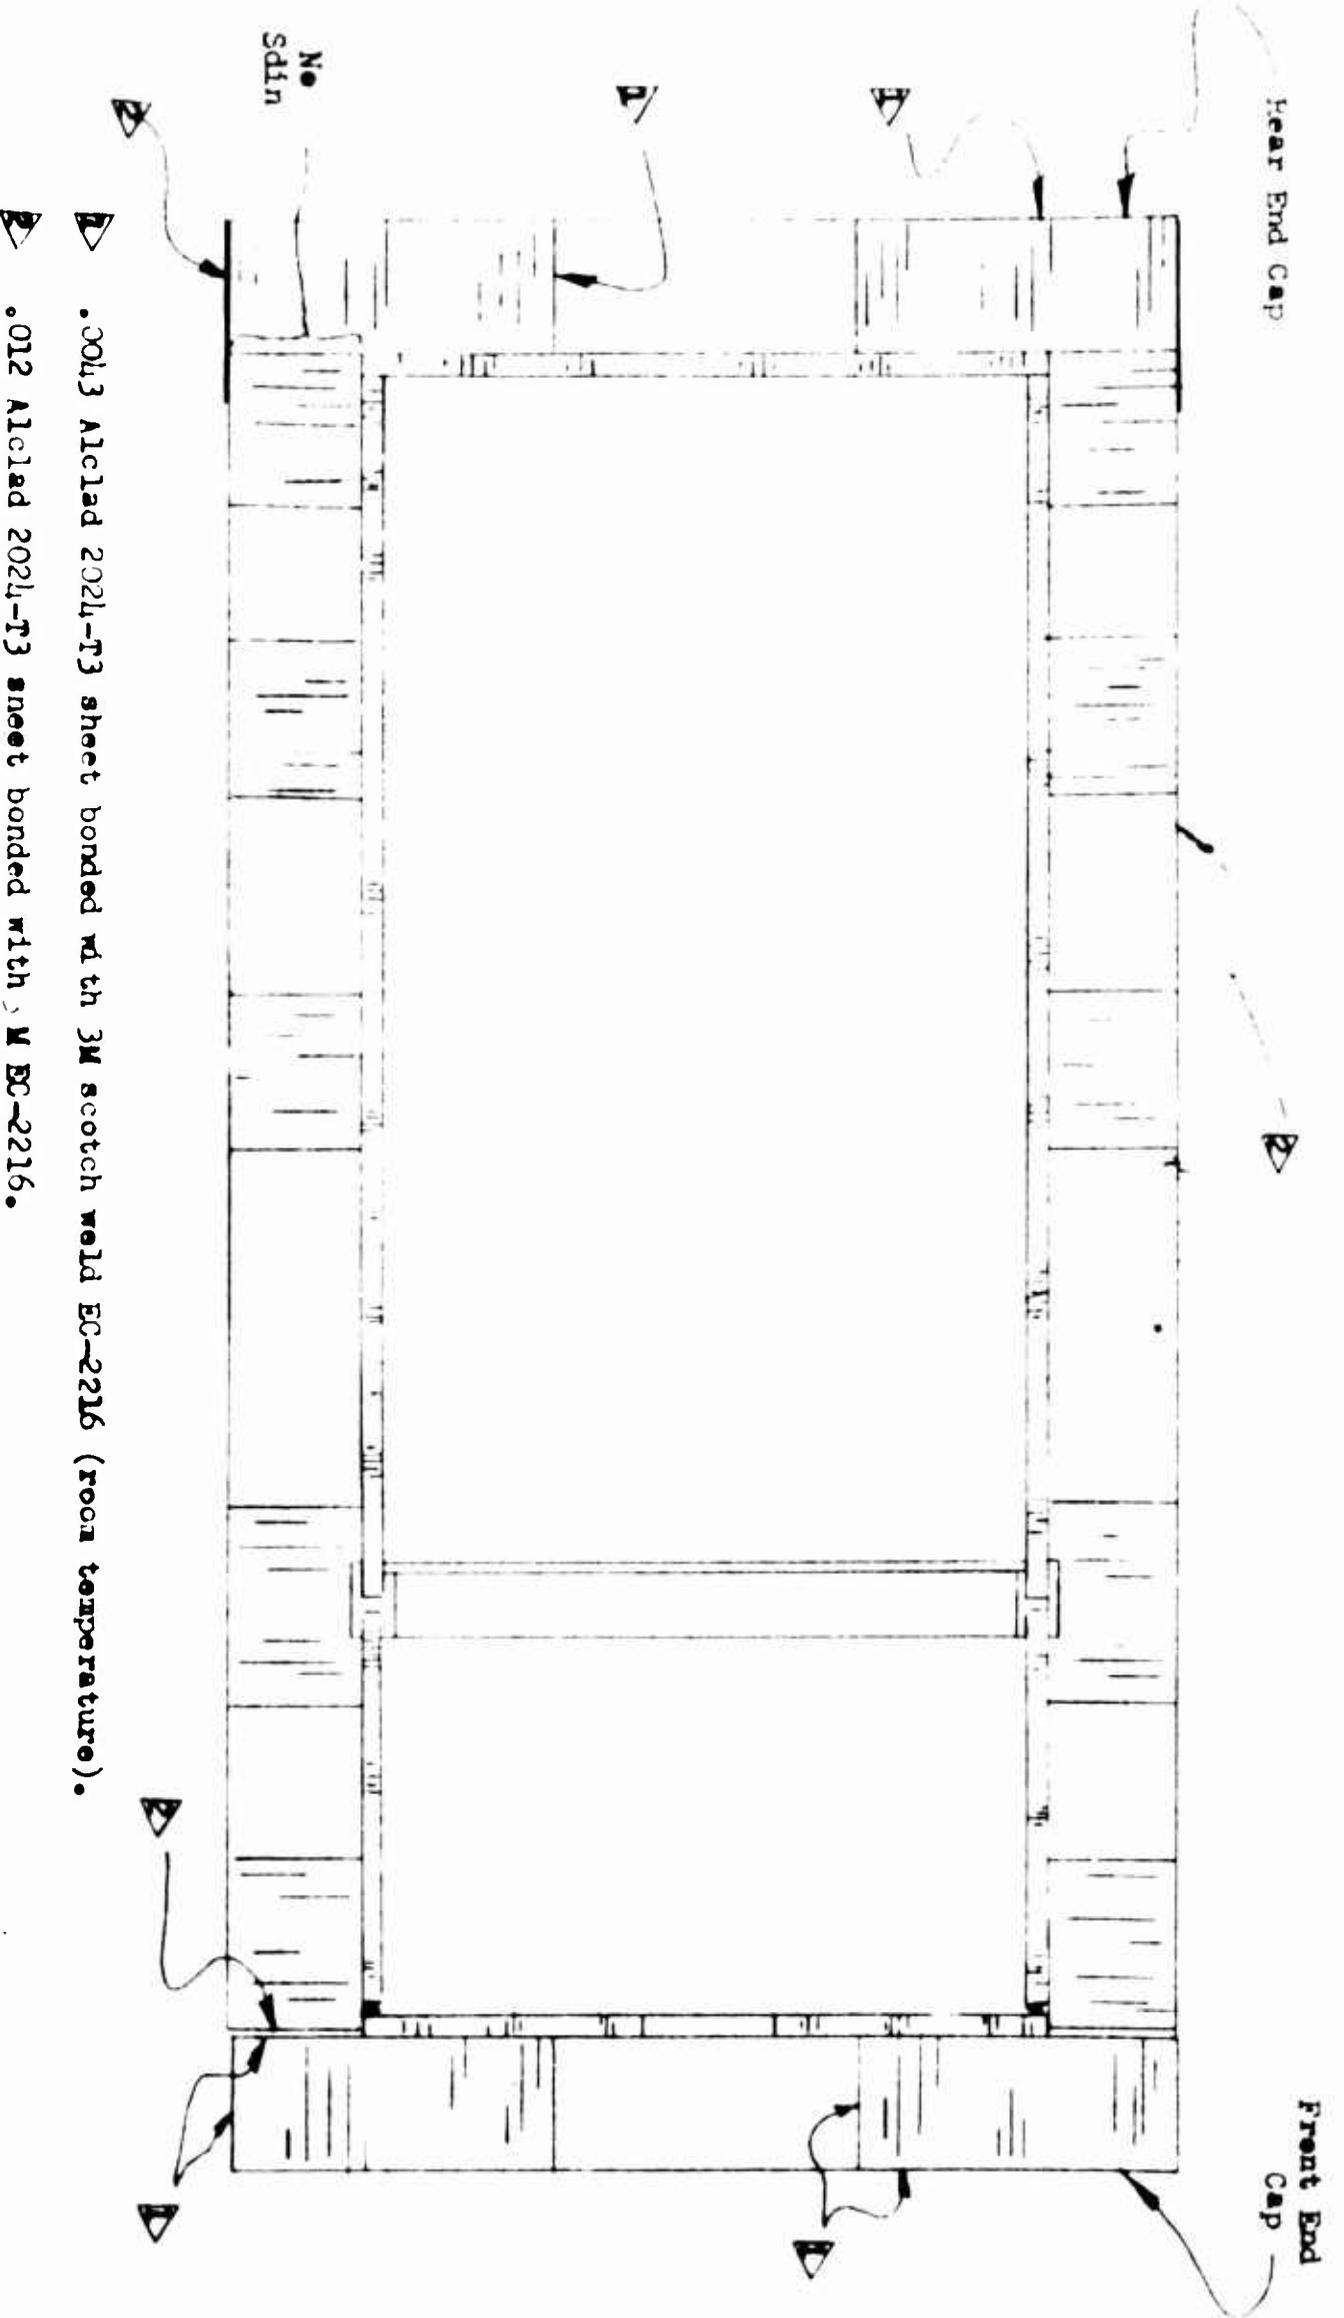
FIGURE 3 CASE HXL-7-477

There was no indication of skin buckling or damage to the seams or joints on the inside of the hydrostatic cylinder. A pattern of longitudinal wrinkles occurred in the energy absorption cylinder skin over each circumferential core cutout. The wrinkles were approximately uniformly spaced around the circumference of the cylinder. The edges of the front and rear end caps had similar patterns of longitudinal wrinkles extending around the circumference of the caps. The circumferential skin joints opened intermittently.
