# USAAVLABS TECHNICAL REPORT 65-43

## SURVIVABILITY SEAT DESIGN DYNAMIC TEST PROGRAM

July 1965

CONTRACT DA 44-177-AMC-191(T)

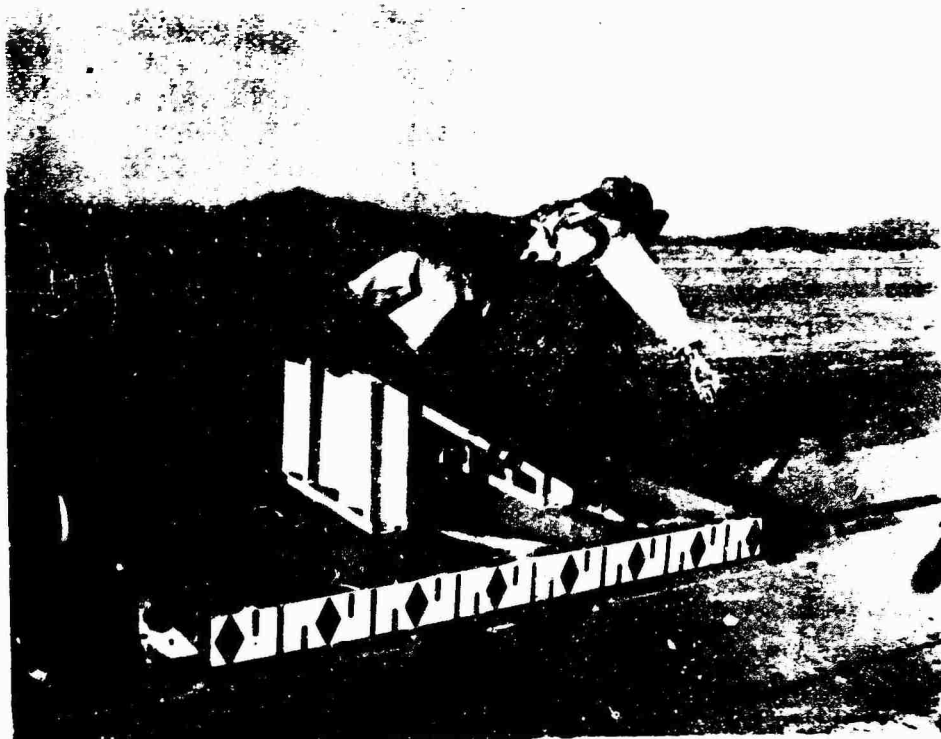
Figure 31. Posttest View of Sikorsky Seat - Test Condition No. 1.

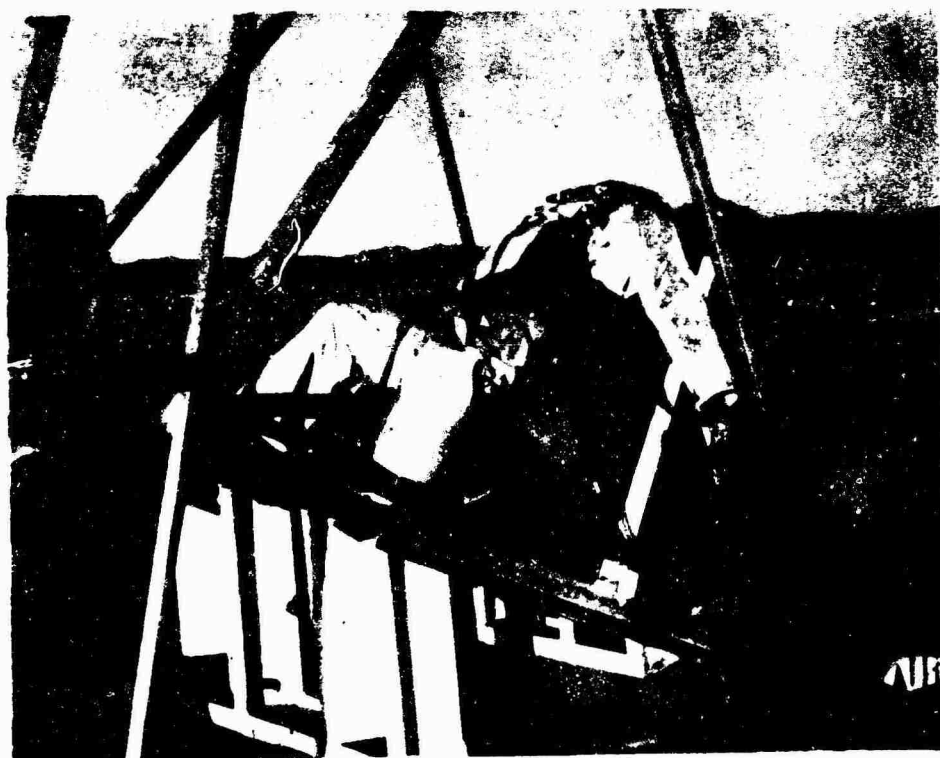
Figure 32. Posttest View of Sikorsky Seat - Test Condition No. 3.
