انتار (شر) مرز بور X-20 WINDOW TESTS نىيىنى ئىرىدۇر يېچى MURRAY N. ENGLAND T **TECHNICAL REPORT AFFDL-TR-65-211** CLEARINGHOUSE FOR REDERA CONVERTING AND Har weig just queen JANUARY 1966 3.60 \$0.58.39 a Code 1 Distribution of This Document Is Unlimited.

X-20 WINDOW TESTS

MURRAY N. ENGLAND

This report describes two structural integrity tests of the X-20A high temperature side window. One test simulated the air leakage from the window during boost and the second test simulated the thermal cycle experienced during reentry. The outside window panel failed prematurely during the thermal cycle, apparently the result of excessive thermal gradients through the frame and a stress concentration caused by thermistor instrumentation leads passing through the frame and under the window seals.

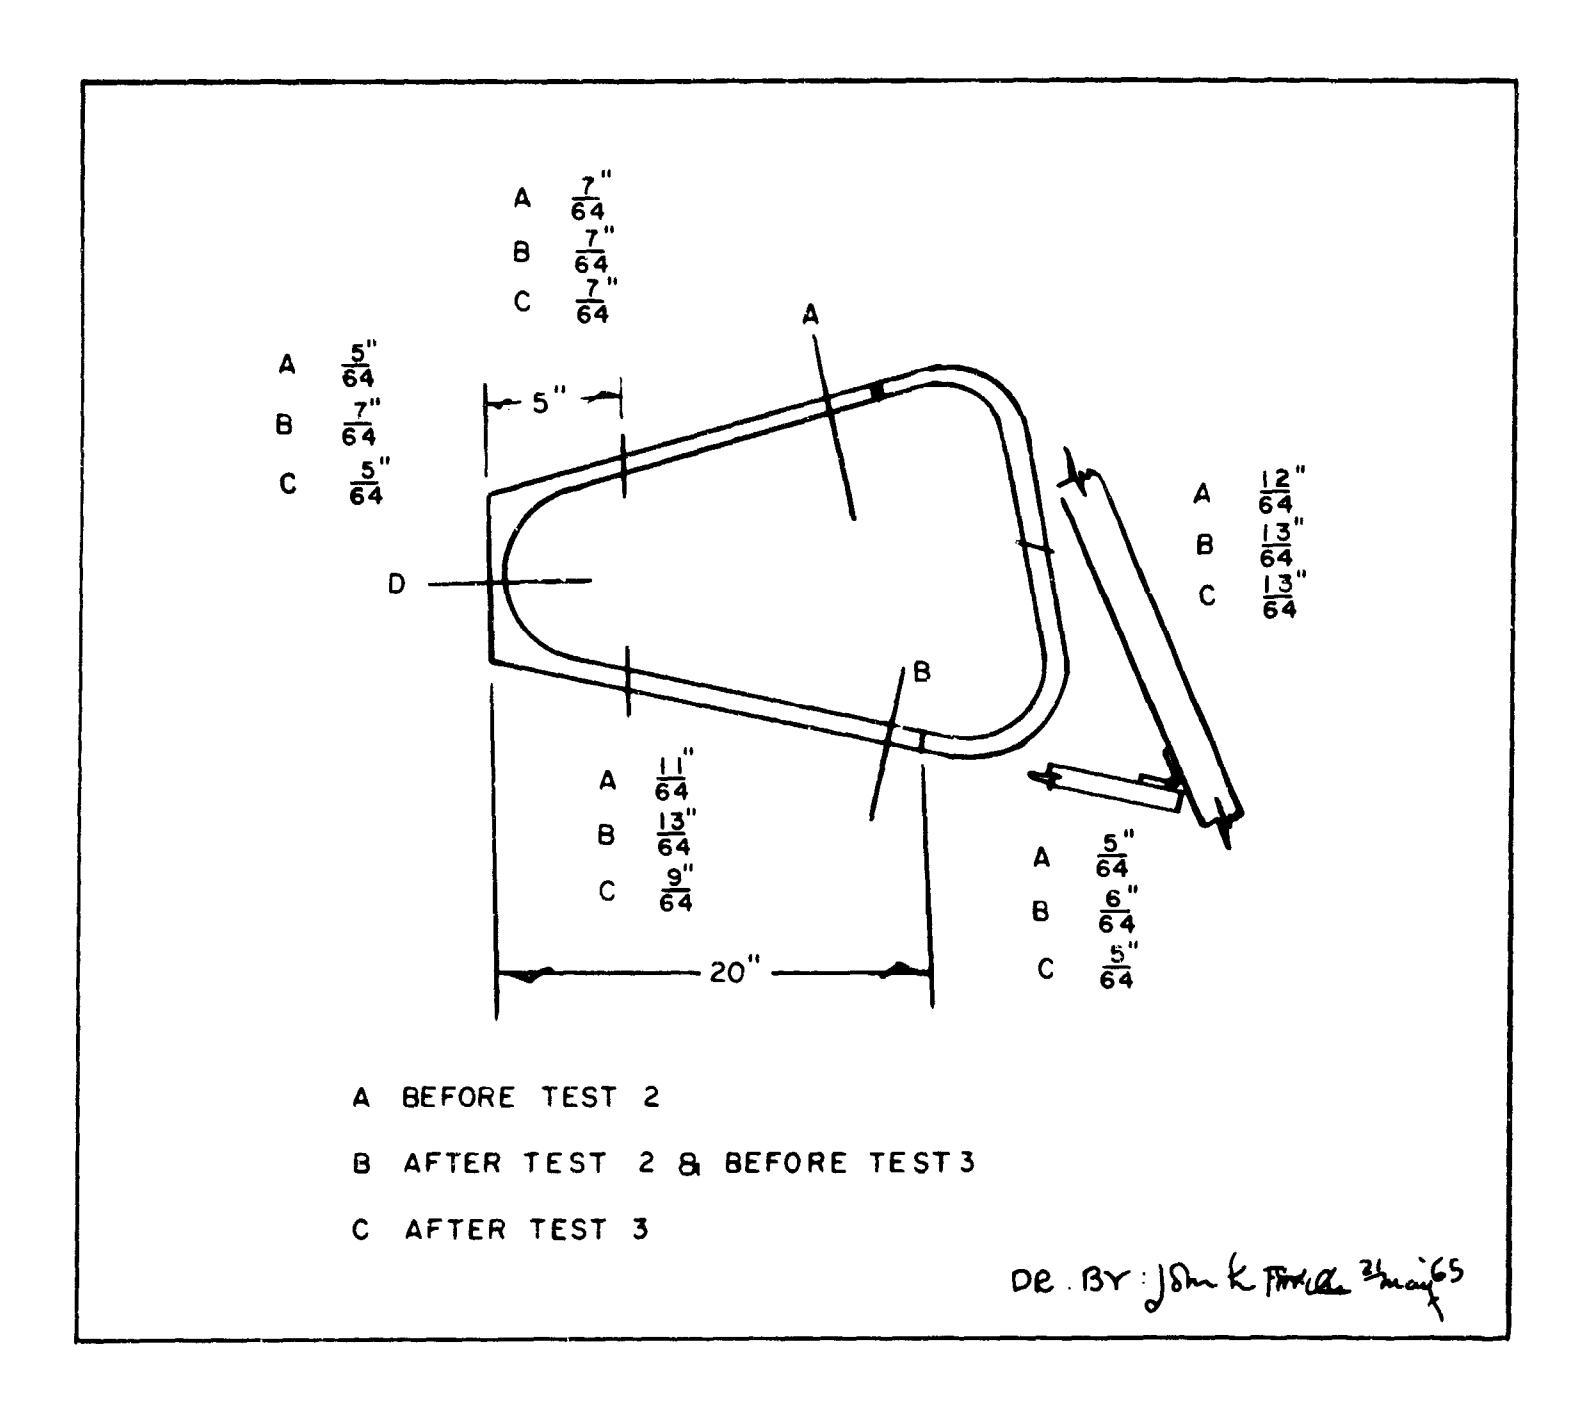
Figure 8. X-20 Window Gaps

The window gaps before and after both tests are shown in Figure 8.

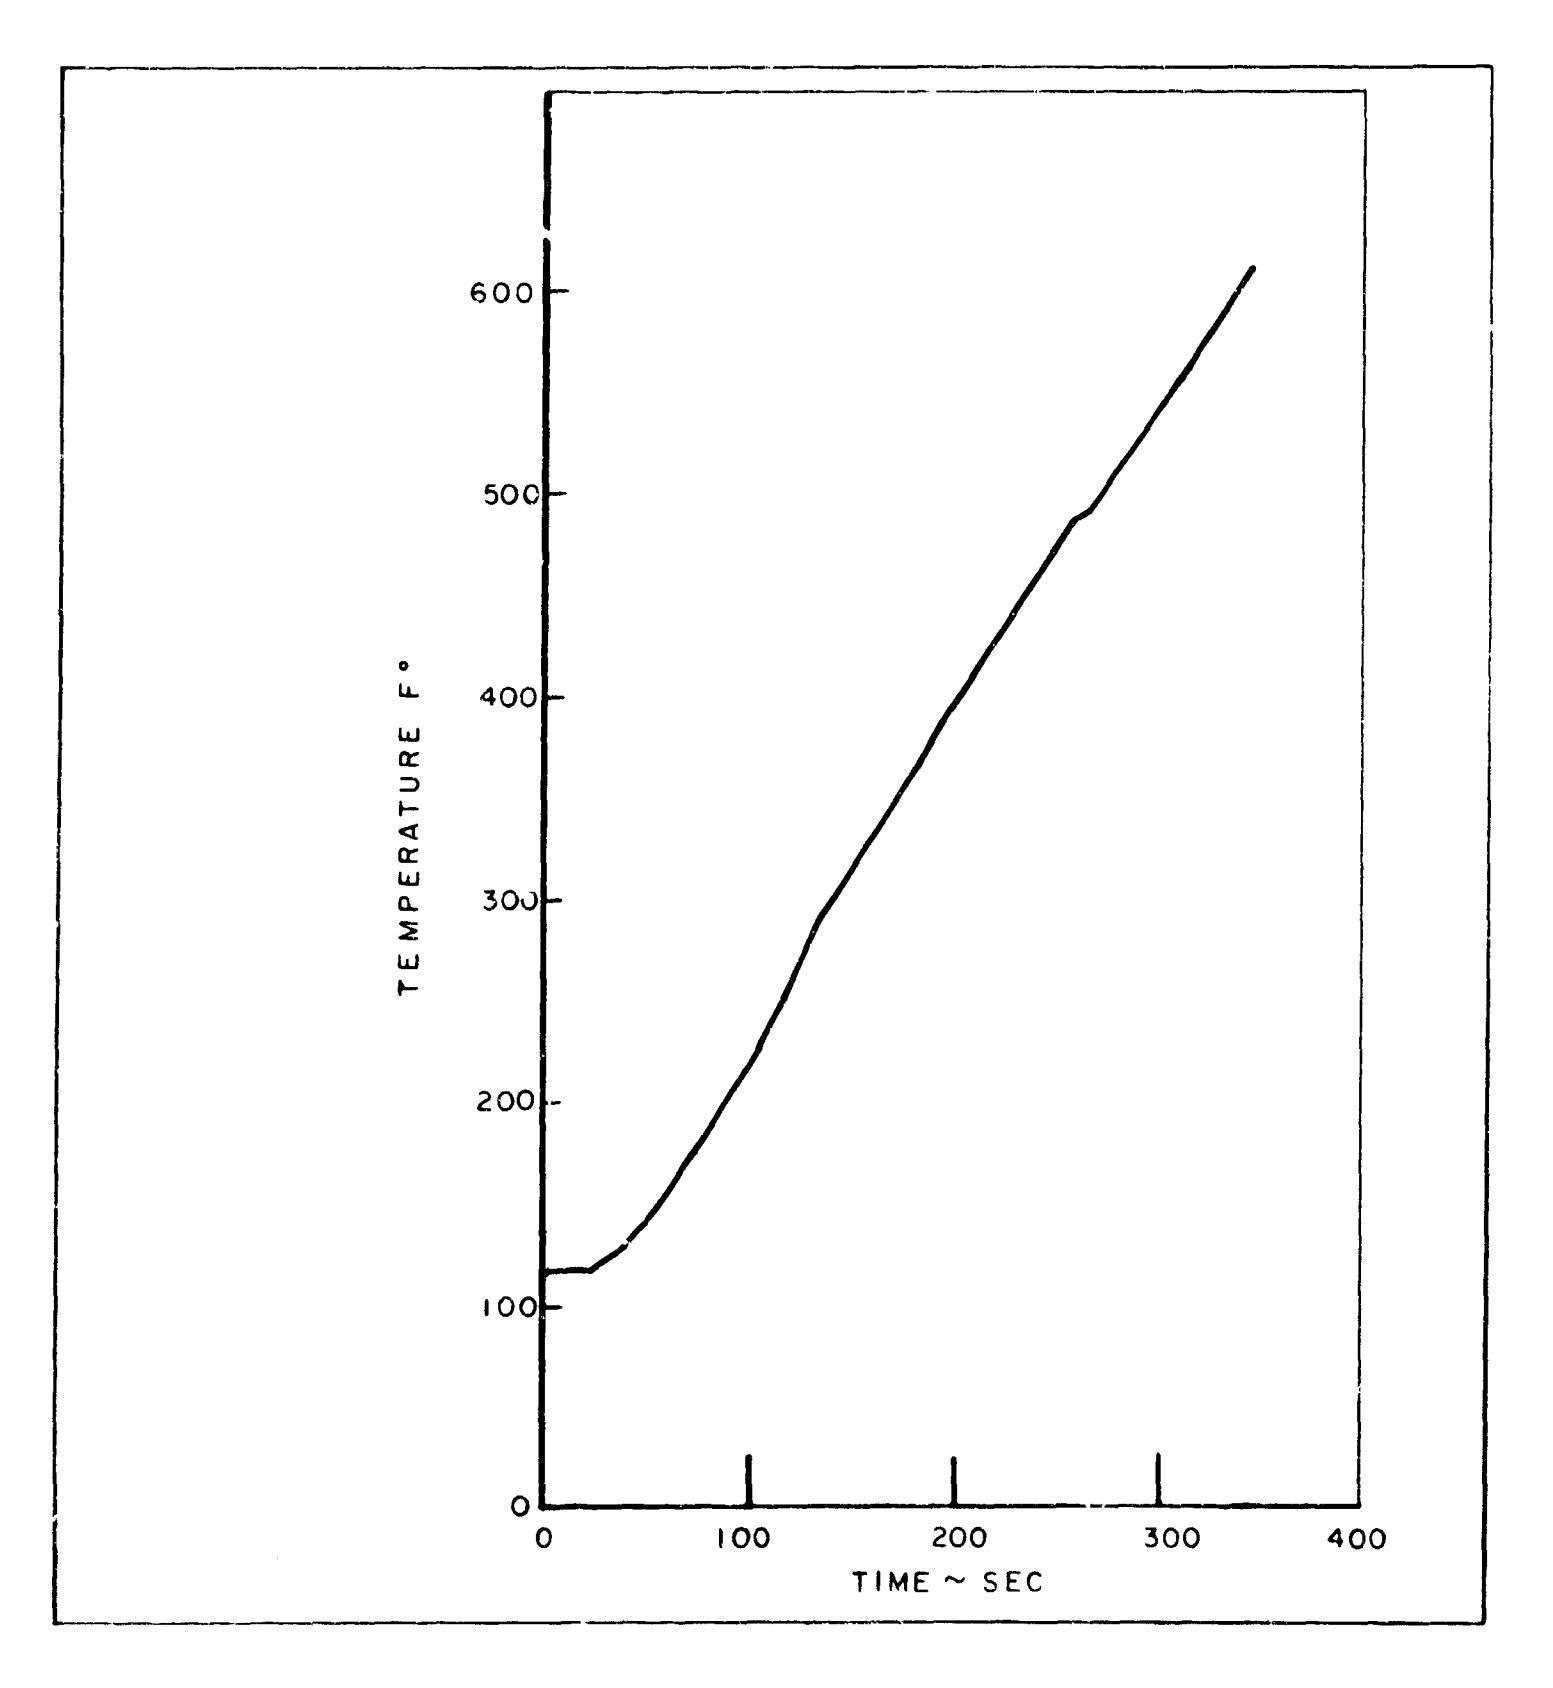
Figure 18. Thermistor No. TM-1, Test Condition No. 3

The heat lamps in the control zone directly over the glass and controlled by thermistor No. 1 did not come on. The lower surface lamps designed to heat the aluminum dummy window likewise did not come on. These areas absorbed heat indirectly from (1) the lamps that heated the frame adjacent to the glass, and (2) from the residue of silicon carbide on the top glass which intensified this effect.
