Collapsible Aluminum Household Effects Shipping Container

"EVALUATION OF AN EXPERIMENTAL COLLAPSIBLE
ALUMINUM HOUSEHOLD EFFECTS CONTAINER"

EVALUATION OF AN EXPERIMENTAL COLLAPSIBLE
ALUMINUM HOUSEHOLD EFFECTS CONTAINER

ADDENDUM TO EVALUATION OF AN EXPERIMENTAL
COLLAPSIBLE ALUMINUM HOUSEHOLD EFFECTS CONTAINER

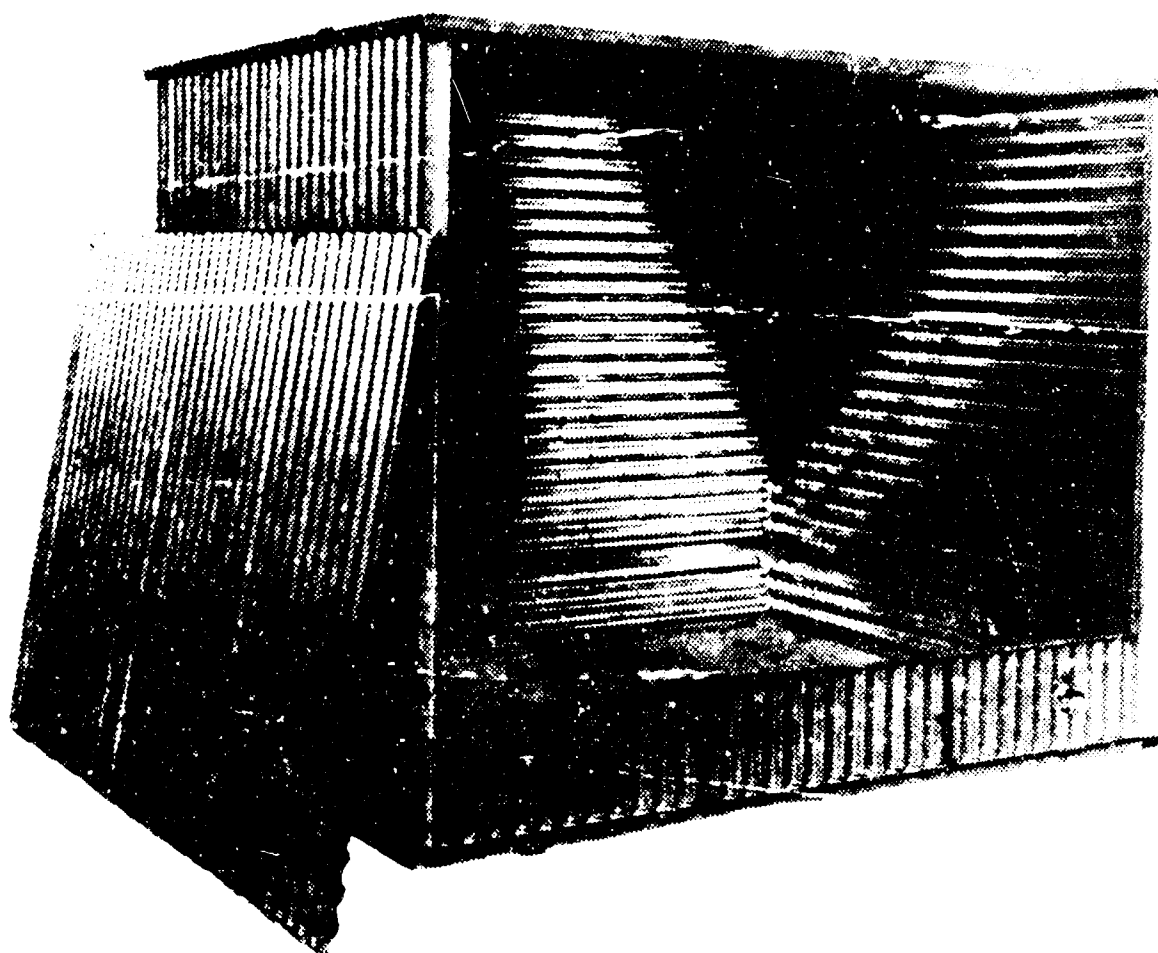
Photo Neg. No. USNSRDF 535-5

ASSEMBLED UNIT

Overall Dimensions - 96-1/2" x 71" x 78" high

Shipping Cube - 310 Cubic Feet

Clear Inside Dimensions - 91" x 66" x 71-1/4" high

Cargo Cube - 243 Cubic feet

Tare Weight - 535 lbs.

Skid Height - 4"

Assembly Time - 1.5 Man hours

Disassembly Time - 1.1 Man hours

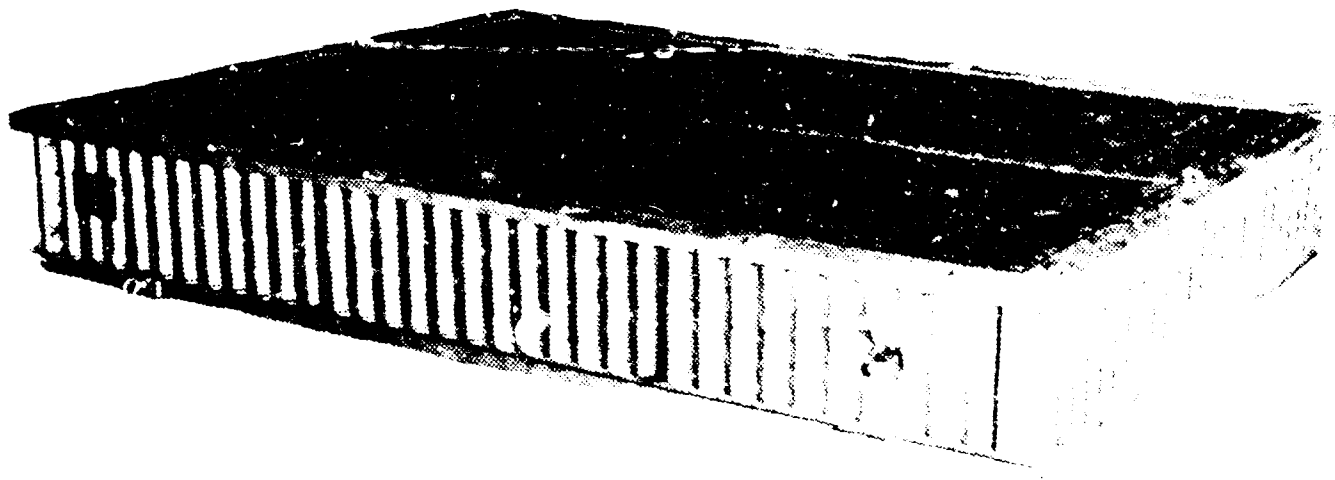
Photo Neg. No. USNSRDF 522-1

KNOCKDOWN UNIT

Overall Dimensions - $96\frac{1}{2}'' \times 71'' \times 17\frac{1}{2}''$

Shipping Cube - 69.5 Cubic feet

Tare Weight - 535 lbs.
