Stress-Corrosion Studies of
Aluminum Alloy 5456-H321 in Seawater

MARINE ENGINEERING LABORATORY
RESEARCH AND DEVELOPMENT REPORT

July 1967

Report 2436

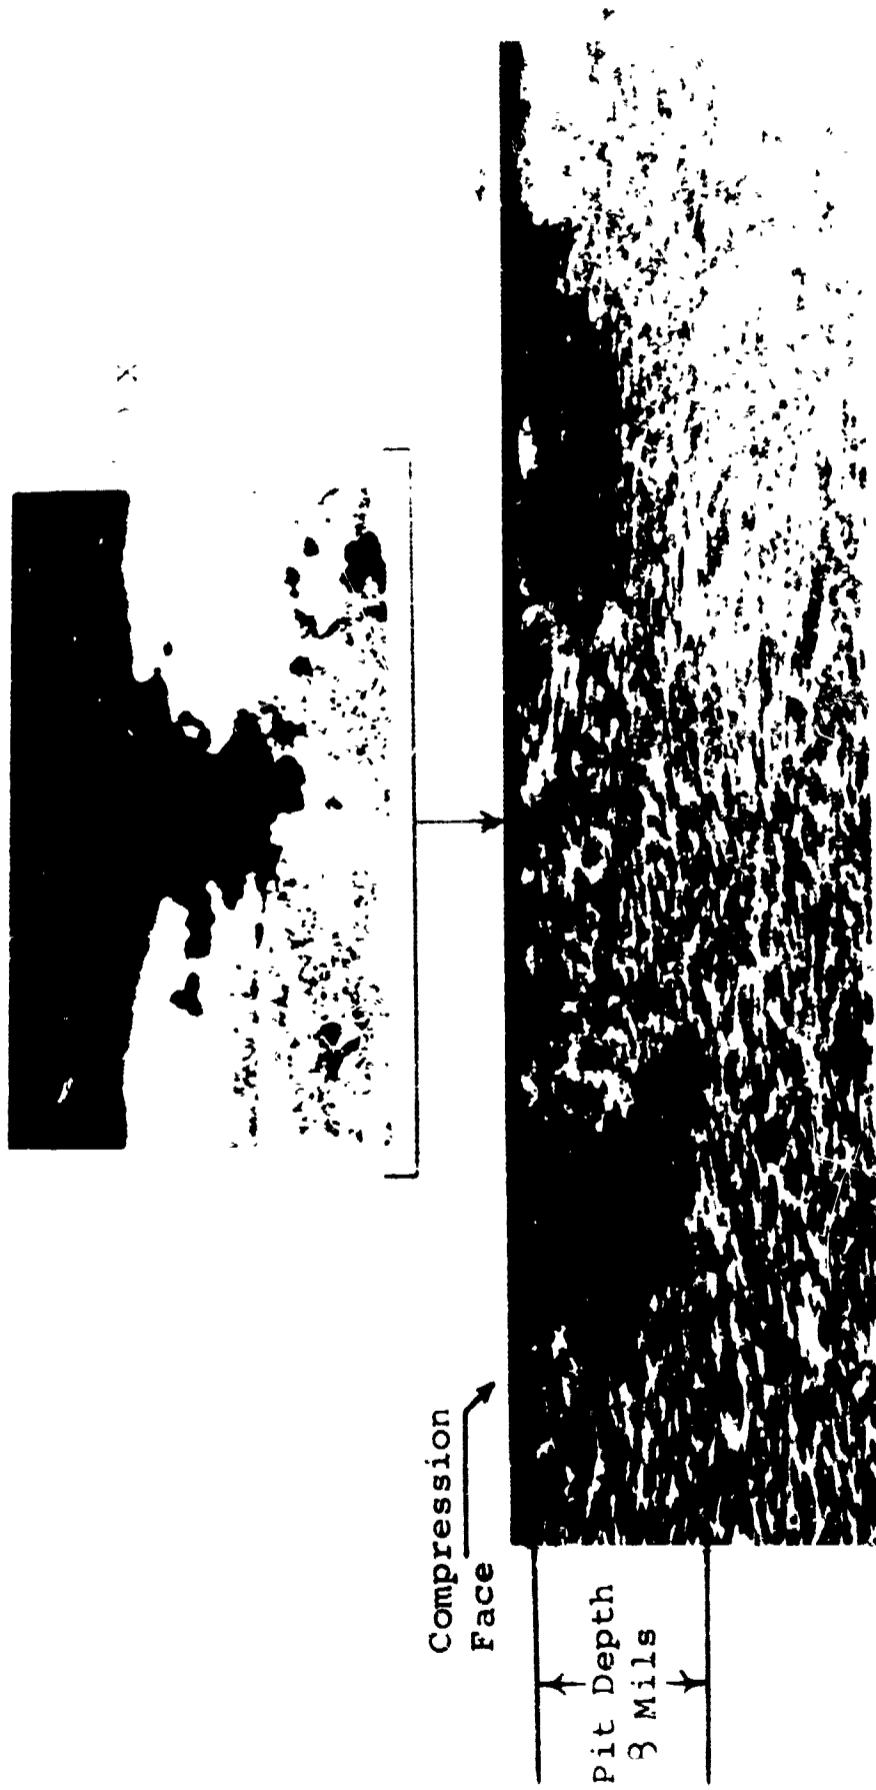
The characteristics and penetration of pitting corrosion appears to be related to plate orientation. Figure 7 shows the "B" microstructural plane of a Type 1 long transverse specimen. With corrosion attack occurring perpendicular to the elongated axes of grains, the pitting is broad and shallow. The same plane, "B," is shown in Figure 8, but representing a cross section of a Type 4 longitudinal specimen. In this case, the direction of attack is parallel to the elongated grain axes, and pitting is deep. Similarly, deep elongated pits occur when the direction of corrosion attack is parallel to the elongated axes of grains in Plane "A," as shown in Figure 9.

It is significant to note that pitting in the three examples cited above developed on the compression side of the specimen. Thus, the pitting is not related to tensile loading. Also significant is the fact that even though the attack is related to grain structure, and the leading edge of attack follows grain boundaries, the metal loss covers a broad area. The broadening of attack, as opposed to its confinement to grain boundary material, is believed to be due to the uniform distribution of the anodic aluminum-magnesium compound throughout the microstructure.

Figure 7
Photomicrographs Illustrating Directionality of Fitting
Attack on Plane "P" in Type 1 Long Transverse Specimens
(Kellers Etc.)

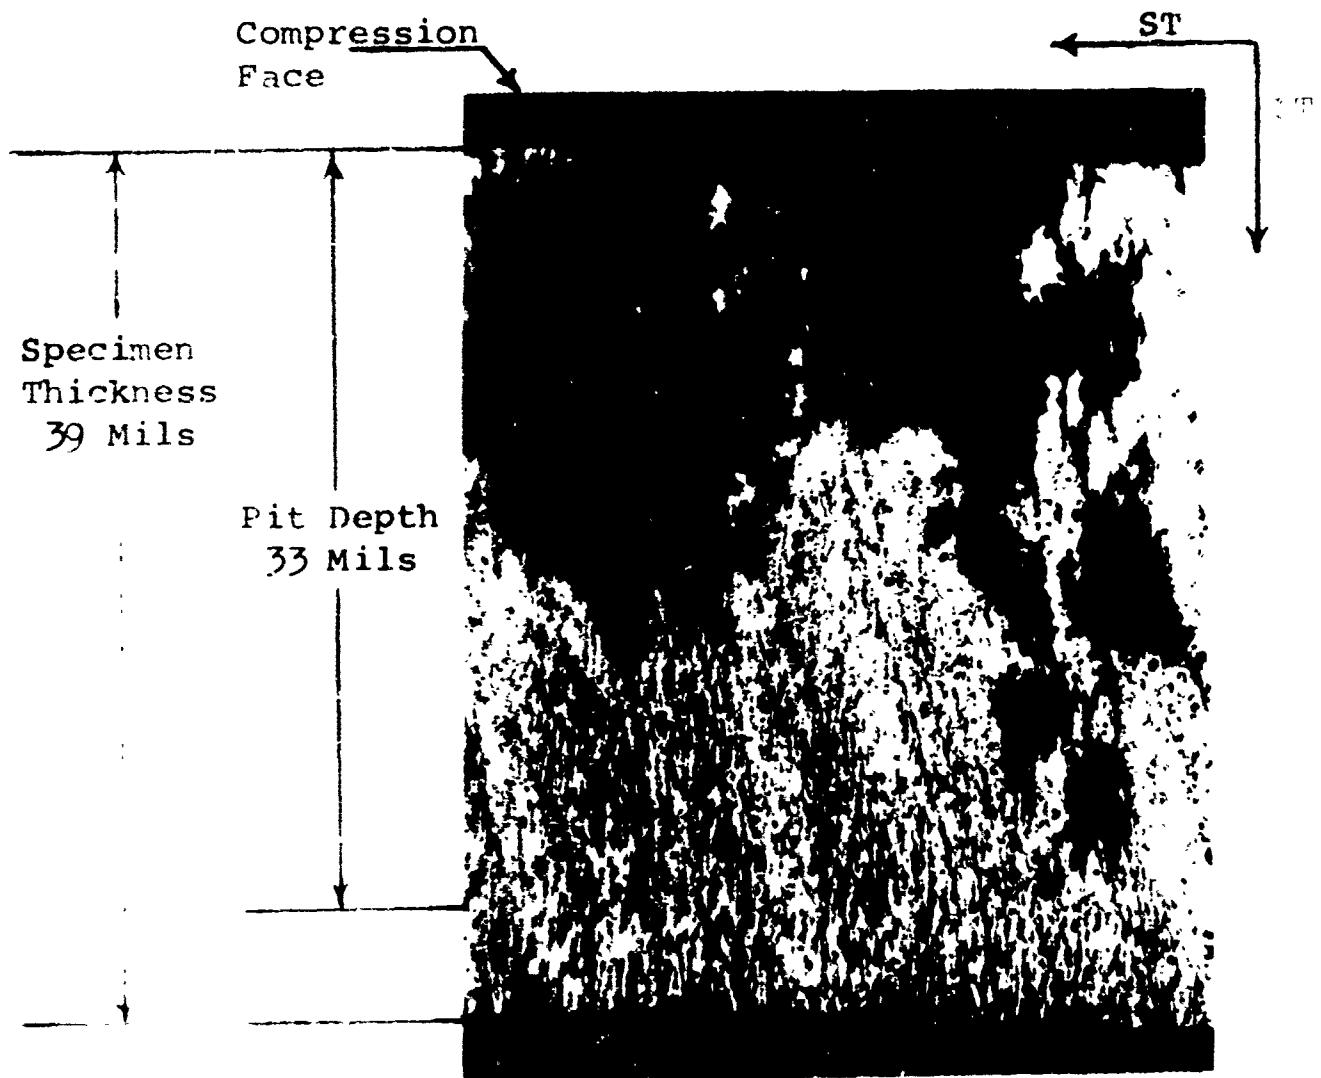
Figure 8

Photomicrograph Illustrating Directionality of Pitting
Attack on Plane "B" in Type 4 Longitudinal Specimens
(100X) (Kellers Etch)

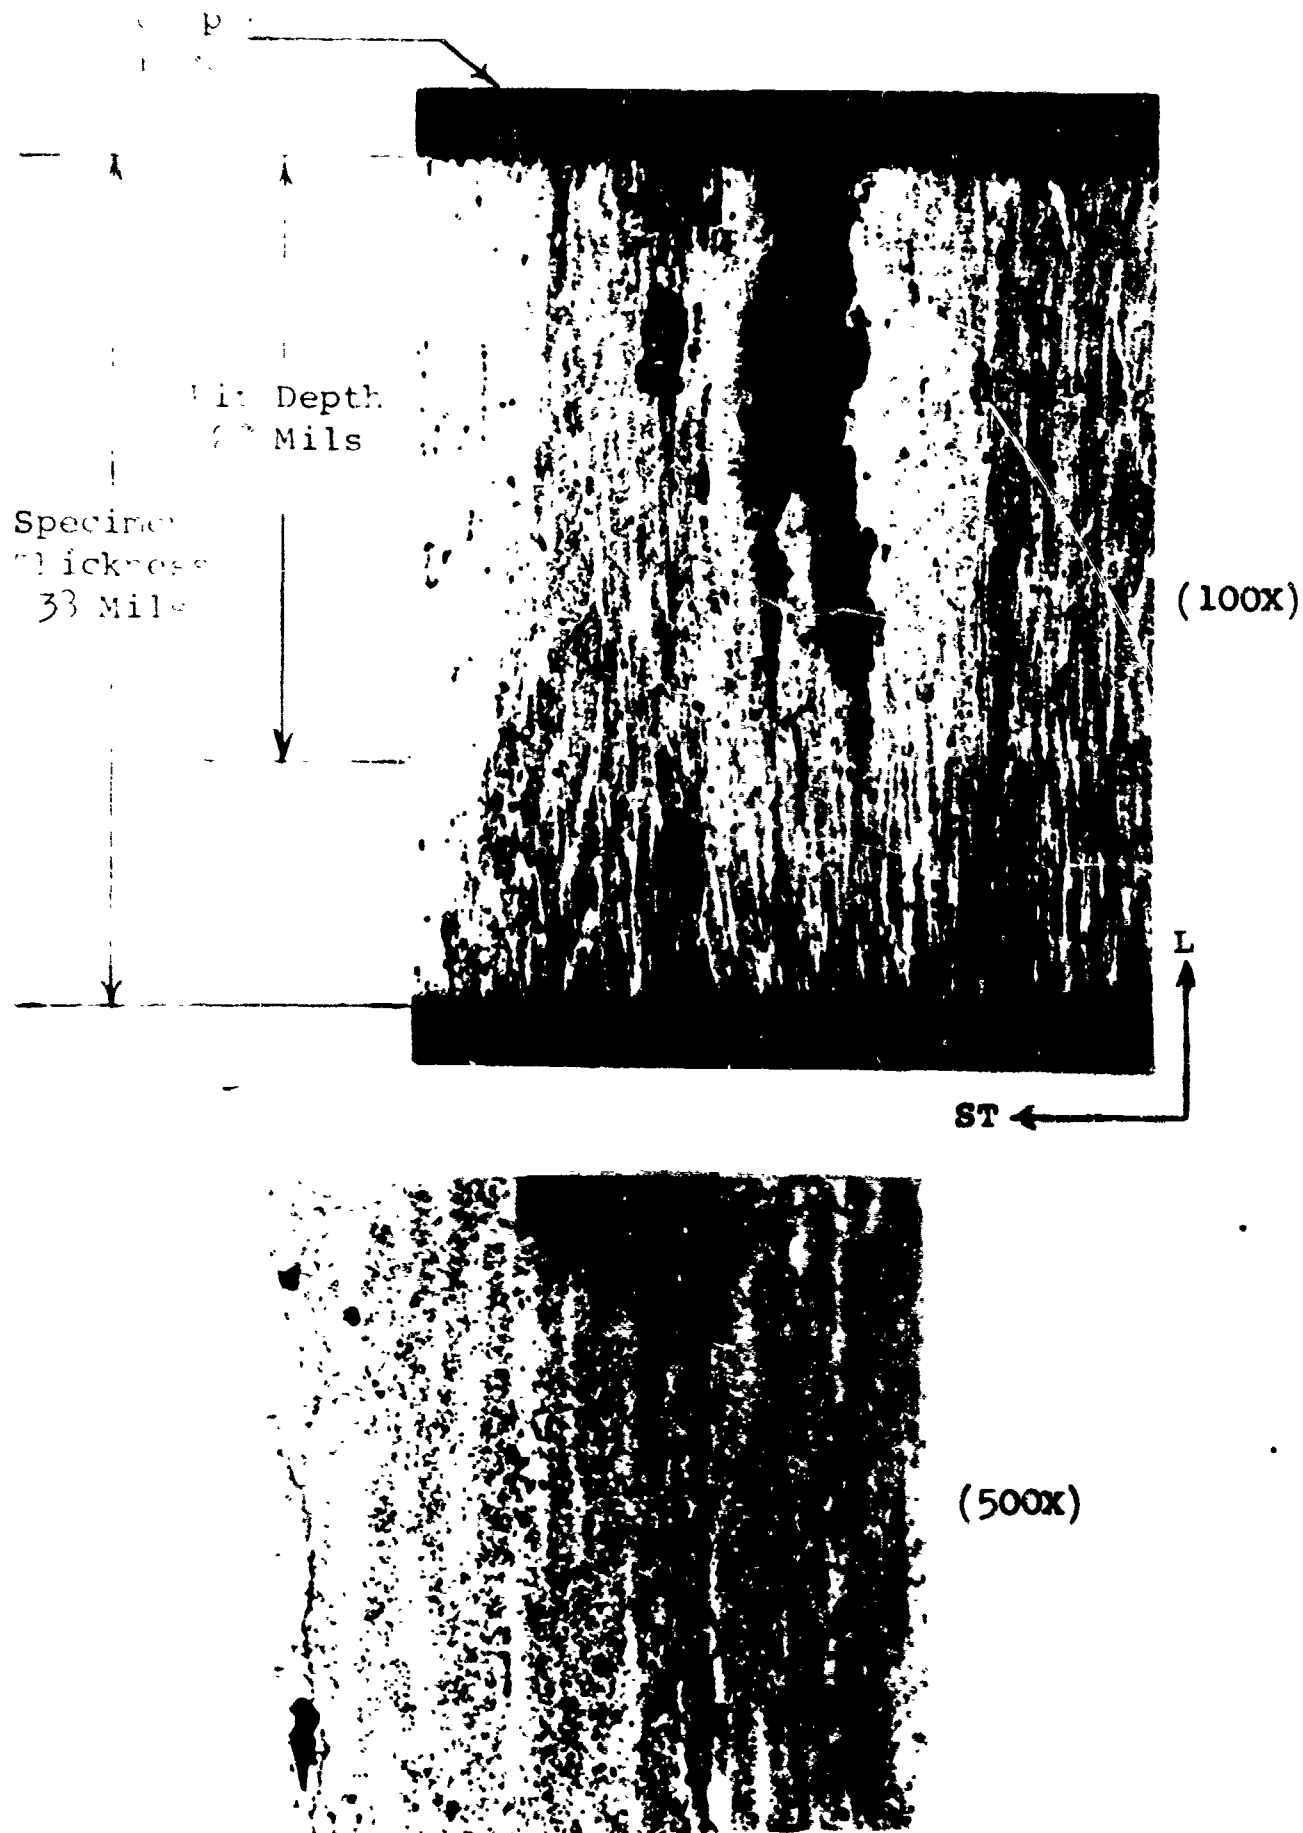
Figure 9 - Photomicrographs Illustrating Directionality of Pitting Attack on Plane "A" in Type 5 Short Transverse Specimens (Kellers Etch)
