INVESTIGATION INTO THE USE OF REINFORCED
PLASTICS IN THE WESSEX HELICOPTER TO
PREVENT CORROSION.

D Mat Report No. 148

July, 1967

N.L. BOTTRELL
(Westland Aircraft Limited)

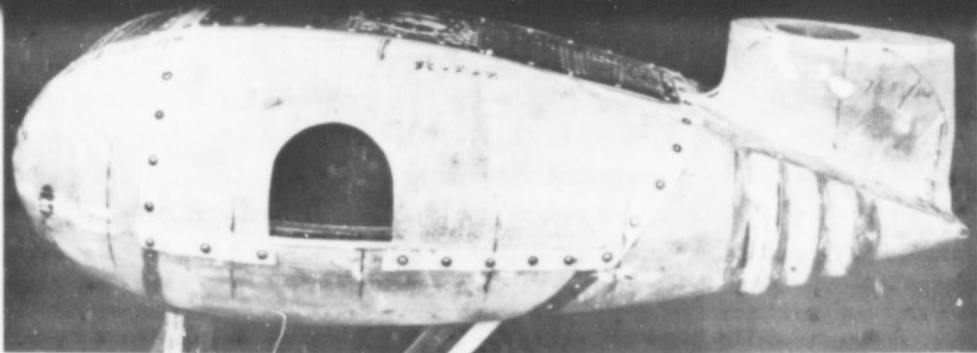
Figure 3

The glass reinforced plastic structure suffered crazing of the resin in the area of contact and, under heavy loads, slight de-lamination occurred. At no stage in the test did the glass reinforced plastic rupture, and any damage incurred in the test was considered repairable by conventional methods.

The impact test has clearly shown that a reinforced plastic component can withstand impact loads that severely damage a magnesium structure.

Glass reinforced plastic tail gearbox fairing after impact loading

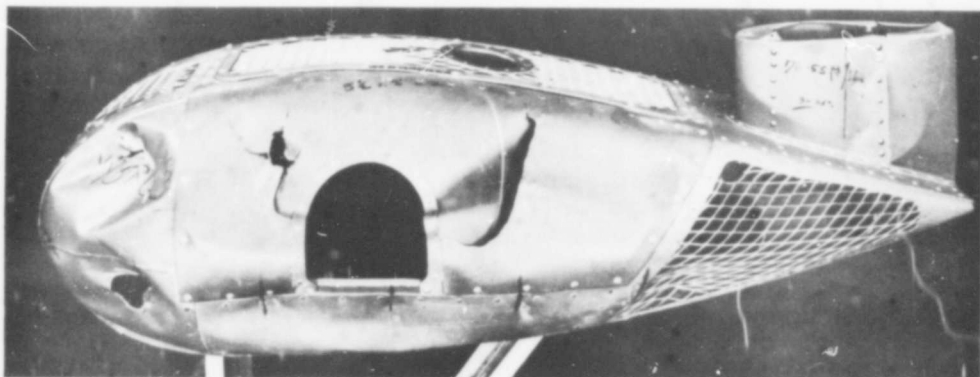
Figure 4

The metal structure sustained permanent deformation in some areas with the 1 in. dia. striker at $\frac{1}{4}$ ft lb impact load. The same areas were penetrated and the metal broken at an impact load of $5\frac{1}{4}$ ft lb. At loads of 4 ft lb, the support rib on the centre section of the removable door buckled.

Magnesium tail gearbox fairing after impact loading

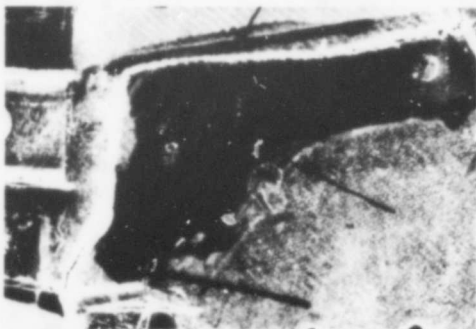
Figure 5

At total loads of 390 lb (simulating 150 knots) and 780 lb, no effects were observed. When the total load was increased to 1170 lb the stiffening member on the front bulkhead buckled slightly and the rear angle bulkhead tore at a point adjacent to the two open edges on the underside of the fairing.

Static load testing showed that the rear angle bulkhead of the fairing is subject to tearing at high loadings. For the test, however, the fairing was in the free state and not riveted along the base to the pylon. If it had been so attached the tearing would have been less. It must not be overlooked that the method of construction would permit substantial local reinforcing of the bulkhead where tearing occurs, thereby eliminating the defect.

Damage to glass reinforced plastic gearbox fairing during static loading
