CRA SHWORTHINESS OF AIRCREW PROTECTIVE ARMOR

TECHNICAL REPORT
68-57-CM

Aviation Safety Engineering and Research
A Division of
Flight Safety Foundation, Inc.
Phoenix, Arizona

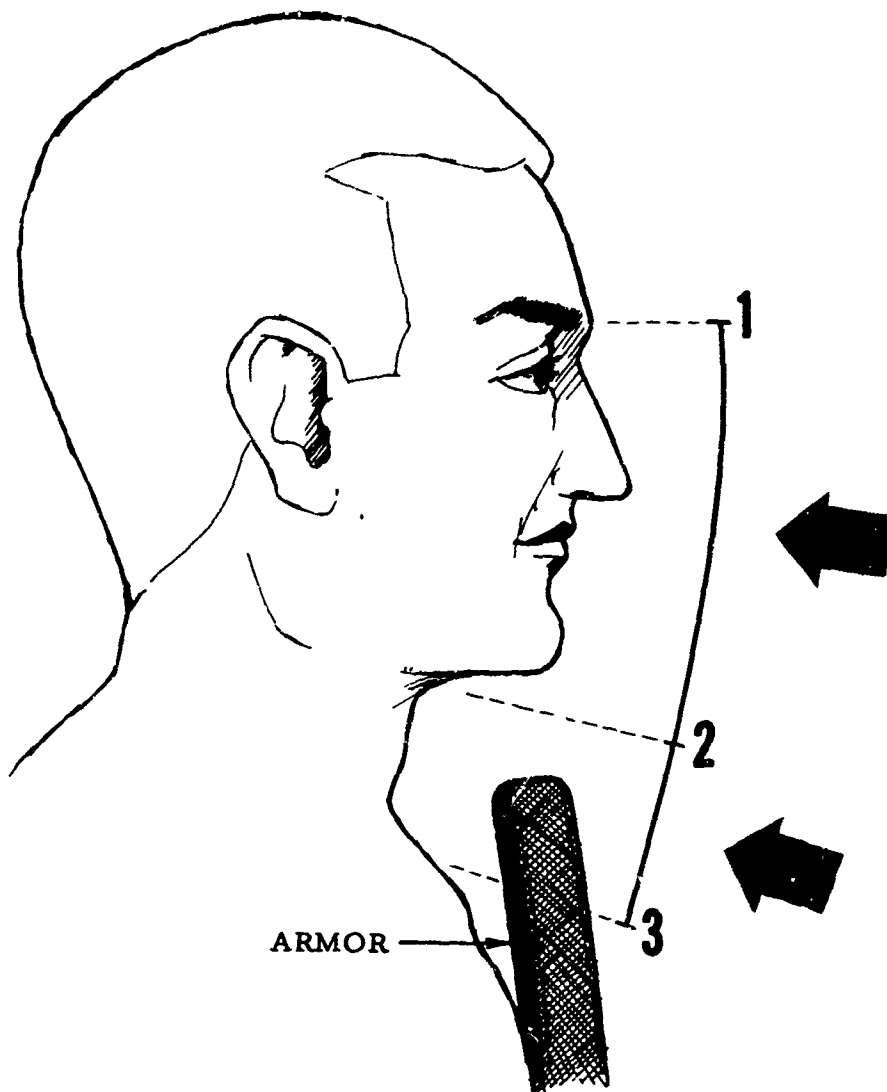
Although face/armor contact did not occur in some tests, a collision between the face and armor was present in all of the longitudinal acceleration tests and in those vertical acceleration tests in which longitudinal forces were present (see columns 8 and 9 of Tables I and II). This indicates that armor contact can be expected when significant

Figure 4. Face/Armor Contact Zones.

Direct contact of the upper edge of the armor with the neck area along the arc from 2 to 3 in Figure 4 could produce serious damage, the most dangerous being fracture of the trachea, especially at the larynx. These are serious injuries, as the vocal cord spasm or collapse of the trachea associated with this trauma may occlude the airway long enough for death to result. The forces measured at the top of the armor were

more than sufficient to cause this trauma⁽⁴⁾. In the test program, direct contact of the armor with the neck area occurred in only one test compared with 19 impacts to the face area in the remaining 29 tests (see Tables I and II for details). However, caution should be exercised in using these figures from which to draw the conclusion that the possibility of neck impact is low. It was recognized during the early planning that the neck area simulation of the anthropomorphic dummy was very poor. Several agencies visited are presently engaged in projects to increase the level of simulation; however, the improvements were not available for incorporation into this test program. What is significant here is the fact that sufficient force was recorded at the top of the armor to cause serious injury to the throat area. A practical modification of the armor-vest-carrier to avoid this occurrence would be to pad the neck area in some fashion. An energy-absorbing, fragment-deflecting, turtle-neck unit (Figure 5) would satisfy this requirement.

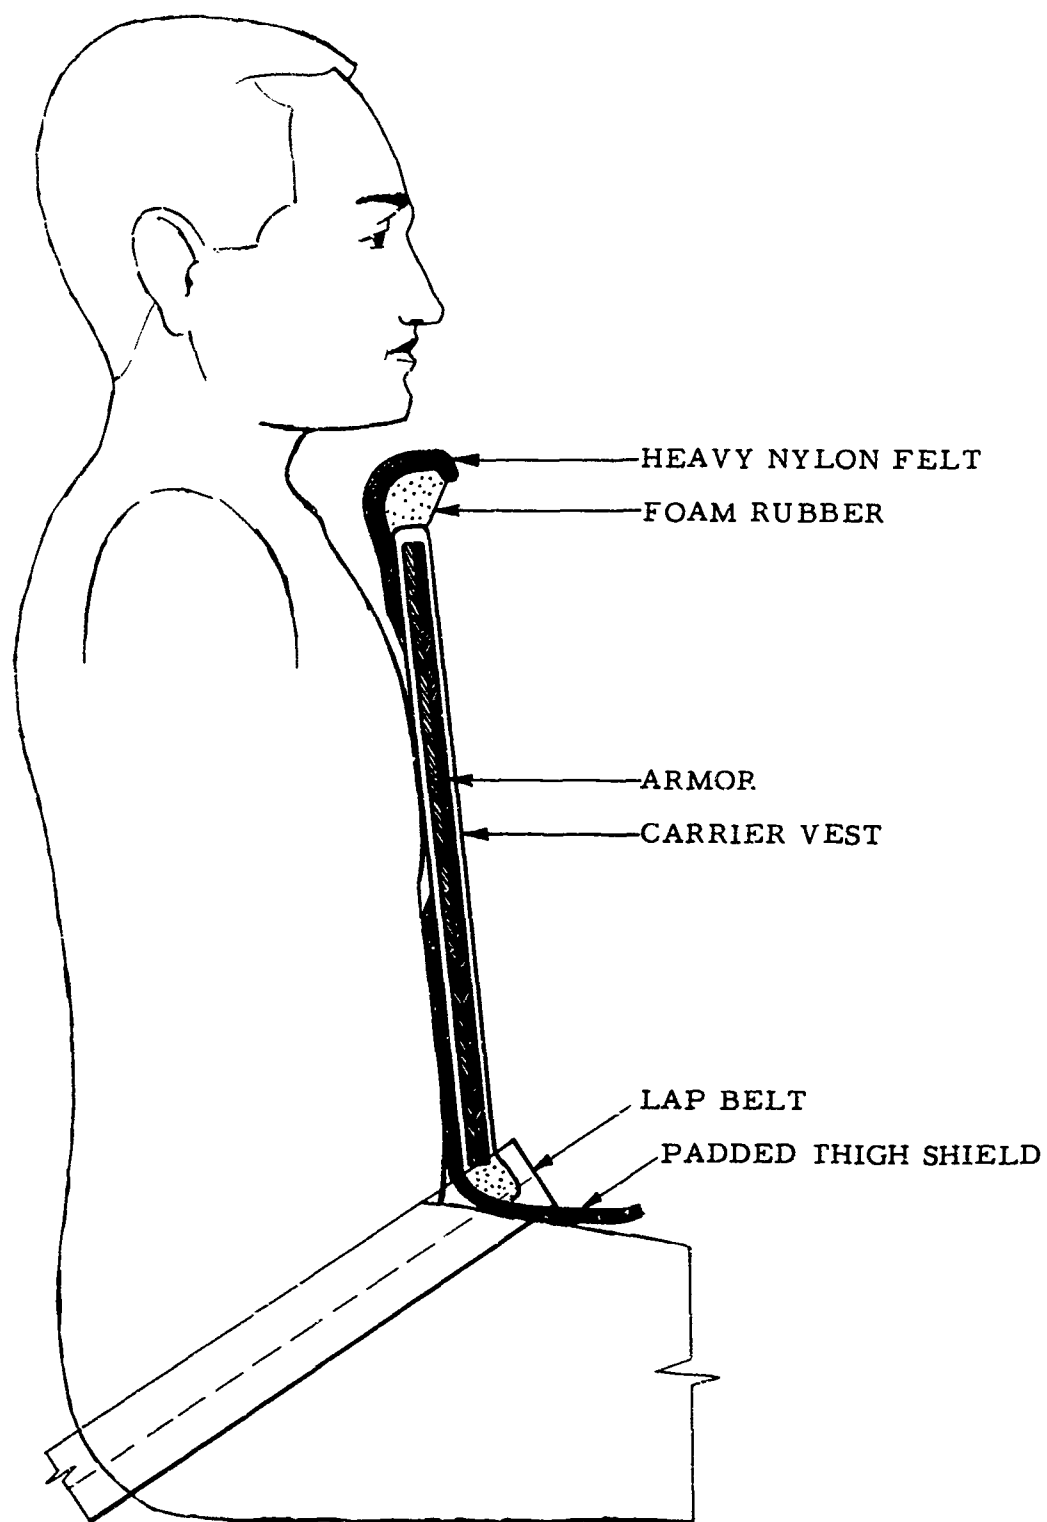
Figure 5. Recommended Padding for Upper and Lower Edge of Armor.

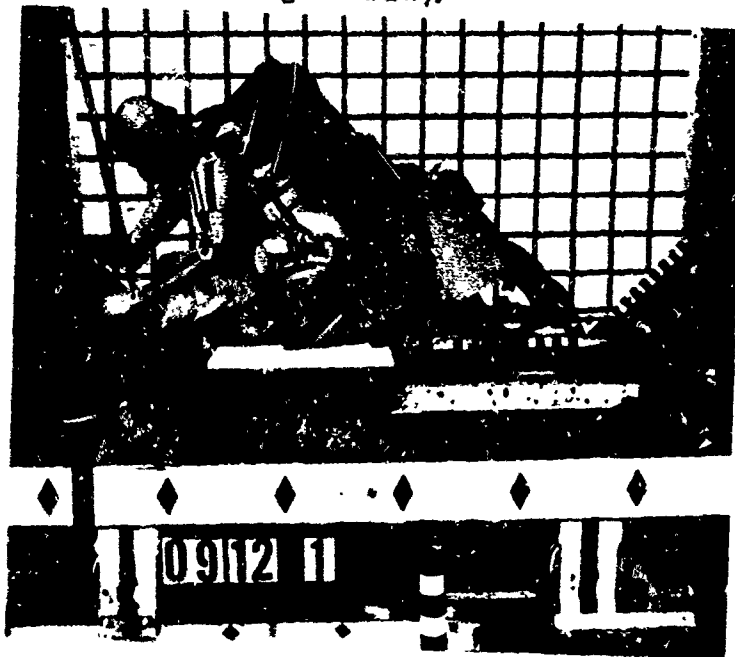
Figure 52. CH-47 Seat Failure, Test 1.

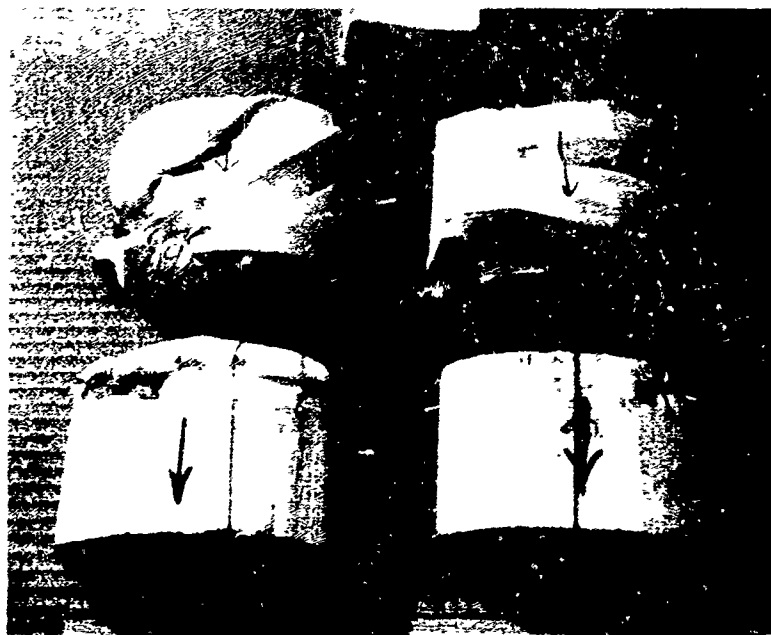
In this series of tests, the thigh pads suffered heavy damage, especially those involving the chest armor. Examination of the thigh pads showed that the damage consisted primarily of shearing failure of the styrofoam caused by the lap belt. Close examination of the pad did not reveal any damage which might have been caused by the armor. The increased damage in the tests involving chest armor was due to the fact that when the armor is worn, the lap belt is farther forward and comes in contact with more of the thigh pad. Figure 56 shows a posttest view of a typical set of pads.

Figure 56. Styrofoam Load Pads. Posttest View Showing Shearing Failure Caused by Lap Belt.

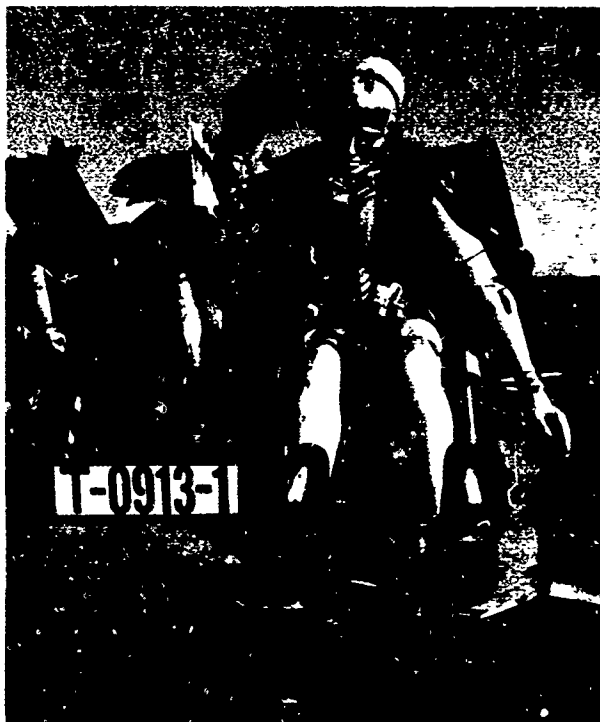
Figures 73 and 74 show the final position of this seat and dummy. Notice again the extremely high position of the lap belt buckle caused by slack that was induced by the vertical displacement of the seat bucket.

Figure 73. Postcrash Front View - Copilot Position.

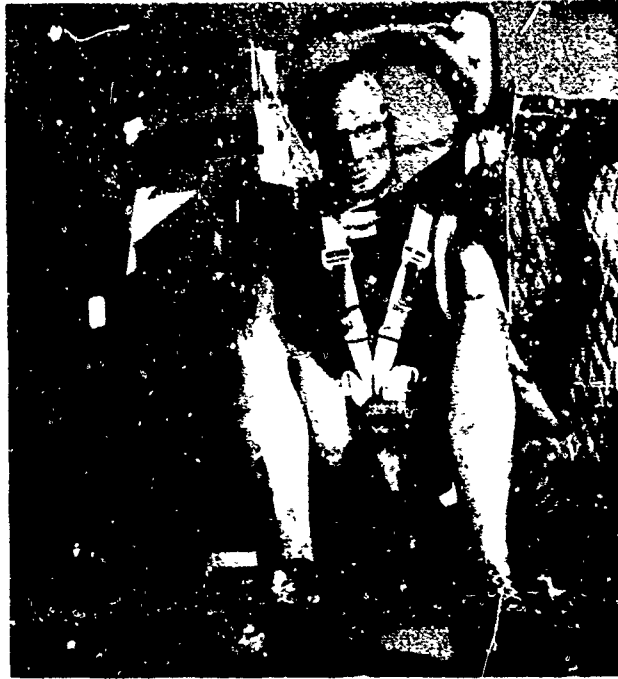
This seat was the only seat in the test to completely collapse. The front outboard support leg pushed its floor attachment fitting through the floor and into the fuel cell area (Figure 77). The dummy moved forward and outward on the seat, failing the canvas seat pan and causing the outboard longitudinal support-tube to rotate forward and down as illustrated in Figure 78. This rotation pulled the rear leg free from its floor attachment. Sufficient load was then transferred through the canvas to fail the

Figure 75. Postcrash Front View - CH-47 Seat.
