THE EFFECT OF LEAD ON MICRO-CRACK
INITIATION AND PROPAGATION IN ALLOY STEELS

FINAL REPORT PHASE I

PART B: A FRACTOGRAPHIC STUDY OF LEADED 4145 STEEL TESTED
AT ELEVATED TEMPERATURES

Date: August 1968

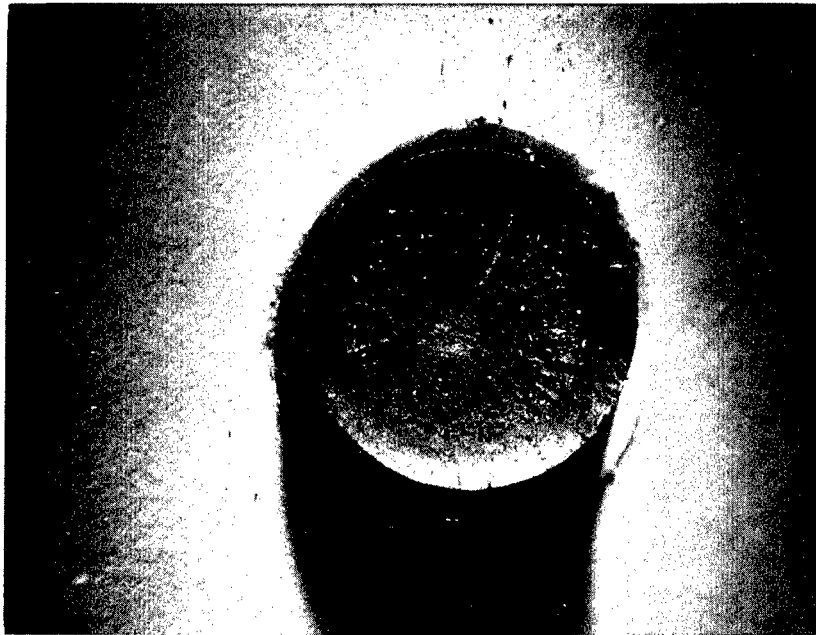
The fracture surfaces of the longitudinal tensile specimens were classified by visual analysis into five categories (A, B, C, D, E) as shown by the schematic sketches of Figure 7 and the macrophotographs of Figures 8 through 12. Type A, shown in Figure 7a and Figure 8, was a low temperature cup and cone fracture consisting of a fibrous central region, a radial shear intermediate region, and a shear lip outer region. In a Type B fracture, shown in Figure 7b and Figure 9, the entire flat fracture surface was very rough, except for very small shear lips, and exhibited a golden brown color. Type C fractures, shown in Figure 7c and Figure 10a, occurred on a plane inclined at about a 45° angle to the axis of the tensile specimen, i.e., they were generally shear fractures. The fracture surfaces of Type C fractures were covered with an adherent blue oxide film. However, there were a number of small flat circular irregularities oriented normal to the tensile axis along the inclined fracture surfaces. These regions resembled

Figure 8. Type A Fracture. Directly Parallel to Axis of Tensile Specimen. 10X

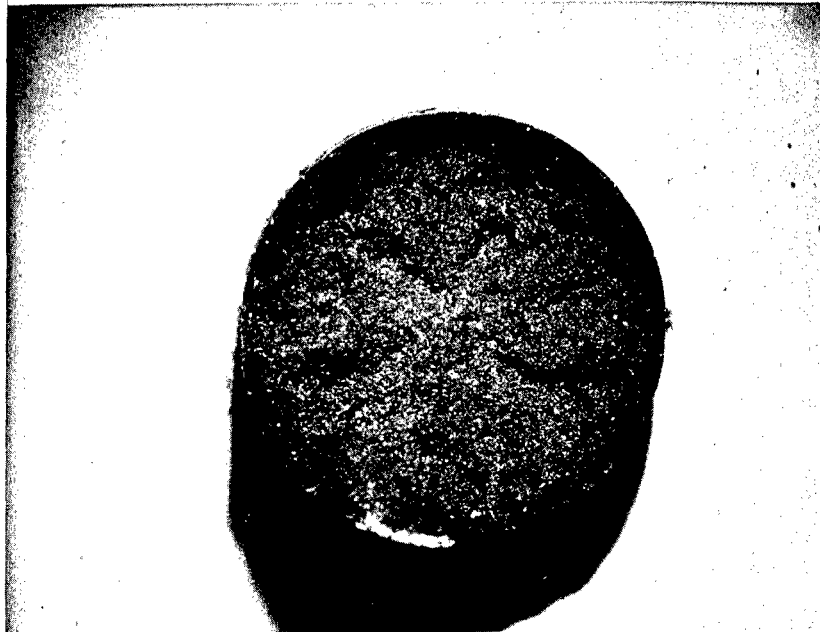
Figure 9. Type B Fracture. Directly Parallel to Axis of Tensile Specimen. 10X

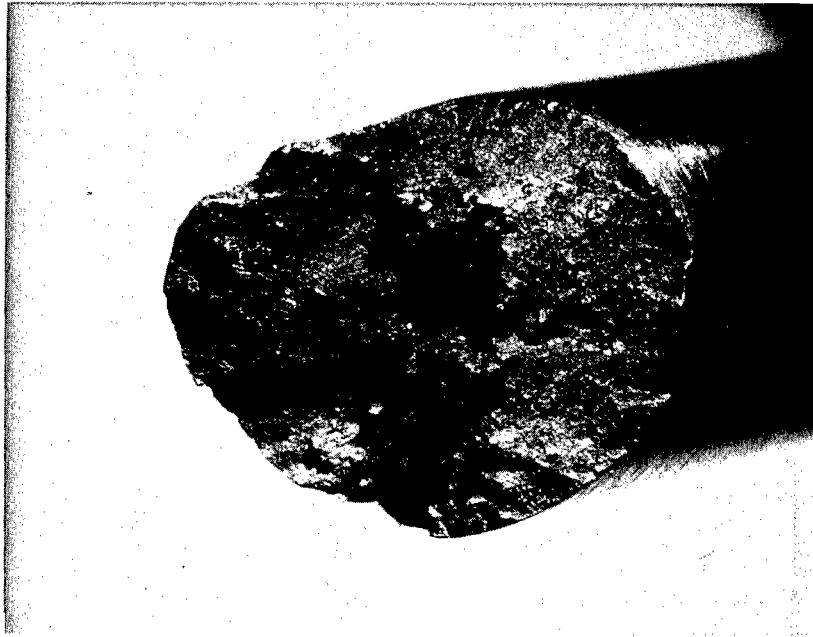
Figure 10a. Type C Fracture. Axis of Tensile Specimen
Rotated 45° to Axis of Camera Lens. 10X

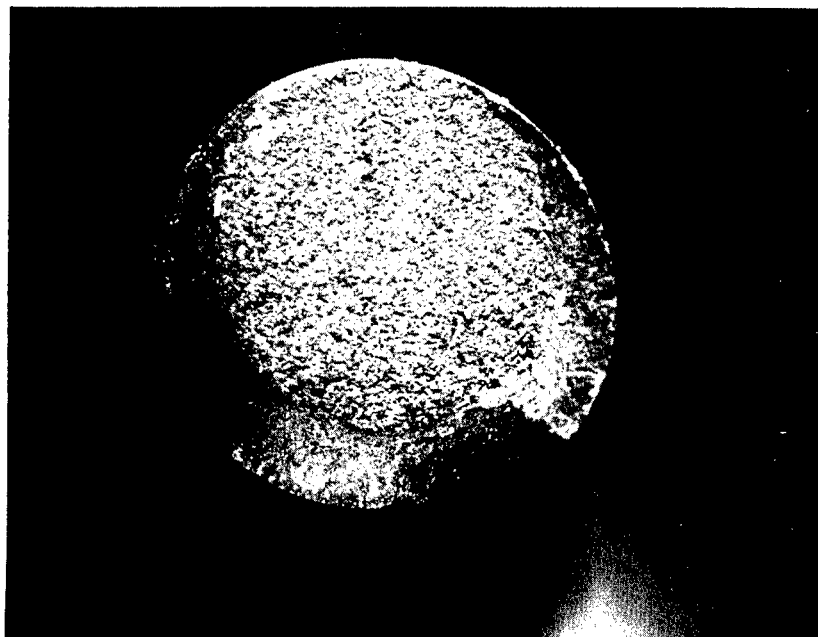
Figure 11. Type D Fracture. Directly Parallel to Axis of Tensile Specimen. 10X

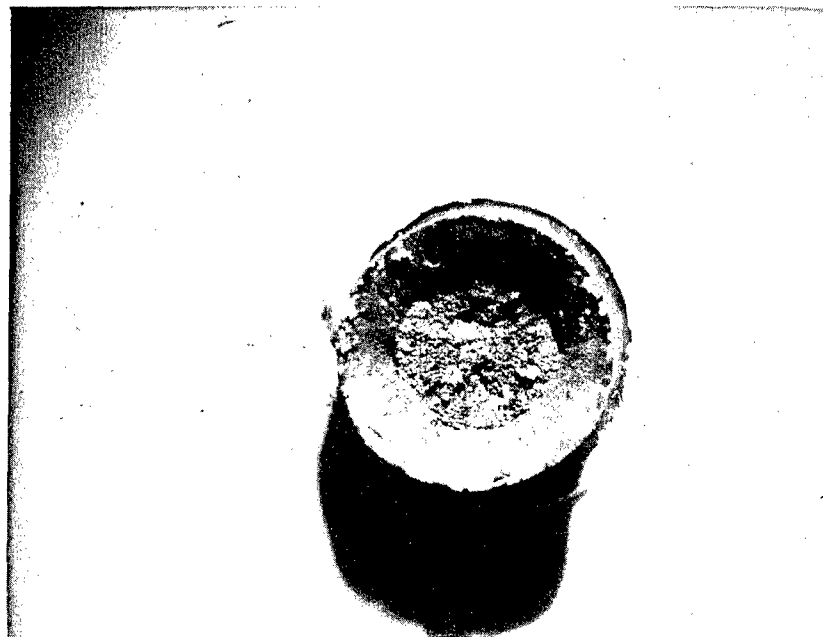
Figure 12. Type E Fracture. Directly Parallel to Axis of Tensile Specimen. 10X

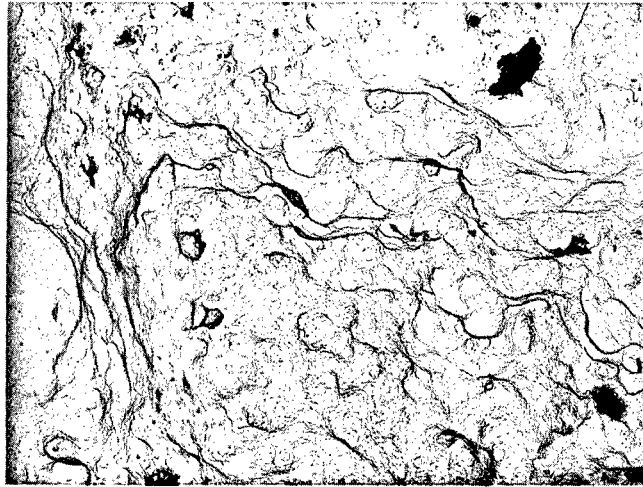
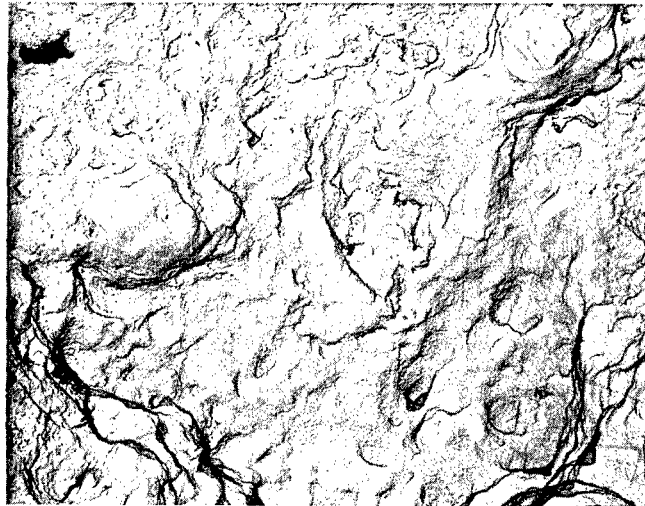
A Type E fracture was previously defined as a high temperature cup and cone fracture consisting of a fibrous center region and shear lip outer region. Fractographs of the fibrous center region taken from high strength L-20 material tested at 900°F are shown in Figures 18a and 18b. Due to the fact that these fractures occurred at high temperatures, the surfaces were badly oxidized. The surfaces appear to have been formed by a dimpled rupture process and the fractographs may be said to show "oxidized dimples." Whether the dimples present are in an oxidized form or not does not change the conclusion that Type E fractures took place in a ductile transgranular mode.

Figure 18a. Transgranular Fracture for a Type E Fracture
in the Form of "Oxidized Dimples." 3,000X

Figure 18b. Transgranular Fracture for a Type E Fracture
in the Form of "Oxidized Dimples." 3,000X

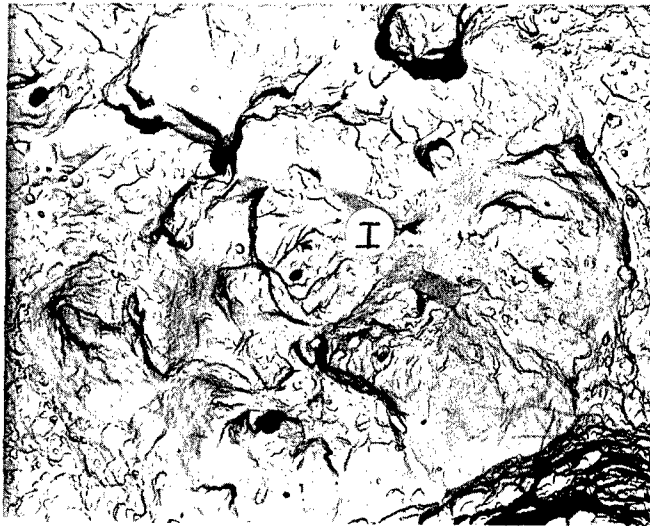
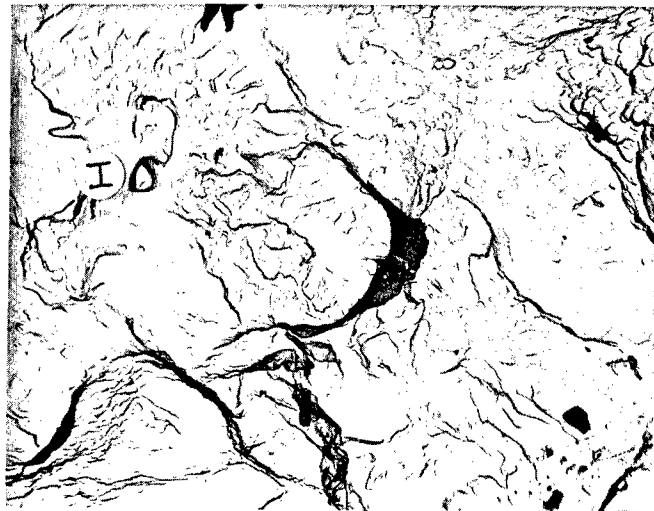
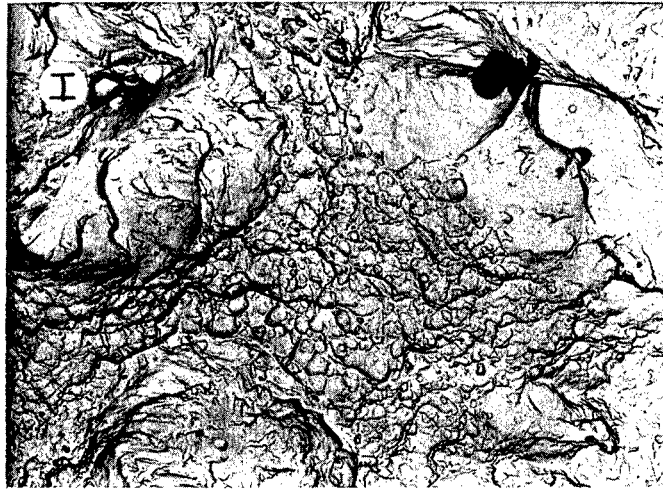
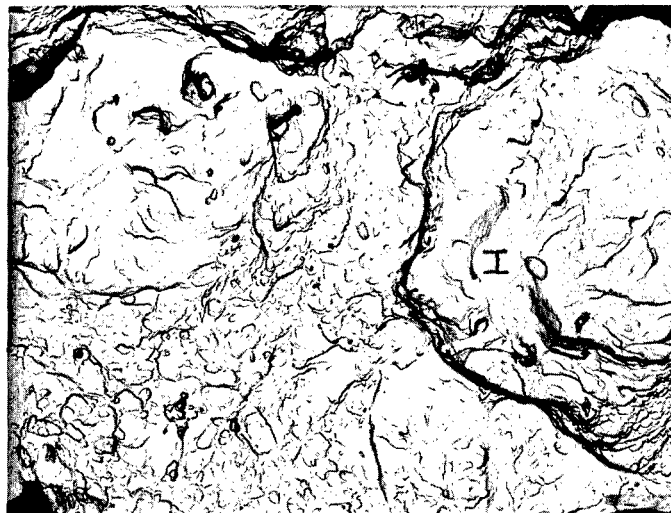
Type B fracture is characterized by a very rough surface with a very small shear lip. Replicas were made from L-24 material tested at 550°F. Typical fractographs taken from the very rough surface are shown in Figures 19a, 19b, 20a, and 20b. These fractographs show an intimate mixture of intergranular and transgranular models of failure, and indicate that in virtually all cases an inclusion, labeled I on the photographs, was present in each region of intergranular grain facets. The area immediately surrounding the inclusion was intergranular, but the area surrounding the intergranular region was transgranular. This seems to suggest that some kind of radial crack growth originating at the inclusion took place in this fracture type.

Figure 19a. Primarily Intergranular Fracture for a Type B Fracture. 3,000X

Figure 19b. Primarily Intergranular Fracture for a Type B Fracture. 3,000X

Figure 20a. Region Showing Both an Intergranular and a Transgranular Mode of Failure for a Type B Fracture. 3,000X

Figure 20b. Region Showing Both an Intergranular and a Transgranular Mode of Failure for a Type B Fracture. 3,000X

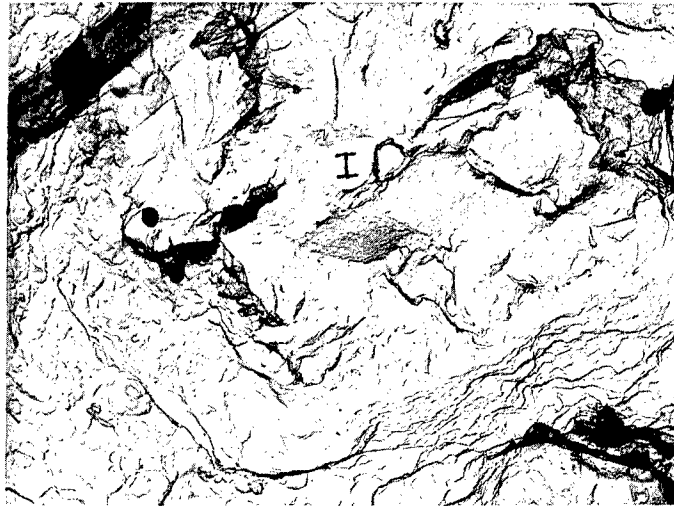
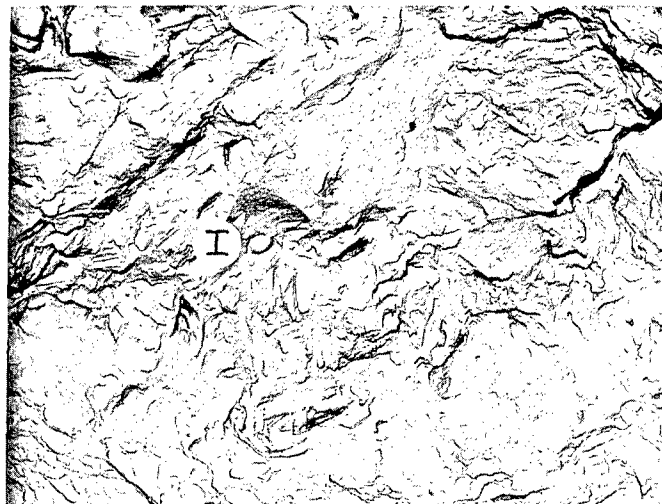
A fracture of C-Type took place on a 45° plane to the axis of the tensile specimen (shear failure) but there were small flat regions of "fish eyes" located on the fracture surface. Replicas of a region containing several of these small "fish eyes" were taken from L-20 material tested at 600°F . Figures 21a and 21b show a region taken from a cluster of small "fish eyes"; this region shows both an intergranular and transgranular mode of failure for a Type C fracture. As in the Type B fracture, note the inclusion, I, present in the region of grain facets. The area immediately surrounding the inclusion was intergranular, but as the failure progressed radially from the inclusion the mode of failure changed from intergranular to transgranular as is evident from the dimples and "river markings." Thus, though the Type C fracture appearance was very similar to that for Type B, there are two differences between these types. First, the extent of intergranular fracture was greater and the micro-cracks were larger in Type C. Second, at the onset of final fracture the remaining section failed in shear on a 45° plane in Type C and in tension normal to the tensile axis in Type B. Otherwise, the basic fracture process was the same for these two fracture types.

Figure 21a. Region Showing Both an Intergranular and a Transgranular Mode of Failure for a Type C Fracture Taken from a Cluster of Small "Fish Eyes." 3,000X

Figure 21b. Region Showing Both an Intergranular and a Transgranular Mode of Failure for a Type C Fracture Taken from a Cluster of Small "Fish Eyes." 3,000X

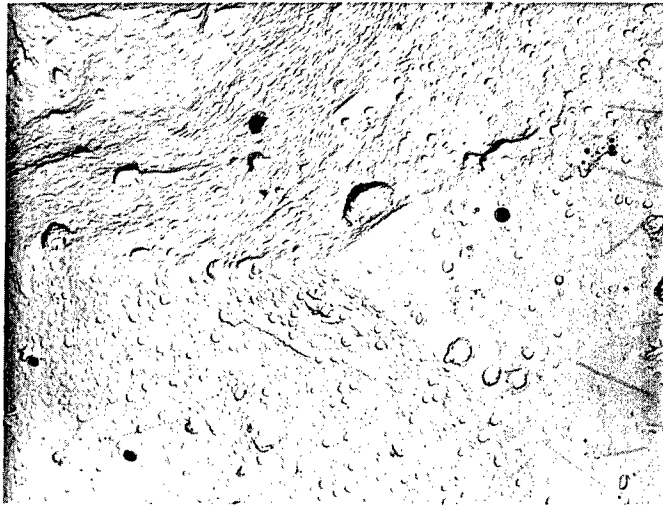
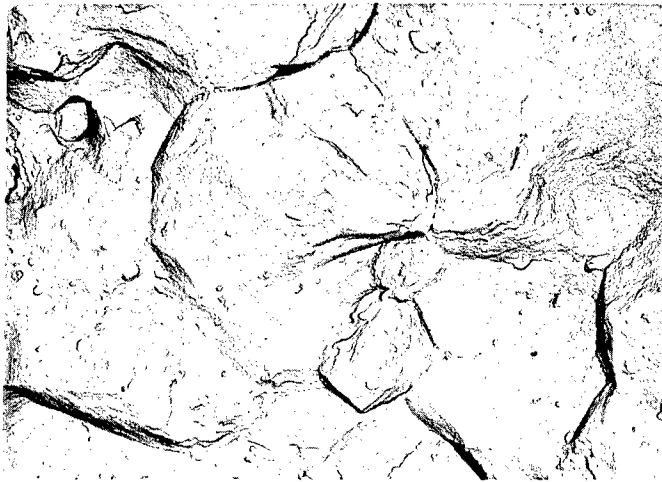
- 1) The origin, located on the flat "fish eye" near the outer surface of the fracture, is completely intergranular as can be seen by the fractographs in Figures 23a and 23b. Note the "rock candy" appearance of the fracture surface.
- 2) The surrounding intermediate region on the flat "fish eye" is a mixture of both intergranular and transgranular (Figure 24).
- 3) The outer region of the "fish eye" is almost completely transgranular (Figure 25).
- 4) The shear lip surrounding the "fish eye" is completely transgranular.

Figure 23a. Origin of Fracture Showing a Complete Intergranular Mode of Failure. 8,000X

Figure 23b. Origin of Fracture Showing a Complete Intergranular Mode of Failure. 3,000X

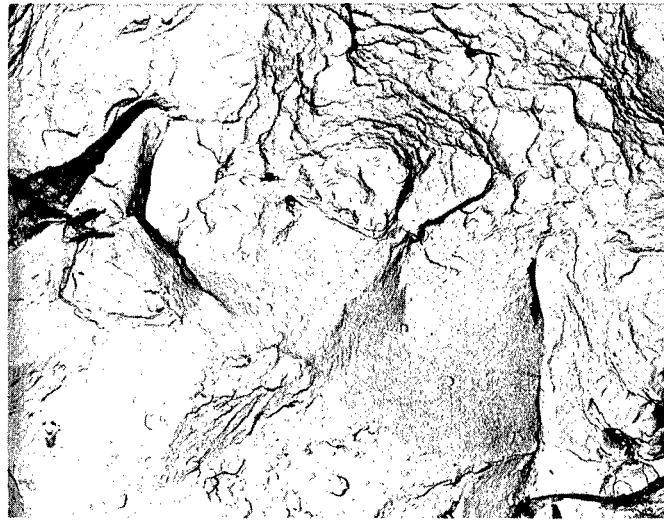
Figure 24. Intergranular and Transgranular Fracture
Located in the Intermediate Region. 3,000X

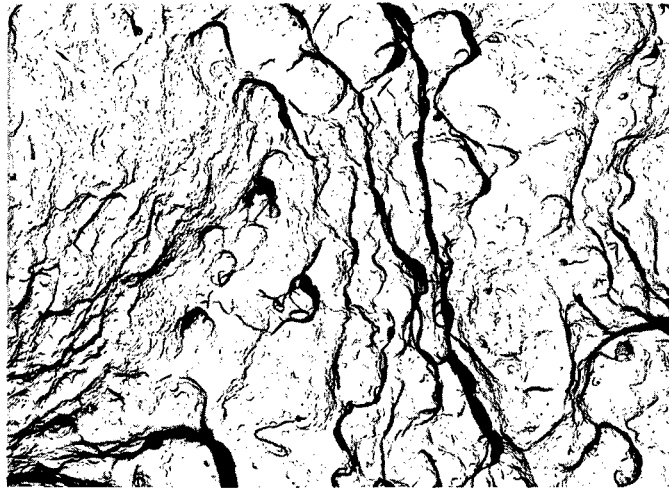
Figure 25. Almost Completely Transgranular Fracture
Located in the Outer Region. 8,000X

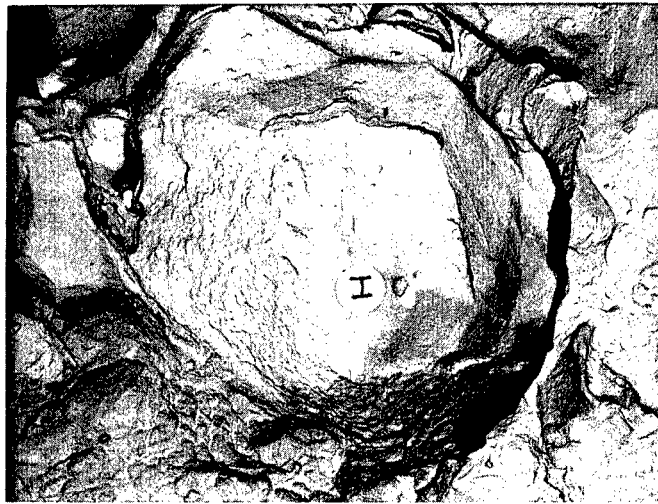
A closer examination near the origin of a Type D fracture revealed that an inclusion was usually present in each region of intergranular grain facets (Figure 26). The inclusion is located adjacent to the letter I on the fractograph.

Figure 26. Inclusion Located on Intergranular Grain Facet for a Type D Fracture.

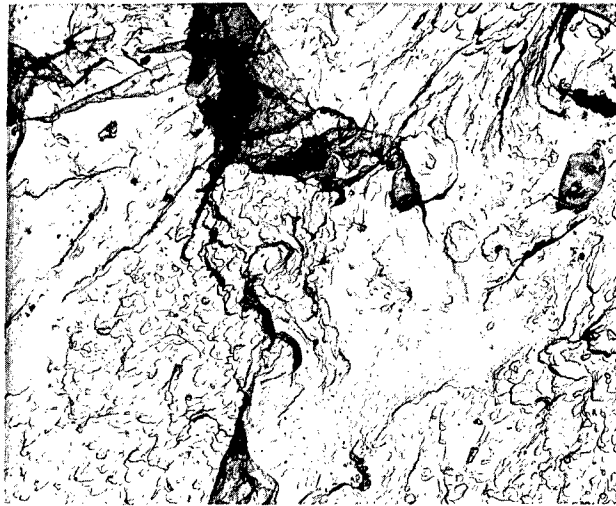
Figure 28. Fractograph of Type B Fracture Taken from a Low Strength Material.

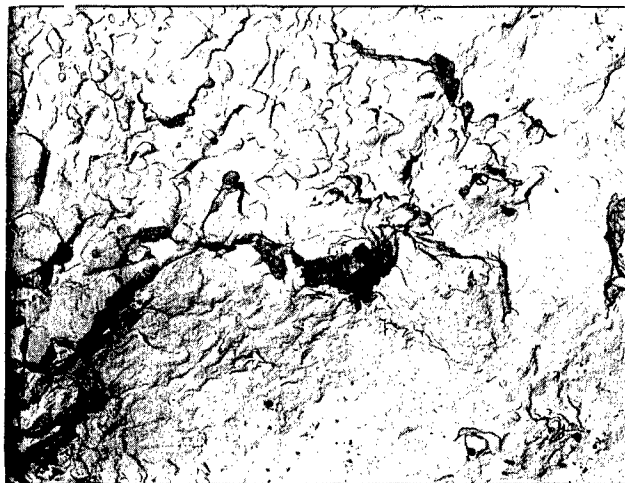
Figure 29. Fractograph of Type C Fracture Taken from a Low Strength Material.

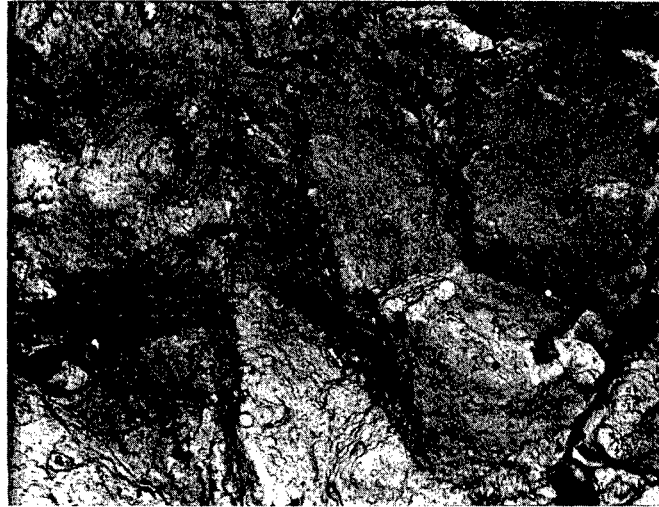
Figure 30. Origin of Low Strength Type D Fracture Showing an Intergranular Mode of Failure.

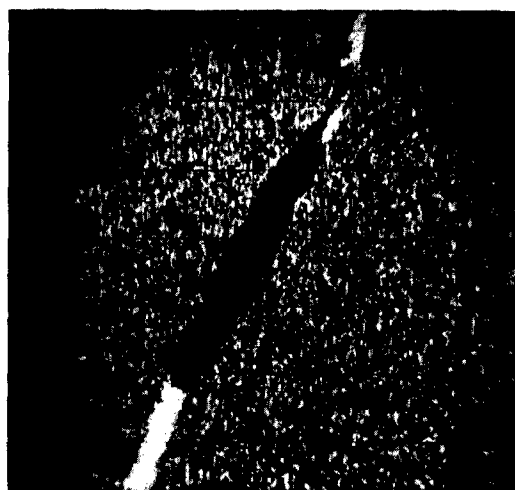
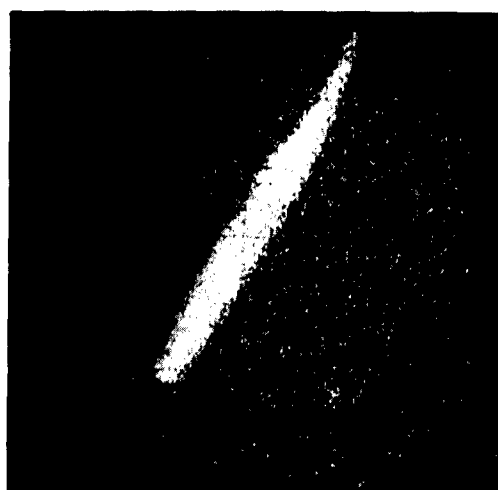
Electron probe work was performed on leaded 4145 steel by John Vettraino at TACOM (Detroit Arsenal). Figure 1B shows the presence of an inclusion that was detected by using back scattered electrons. The dark areas contained in the inclusion represent elements that have low atomic numbers, while the light areas represent elements that have high atomic numbers. The inclusion was scanned for manganese (Figure 2B) and the electron pattern revealed that the manganese was present in the dark central region of Figure 1B. Next, the inclusion was scanned for sulfur (Figure 3B) and the results showed that the sulfur was also present in the dark center region of Figure 1B. When the inclusion was examined for lead (Figure 4B), the resulting electron pattern revealed that the lead was located in the light tail end regions of Figure 1B. From the above analysis it can be concluded that the manganese sulfide inclusions in leaded 4145 steel are surrounded by an envelope of lead.

Figure 1B. Inclusion Detected by Back Scattered Electrons.

Figure 2B. $K\alpha$ Radiation Revealing the Presence of Manganese in the Inclusion.

Figure 3B. $K\alpha$ Radiation Revealing the Presence of Sulfur in the Inclusion.

Figure 4B. $M\alpha$ Radiation Revealing the Presence of Lead in the Inclusion.
