MISCELLANEOUS PAPER S-68-13

**MEMBRANE - ENVELOPE TECHNIQUE FOR
WATERPROOFING SOIL BASE COURSES
FOR AIRSTRIPS
BARE BASE SUPPORT**

July 1968

Conducted by
**U. S. Army Engineer Waterways Experiment Station
CORPS OF ENGINEERS
Vicksburg, Mississippi**

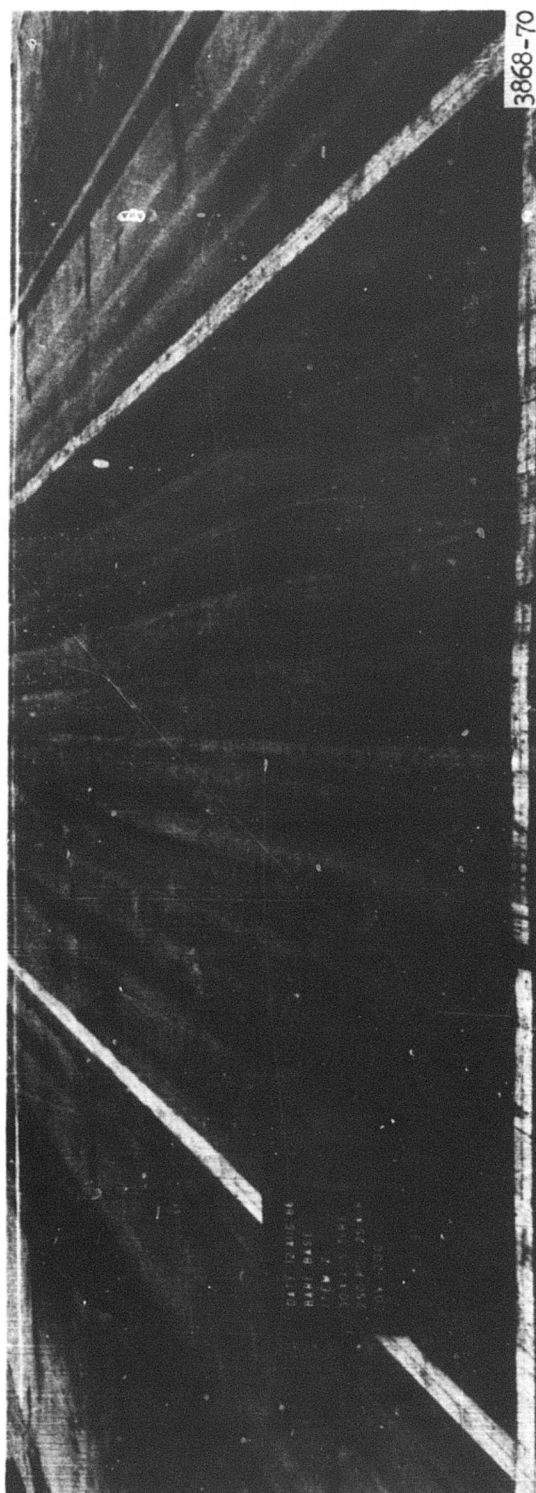
section, making a cumulative total of 160 coverages. During this period, it was necessary to make repairs to the T1 membrane in items 1 and 2 several times due to glue failure in the longitudinal joints. No difficulties were experienced with either the T16 or T17 membranes. On 11 August, the test section received an additional 40 coverages (total 200), part of which was applied during rain showers. After the first two coverages had been applied, ruts began to develop in isolated spots in items 1 and 2 as a result of the base soil's getting wet from water leakage through openings in the longitudinal joints. At 200 coverages (cumulative), traffic was stopped, and repairs were made to the base and membrane in items 1 and 2. Items 3-6 were in excellent condition. Views of items 1-6 after 200 coverages are shown in photographs 18-20.

Photograph 18. Items 1 and 2 after 200 coverages

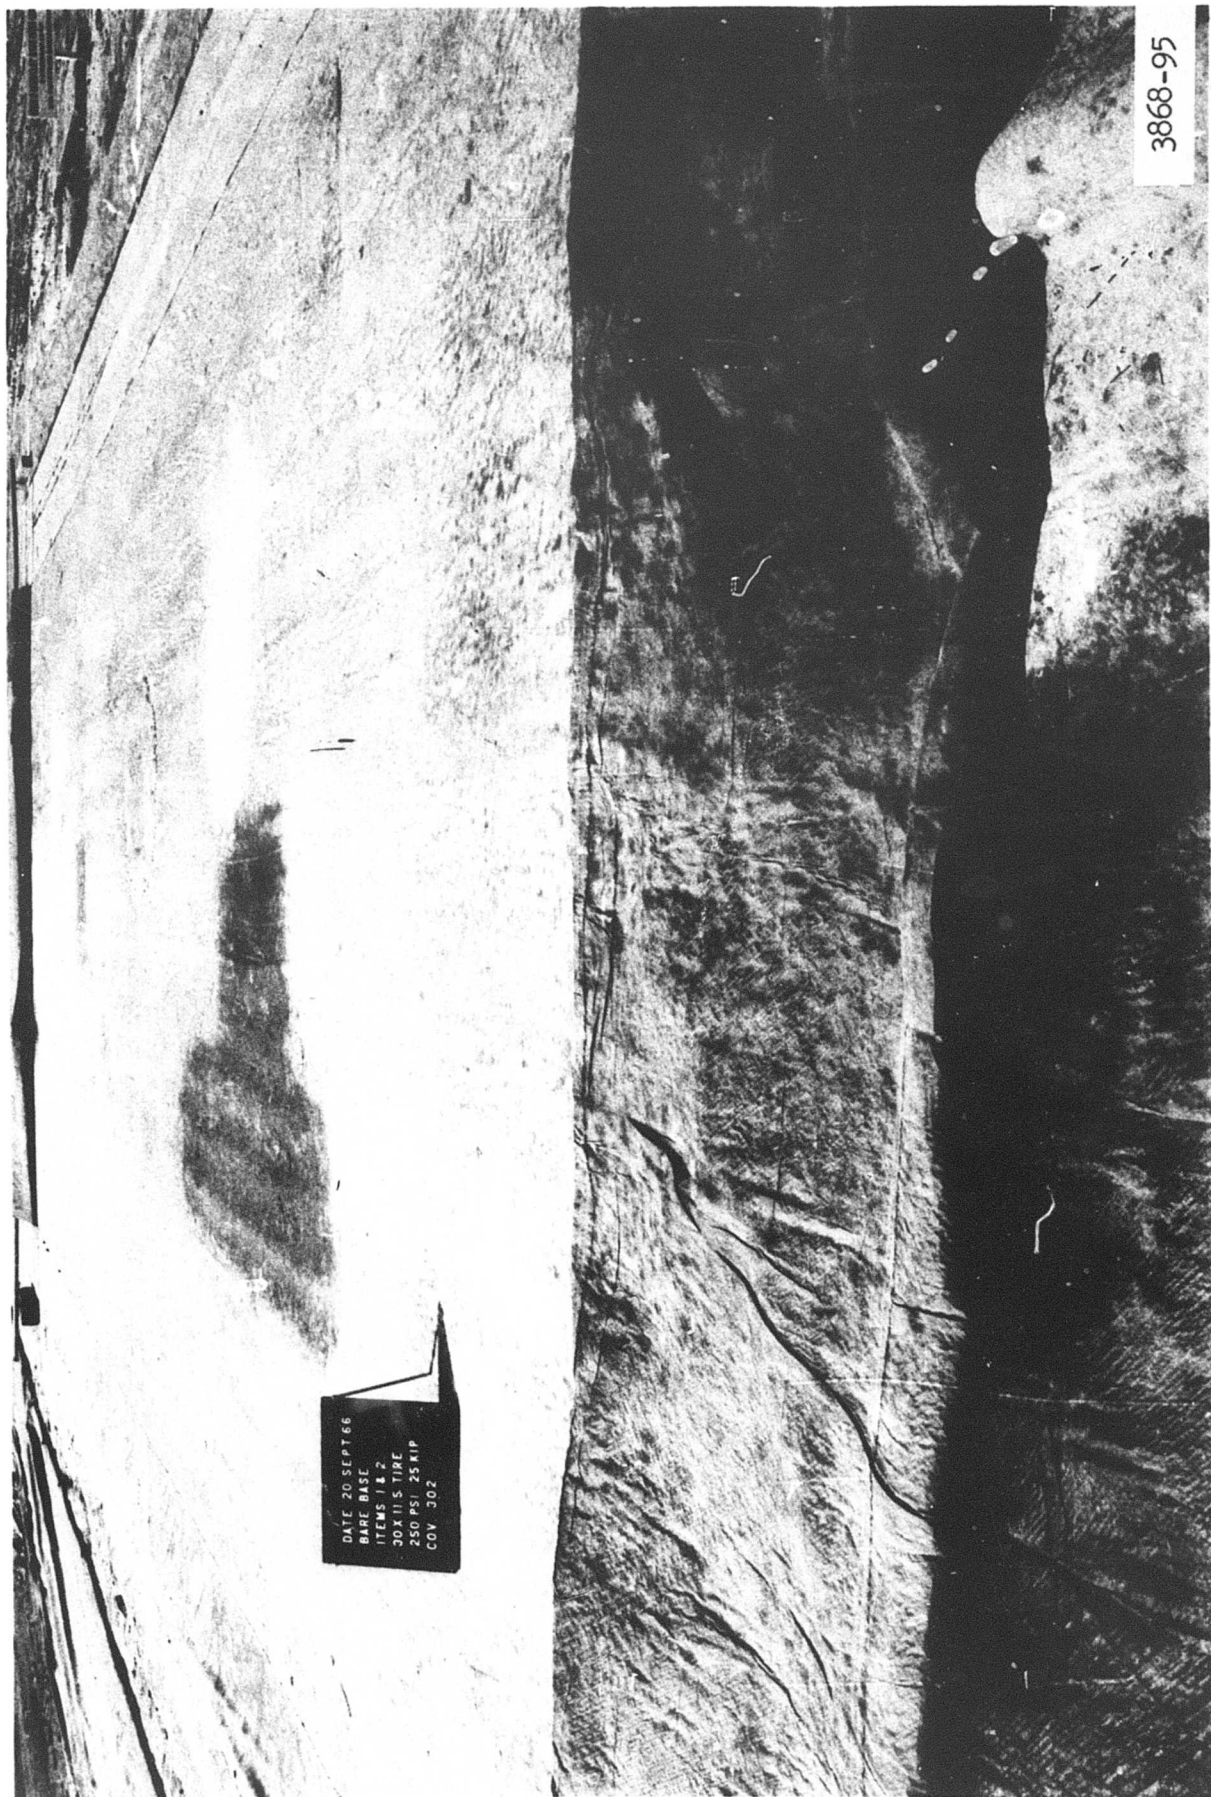
51. During the period 1-6 September, 40 additional coverages of traffic were applied to the test section, making a cumulative total of 280 coverages. During this time, minor repairs were required on the T1 membrane in item 1, and a previously failed area at the transition between items 5 and 6 was repaired. On 12 September, 22 coverages (cumulative total 302) were applied to the test section, with only minor difficulties occurring in item 6. All other items were in excellent condition. From 13-22 September, no additional traffic was applied; however, approximately 0.87 in. of rainfall occurred in the area. Inspection of the test section revealed that water had leaked through failed joints in the T1, T16, and T17 membranes, and localized soft areas were found in all items except item 4. In items 1 and 2, the T1 membrane and Griffolyn were removed, and the base was exposed for repairs (photograph 22). After base repairs had been completed, new T1 membrane was placed on the test section to replace the original T1 that had become irreparable due to a buildup of glue on the longitudinal joints. In item 3, the membrane was opened along a longitudinal joint, the base soil was removed and replaced, and the membrane was sealed. In items 5 and 6, several soft spots were repaired at this time. Photograph 23 shows an area in item 5 that had become wet due to leakage at a longitudinal joint, and photograph 24 shows the shallow depth to which repairs were required.

Photograph 22. Base in items 1 and 2 exposed after 302 coverages

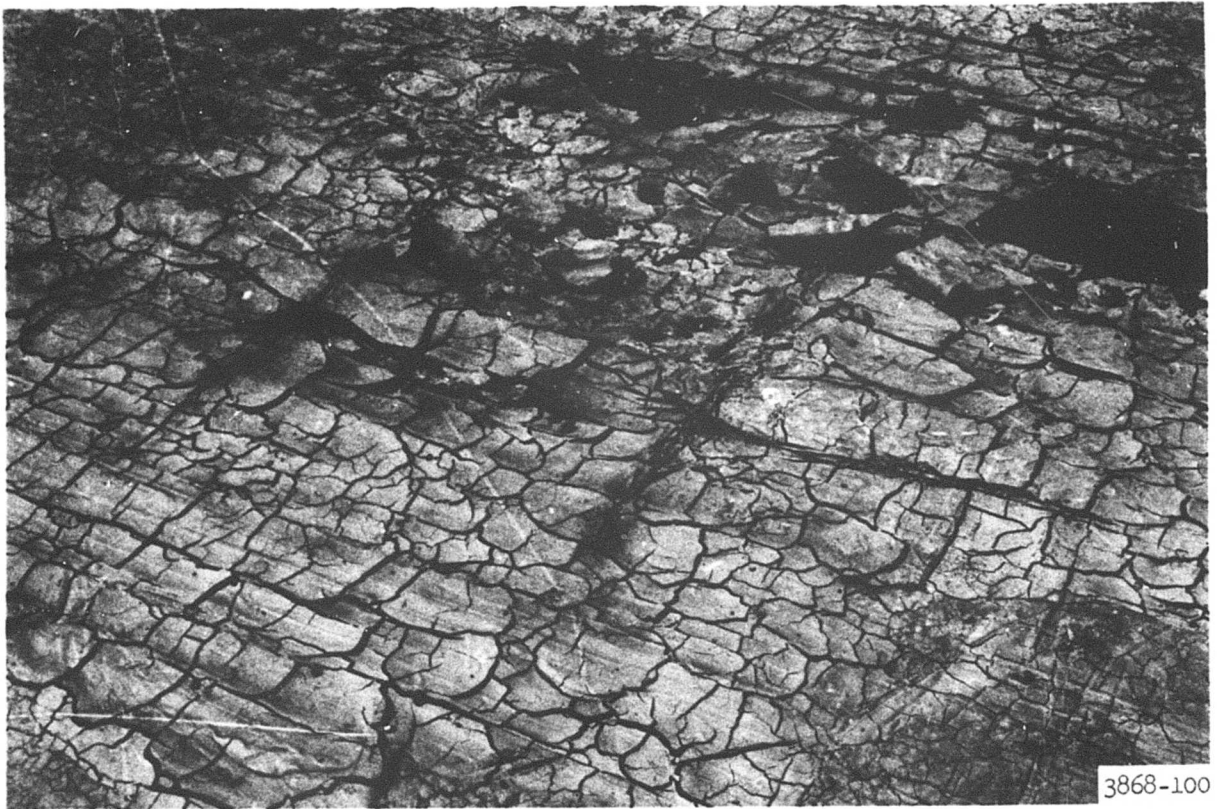
Photograph 23. Isolated wet spot in item 5 at 302 coverages

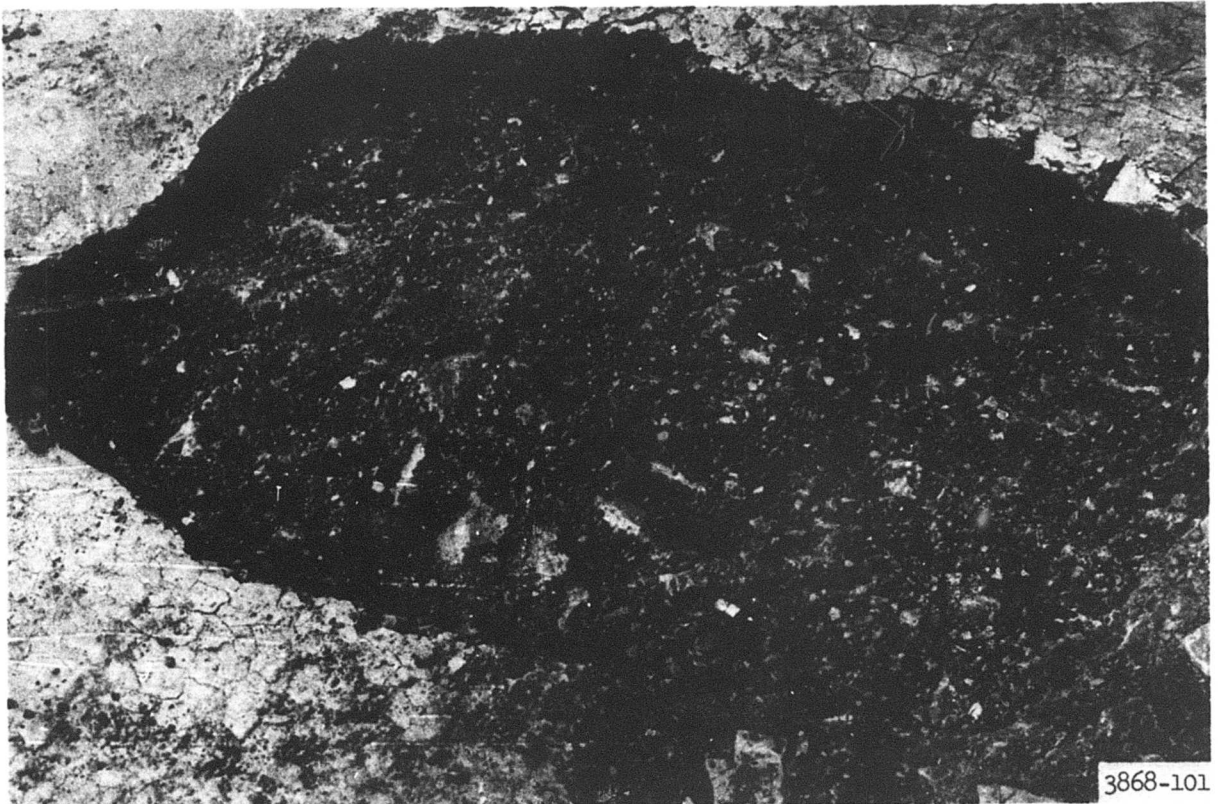
Photograph 24. Repair area in item 5 at 302 coverages. Wet soil has been removed and will be replaced with dry material

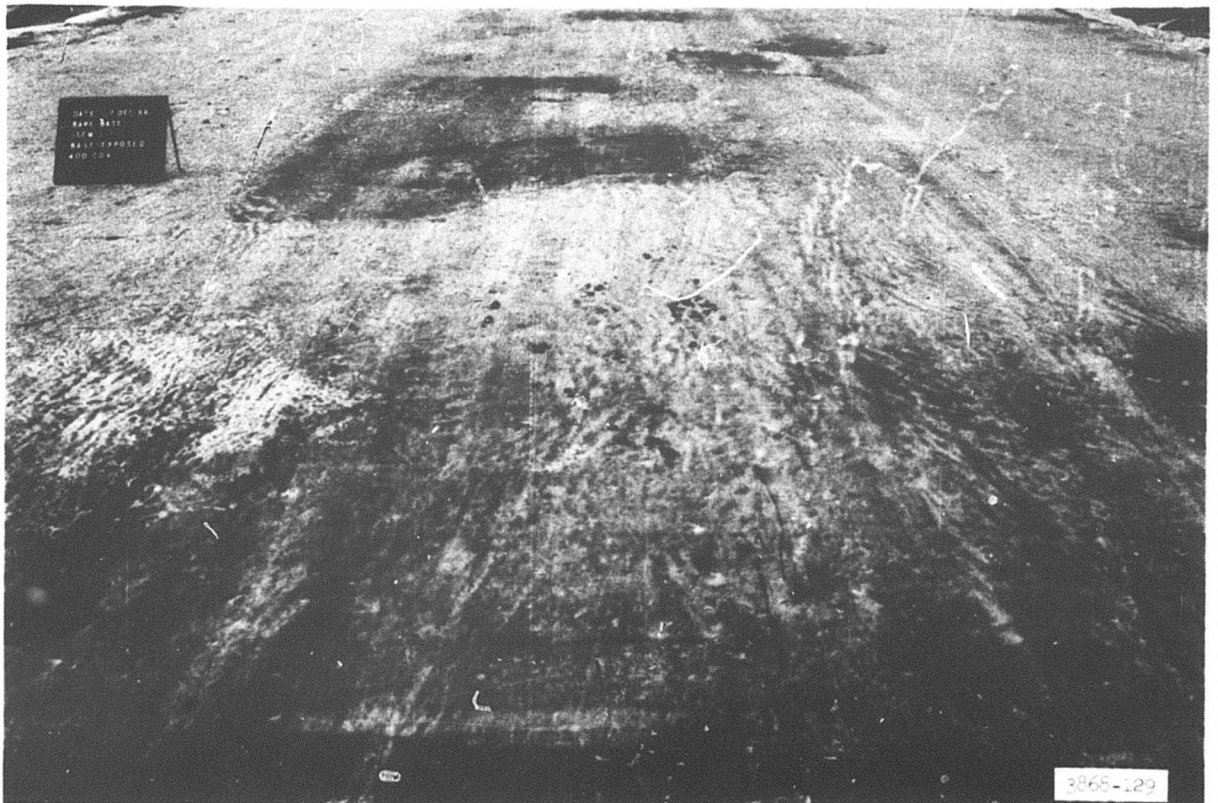
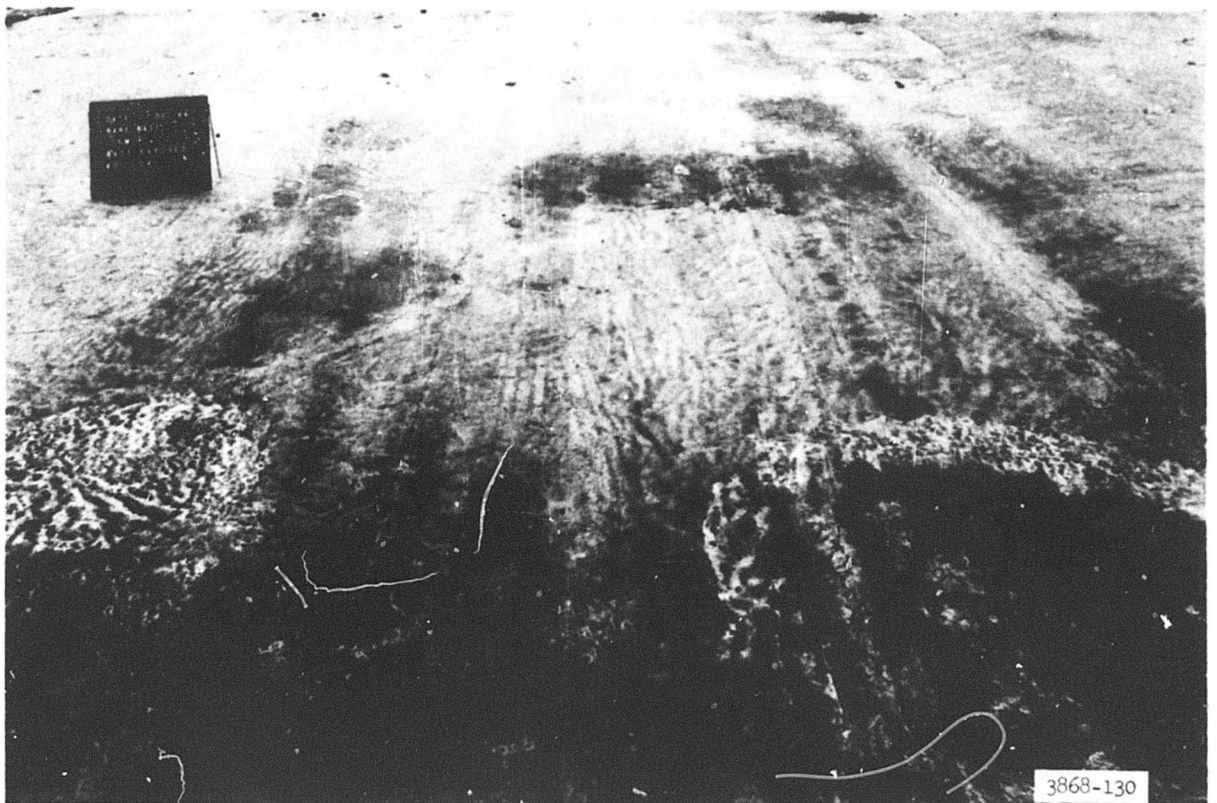
Photograph 29. Base in items 1 and 2 exposed after 400 coverages

56. The surface of the base soils was refinished with a road grader. The base soils were graded off approximately 1 to 2 in. to obtain a smooth finish. After refinishing of the base had been completed, several small areas in items 1 and 2 that had previously been refilled and that appeared to be relatively soft were repaired. Also, the surface of the base in item 1 was treated with an 85- to 100-penetration grade asphalt cement, AC-8, at a rate of 0.5 gal per sq yd prior to replacement of the membrane in order to provide additional waterproofing protection.

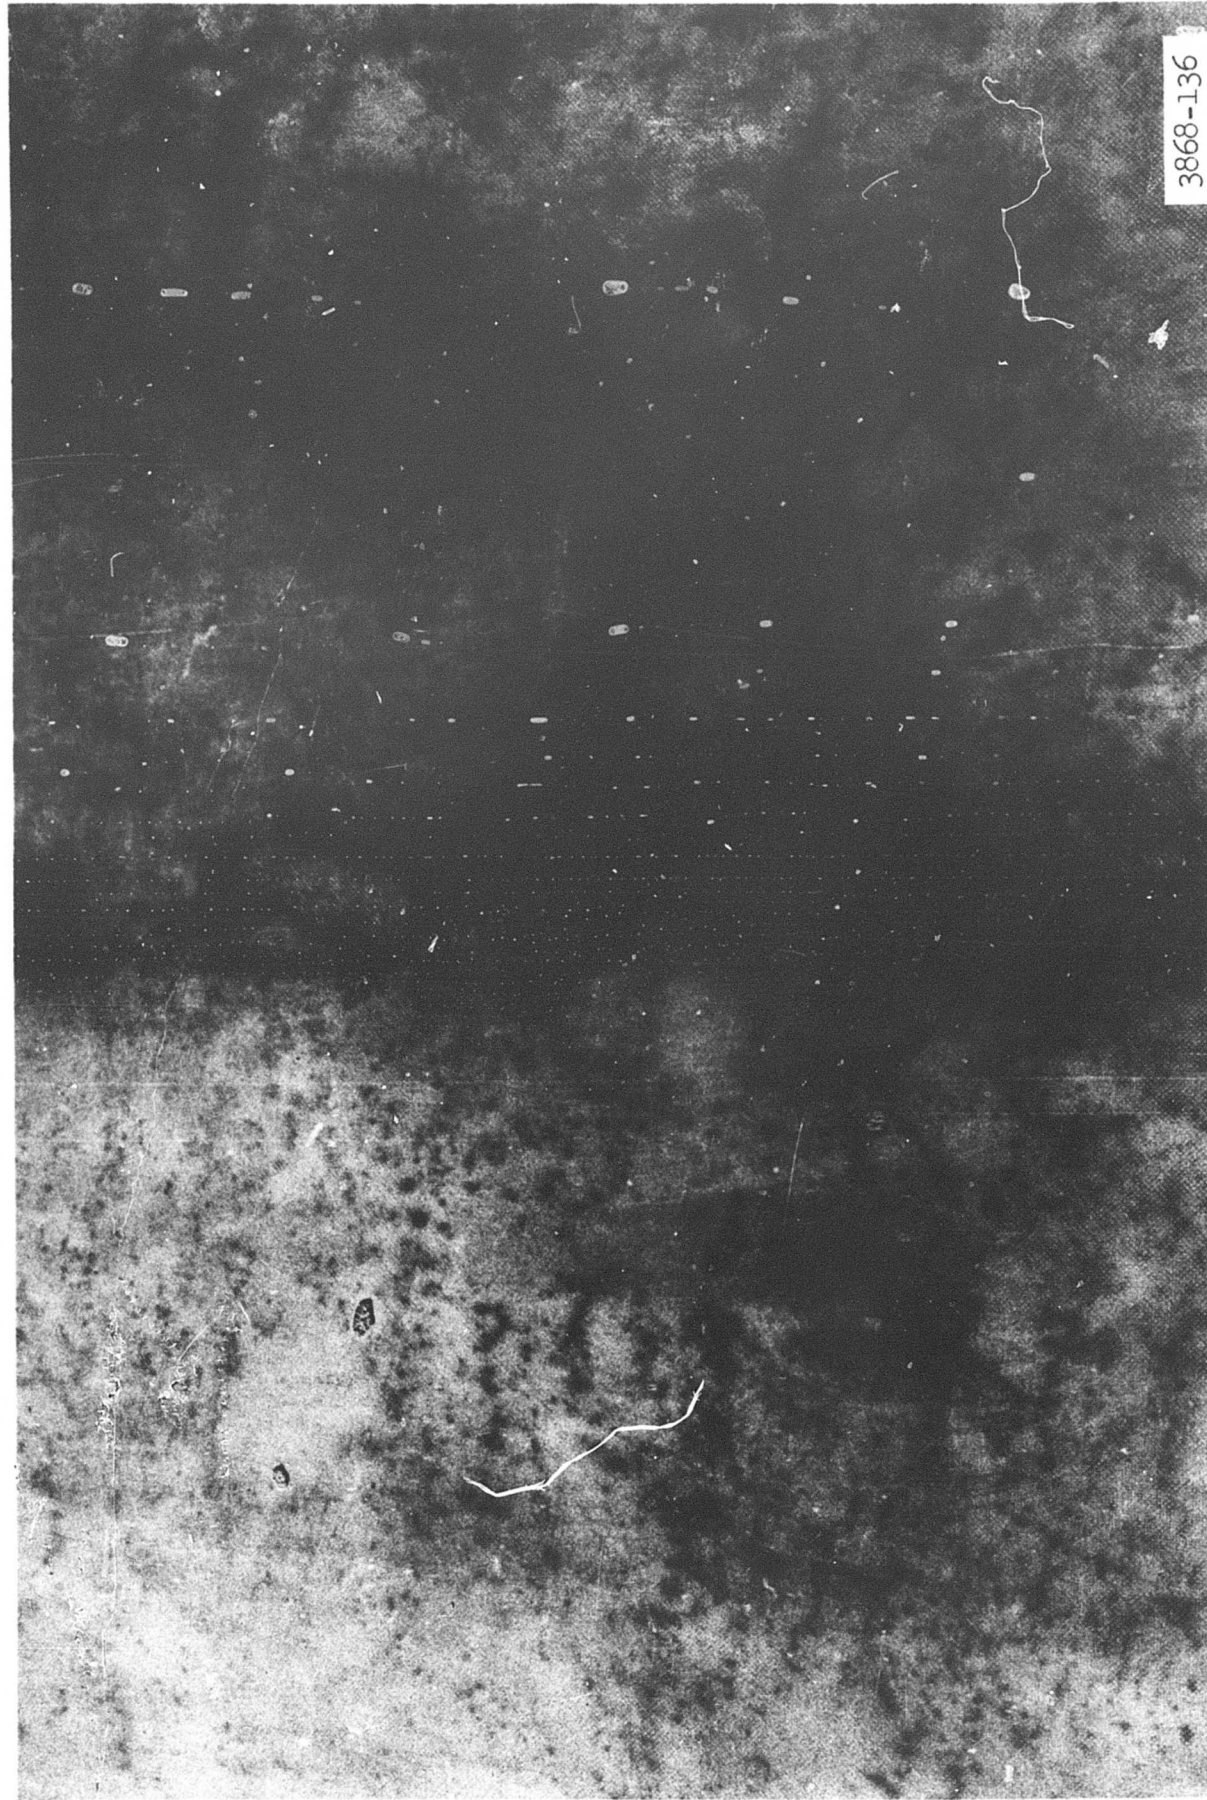
68. An analysis of the relative performance of the T16, T17, and WX18 membranes showed that the best service was obtained with the T16 and WX18. The T17 was not entirely satisfactory due to excessive failure of the factory-fabricated longitudinal joints. Since all three membranes are constructed of neoprene-coated nylon and differ only in weight and ply, it follows that the best service should be obtained with the WX18. In fact, in a recently completed comparison study in which both T16 and WX18 membranes were subjected to locked-wheel skid and short-radius turn tests using equivalent F-4C loadings, the WX18 membrane withstood the severe abrasions and tearing action of the skid and turn tests, whereas the T16 membrane failed.* In the same study, DBST over T1 membrane was also subjected to locked-wheel skid tests using equivalent F-4C loadings; however, both the DBST and T1 failed completely. Therefore, the WX18 is considered to be the superior membrane for use in areas on a runway or taxiway that are likely to be subjected to severe tire abrasion.

Photograph 32. Worn Tl6 membrane
