NRL Memorandum Report 1987

Examination of the Corrosion and Salt Contamination of Structural Metal From the USS TECUMSEH

H. R. BAKER, R. N. BOLSTER, P. B. LEACH, AND C. R. SINGLETERRY

> > March 1969

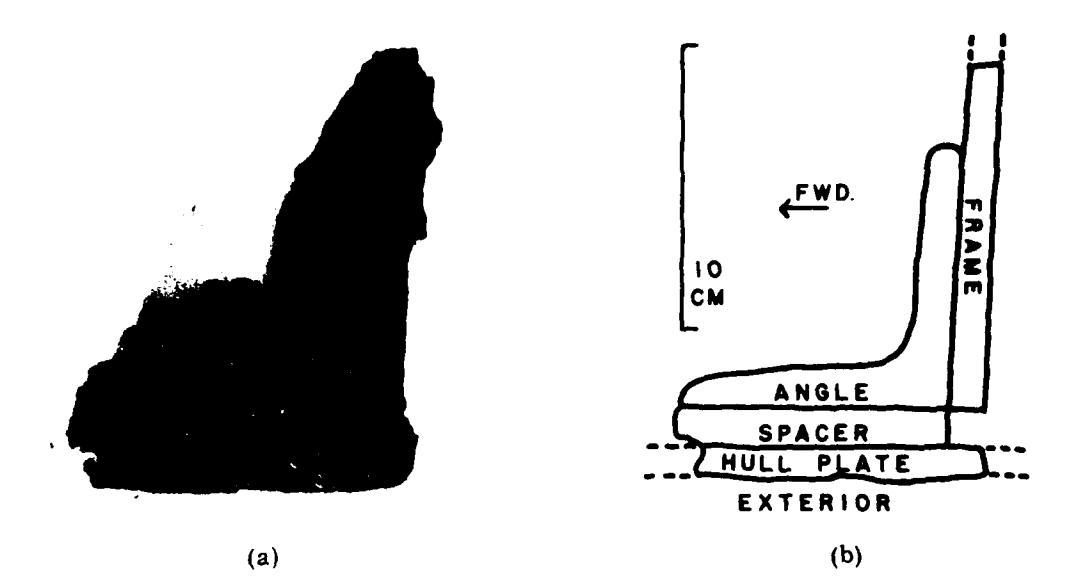
The specimens brought up by divers for study were a portion of a blower housing, two pieces of cast iron engine room deck plate, and of greatest interest, a section of the hull including hull plating and a portion of a transverse frame. This ship was not of ironclad construction. Although some wood was used in its construction, the hull was built principally of wrought iron plates 1/2 inch thick joined by rivetting. The hull specimen was cut from the "B" strake on the starboard side near frame 42. Roughly 60 x 40 cm in size, it consisted of exterior hull plating, a spacer, and frame plate fastened to 9 cm angle iron by 6 rivets (Fig. 1). The specimen and the deck plate were selected for careful study as being of particular interest and generally representative of the condition of all the iron structure and objects in the ship. The hull specimen and the large piece of deck plate were sectioned with a bandsaw into manageable pieces for laboratory examination.

Fig. 1 - Section of hull structure from the Tecumseh

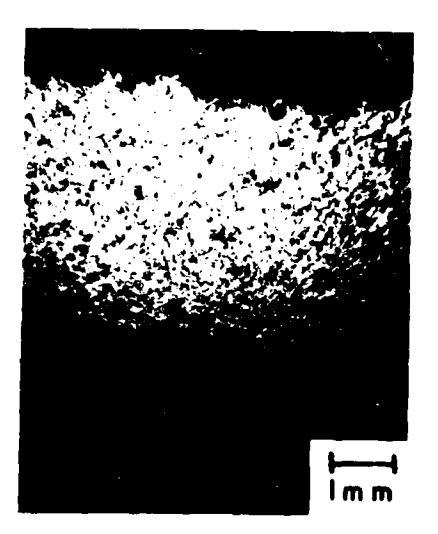
Fig. 3 - Polished section of cast iron deck plate and oxide layers showing inclusions in the metal (perpendicular to the plane of the plate, not etched)

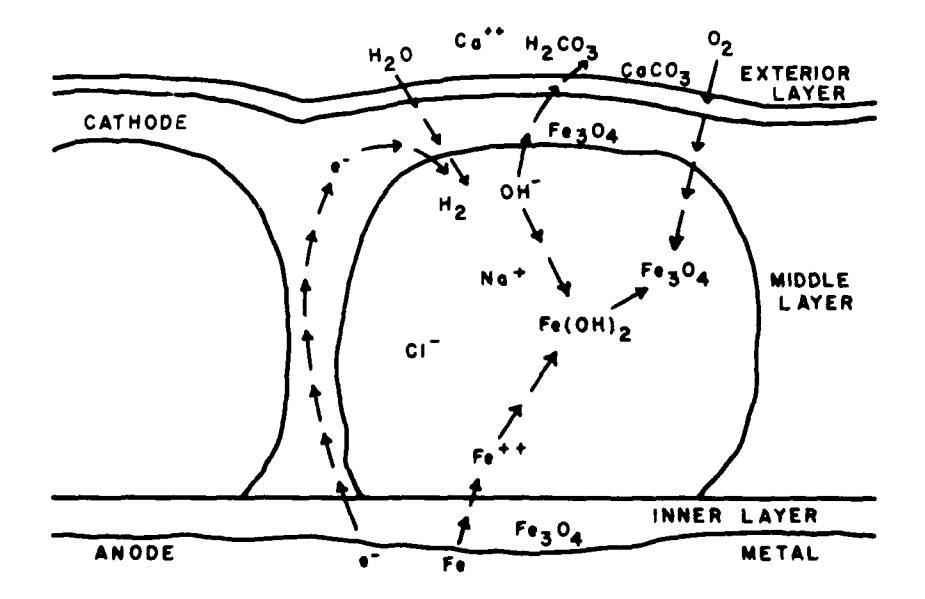
The observed characteristics of the scale are compatible with the corrosion mechanisms described by Evans (4). Figure 9 is a schematic representation of a porous oxide layer, in contact with the metal, and permeated with seawater. The oxide is cathodic to the metal, so that a galvanic corrosion cell is formed. Ferrous chloride is formed at the metal surface and sodium hydroxide at the oxide surface. These come together and form ferrous hydroxide which is further oxidized by oxygen diffusing into the scale. The oxides thus are formed within the scale, causing it to grow outward from the region in which the mobile ferrous ions and hydroxyl ions meet to form the insoluble ferrous hydroxide. This region is apparently in the middle scale layer. The rate at which the corrosion proceeds is controlled by the rate at which oxygen diffuses into the scale from the

surrounding water. Meanwhile, the slight alkalinity in the scale causes calcium carbonate to deposit forming the exterior layer. This dense layer ultimately limits the diffusion of oxygen into the scale and virtually halts the corrosion of the metal over which it lies.

Fig. 9 - Scale-forming reactions
