SKIWAY FOR C-130 AIRCRAFT AT PALMER STATION,  
ANTARCTICA

Naval Civil Engineering Laboratory  
Port Hueneme, California

Technical Note N-1067

December 1969

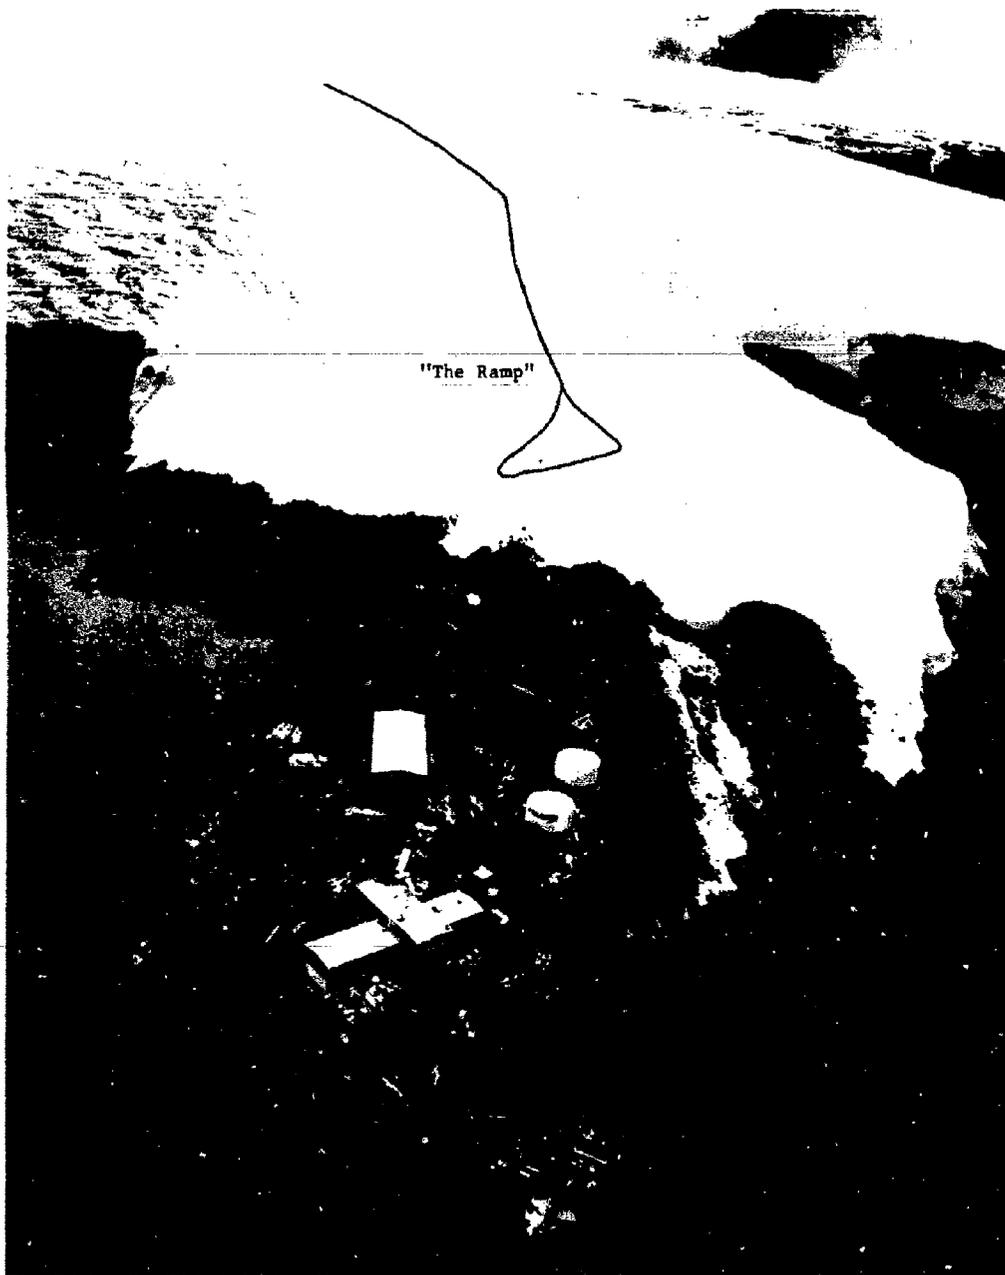
Access. East of Palmer Station, the ice cap extends from the coastal rock contact to an elevation of about 350 feet in the form of a buttress-shaped ice hill situated between vertical ice cliffs 80 to 100 feet high (Figure 4). This hill, known as The Ramp, is free of crevasses for a width of at least 600 feet and provides an excellent and stable access route to the upper ice piedmont. The trail up the ramp trends almost due east for about 3,000 feet with slopes varying between 5 and 7 degrees from the horizontal. The trail then curves to approximately true north where it goes between two large crevasses that are about 150 feet apart and 300 feet long (Figure 5).

Figure 4. The snow ramp providing access to the upper ice piedmont from Palmer Station.

Future cargo handling requirements between Palmer and the skiway are not known; however, it is assumed that transportation needs will be mostly for personnel and light cargo. The steep gradient of the ramp would require a tracked vehicle powerful enough to pull a fully loaded 1-ton sled up a 7 degree slope and stable enough to turn on or traverse the hillside. A commercially available 10-passenger 1-ton tracked vehicle would probably be sufficient for this work.

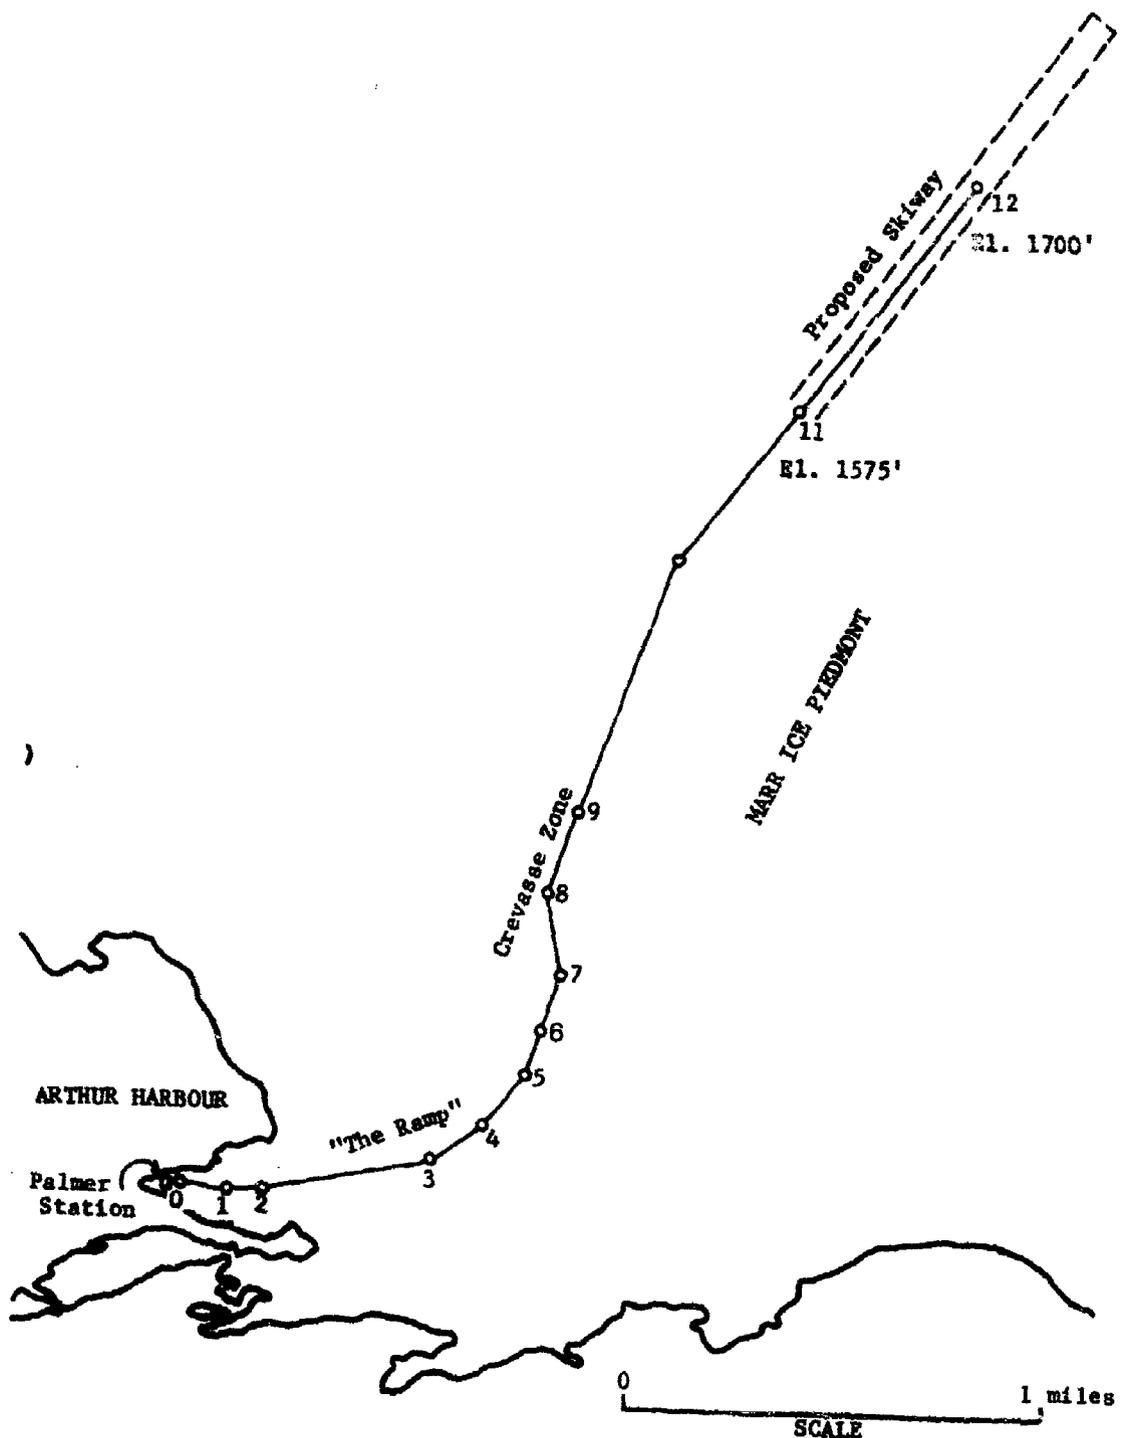
Figure 5. Surveyed route to the proposed skiway on the Marr Ice Piedmont.

Trail Marking. The trail shown in Figure 5 should be marked with a single line of bamboo poles spaced no more than 200 feet apart and well flagged. During travel, the vehicle driver should keep the trail on his left and not wander more than 30 feet from the flagged poles on either side of the trail. During February 1969, the surveyed route was traveled several times with a heavily loaded motor toboggan and is considered safe for light to medium-weight tracked vehicles; however, short-cuts should not be attempted under any circumstances.

- (1) The access route to the skiway should be relocated using the data in Table I.
- (2) A single row of flags, spaced at 200-foot intervals, should be used to mark this route.
- (3) When traveling over this route, the vehicle driver should adhere closely to the flagged trail.
- (4) The skiway markers should consist of flagged, bamboo-pole tripods to minimize drift.
- (5) Permanent facilities at the skiway should not be considered because of the heavy annual snowfall.
- (6) Skiway markers and route flags will require annual replacement because of the heavy snowfall.
